MONITORING YEAR 2 ANNUAL REPORT FINAL

MCLENNY ACRES MITIGATION SITE

Wayne County, NC
Neuse River Basin
HUC 03020201

DMS Project No. 100038
NCDEQ Contract No. 7423
DWR Project No. 2018-0197
USACE Action ID No. 2018-02042

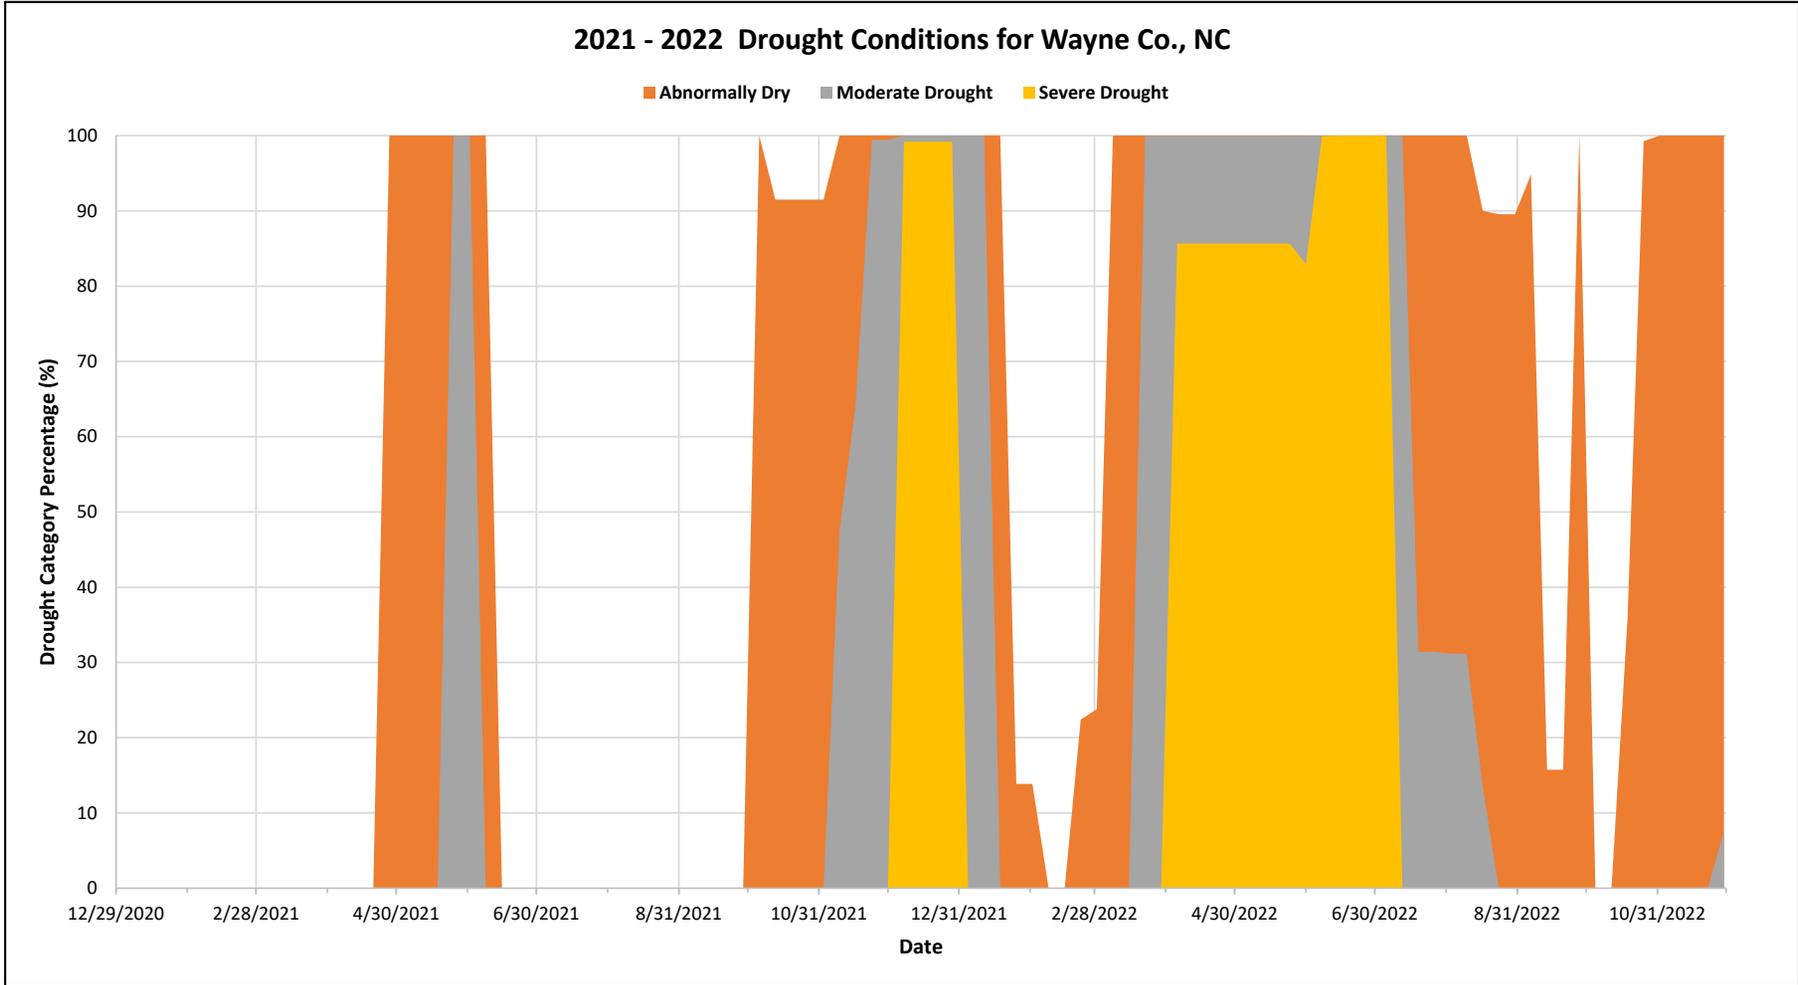
Graph 1. 2021 - 2022 Drought Conditions for Wayne Co., NC

Stream and wetland hydrology has been significantly affected by drier than normal weather conditions that have occurred from September of 2021 until the present in the Wayne County area. The National Integrated Drought Information System (NIDIS) indicates that conditions ranging from “abnormally dry” to “severe drought” have occurred almost continuously since September of 2021 (Graph 1). Water levels in streams and wetlands on mitigation sites throughout the Wayne County area were clearly lower for more prolonged periods of time during 2022 than has occurred in at least the past five years of mitigation monitoring observation.
