**MONITORING YEAR 3
ANNUAL REPORT
FINAL**

MCLENNY ACRES MITIGATION SITE

Wayne County, NC
Neuse River Basin
HUC 03020201
DMS Project No. 100038
NCDEQ Contract No. 7423
DWR Project No. 2018-0197
USACE Action ID No. 2018-02042

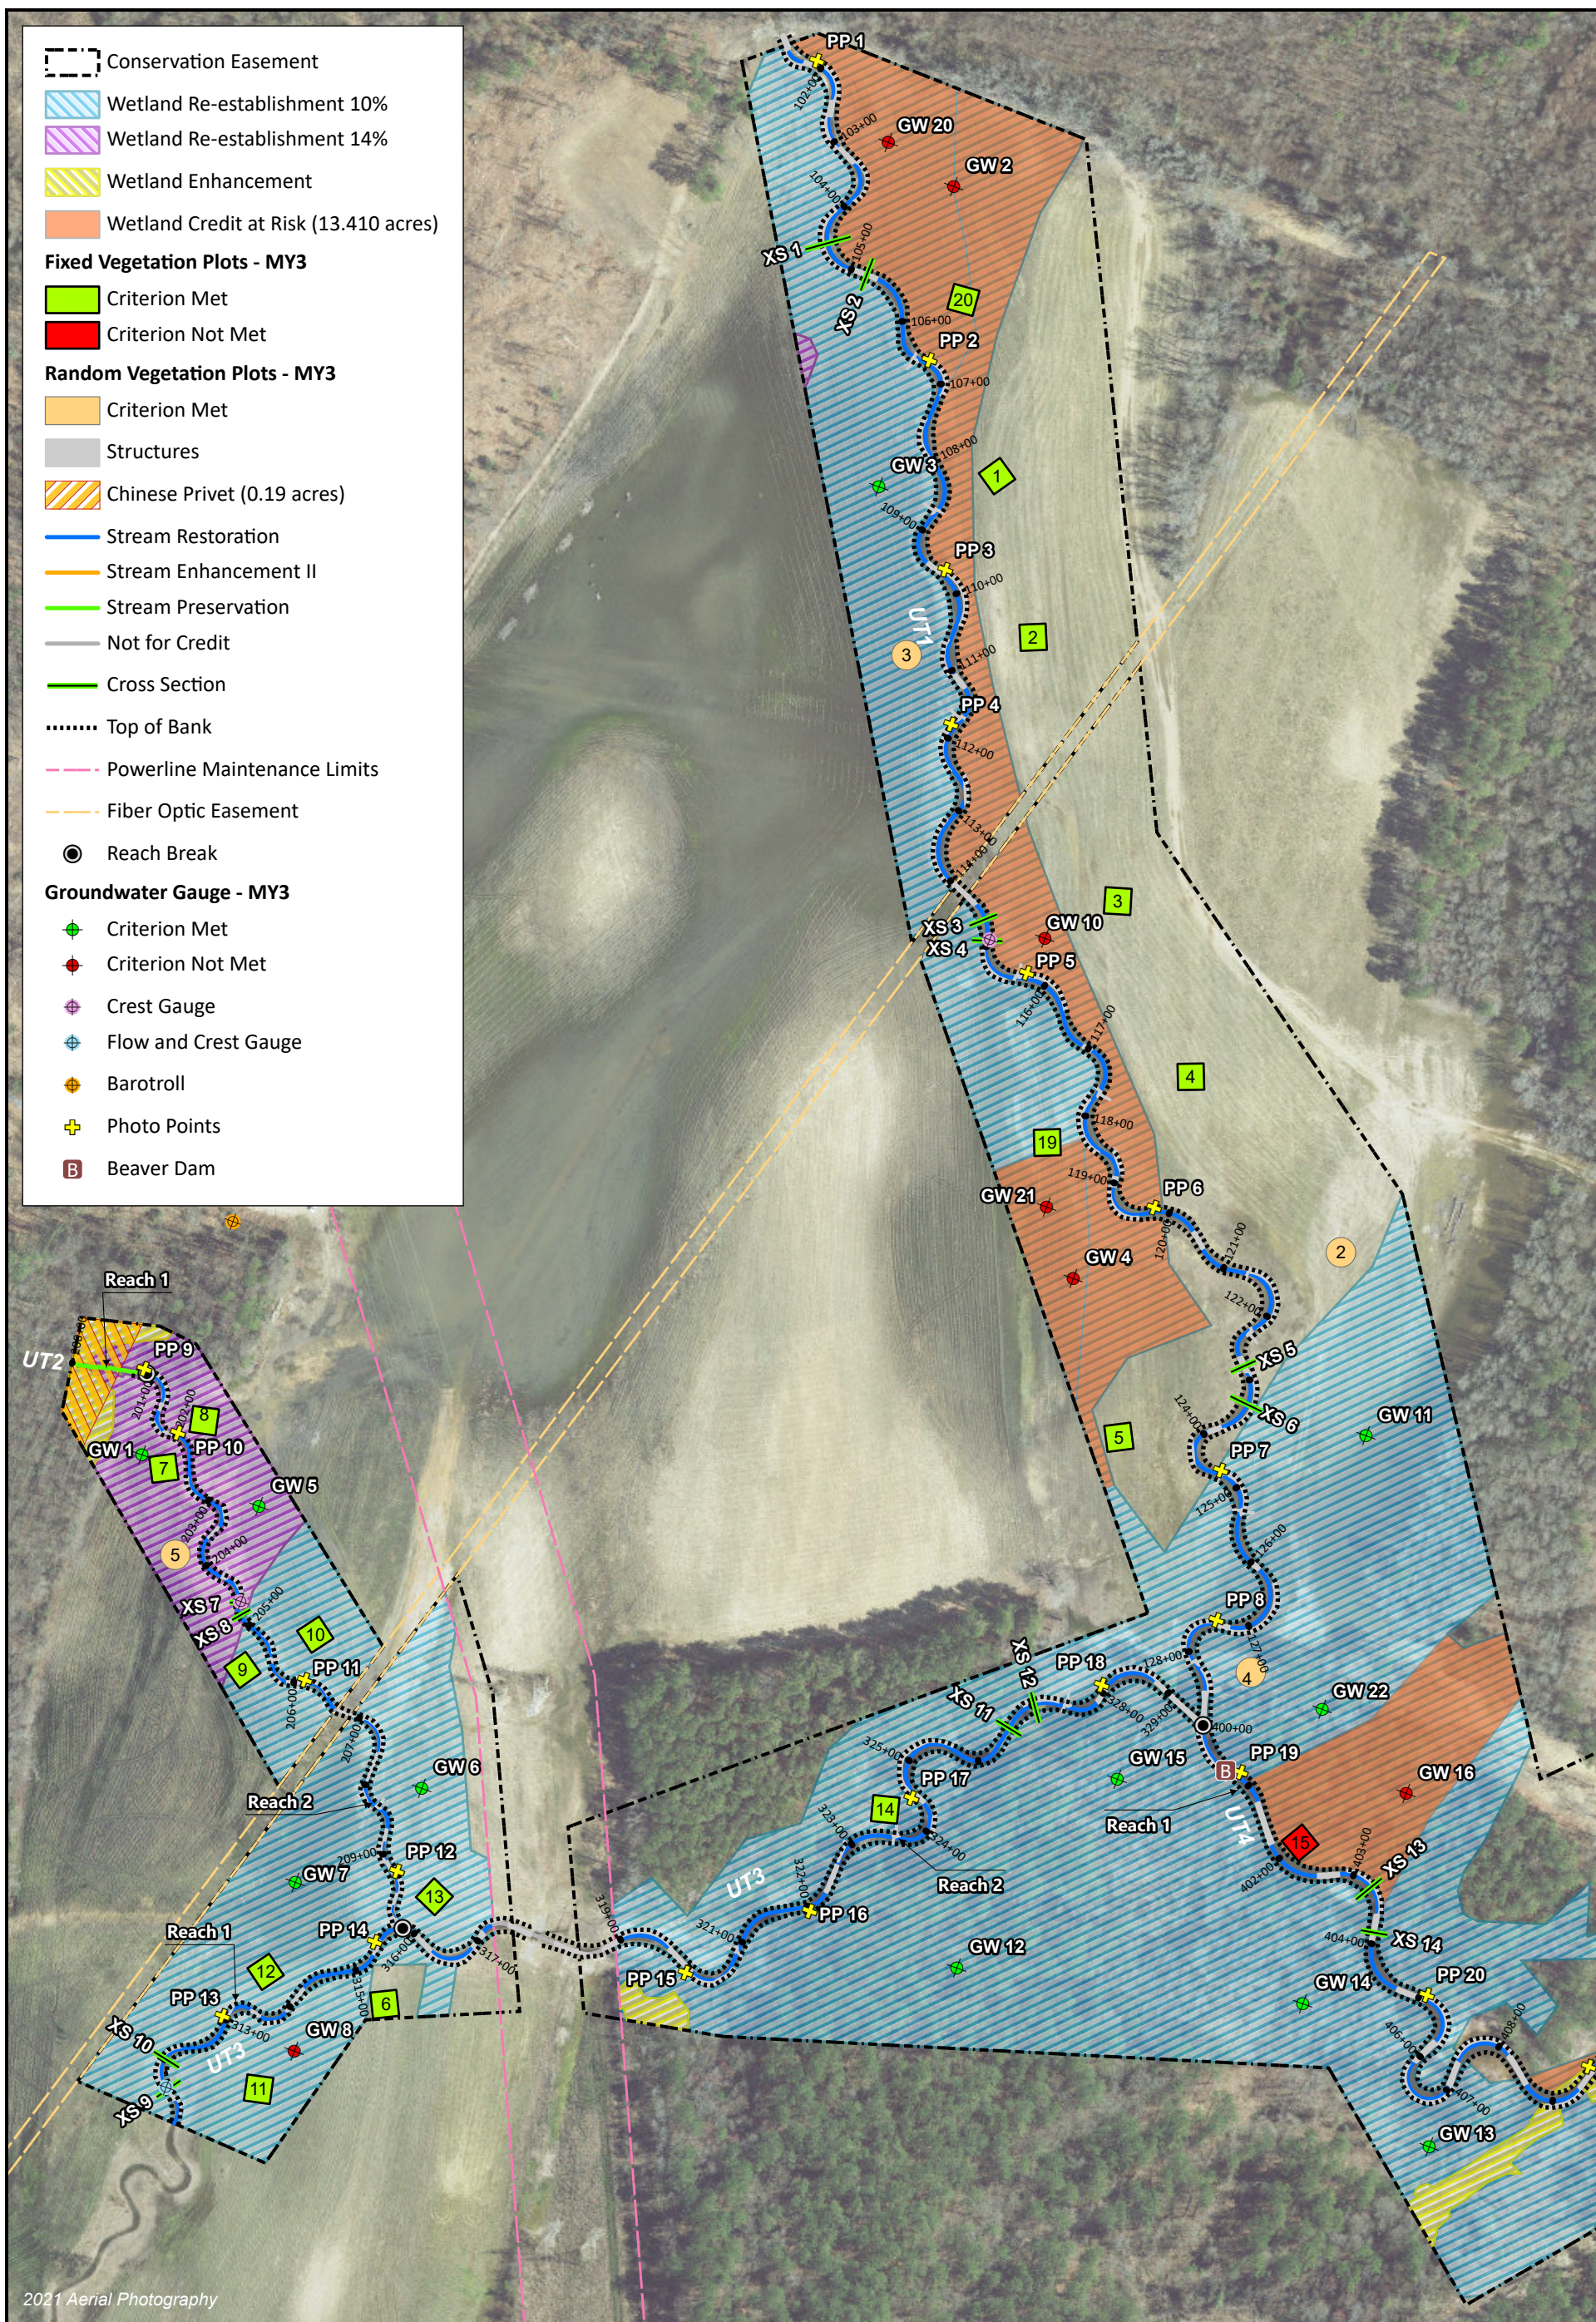
Chinese privet (*Ligustrum sinense*) was previously treated within a 0.19 acre forested area during December 2022 (Table 14). Scattered stems of privet have resprouted in this area (Figure 1a) but it is low growing and treatable with a foliar spray.

Beaver activity was observed during November of MY3. A small beaver dam is located just below the confluence of UT1 and UT3 (Figure 1a). The top of the dam and the backwater are below bankfull elevation. Impacts to vegetation area minimal and full vegetation recovery is likely. Coordination for beaver removal is currently ongoing.
