**MCDONALDS POND RESTORATION SITE  
2006 Annual Monitoring Report (Year 1)**

**Richmond County, North Carolina  
EEP Project No. D04020-2  
Design Firm: International Paper**

**December 2006**

**Prepared by: ECOSCIENCE CORPORATION  
1101 Haynes Street, Suite 101  
Raleigh, North Carolina 27604**

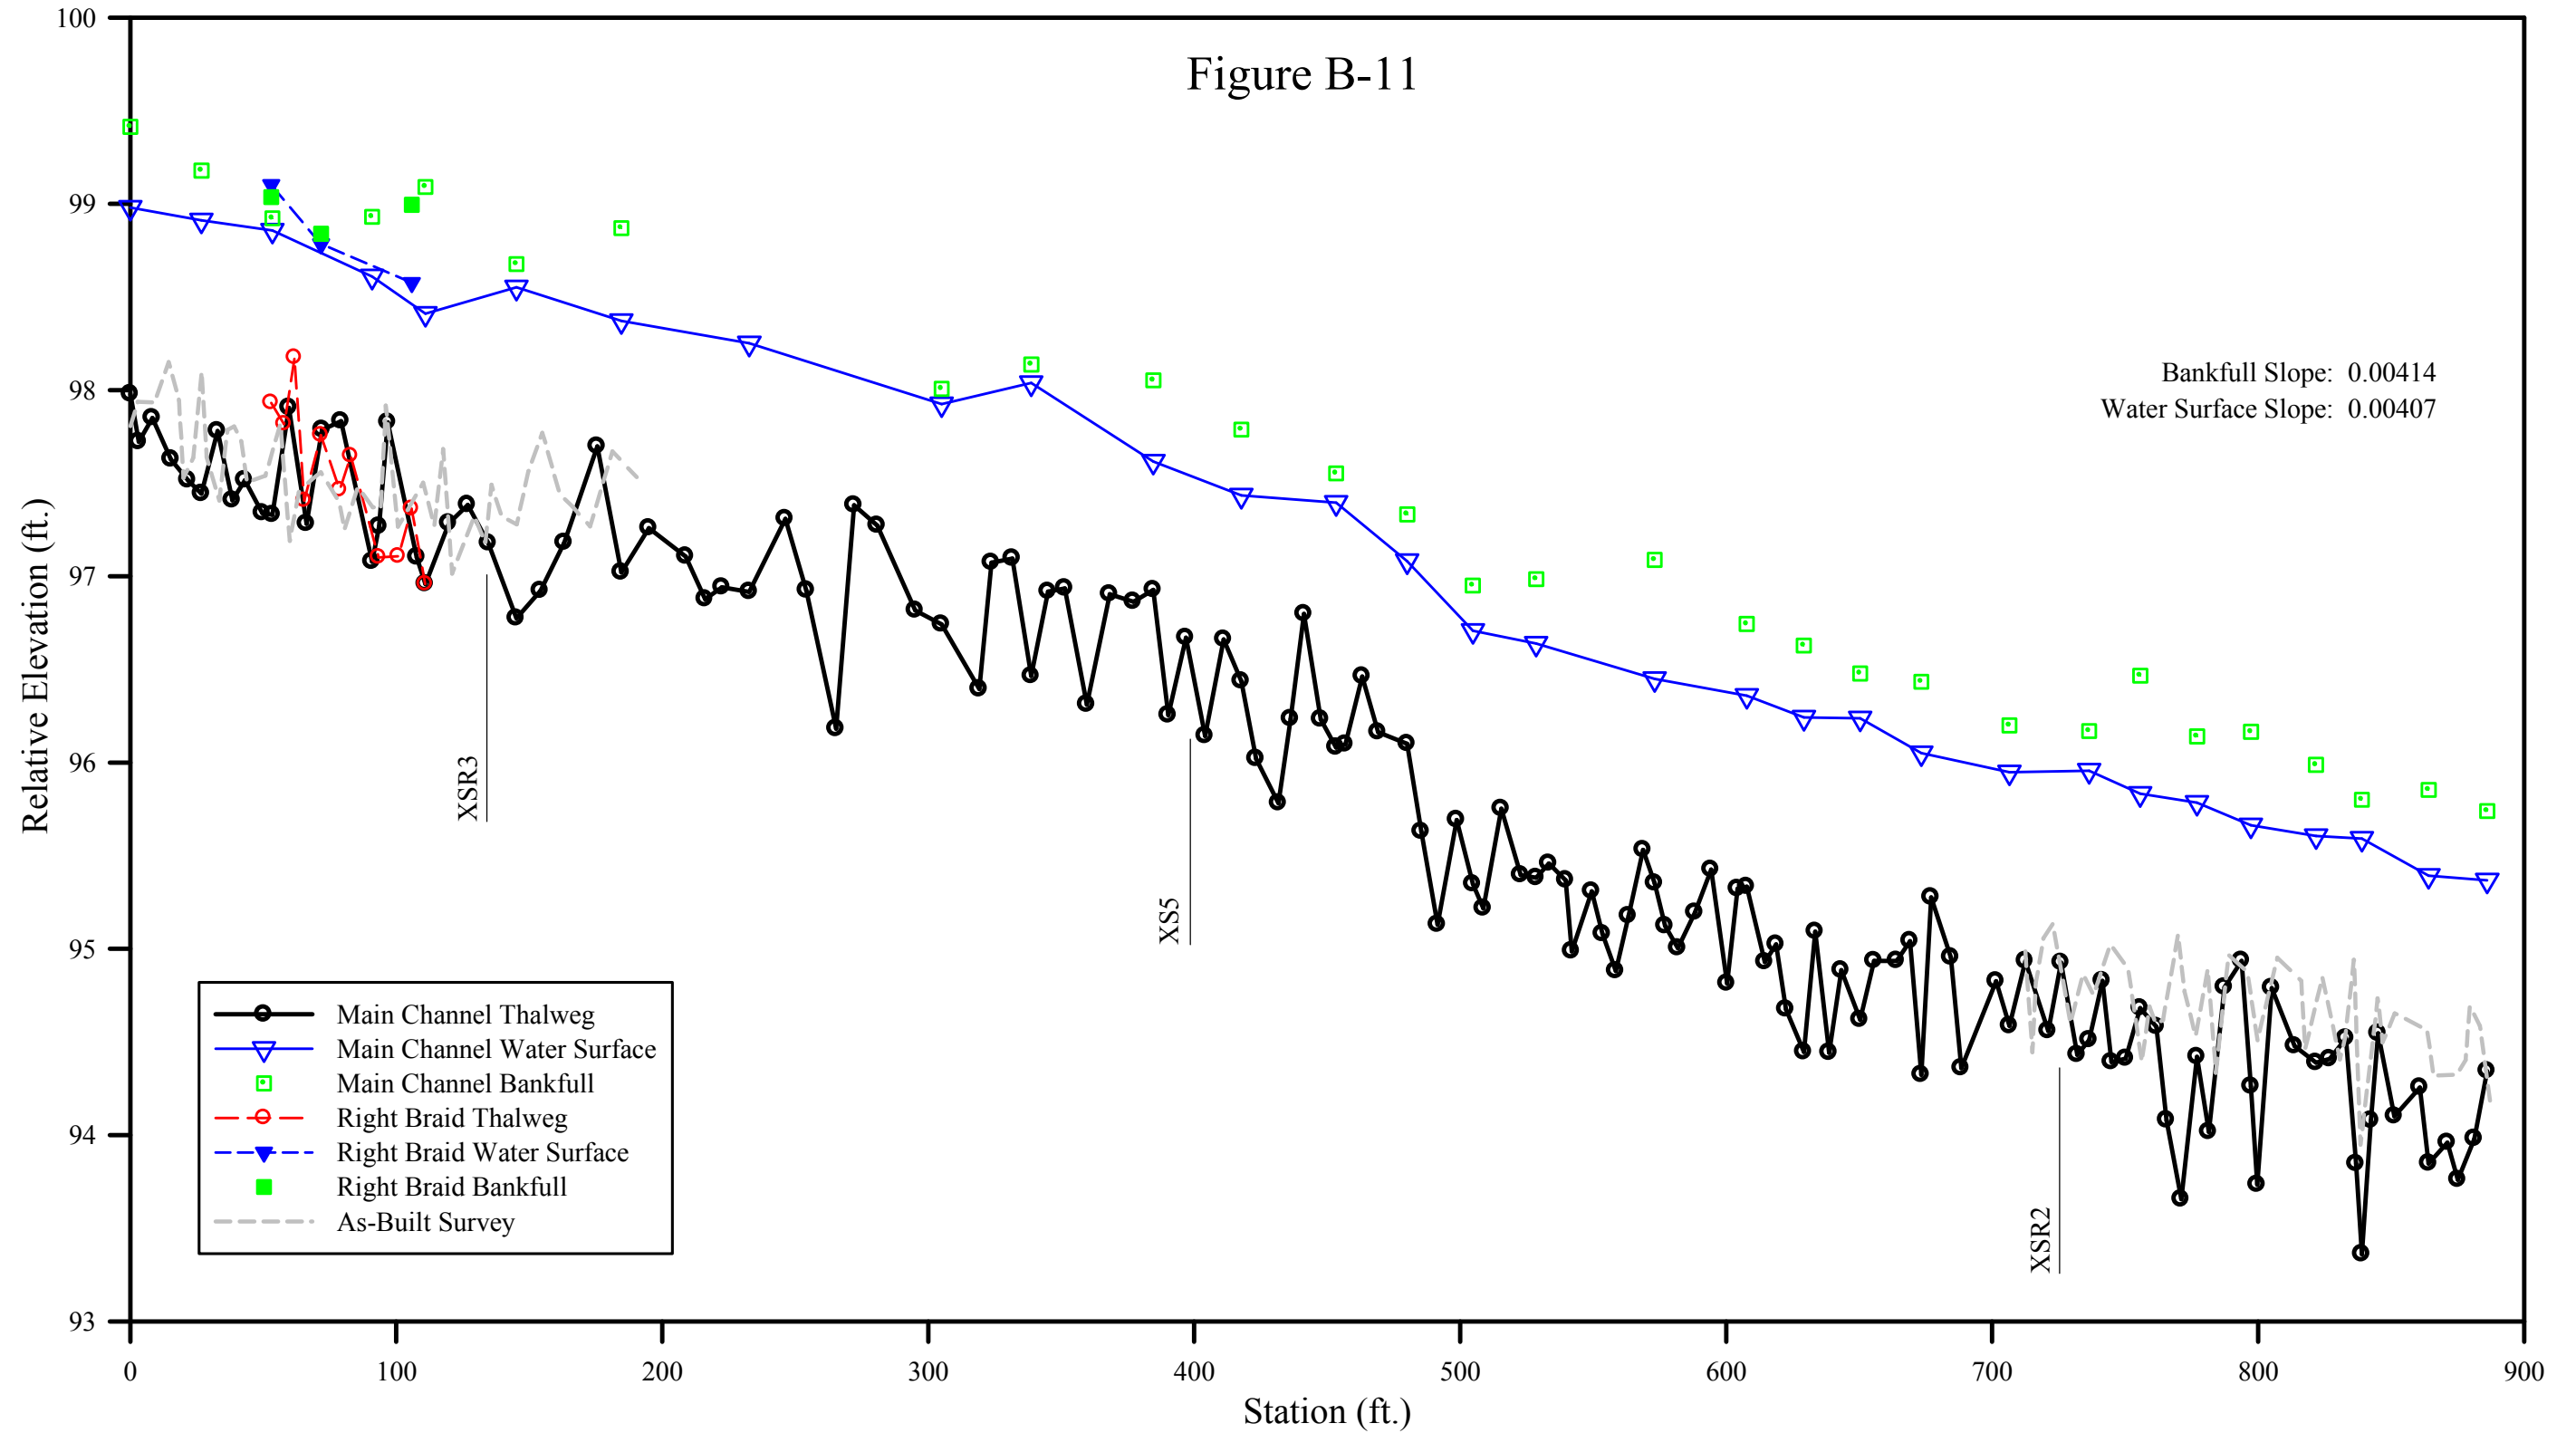
## Longitudinal Profile

Stream longitudinal profile was surveyed for approximately 900 feet within the restored channel, including the section of stream between on-Site Reach 3 and on-Site Reach 2 (Figure 2, Appendix A). Longitudinal profile data for this portion of the stream was plotted along with available As-Built conditions in Figure B-11, Appendix B. A typical riffle/pool sequence is currently absent from this portion of the stream. The Site's natural low gradient and the large amount of coarse woody debris present within the channel has produced numerous depositional features (traverse and diagonal bars) scattered among scour pools of varying sizes. As a result, longitudinal profile parameters were not generated for the stream due to the complexity and irregularity of the channel bed.

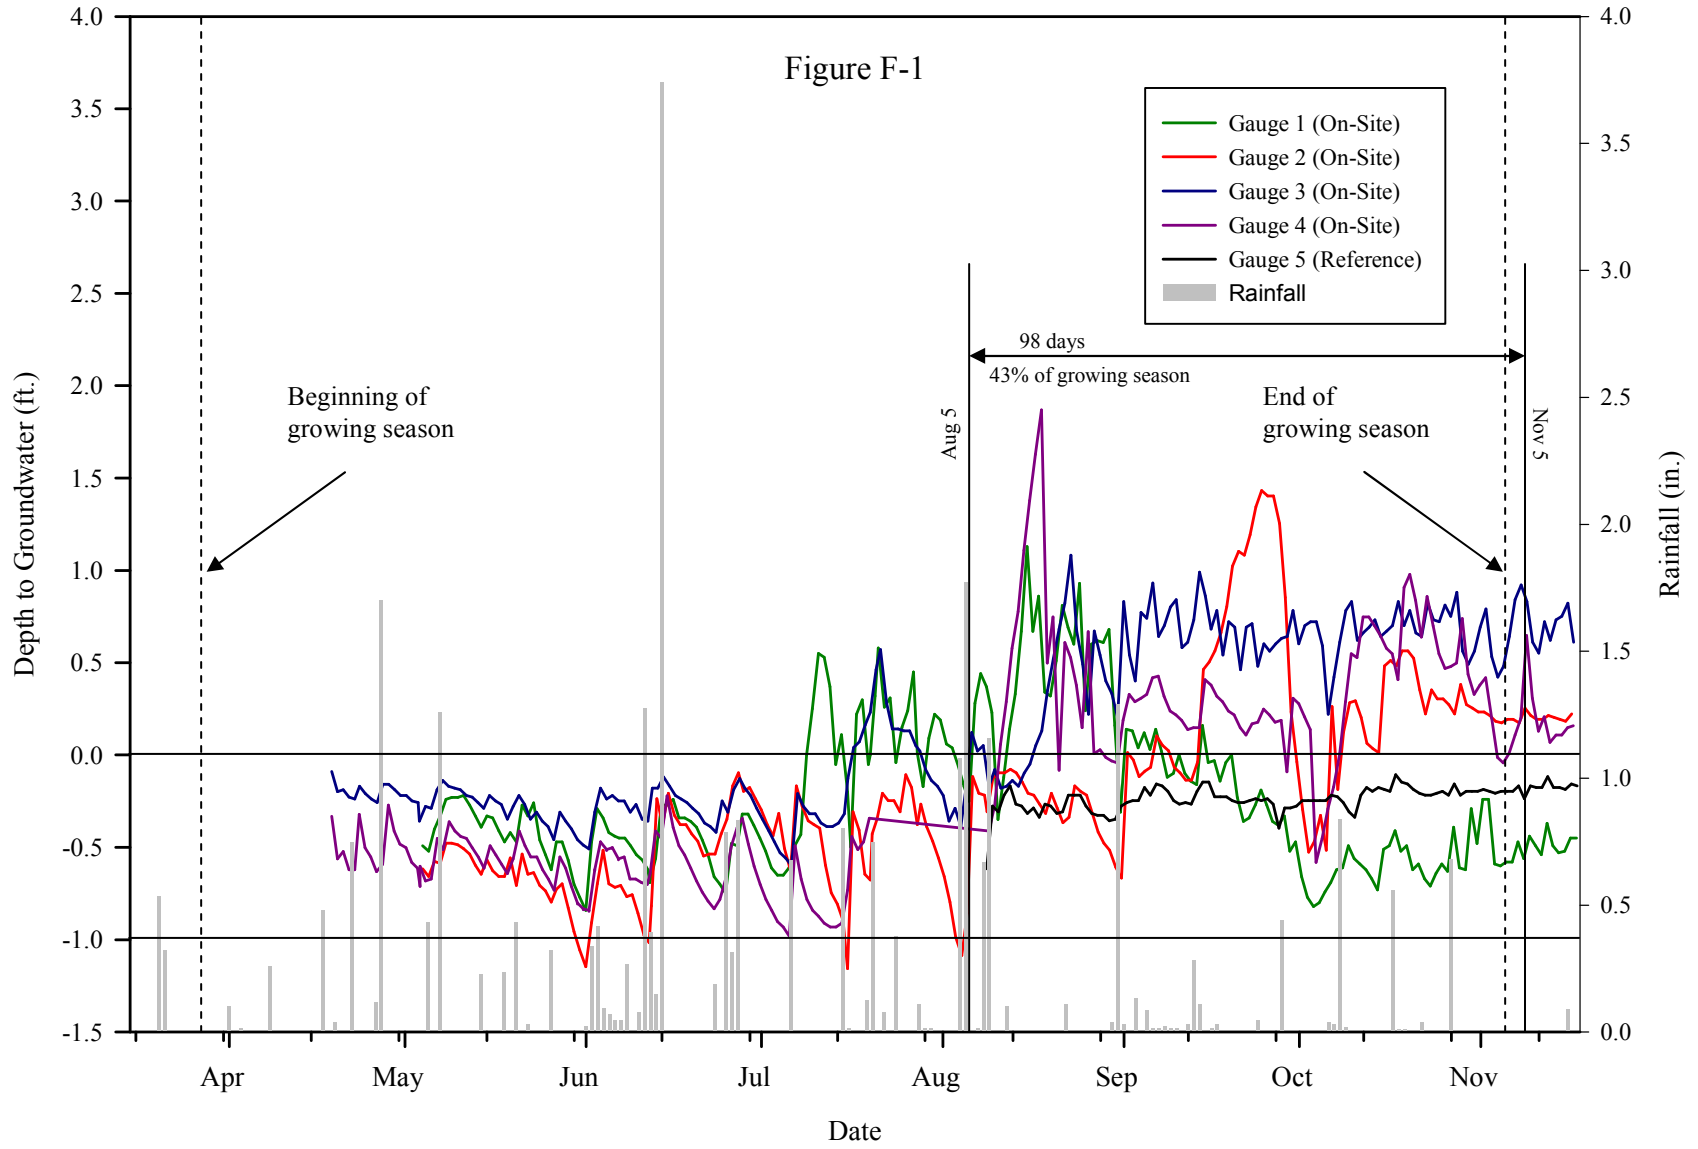
### McDonalds Pond Restoration Site Groundwater Gauge Hydrographs Monitoring Year 1 (2006)

All four (4) groundwater gauges located on-Site are currently meeting the wetland hydrologic success criteria. Groundwater levels were recorded within the upper 12 inches of the soil surface for approximately 98 consecutive days corresponding to approximately 43 percent of the growing season [March 27<sup>th</sup> – November 5<sup>th</sup>] in Richmond County (NRCS 1999). Groundwater gauge locations are depicted in Figure 5 (Appendix A). Groundwater gauge hydrographs are plotted on Figure F1 (Appendix F).
