**MCDONALDS POND RESTORATION SITE
2007 Annual Monitoring Report (Year 2)**

**Richmond County, North Carolina
EEP Project No. D04020-2
Design Firm: International Paper**

February 2008

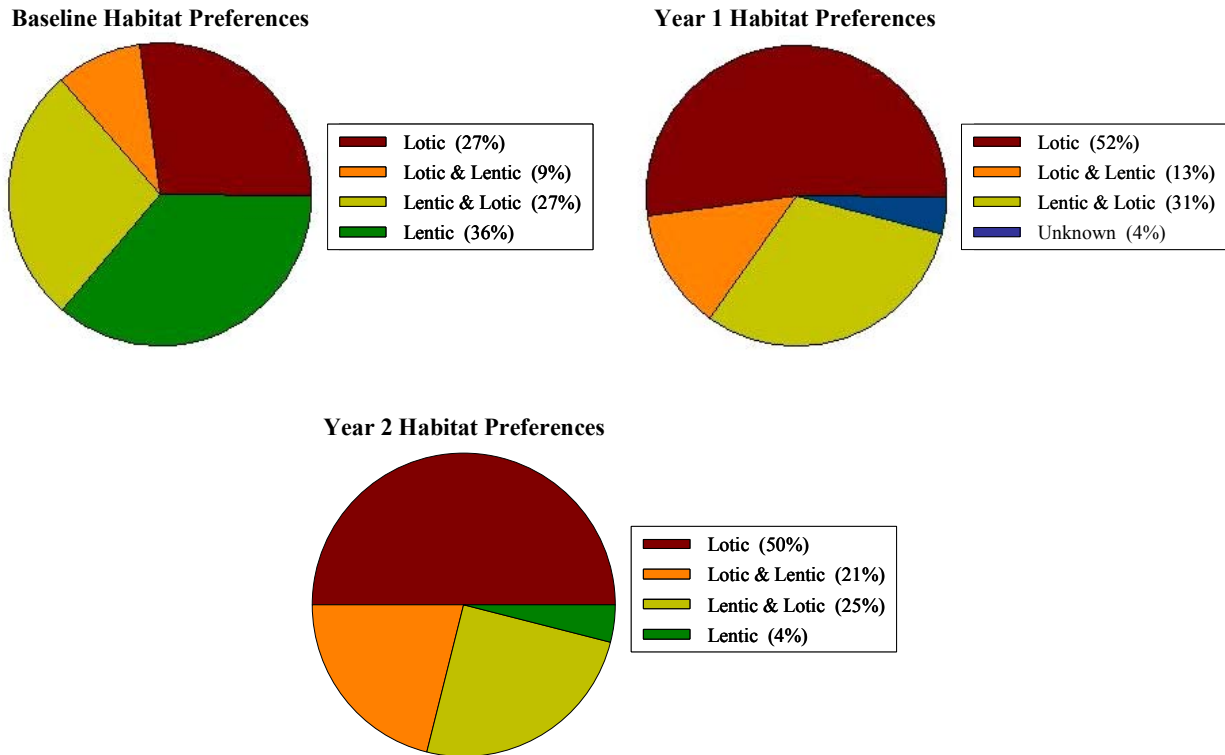
Graph 1. Baseline, Year 1, and Year 2 comparisons between collected benthic macroinvertebrates and their habitat preferences (Source: Merritt and Cummins 1984).

Aquatic community assemblages within the former pond continue to develop characteristics associated with a lotic system. Fifty percent (50%) of the macroinvertebrate samples collected during Year 2 monitoring from restored segments of Falling Creek (within the former pond) consisted of macroinvertebrate genera predominantly found in lotic systems. Compared to Year 1 monitoring, genera found in both lotic and lentic systems (with a preference for lotic) increased by 8 percent (8%) within Falling Creek. Genera predominantly found in lentic systems made up only 4 percent (4%) of taxa collected from Falling Creek.

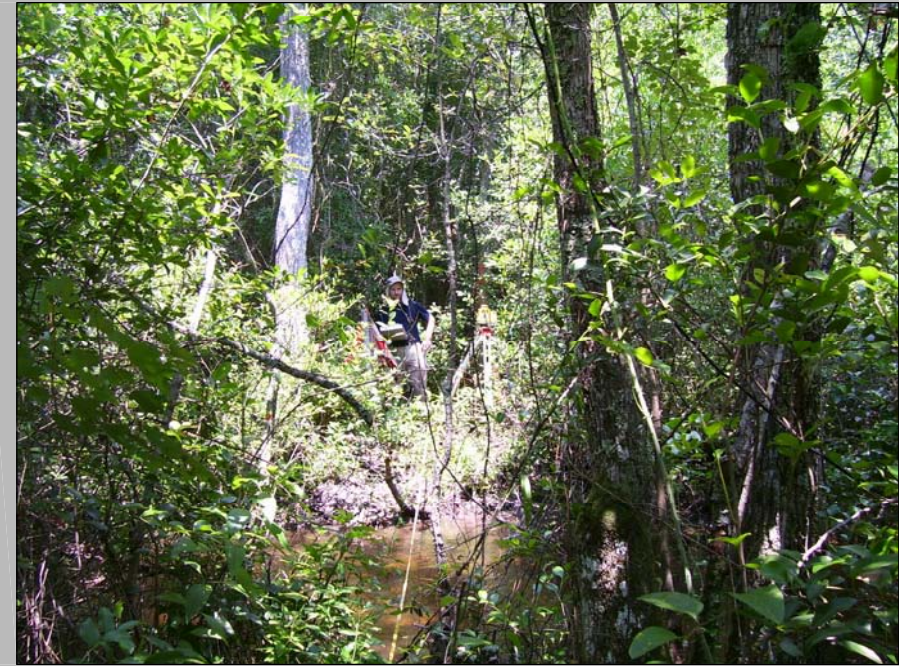
XS1 LEFT BANK LOOKING RIGHT BANK

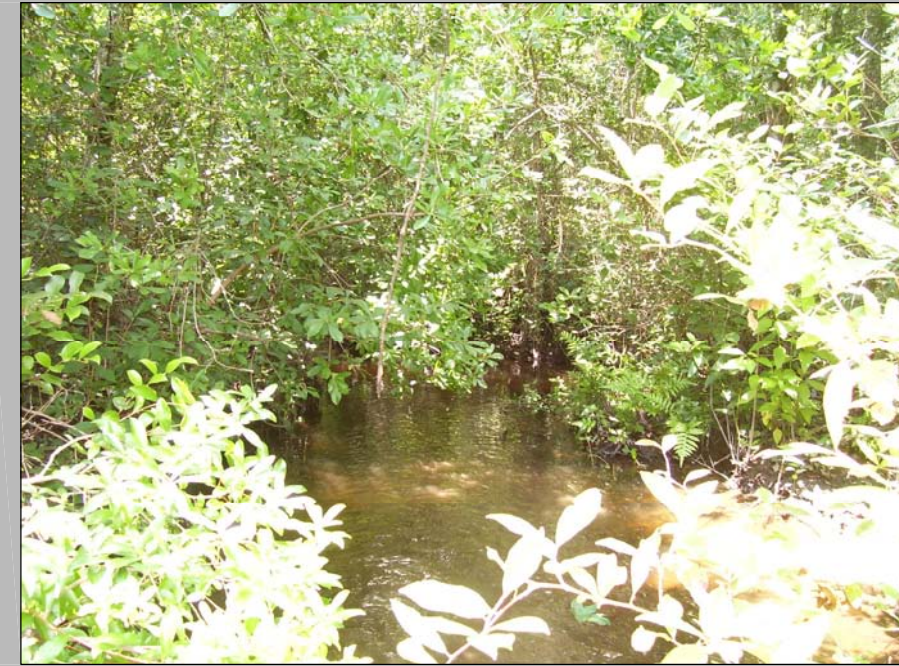
XS1 LOOKING DOWNSTREAM

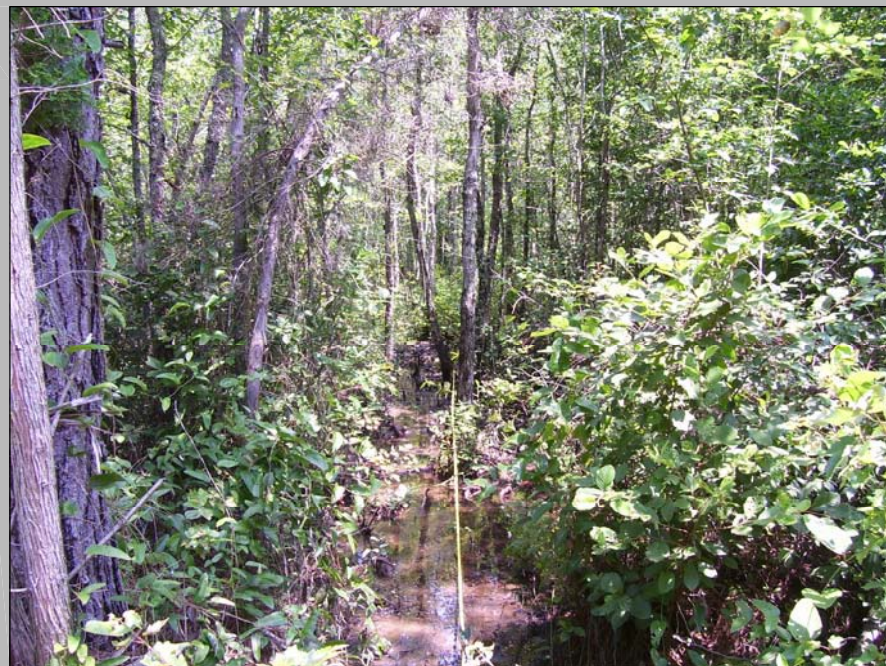
XS2 LEFT BANK LOOKING RIGHT BANK

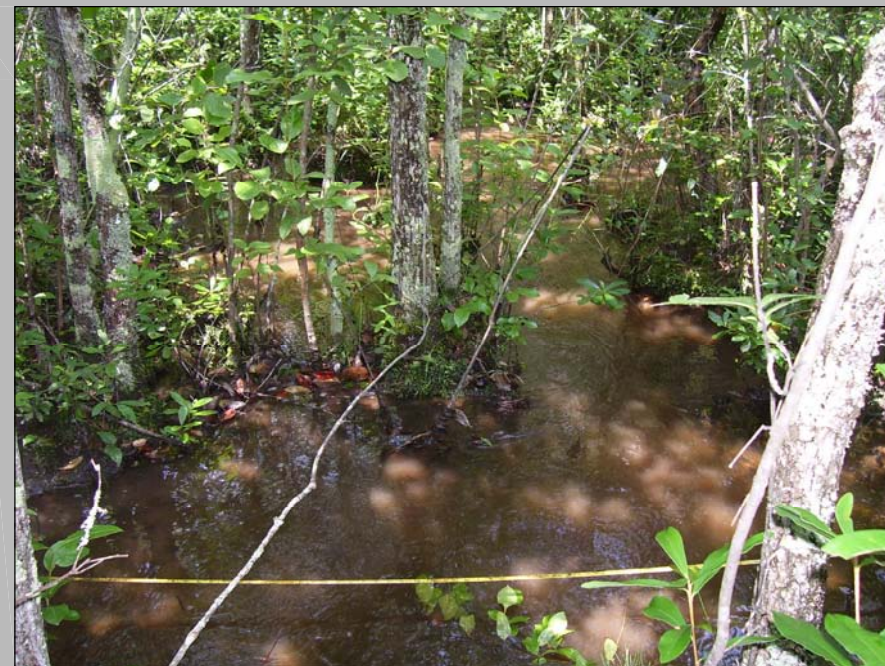
XS2 LOOKING DOWNSTREAM AT 113 ft.

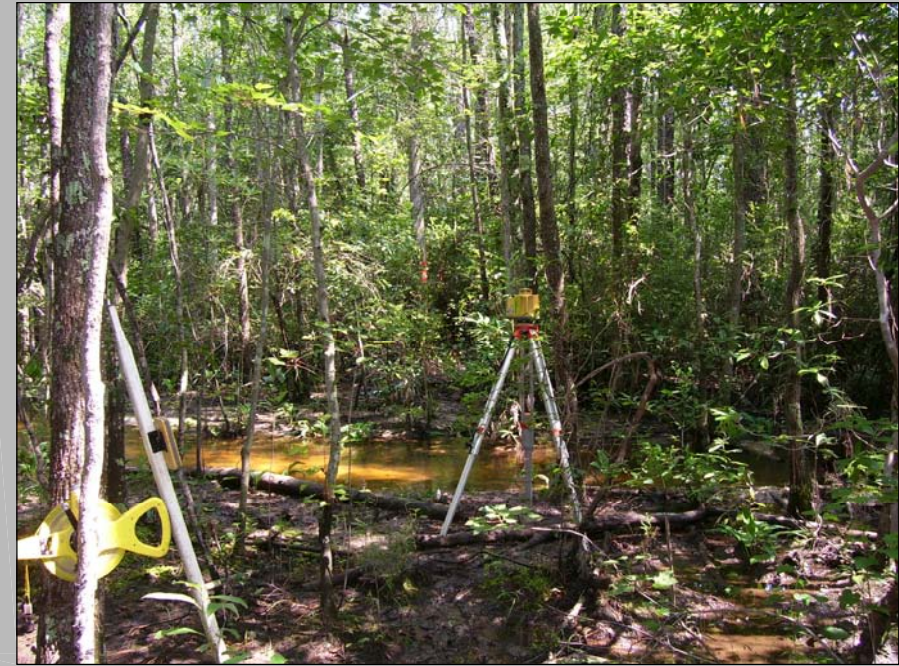
XS3 LEFT BANK LOOKING RIGHT BANK

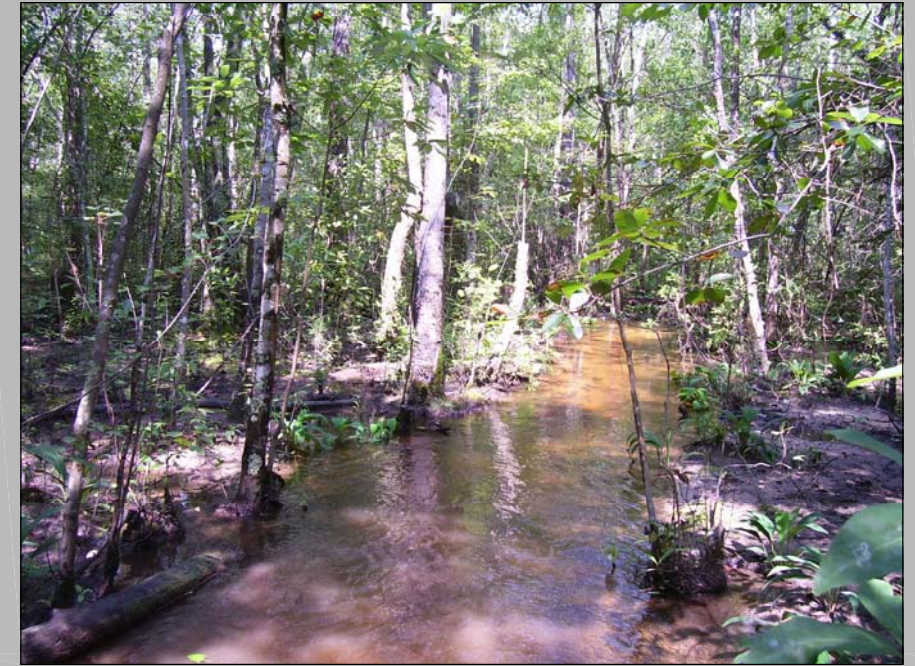
XS3 LOOKING DOWNSTREAM

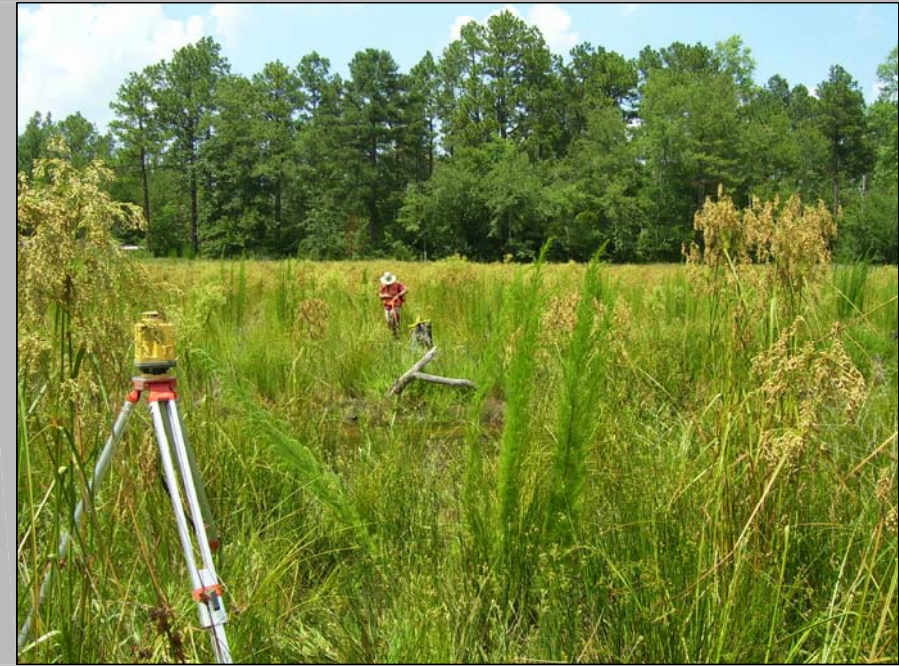
XS4 LEFT BANK LOOKING RIGHT BANK

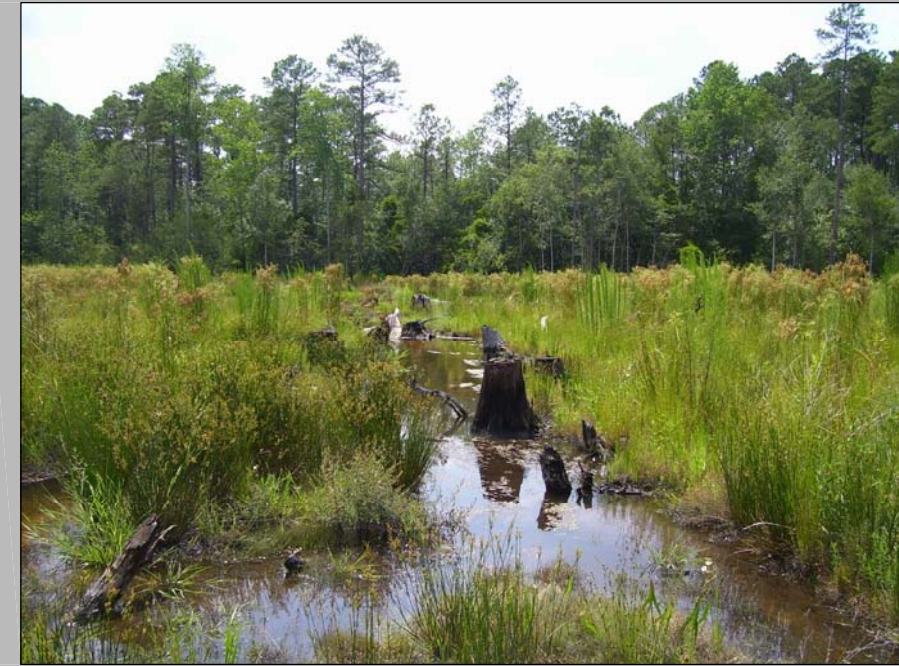
XS4 LOOKING DOWNSTREAM

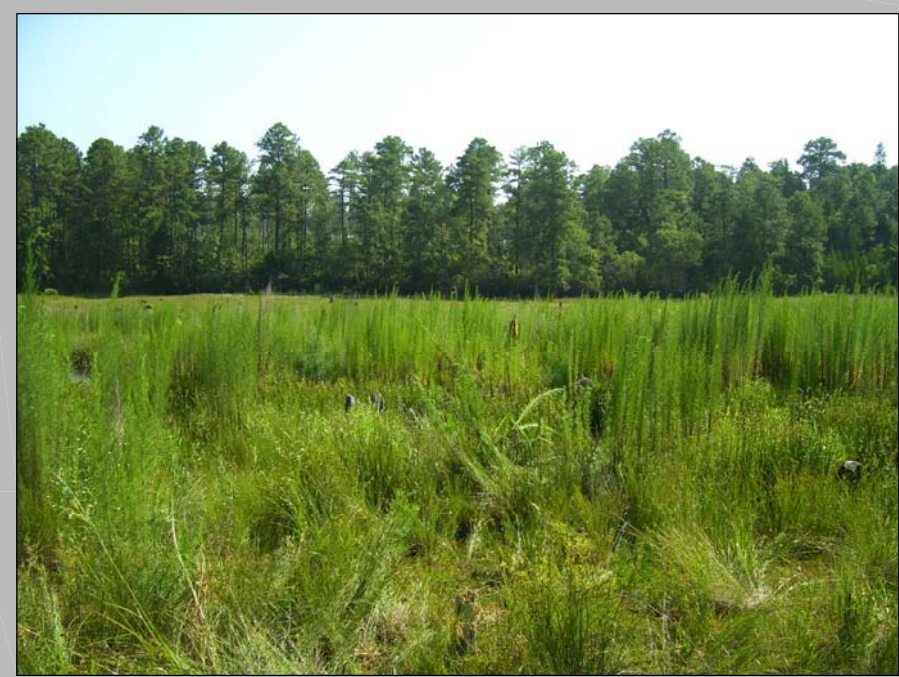
XS5 LEFT BANK LOOKING RIGHT BANK

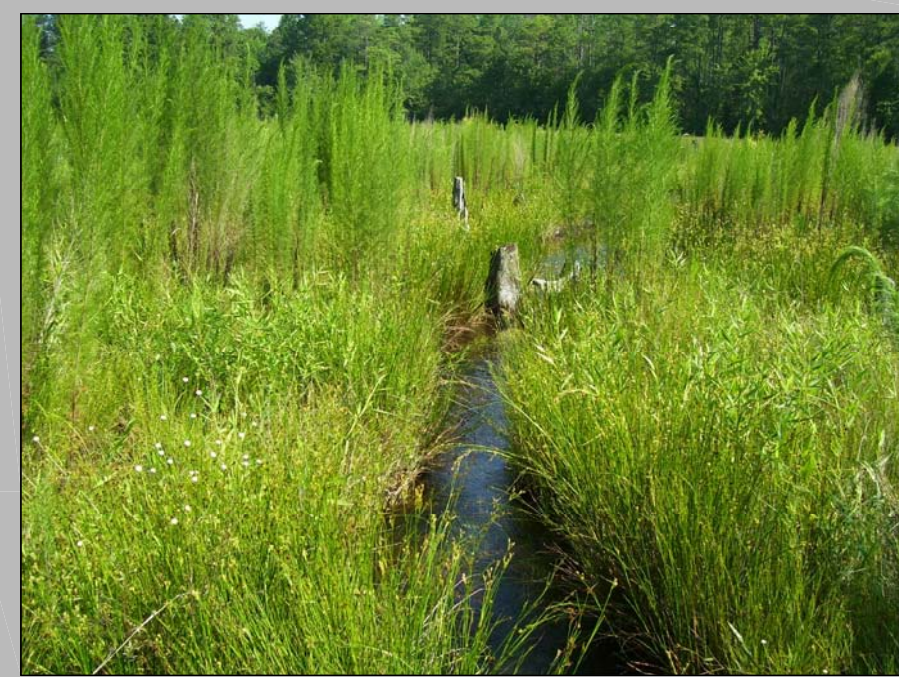
XS5 LOOKING DOWNSTREAM

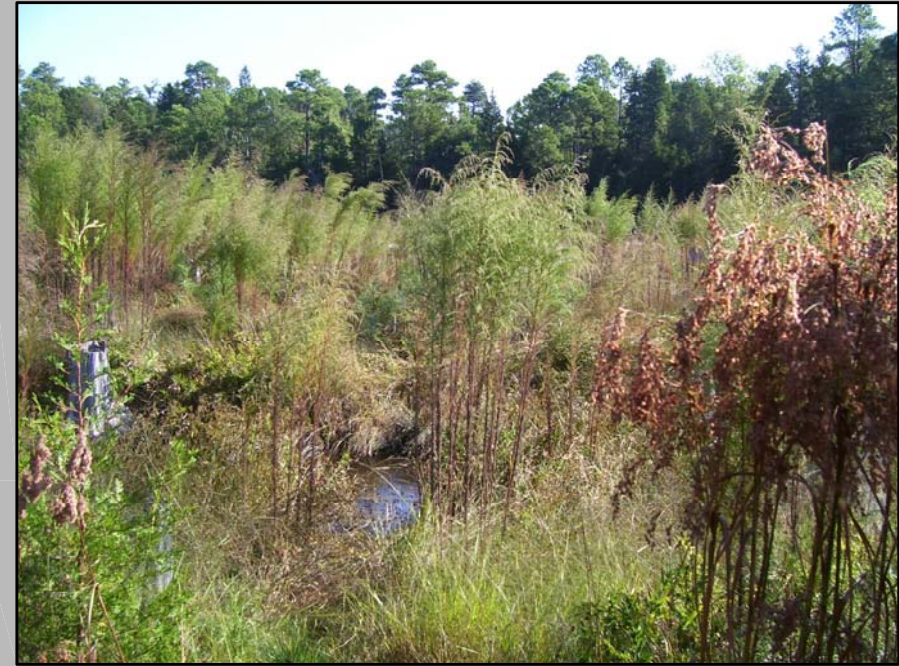
XSR3 LEFT BANK LOOKING RIGHT BANK

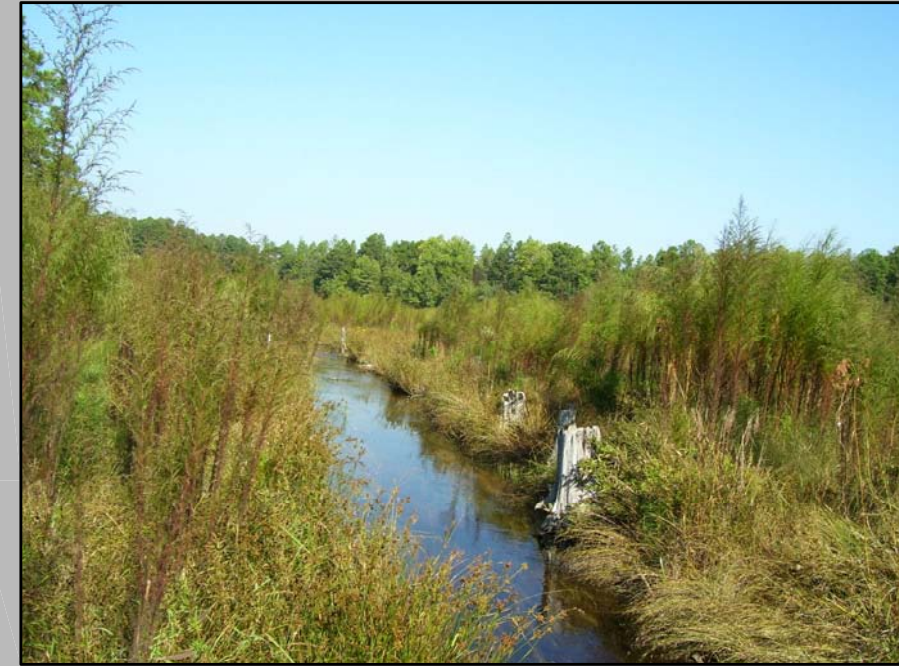
XSR3 LOOKING DOWNSTREAM

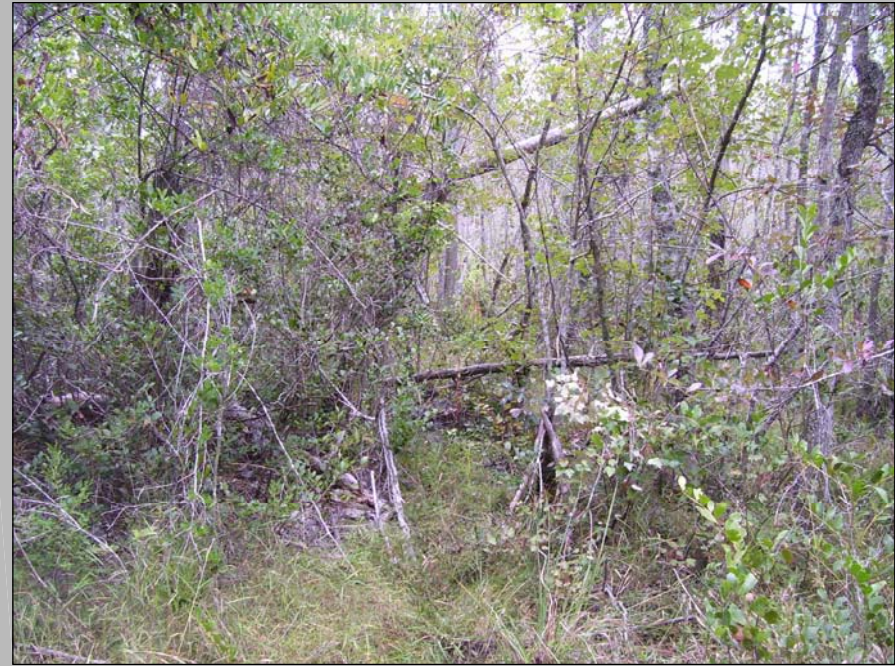
XS7 LEFT BANK LOOKING RIGHT BANK

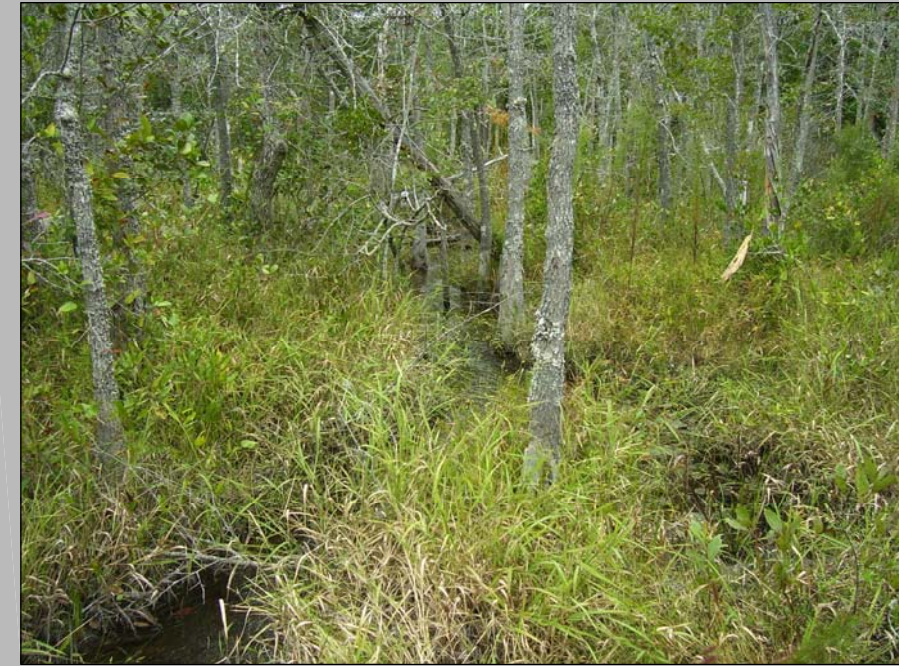
XS7 LOOKING DOWNSTREAM

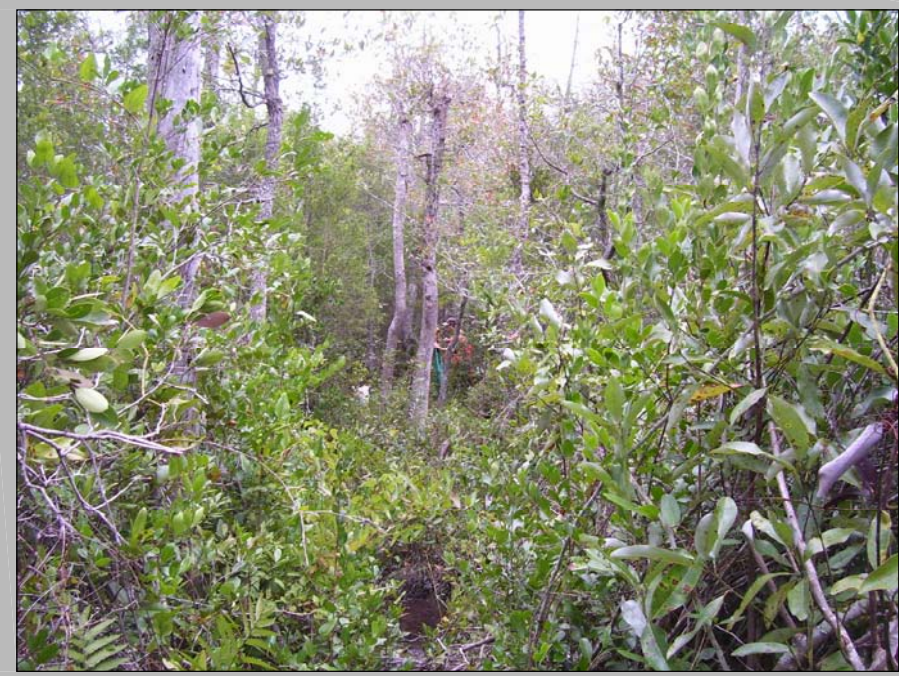
XS8 LEFT BANK LOOKING RIGHT BANK

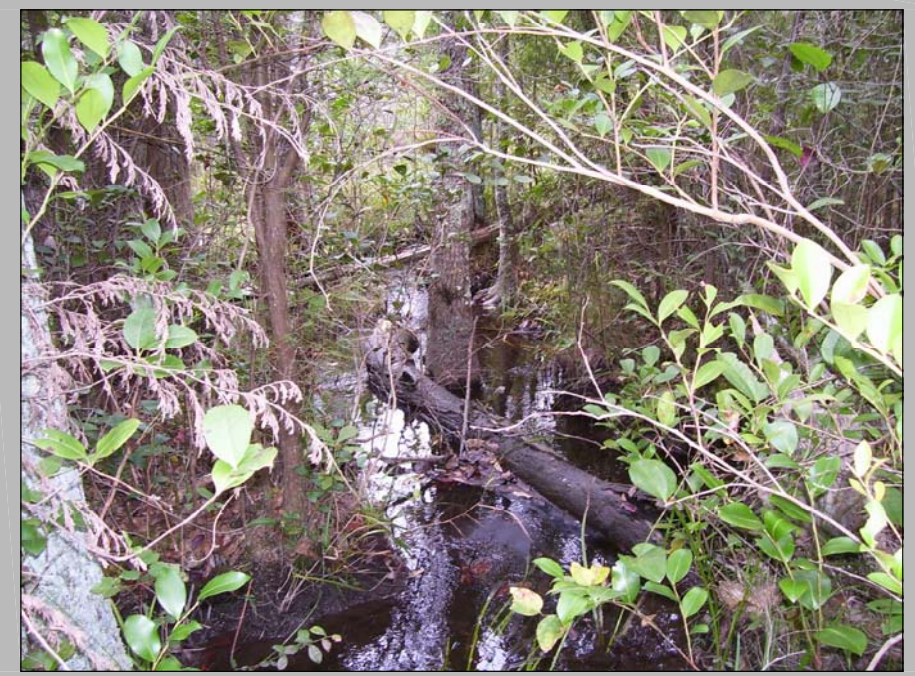
XS8 LOOKING DOWNSTREAM
