**MCDONALDS POND RESTORATION SITE
2009 Annual Monitoring Report (Year 4)**

**Richmond County, North Carolina
EEP Project No. D04020-2
Design Firm: International Paper**

March 2010

**Prepared for: NCDENR – ECOSYSTEM ENHANCEMENT PROGRAM
1652 Mail Service Center
Raleigh, North Carolina 27699-1619**

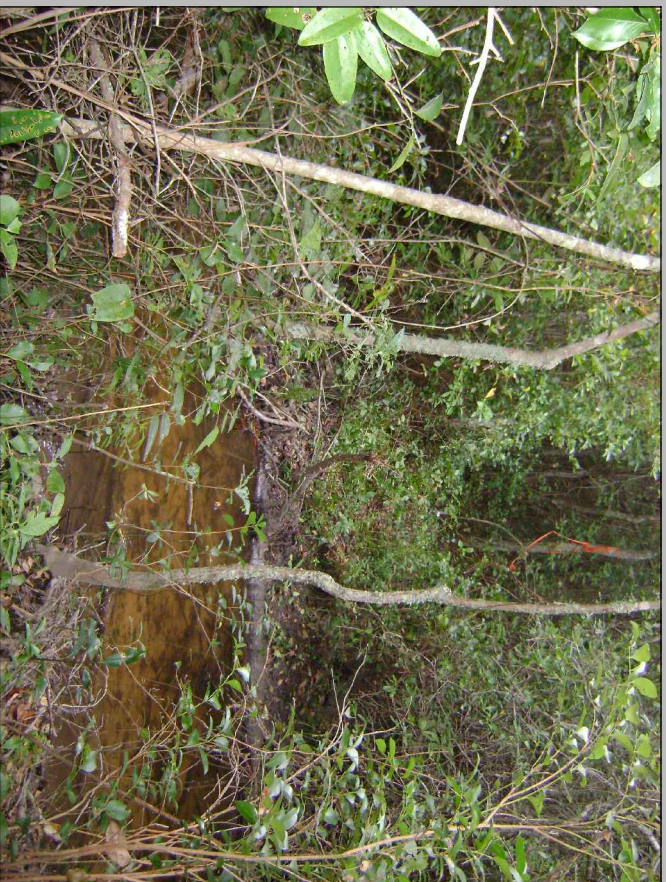
XS1 LEFT BANK LOOKING RIGHT BANK

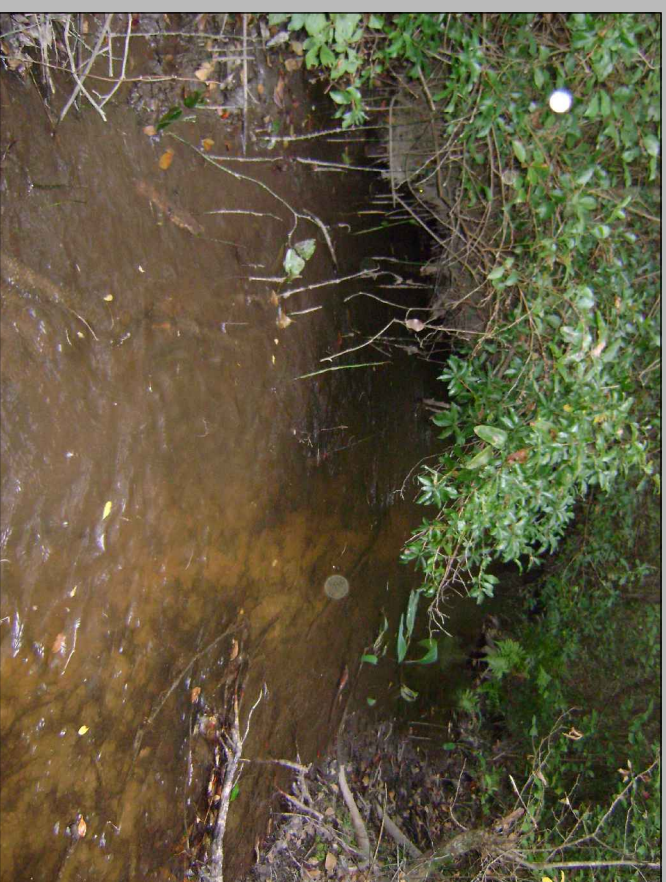
XS1 LOOKING DOWNSTREAM

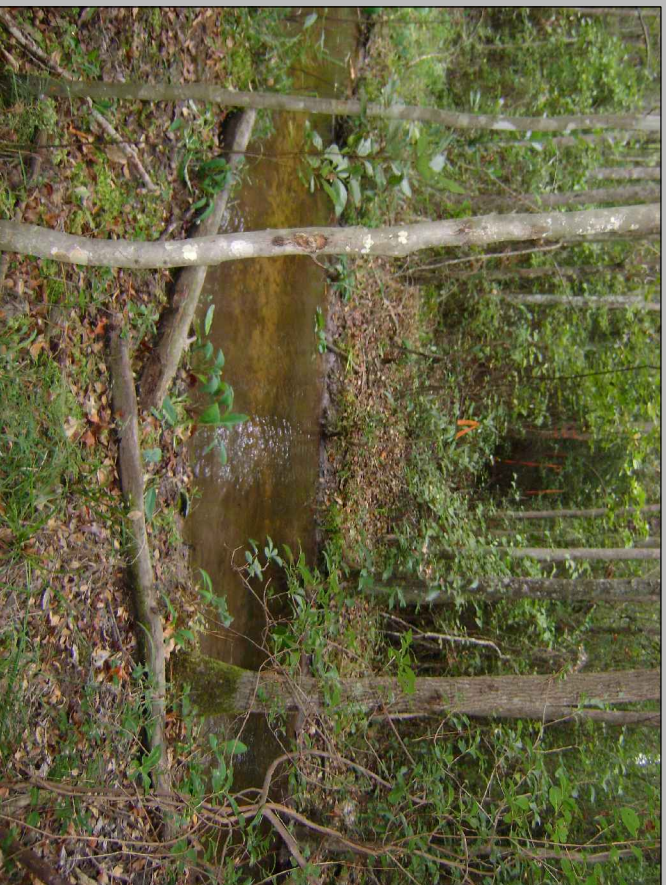
XS3 LEFT BANK LOOKING RIGHT BANK

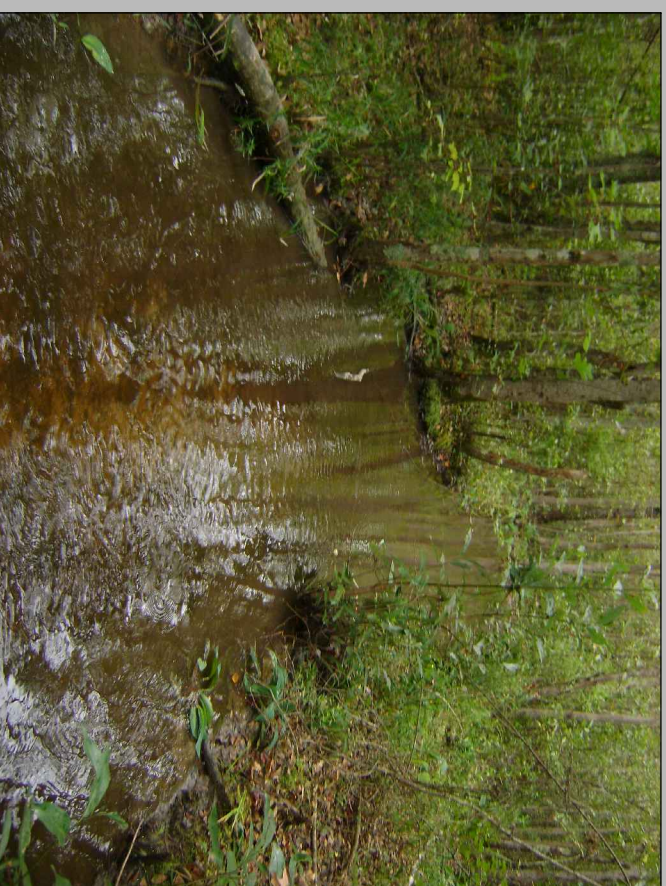
XS3 LOOKING DOWNSTREAM

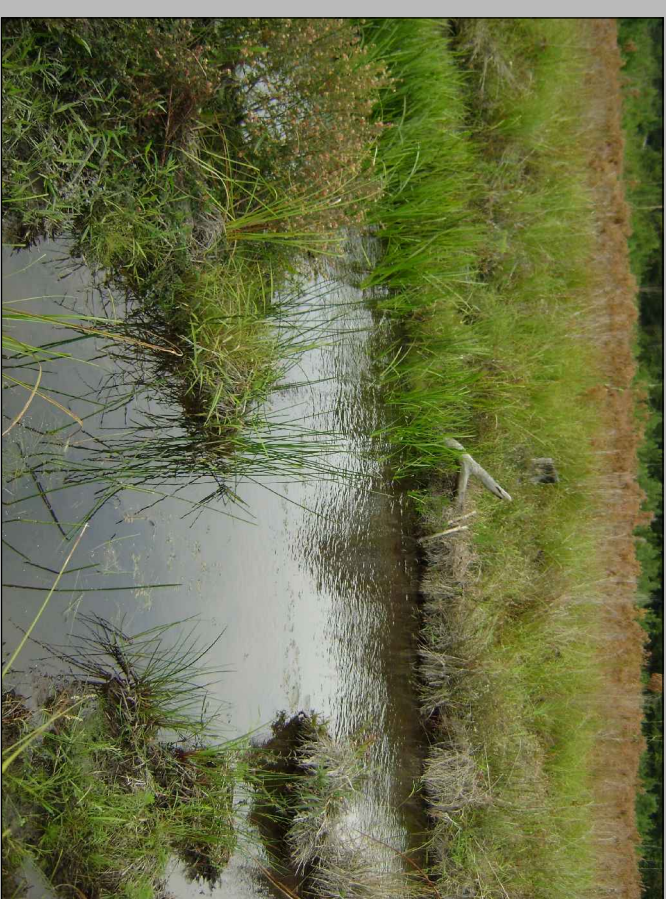
XS4 LEFT BANK LOOKING RIGHT BANK

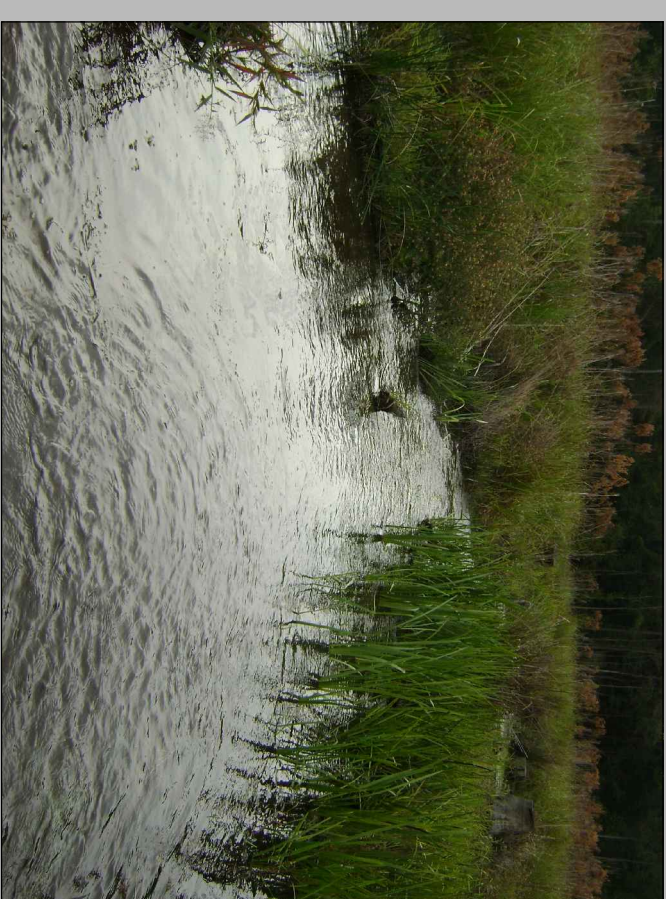
XS4 LOOKING DOWNSTREAM

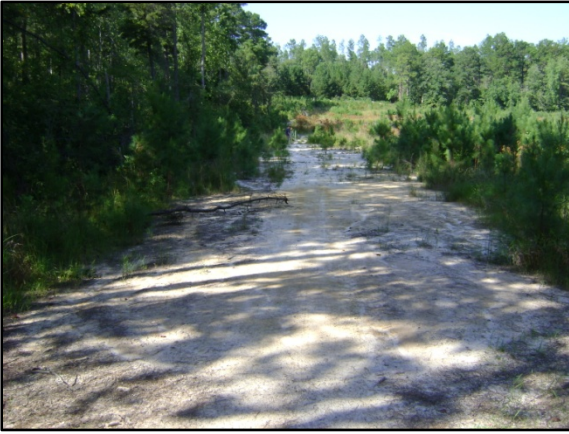
Dam surface prior to grading activities

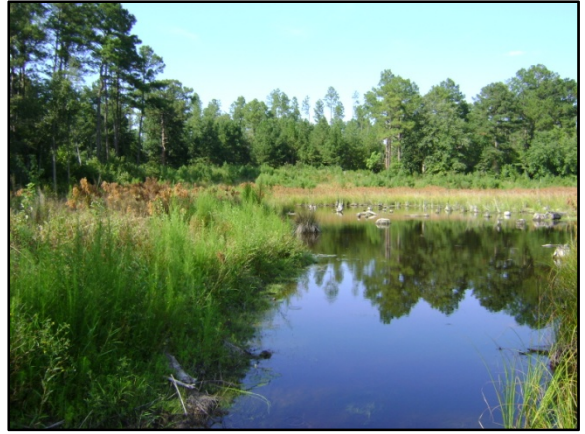
Plant survivorship was assessed within the limits of the former beaver dam impoundment. Mortality of plant species was found to be near 100 percent. Nearly all planted and volunteer species within the limits of the impoundment succumbed to inundation and/or were felled/uprooted by beaver. PBSJ suggests that inundated and graded areas be replanted. Site planting will be require a supplemental contract to be initiated in Winter/Spring 2010 (or sooner based on seedling availability). Planting should be performed within all graded areas, as well as within areas affected by beaver activity (total area approximately 2.0 acres). Plant species will be selected according to reference plant communities at the required stocking levels (680 trees/acre). Once planting is complete, an immediate inventory of planted stems will be taken.

Beaver impoundment prior to grading activities

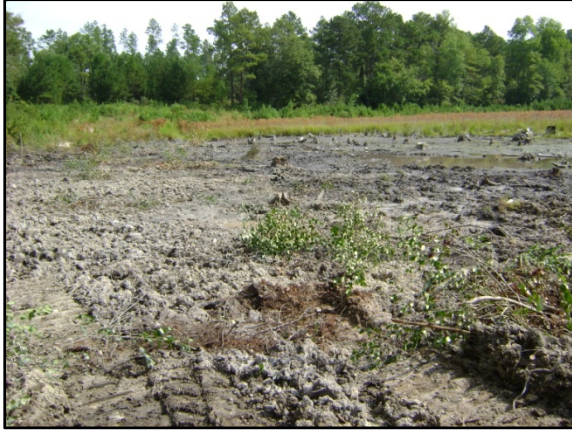
Following grading, the former dam elevation now matches the surrounding floodplain

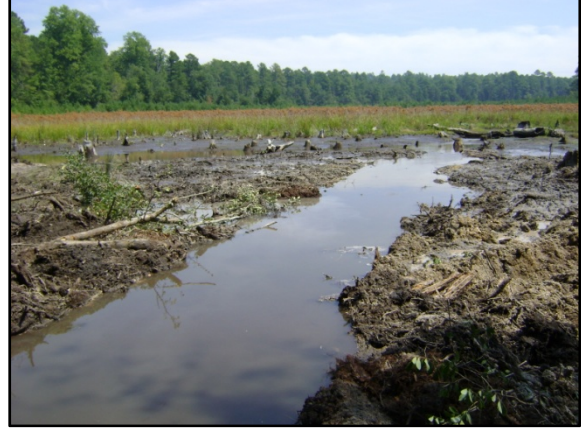
Stream channel flowing through newly graded area

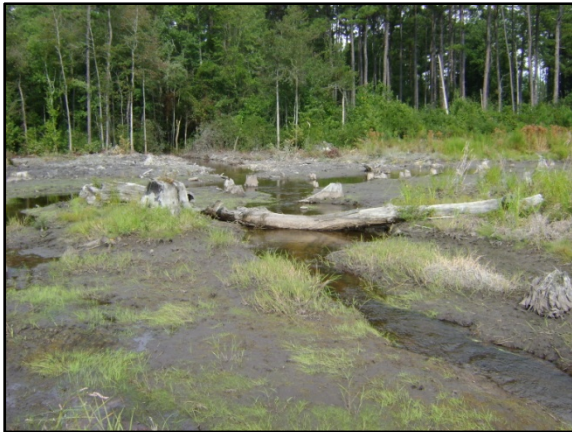
Confluence of existing channel with newly reshaped channel

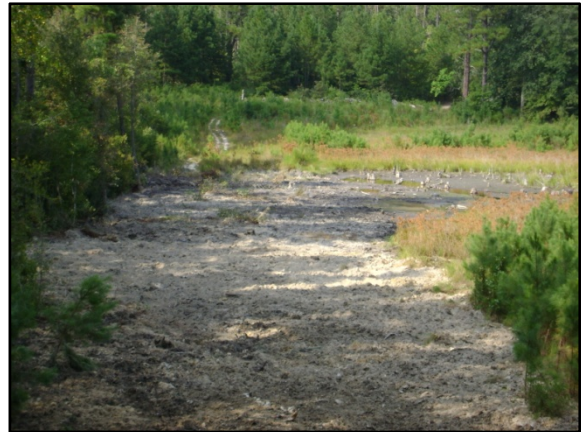
Finished grade near wetland boundary

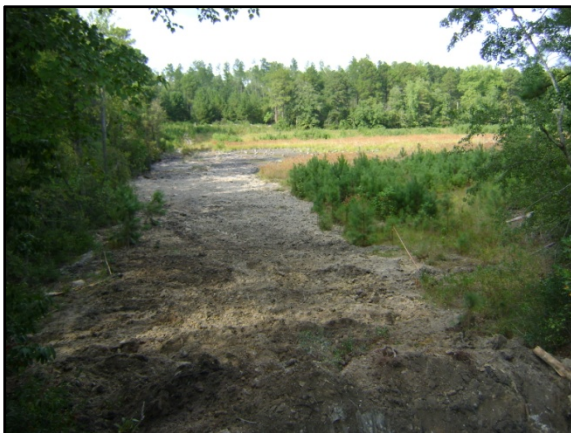
Finished grade of former dam from southern Site boundary

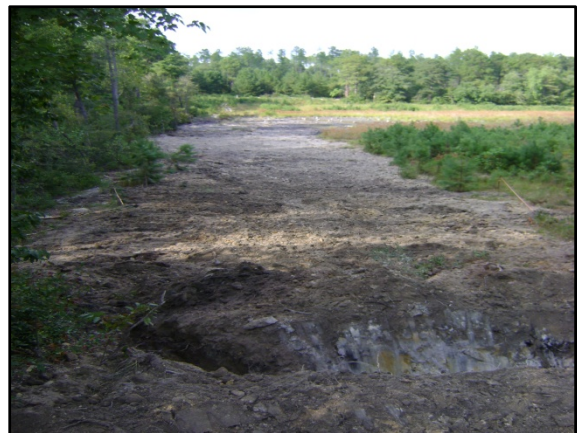
Trench and soil pile at southern Site boundary
