**MCDONALDS POND RESTORATION SITE
2010 Annual Monitoring Report (Year 5)**

**Richmond County, North Carolina
EEP Project No. D04020-2
Design Firm: International Paper**

January 2011

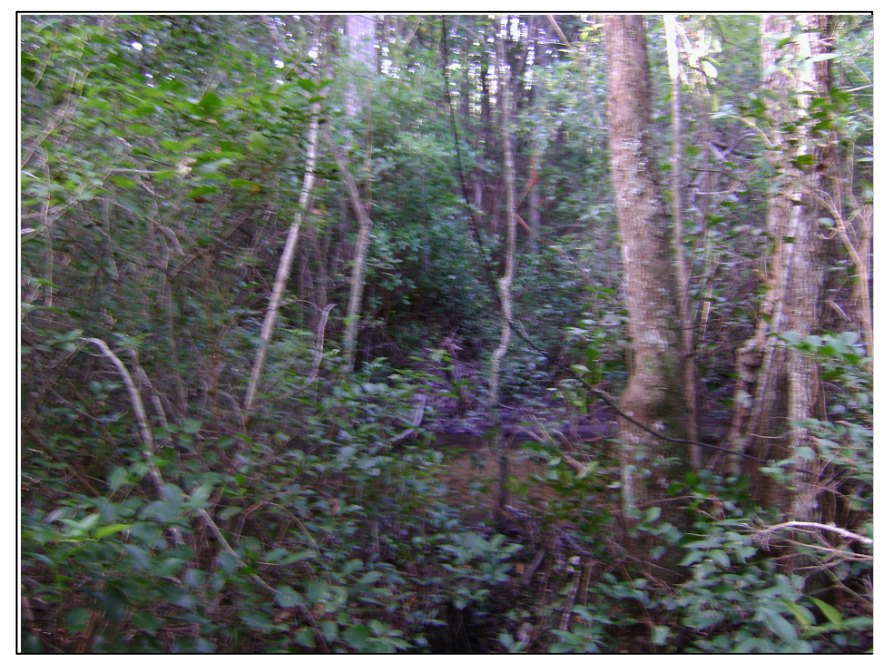
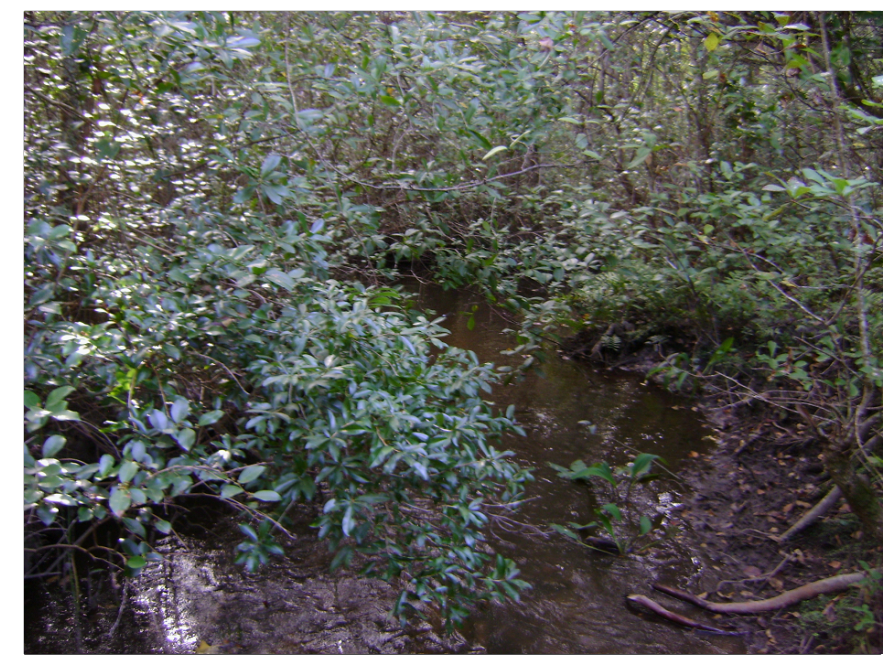
SHEET
B1

XS1 LEFT BANK LOOKING RIGHT BANK

XS1 LOOKING DOWNSTREAM

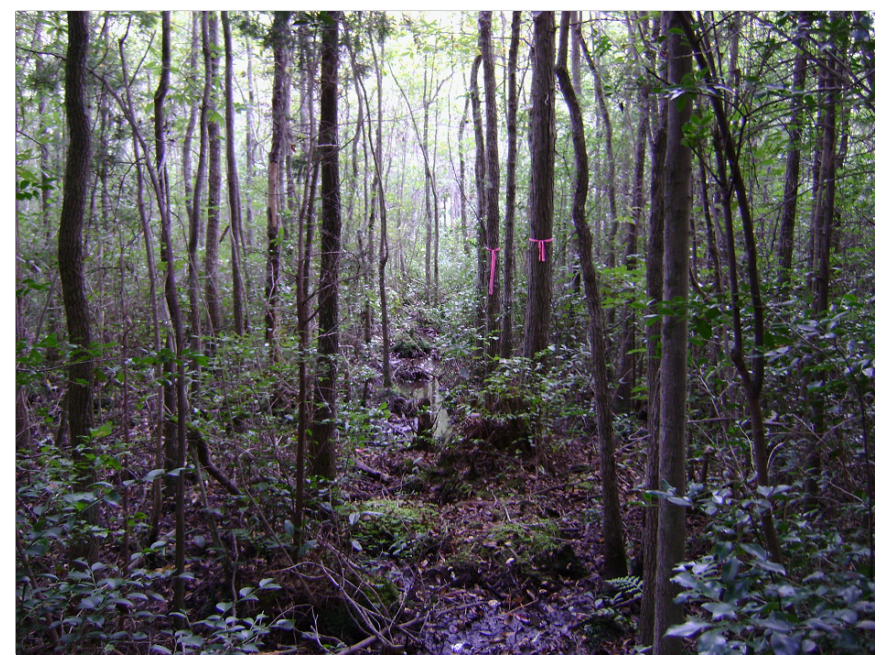
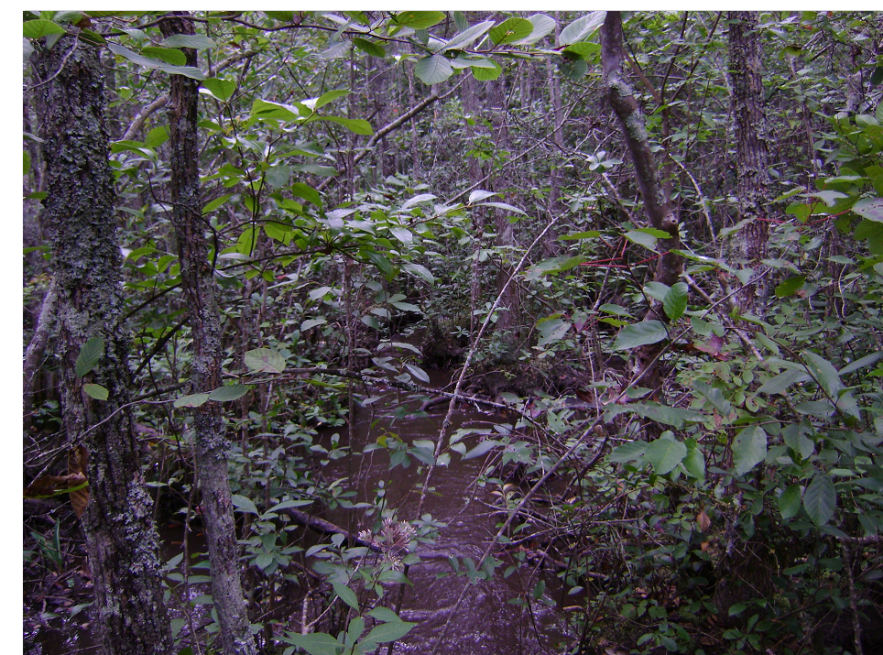
SHEET
B2

XS2 RIGHT BANK LOOKING LEFT BANK

XS2 LOOKING DOWNSTREAM

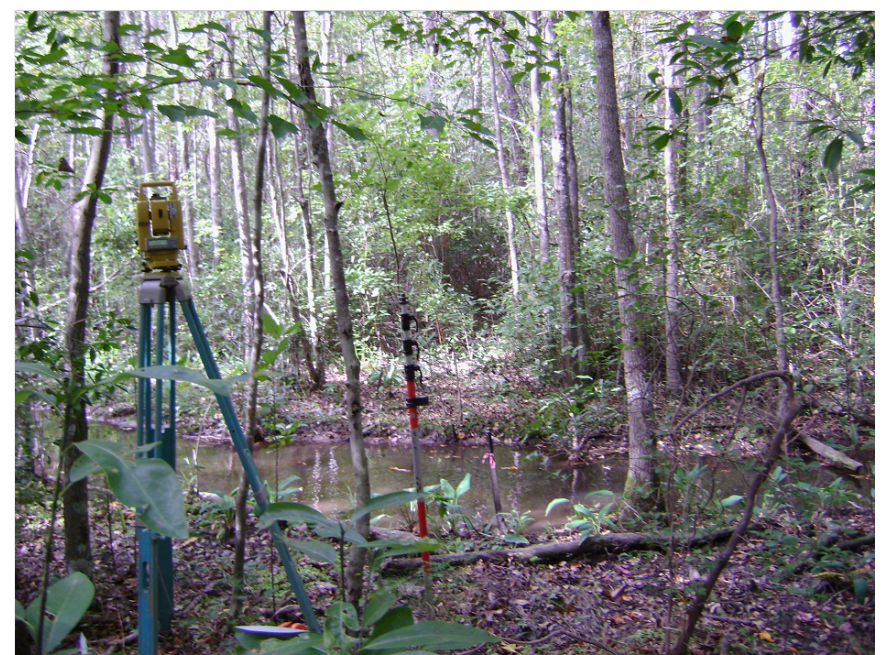
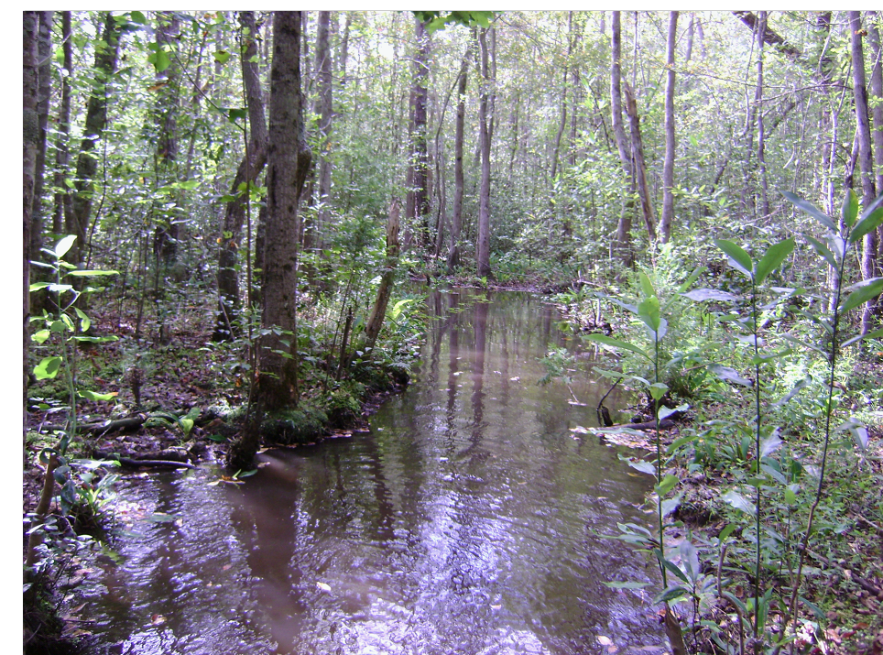
SHEET
B3

XS3 LEFT BANK LOOKING RIGHT BANK

XS3 LOOKING DOWNSTREAM

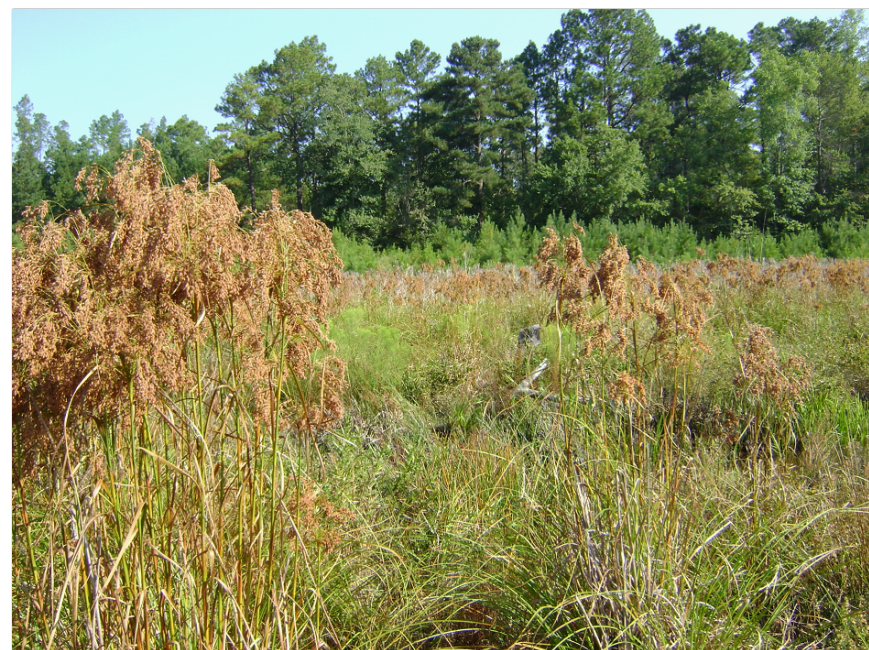
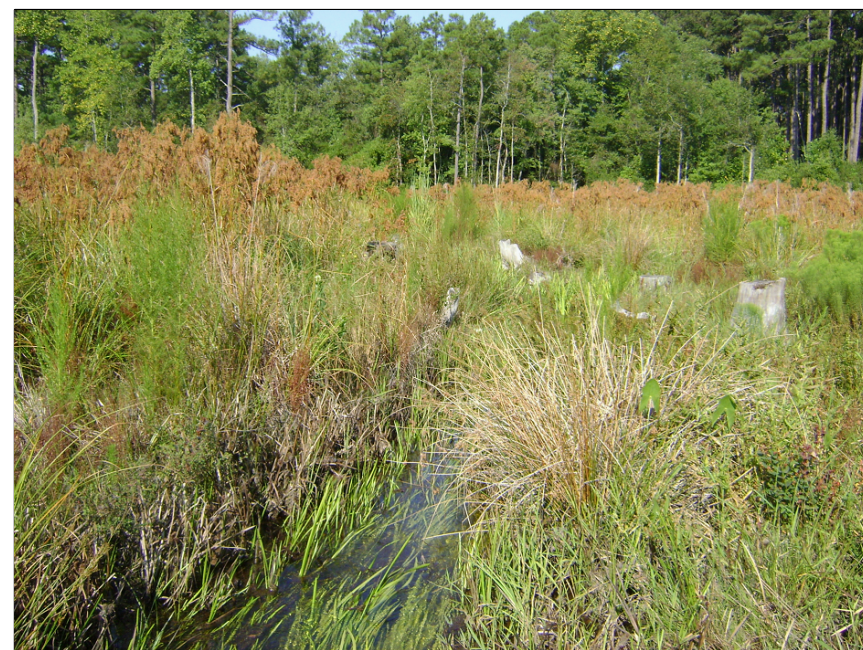
SHEET
B4

XS4 LEFT BANK LOOKING RIGHT BANK

XS4 LOOKING DOWNSTREAM

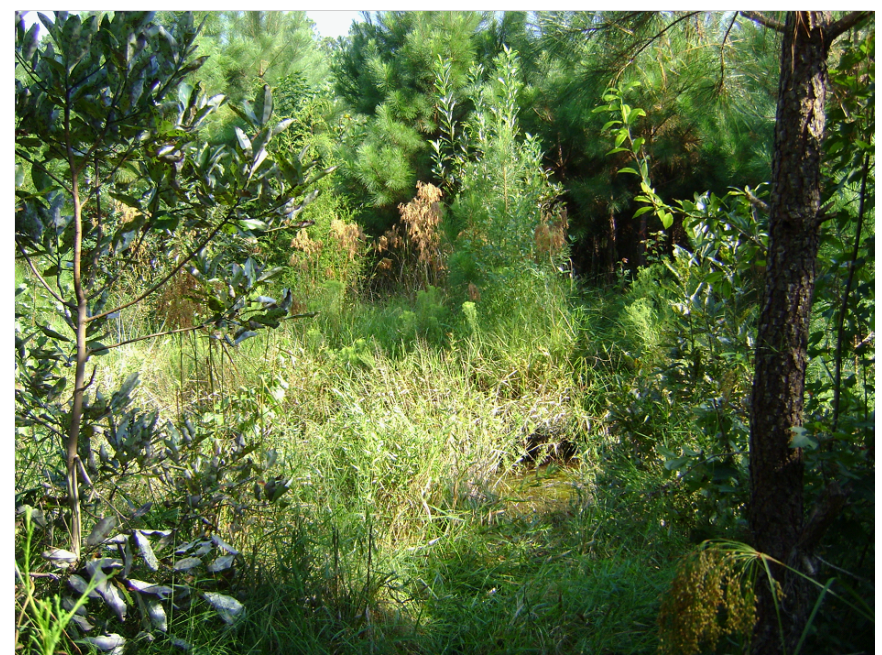
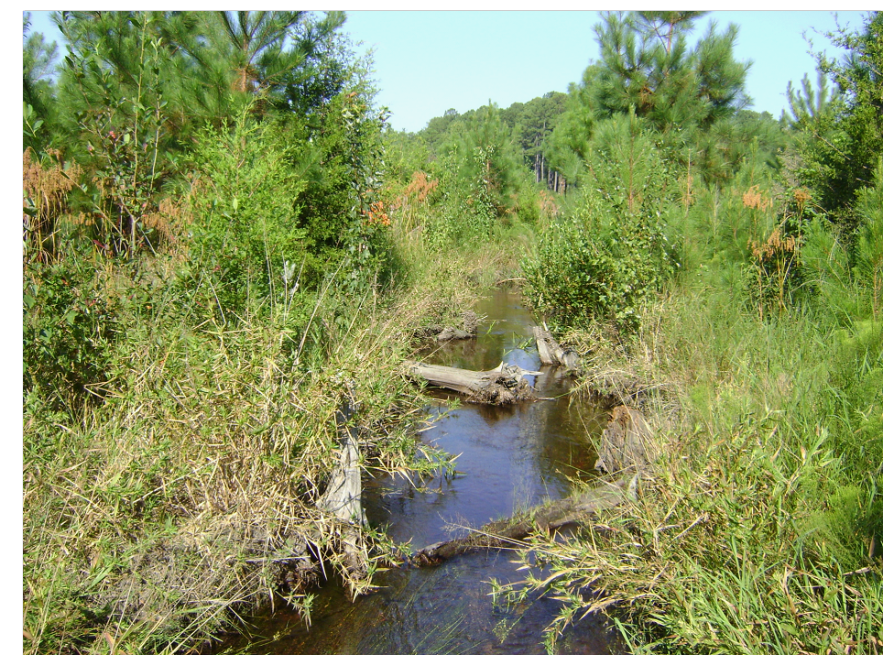
XSR2 LEFT BANK LOOKING RIGHT BANK

XSR2 LOOKING DOWNSTREAM

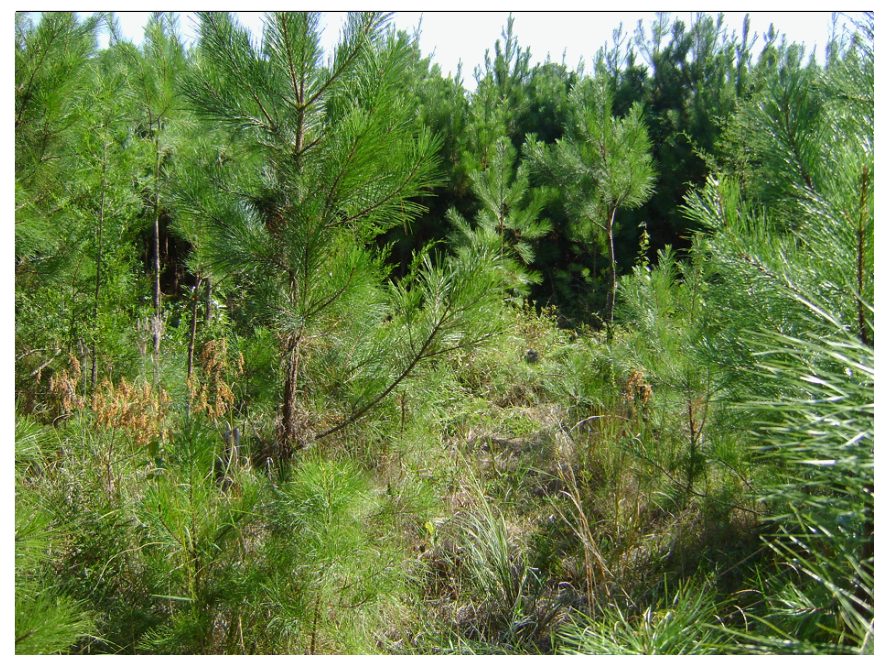
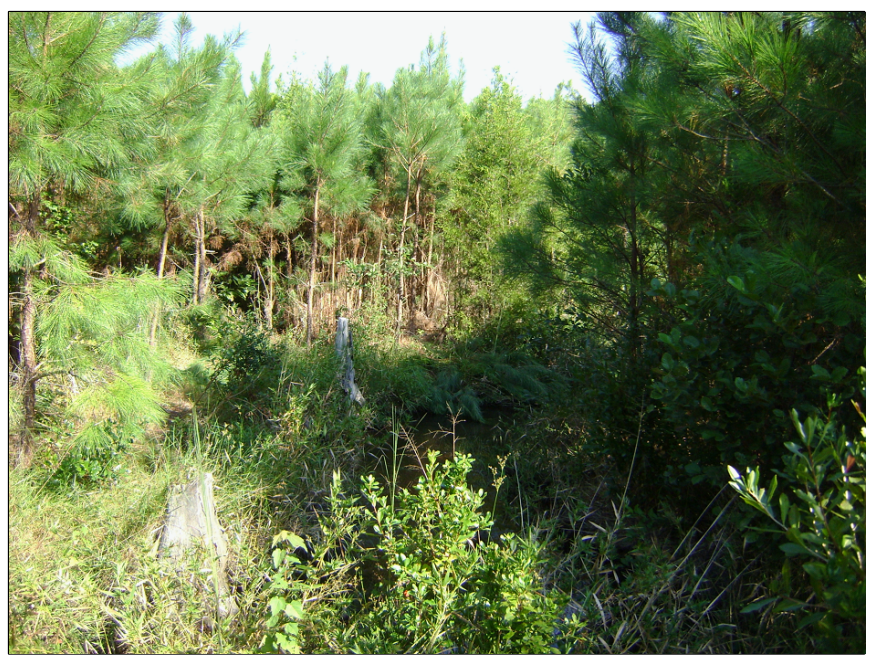
SHEET
B6

XS5 LEFT BANK LOOKING RIGHT BANK

XS5 LOOKING DOWNSTREAM

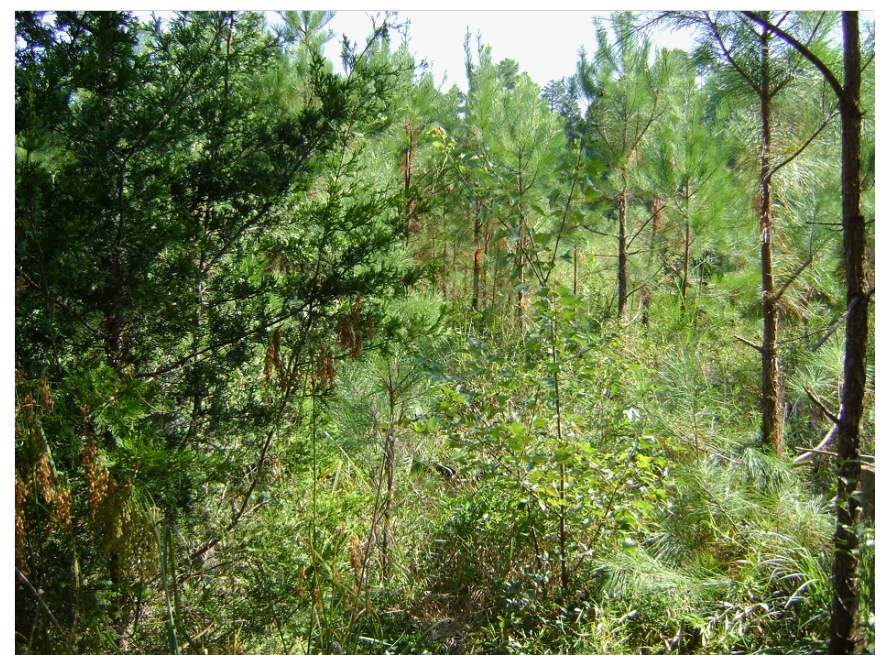
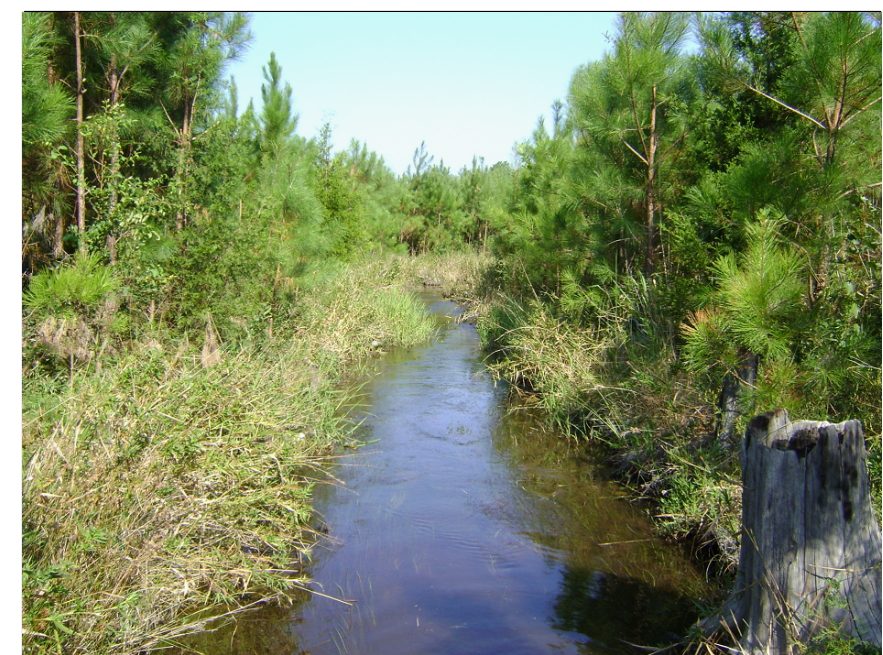
XSR3 LEFT BANK LOOKING RIGHT BANK

XSR3 LOOKING DOWNSTREAM

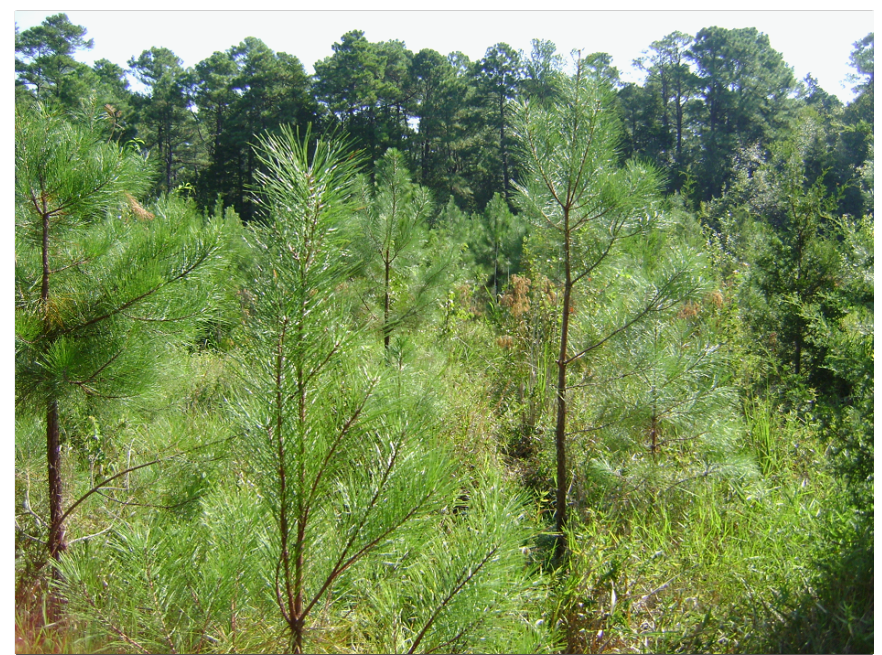
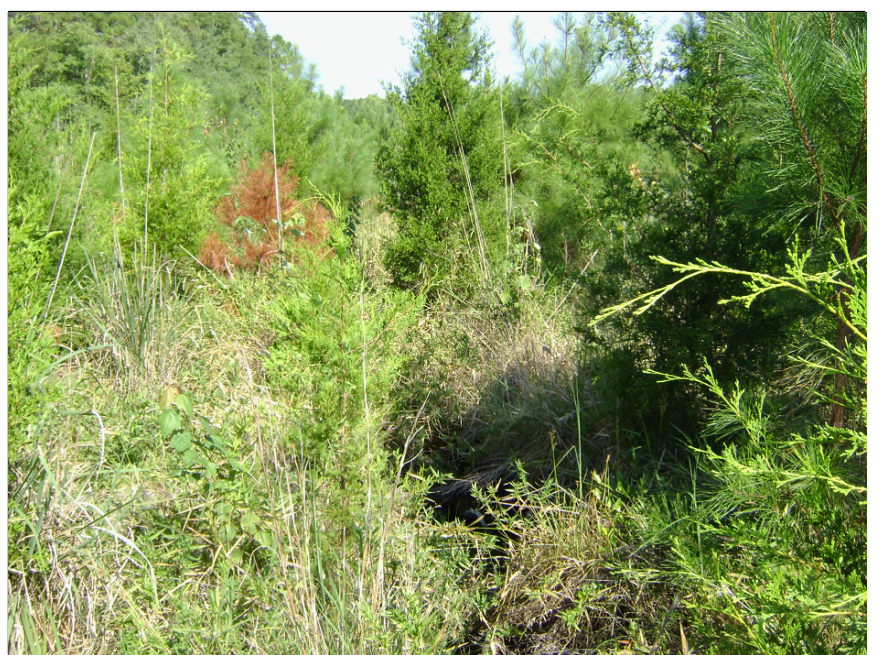
SHEET
B8

XS6 LEFT BANK LOOKING RIGHT BANK

XS6 LOOKING DOWNSTREAM

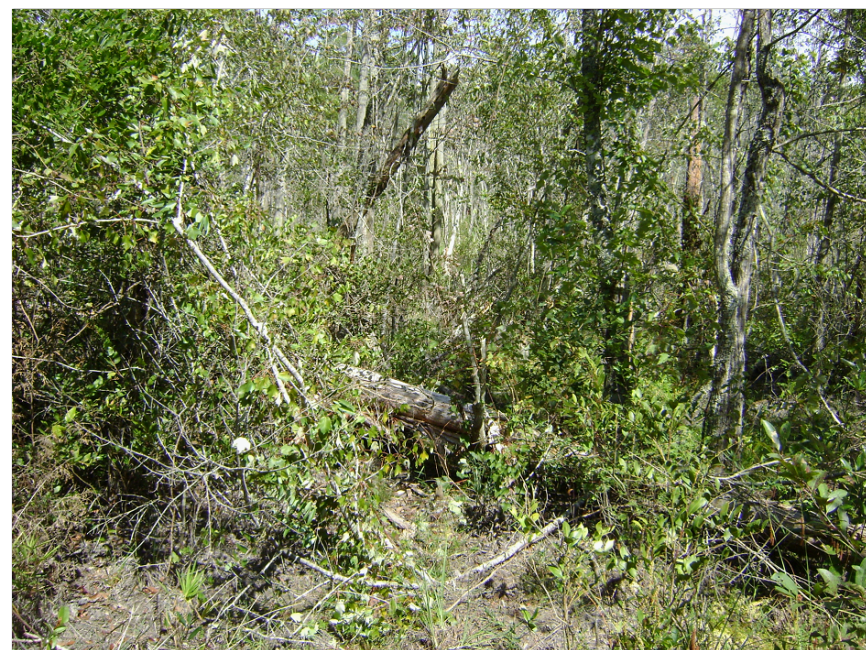
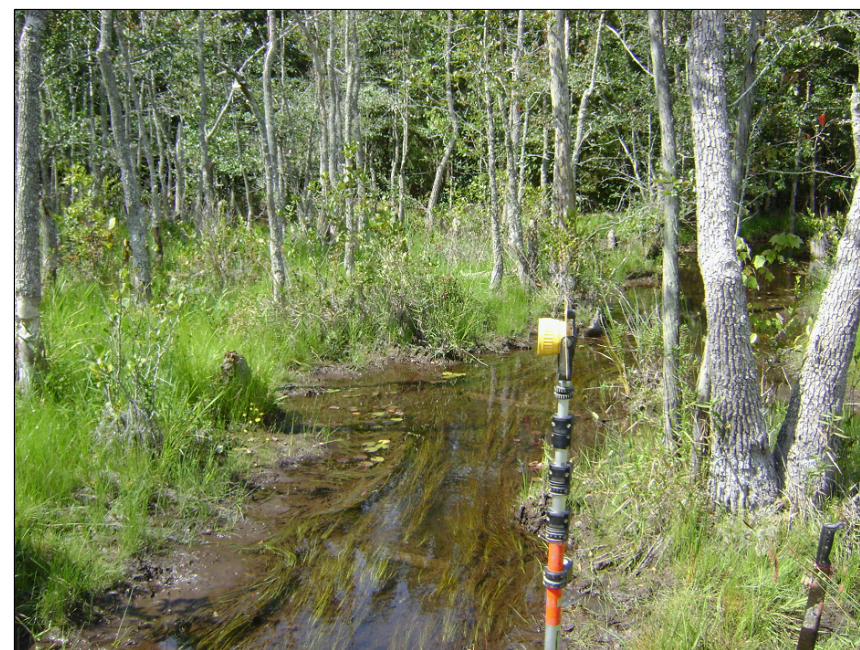
SHEET
B9

XS7 LEFT BANK LOOKING RIGHT BANK

XS7 LOOKING DOWNSTREAM

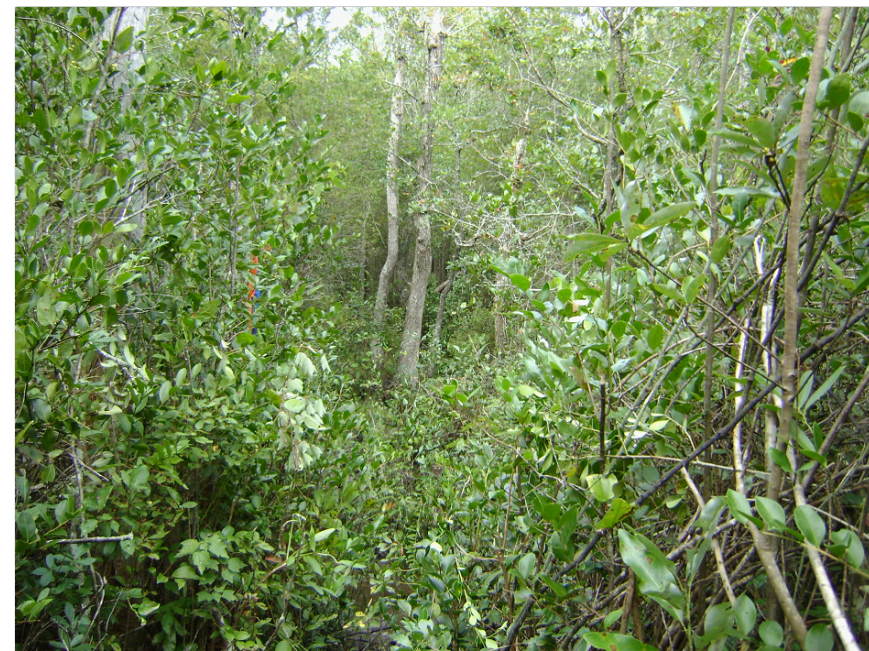
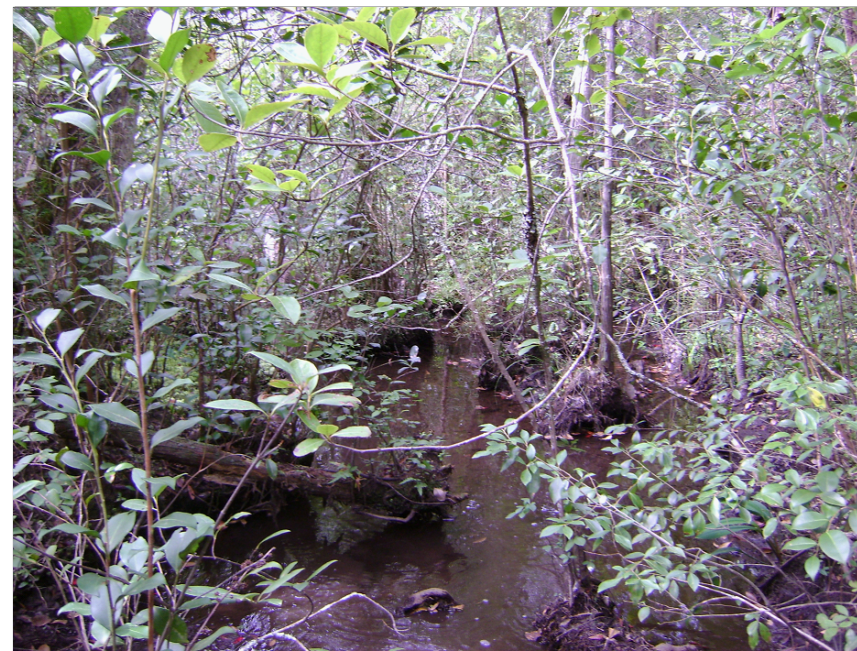
SHEET
B10

XS8 LEFT BANK LOOKING RIGHT BANK

XS8 LOOKING DOWNSTREAM
