**FINAL**  
**ANNUAL MONITORING REPORT**  
**MCINTYRE CREEK RESTORTION SITE**  
**AT HORNETS NEST PARK**  
**MECKLENBURG COUNTY, NORTH CAROLINA**  
**(EEP Project No. 243)**

February 2011

Prepared by:  
Axiom Environmental, Inc.  
218 Snow Avenue  
Raleigh, North Carolina 27603

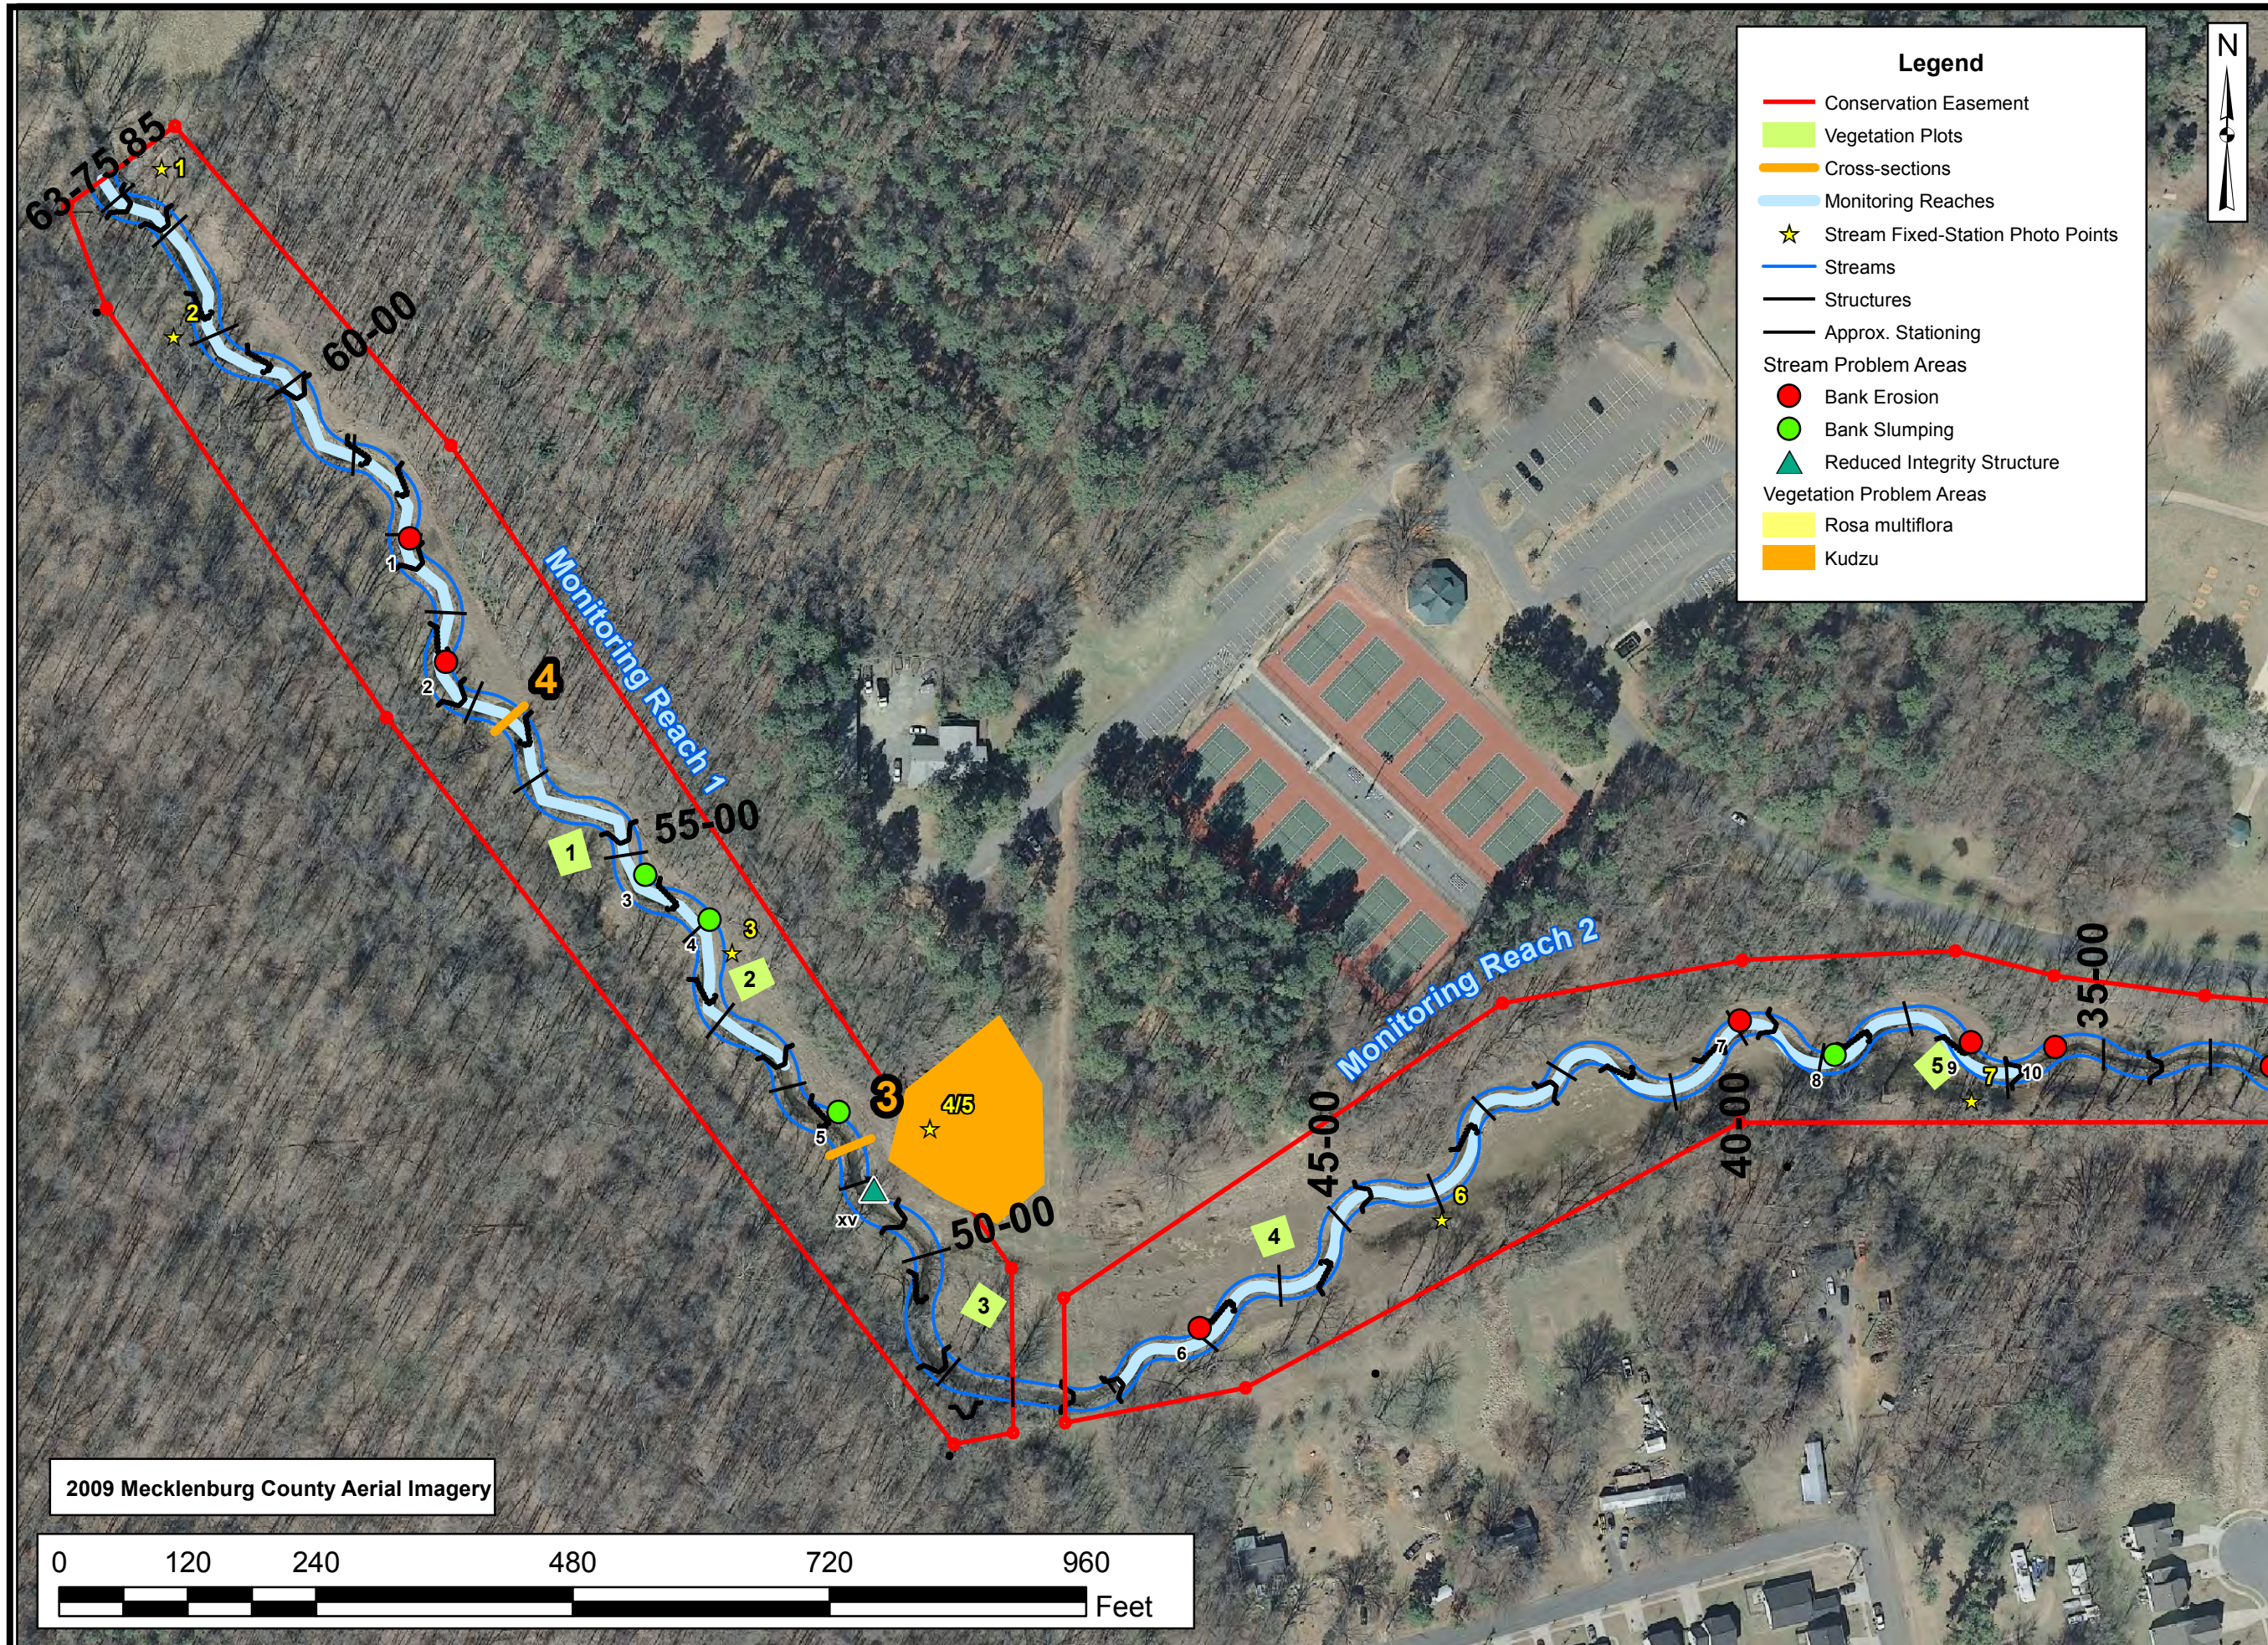
FIGURE  
**2A**

Several areas of bank erosion are located throughout the project as the result of high stream flows, vertical banks, urbanized watershed, flashy flows, and tight radius of curvatures. These areas are depicted on Figures 2 and 2A-2B (Appendix B) and should continue to be monitored closely. Currently, the stream channel is considered to be within an acceptable range of variation compared to the as-built construction channel. However, due to the extensive impervious surfaces located within the upstream watershed the Site has periods of flashy flood flows even during smaller rain events. Flashy flood flows, compiled with minor bank instability has resulted in some degradation of the channel including eroding outer bends and slumping banks with loss of planted vegetation and reduced integrity of several structures. The loss of planted stems due to sloughing banks will most likely make the banks, particularly outer bends, more vulnerable to erosive flows and continued bank loss. Degradation is anticipated to continue to occur due to the characteristics of the watershed.

Vegetation problem areas within the Site include a small patch of multiflora rose (*Rosa multiflora*) north of the stream near cross-section 3 and a patch of kudzu (*Pueraria lobata*) north of the stream near cross-section 2 (depicted on Figure 2, Appendix B). The kudzu is located on a filled area spreading from outside of the easement towards the stream channel.

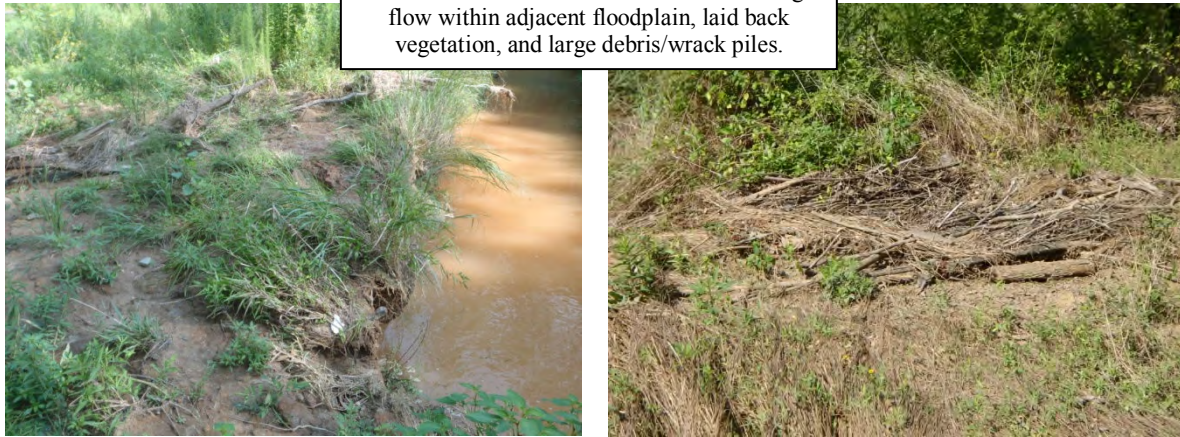
Photos 1-2: Evidence of overbank including flow within adjacent floodplain, laid back vegetation, and large debris/wrack piles.

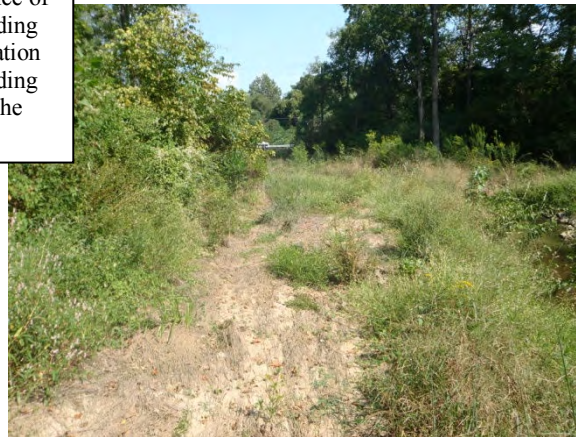
Photo 3: Evidence of overbank including laid back vegetation and recent standing water within the floodplain.
