FINAL
ANNUAL MONITORING REPORT
YEAR 2 (2011)
MCINTYRE CREEK RESTORTION SITE
AT HORNETS NEST PARK
MECKLENBURG COUNTY, NORTH CAROLINA
(EEP Project No. 243)

December 2011

Prepared by:
Axiom Environmental, Inc.
218 Snow Avenue
Raleigh, North Carolina 27603

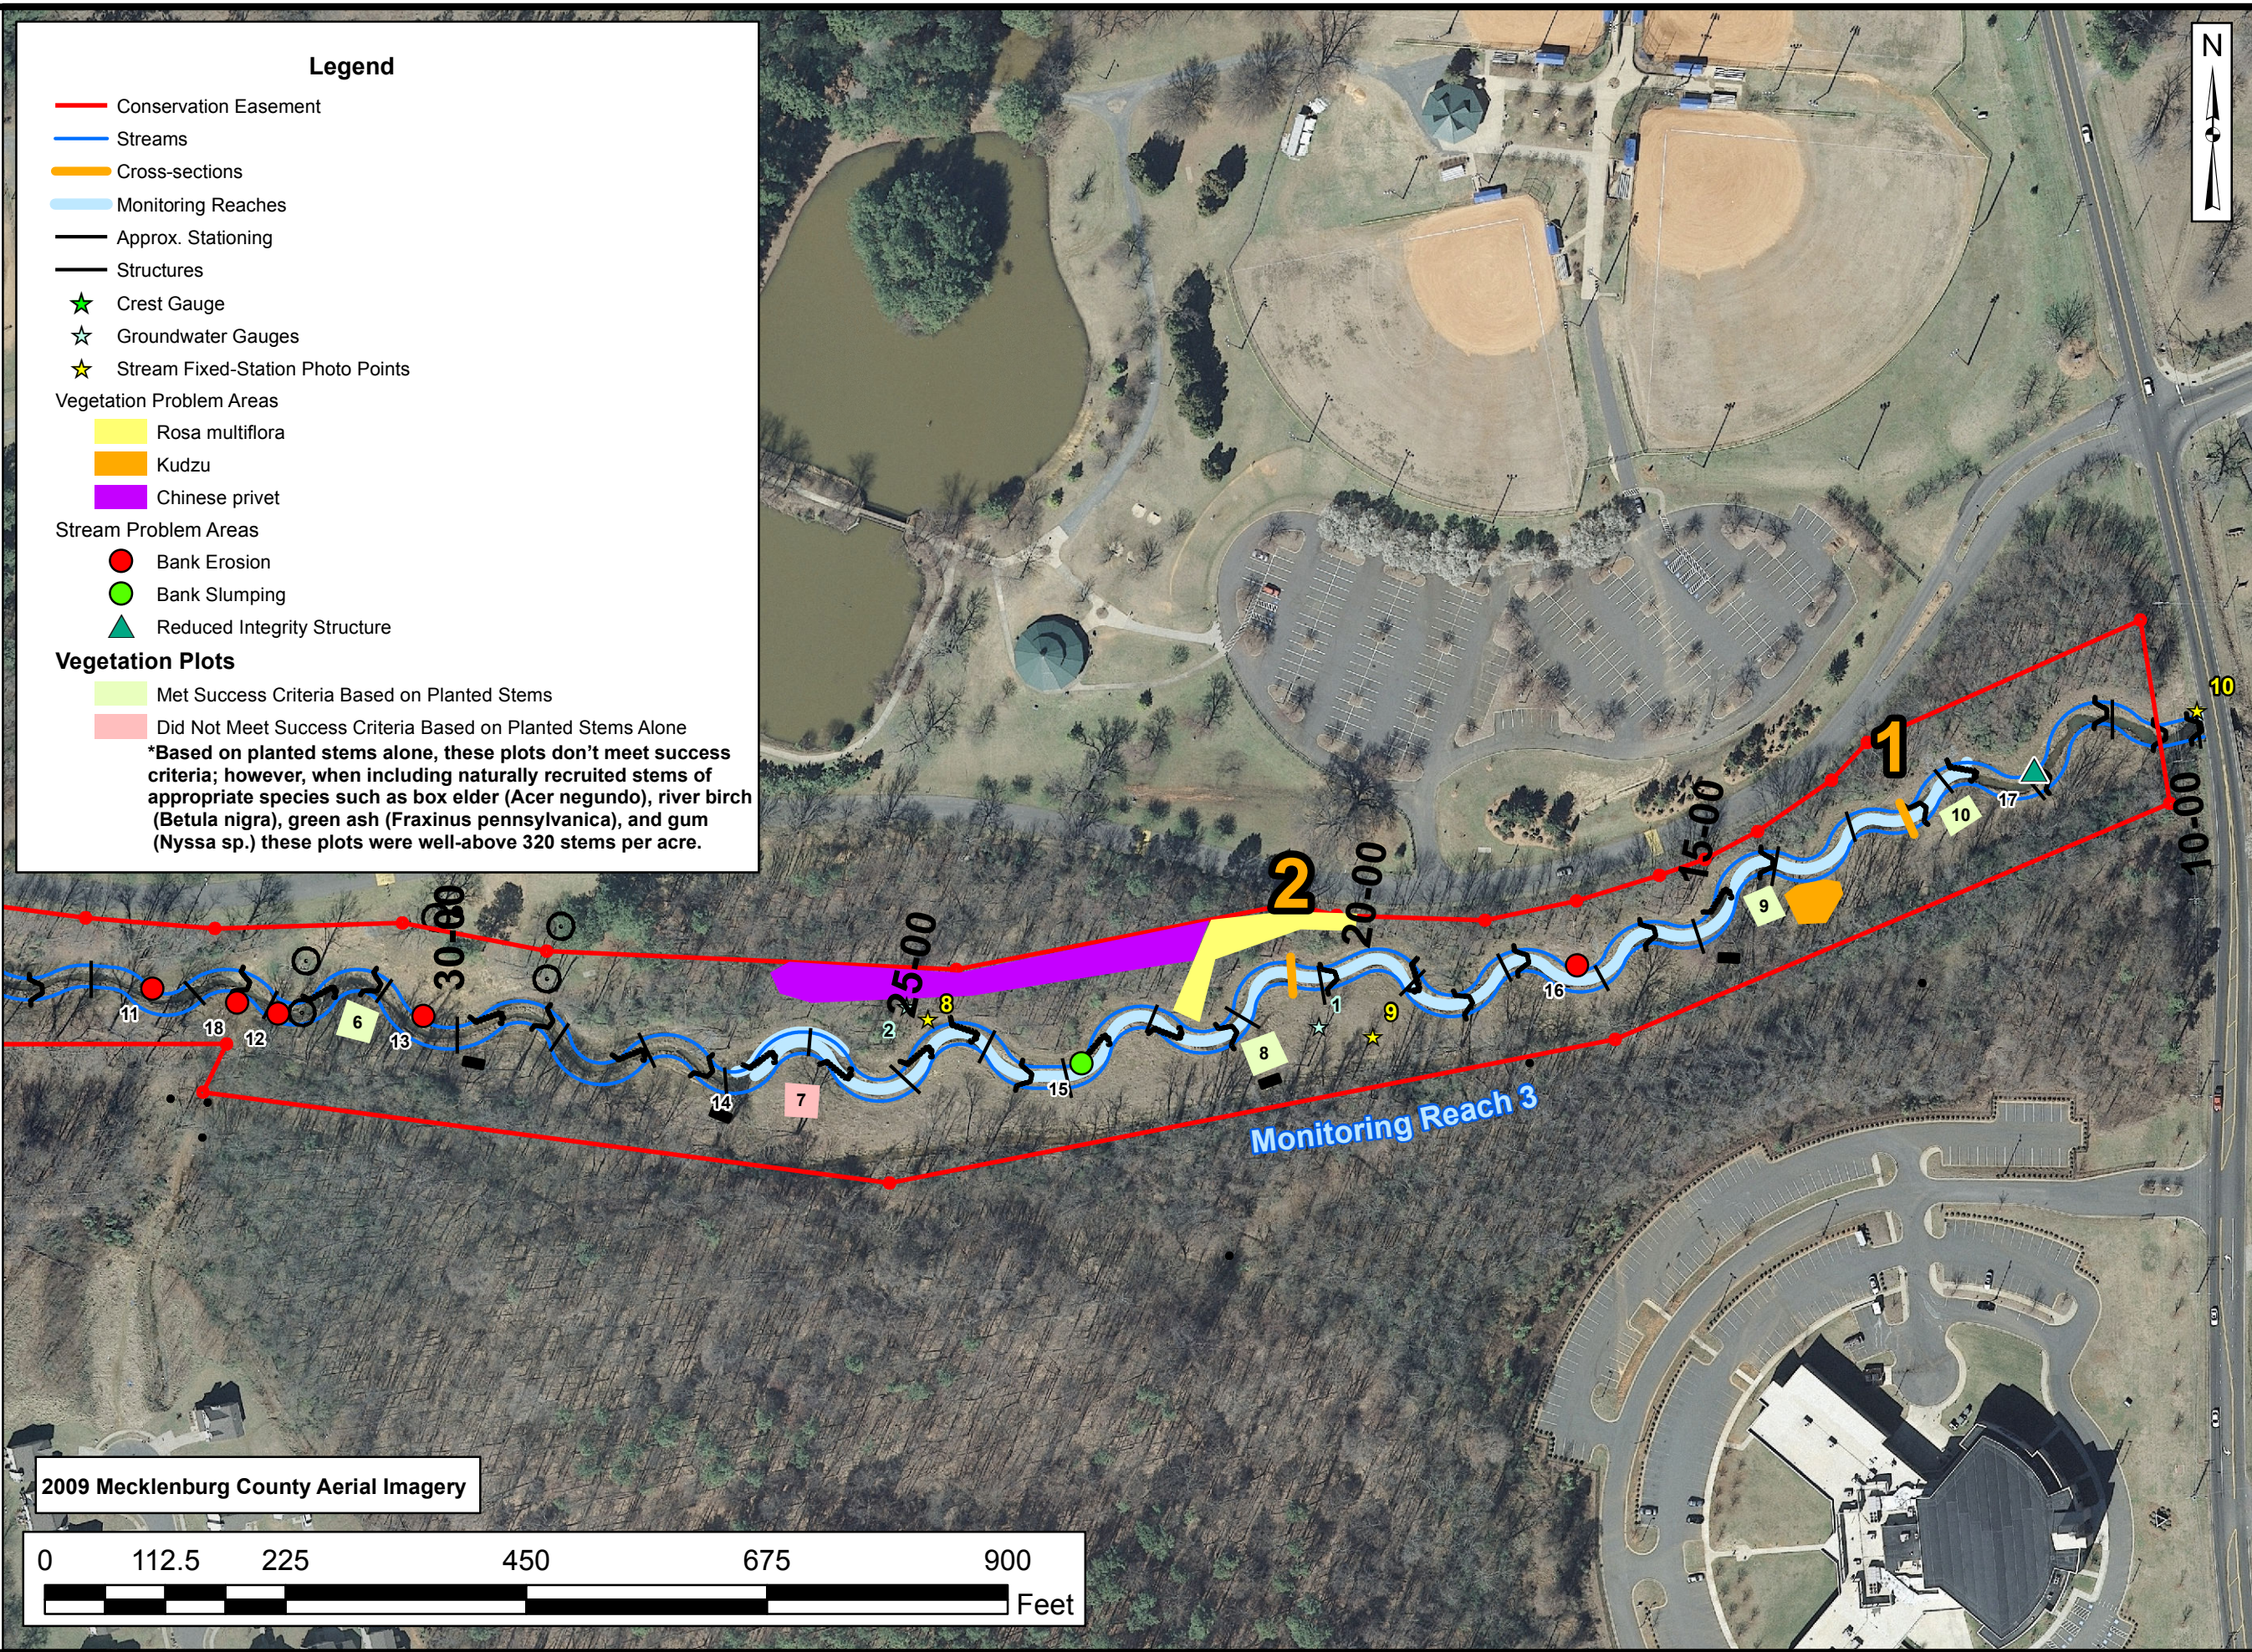
FIGURE
2A

Several areas of bank erosion are located throughout the project as the result of high stream flows, vertical banks, urbanized watershed, flashy flows, and tight radius of curvatures. These areas are depicted on Figures 2 and 2A-2B (Appendix B) and should continue to be monitored closely. Currently, the stream channel is considered to be within an acceptable range of variation compared to the as-built construction channel. However, due to the extensive impervious surfaces located within the upstream watershed the Site has periods of flashy flood flows even during smaller rain events. Flashy flood flows, compiled with minor bank instability has resulted in some degradation of the channel including eroding outer bends and slumping banks with loss of planted vegetation and reduced integrity of several structures. The loss of planted stems due to sloughing banks will most likely make the banks, particularly outer bends, more vulnerable to erosive flows and continued bank loss. Degradation is anticipated to continue to occur due to the characteristics of the watershed.

Vegetation problem areas within the Site include a large patch of multiflora rose (*Rosa multiflora*) and Chinese privet (*Ligustrum sinense*) north of the stream near cross-section 3, a large of kudzu (*Pueraria lobata*) north of the stream near cross-section 2, and scattered smaller patches of multiflora rose, Chinese privet, and kudzu (depicted on Figures 2A-2B, Appendix B).

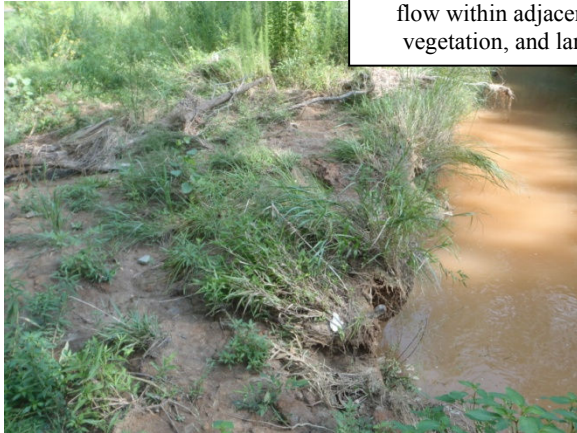
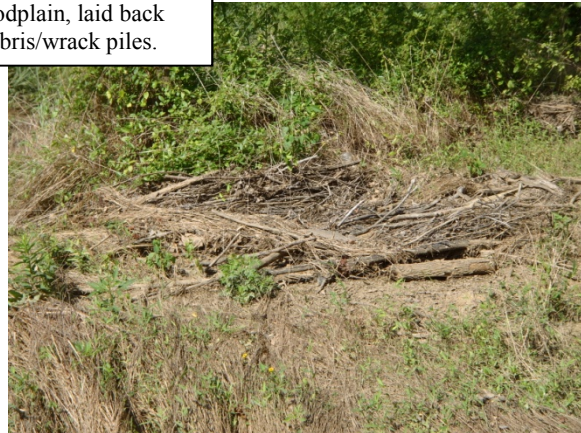
Photos 1-2: Evidence of overbank including flow within adjacent floodplain, laid back vegetation, and large debris/wrack piles.

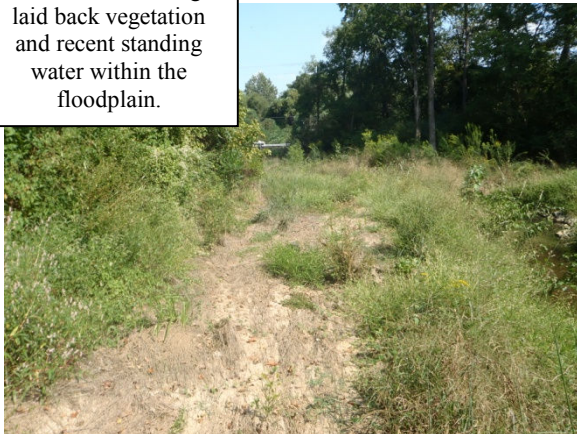
Photo 3: Evidence of overbank including laid back vegetation and recent standing water within the floodplain.

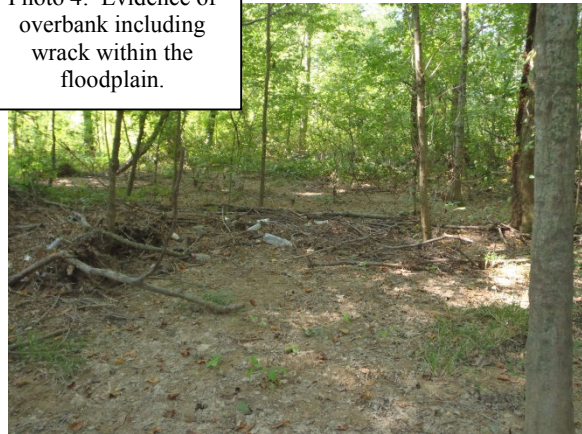
Photo 4: Evidence of overbank including wrack within the floodplain.
