FINAL
ANNUAL MONITORING REPORT
YEAR 3 (2012)
MCINTYRE CREEK RESTORTION SITE
AT HORNETS NEST PARK
MECKLENBURG COUNTY, NORTH CAROLINA
(EEP Project No. 243, Contract No. 004499)

November 2012

Prepared by:
Axiom Environmental, Inc.
218 Snow Avenue
Raleigh, North Carolina 27603

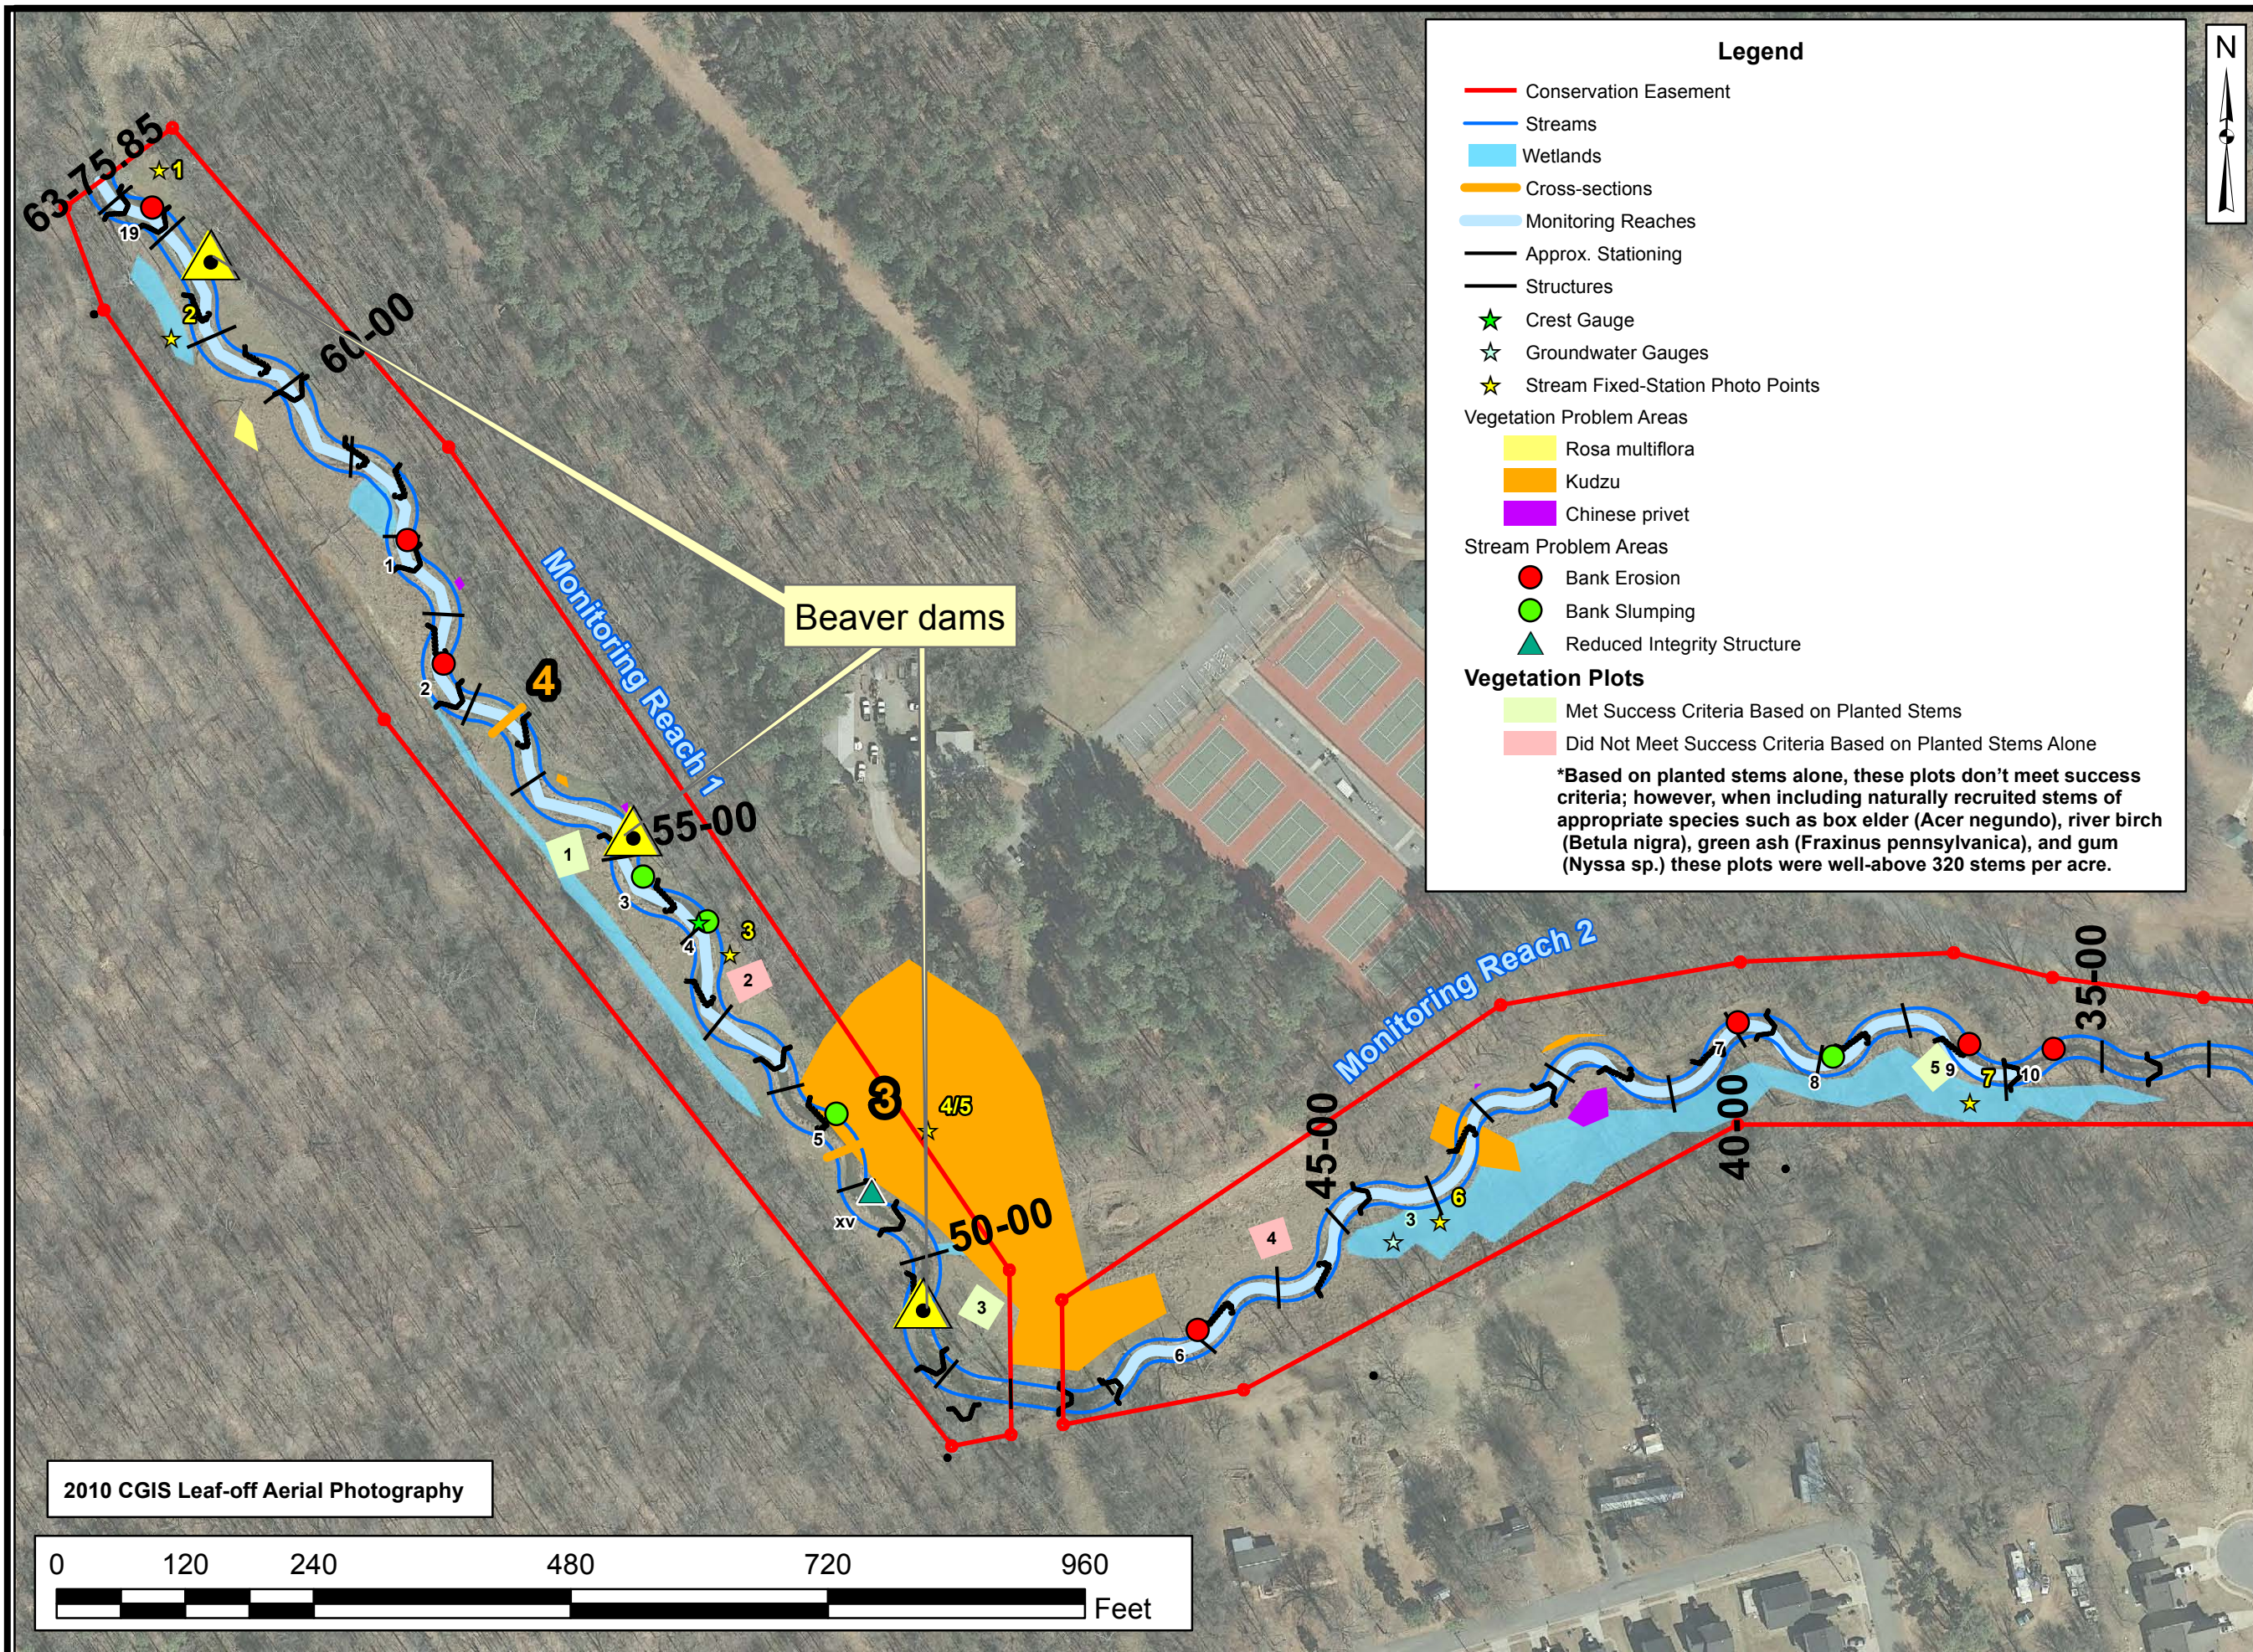
FIGURE

Several areas of bank erosion are located throughout the project as the result of high stream flows, vertical banks, urbanized watershed, flashy flows, and tight radius of curvatures. These areas are depicted on Figures 2 and 2A-2B (Appendix B) and should continue to be monitored closely. Due to the extensive impervious surfaces located within the upstream watershed the Site has periods of flashy flood flows even during smaller rain events. Flashy flood flows, compiled with minor bank instability has resulted in some degradation of the channel including eroding outer bends and slumping banks with loss of planted vegetation and reduced integrity of several structures. The loss of planted stems due to sloughing banks will most likely make the banks, particularly outer bends, more vulnerable to erosive flows and continued bank loss. Degradation is anticipated to continue to occur due to the characteristics of the watershed.

Vegetation problem areas within the Site include a large patch of multiflora rose (*Rosa multiflora*) and Chinese privet (*Ligustrum sinense*) north of the stream near cross-section 3, a large patch of kudzu (*Pueraria lobata*) north of the stream near cross-section 2, and scattered smaller patches of multiflora rose, Chinese privet, and kudzu (depicted on Figures 2A-2B, Appendix B).

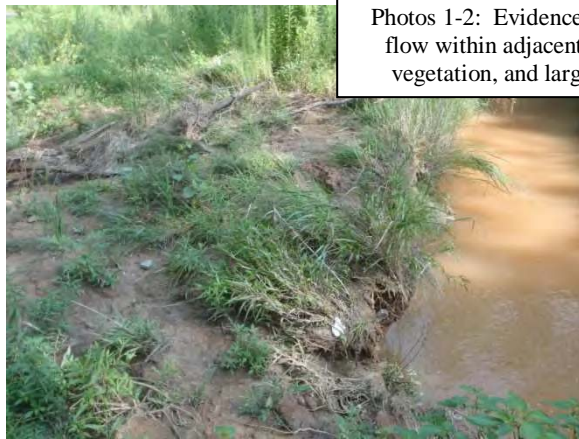
Photos 1-2: Evidence of overbank including flow within adjacent floodplain, laid back vegetation, and large debris/wrack piles.
