**FINAL
ANNUAL MONITORING REPORT
YEAR 4 (2013)
MCINTYRE CREEK RESTORATION SITE
AT HORNETS NEST PARK
MECKLENBURG COUNTY, NORTH CAROLINA
(EEP Project No. 243, Contract No. 004499)**

December 2013

Prepared by:
Axiom Environmental, Inc.
218 Snow Avenue
Raleigh, North Carolina 27603

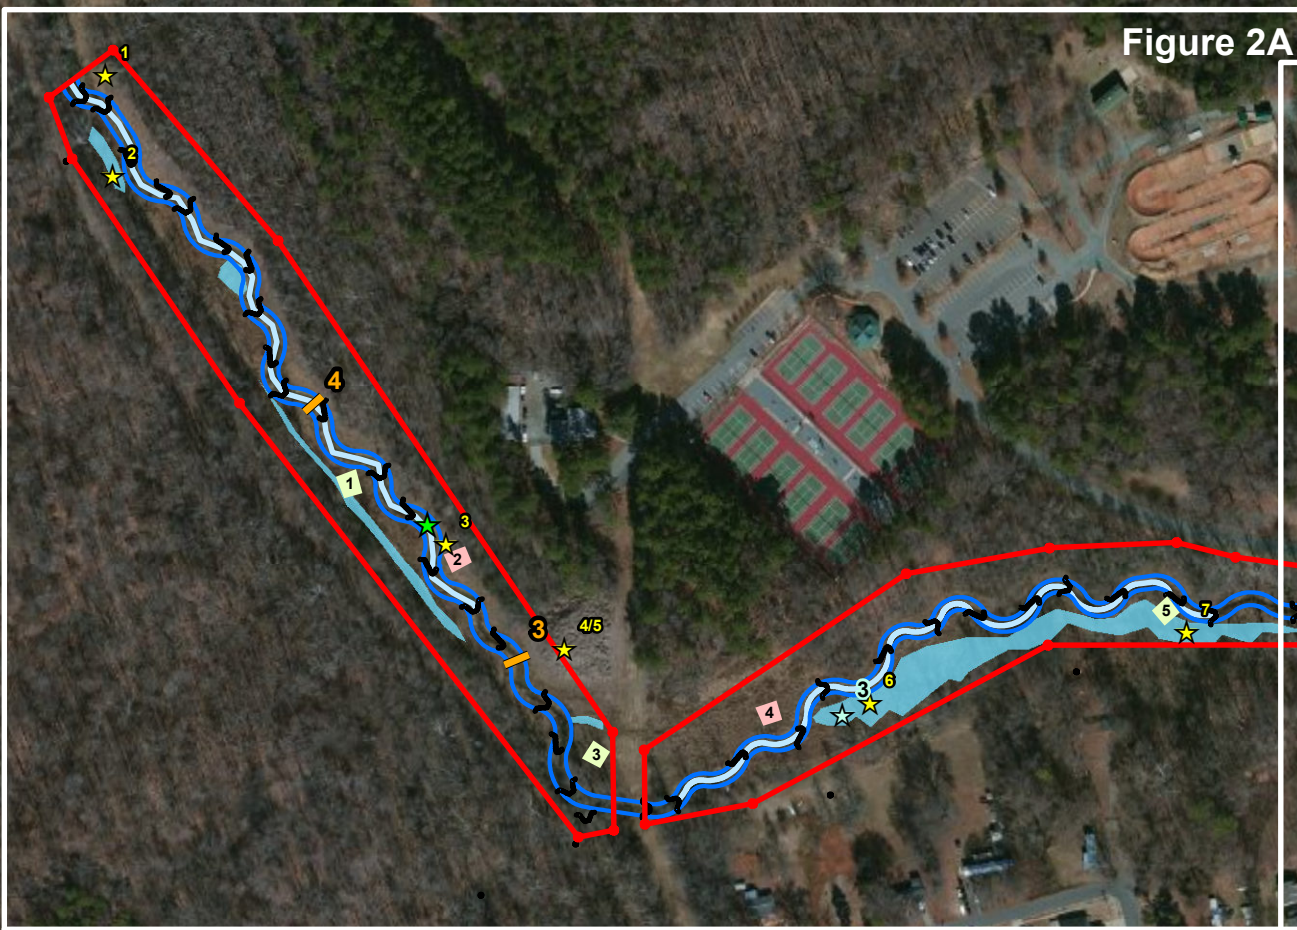
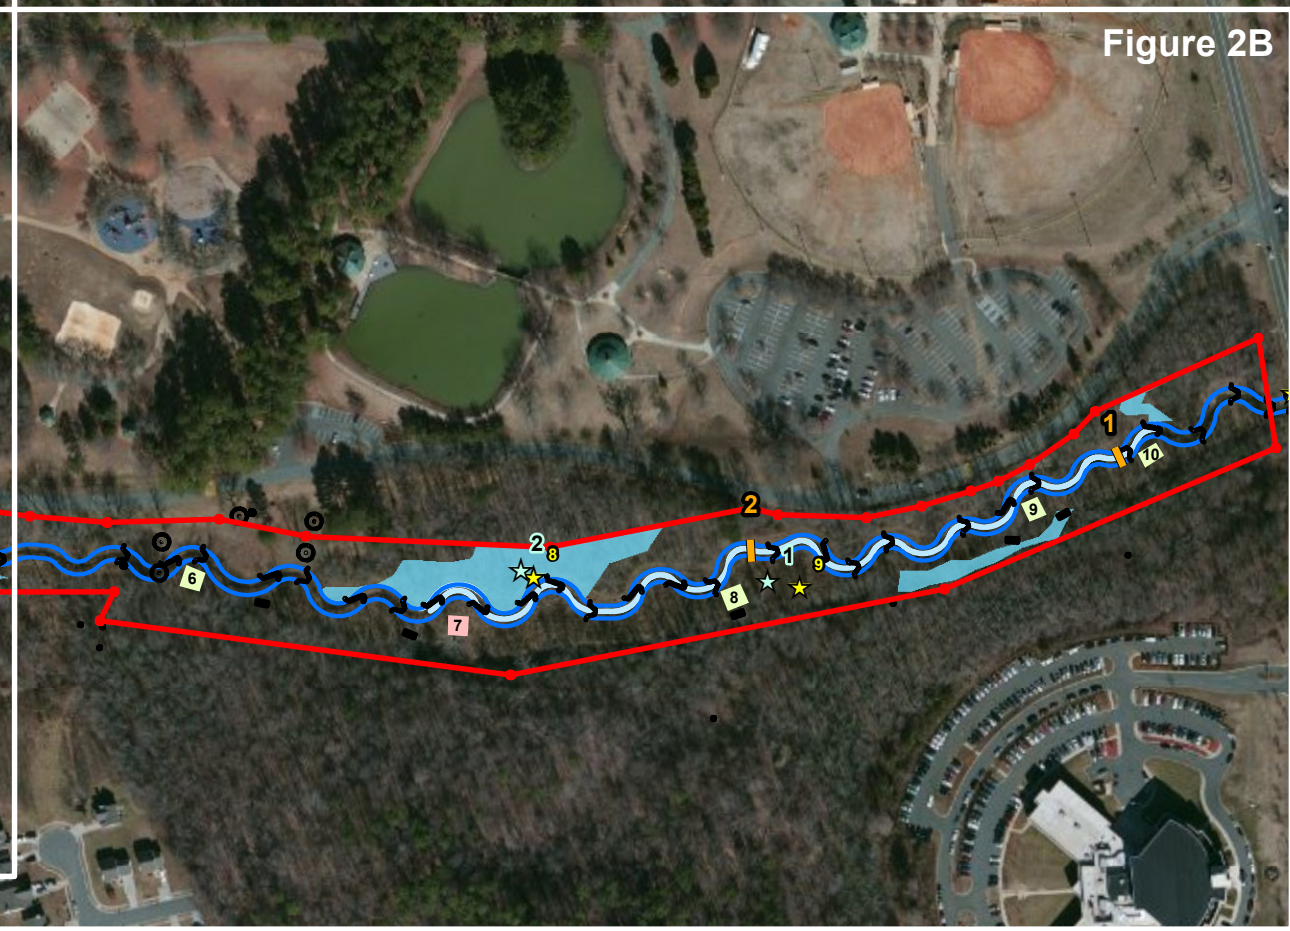
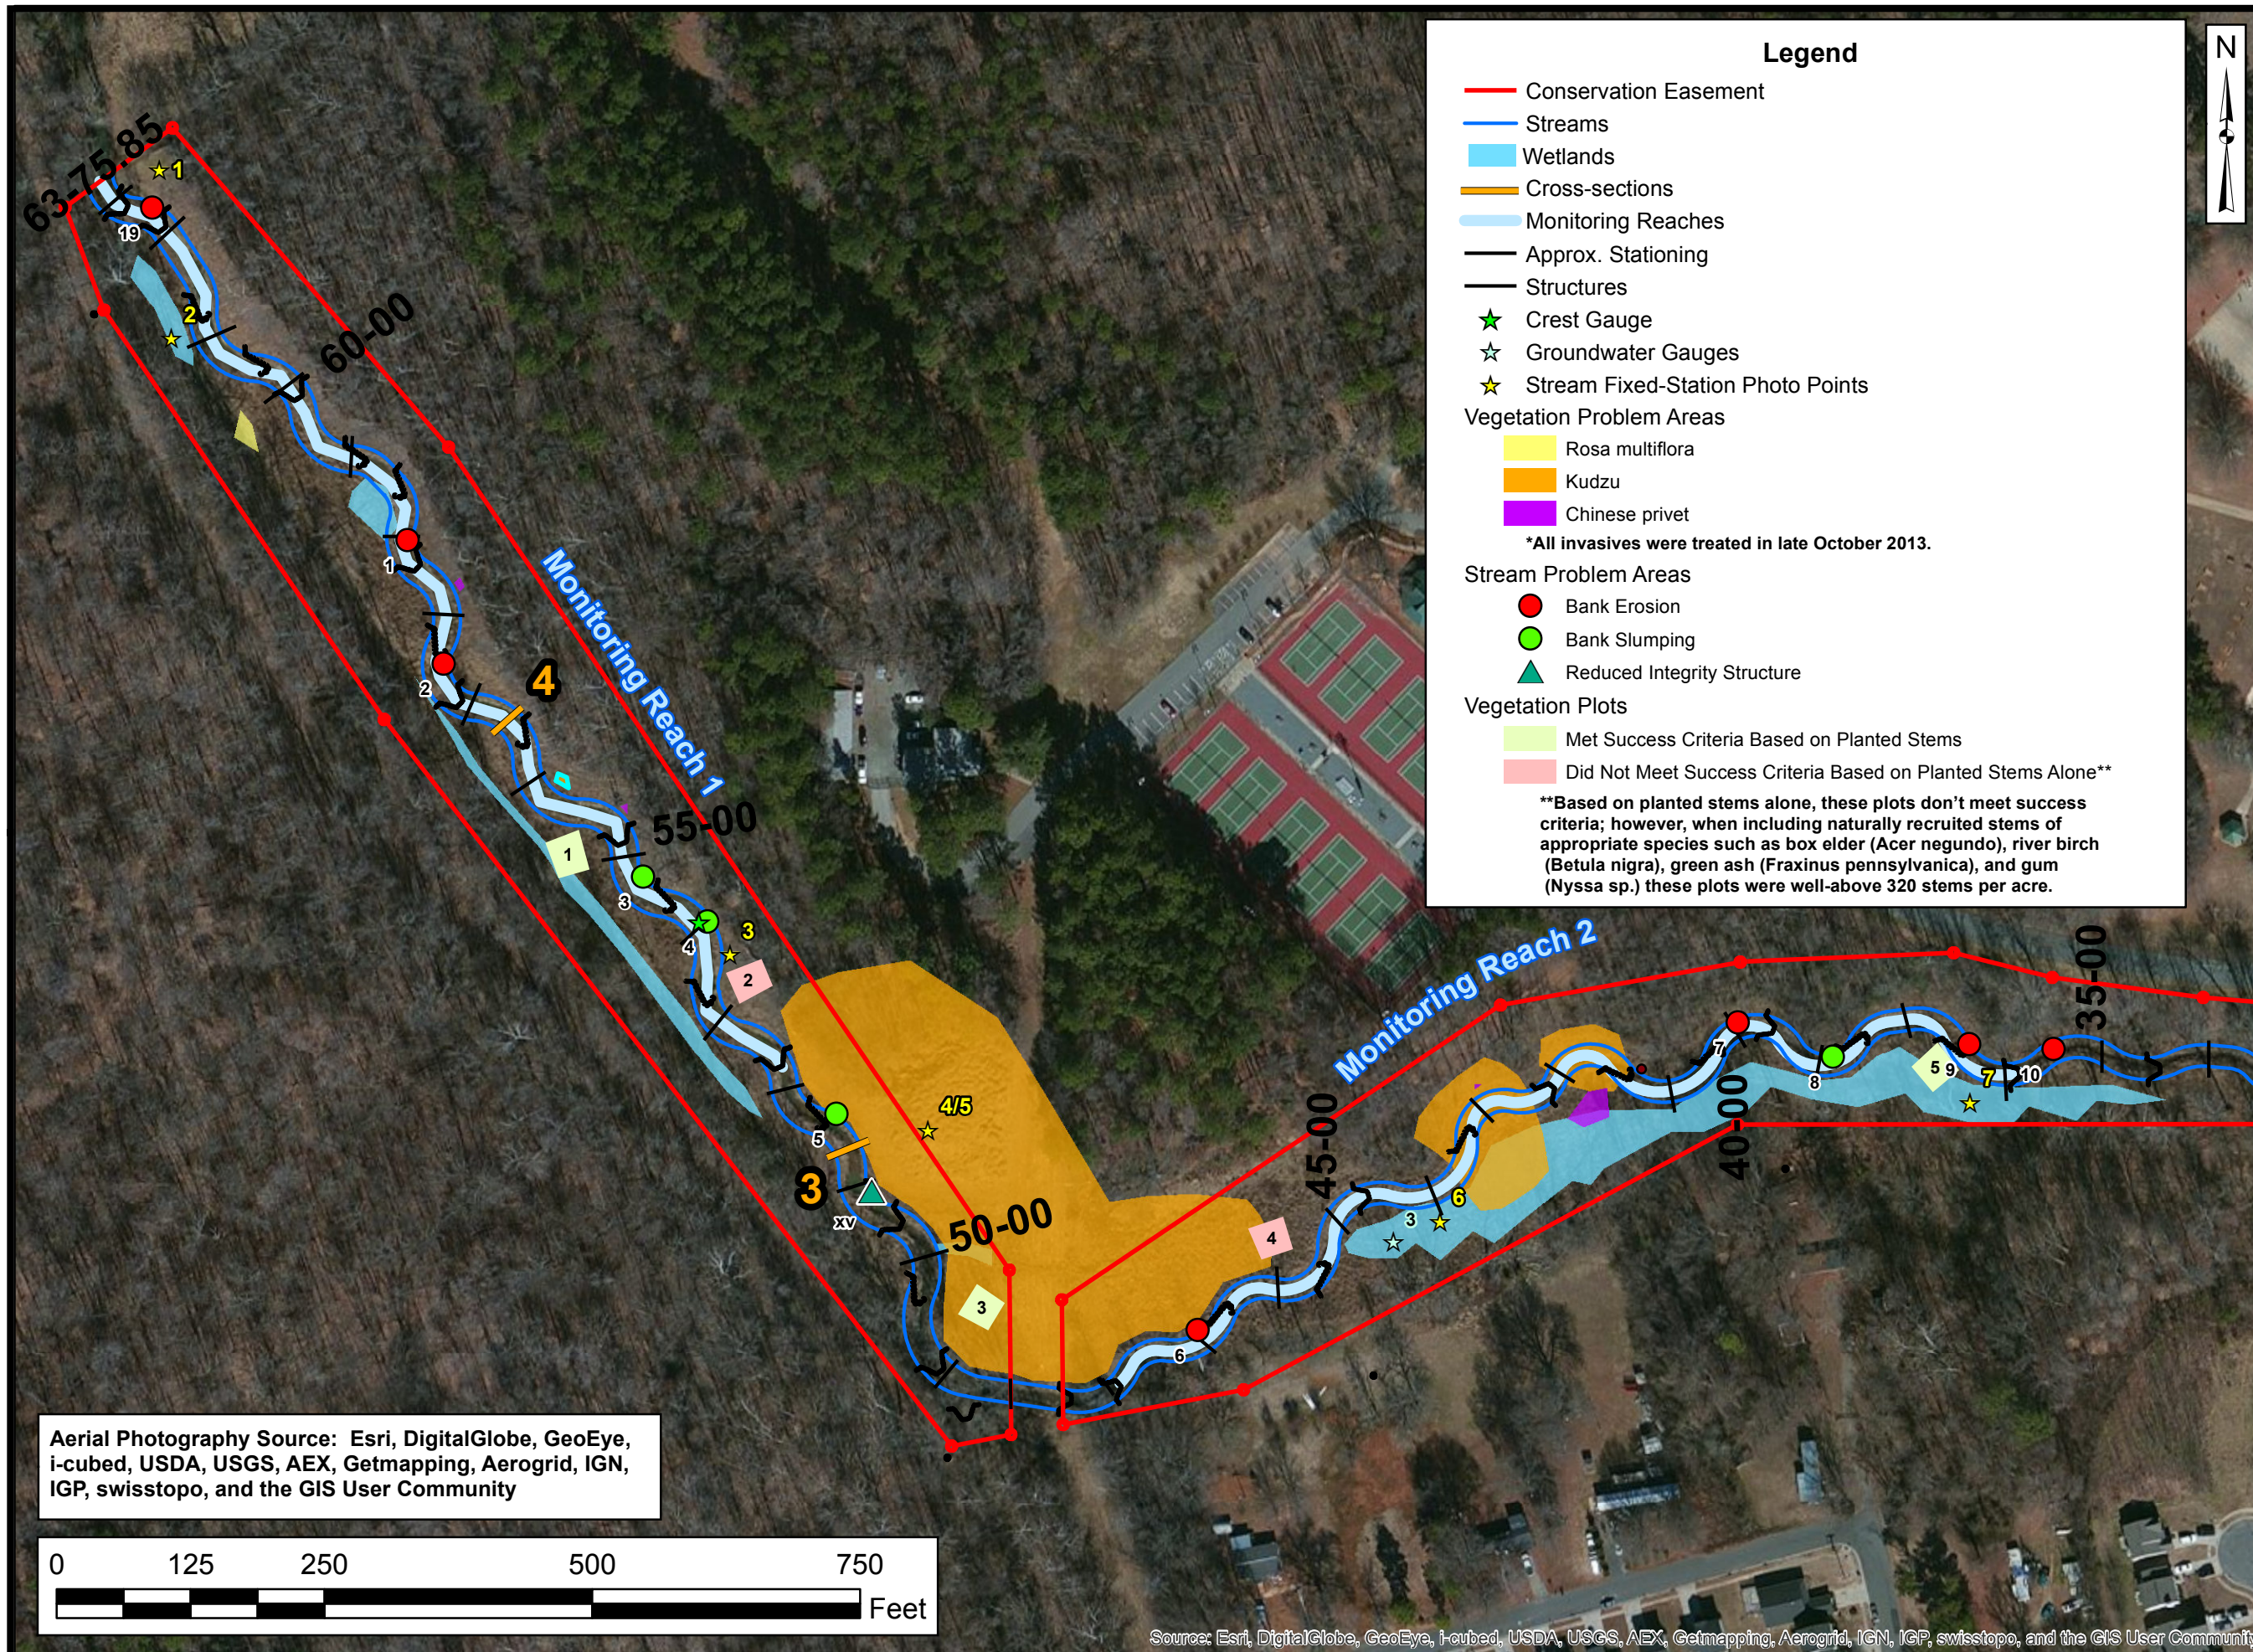
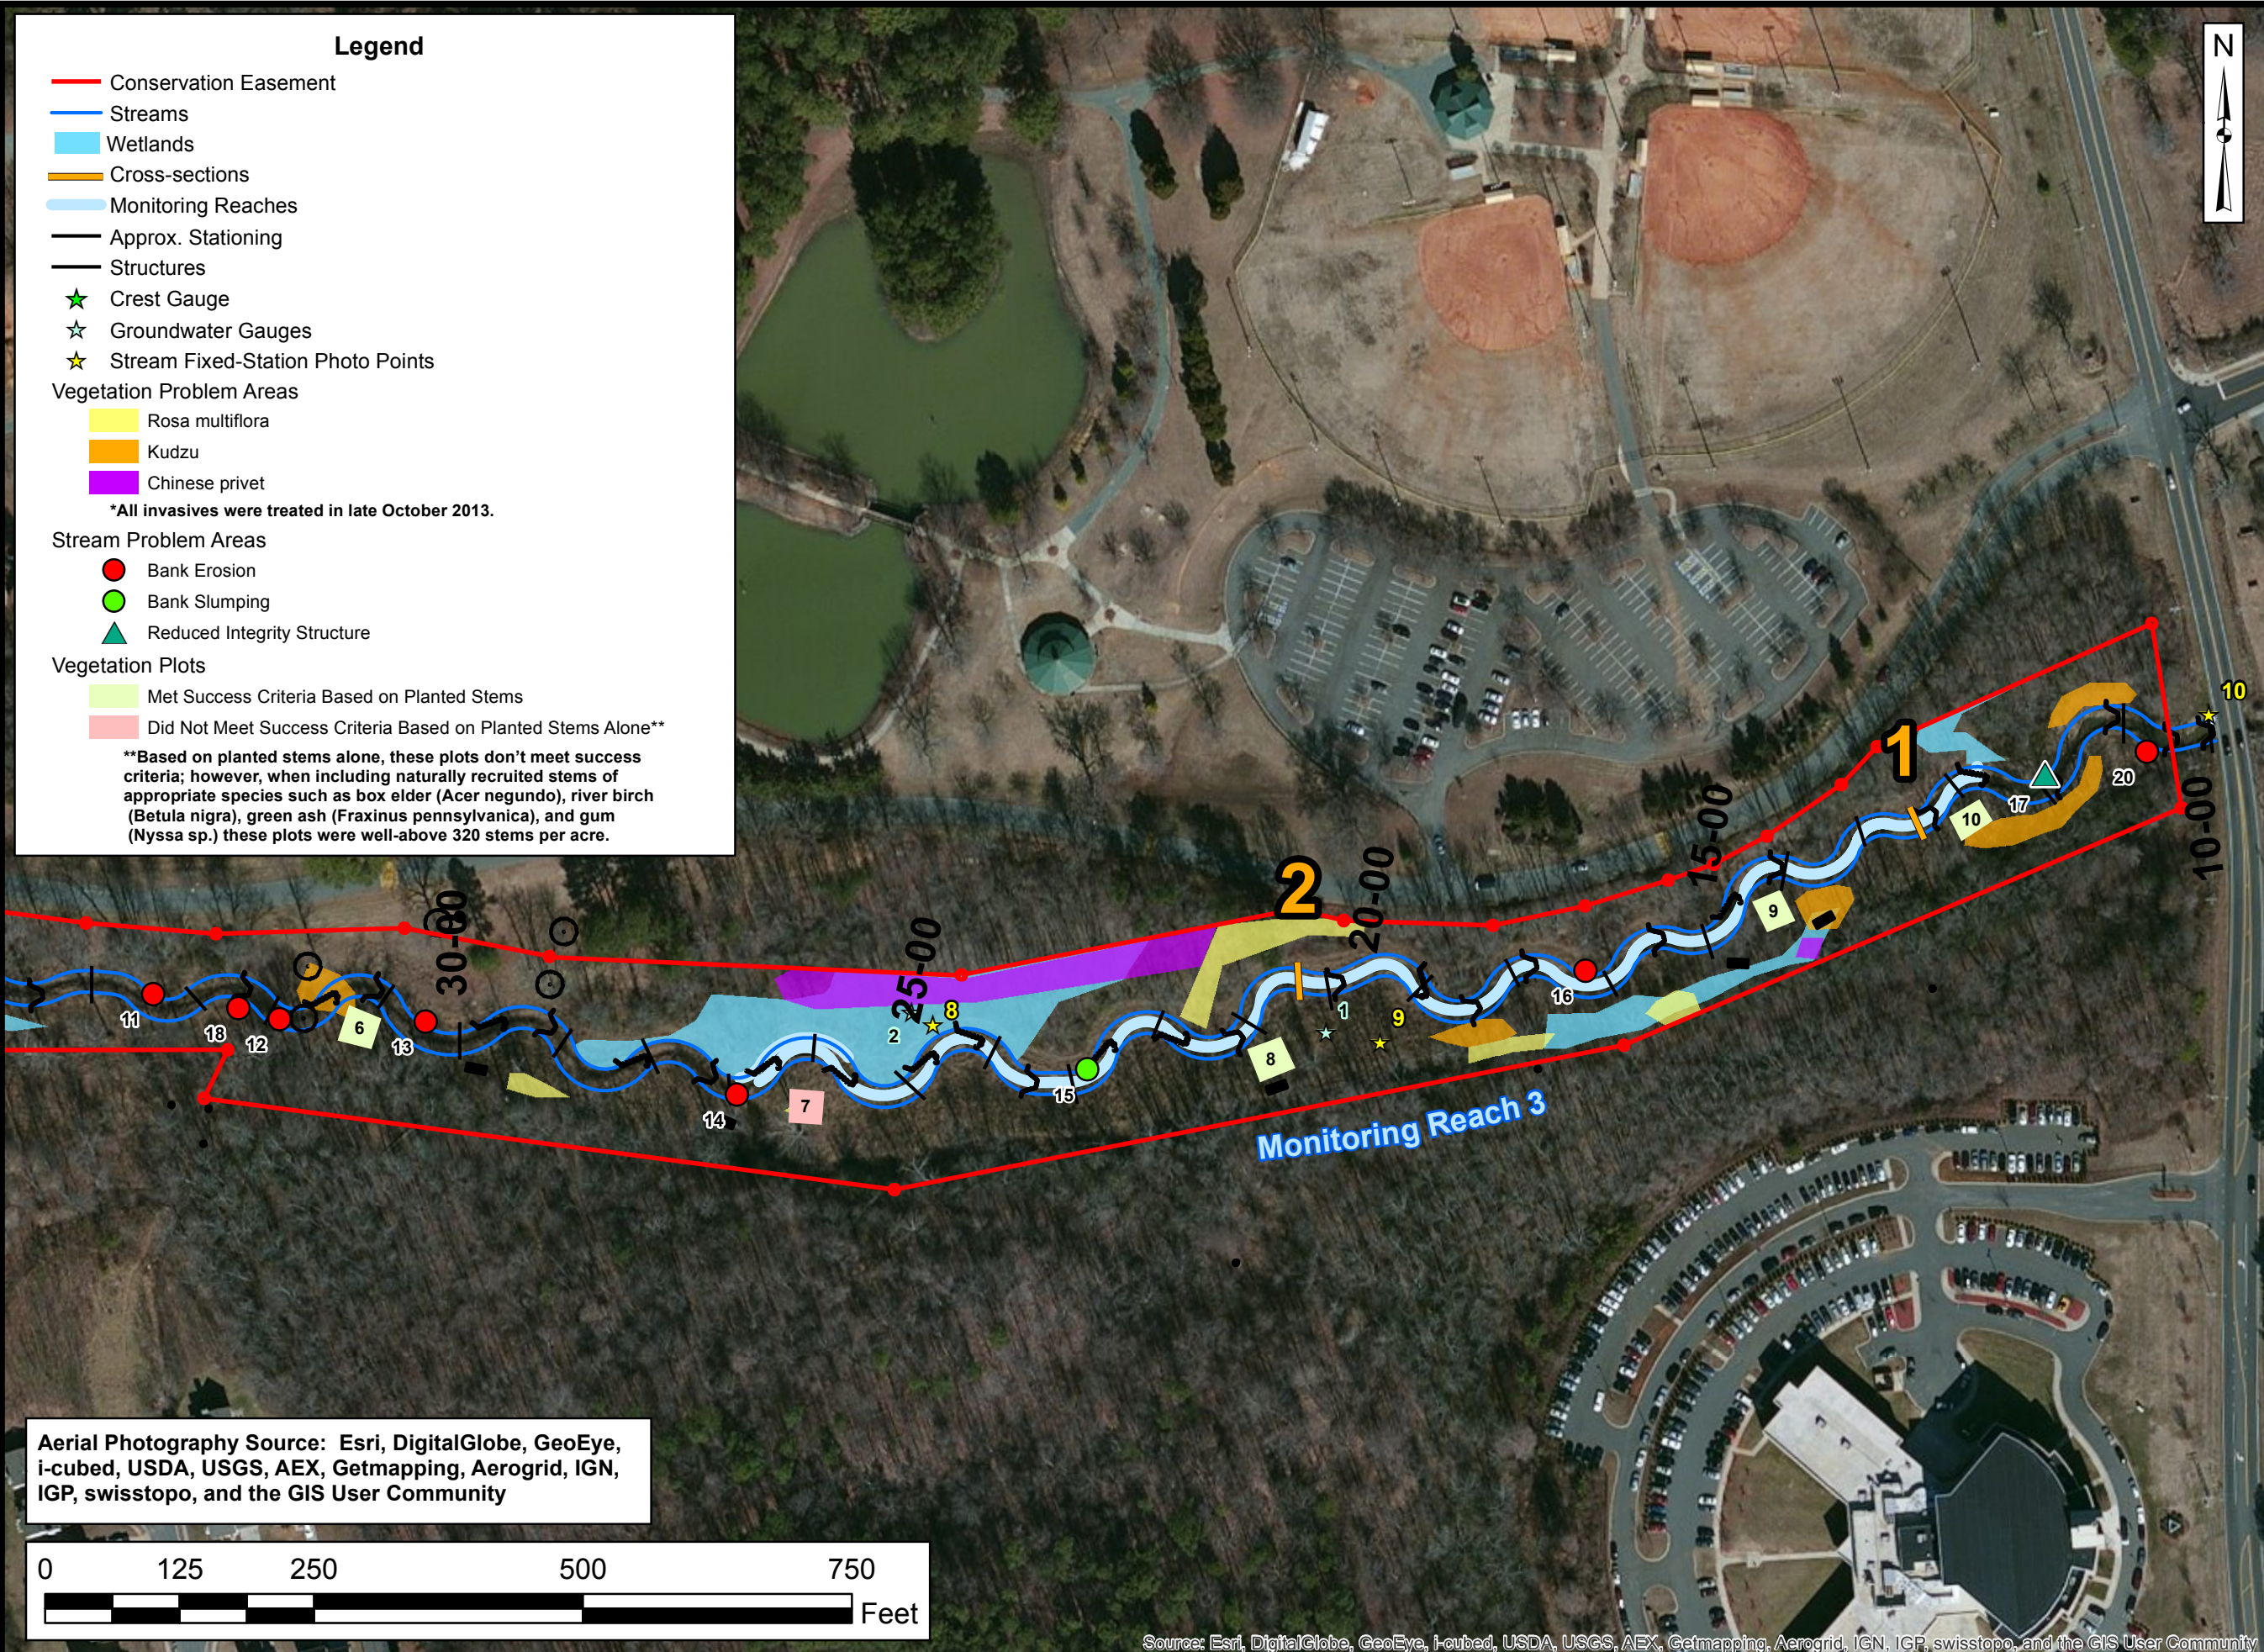
Figures 2 and 2A-2B. Current Conditions Plan View

Several areas of bank erosion are located throughout the project as the result of high stream flows, vertical banks, urbanized watershed, flashy flows, and tight radius of curvatures. These areas are depicted on Figures 2 and 2A-2B (Appendix B) and should continue to be monitored closely. Due to the extensive impervious surfaces located within the upstream watershed the Site has periods of flashy flood flows even during smaller rain events. Flashy flood flows, compiled with minor bank instability has resulted in some degradation of the channel including eroding outer bends and slumping banks with loss of planted vegetation and reduced integrity of several structures. The loss of planted stems due to sloughing banks will most likely make the banks, particularly outer bends, more vulnerable to erosive flows and continued bank loss. Degradation is anticipated to continue to occur due to the characteristics of the watershed. Stream repairs will be completed in the downstream portion of the Site in early 2014.

Vegetation areas of concern within the Site include a large patch of multiflora rose (*Rosa multiflora*) and Chinese privet (*Ligustrum sinense*) north of the stream near cross-section 3, a large patch of kudzu (*Pueraria lobata*) north of the stream near cross-section 2, and scattered smaller patches of multiflora rose, Chinese privet, and kudzu (depicted on Figures 2A-2B, Appendix B). A treatment of all invasive

species occurred in late October 2013; these treatments appeared to be successful. Existing invasive areas will continue to be monitored after treatment. EEP will continue to treat invasive species within the site as needed; there are currently two additional treatments scheduled for 2014 and one for the 2015 growing season.

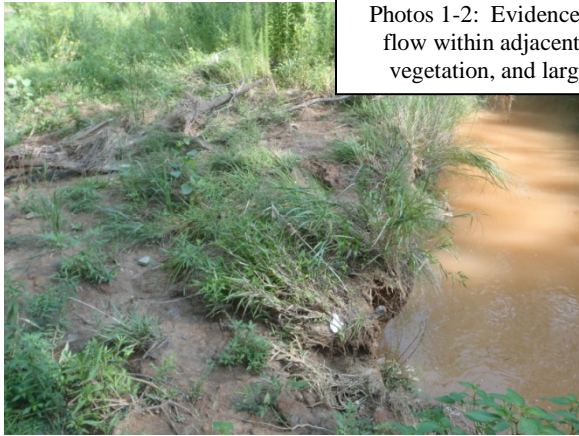
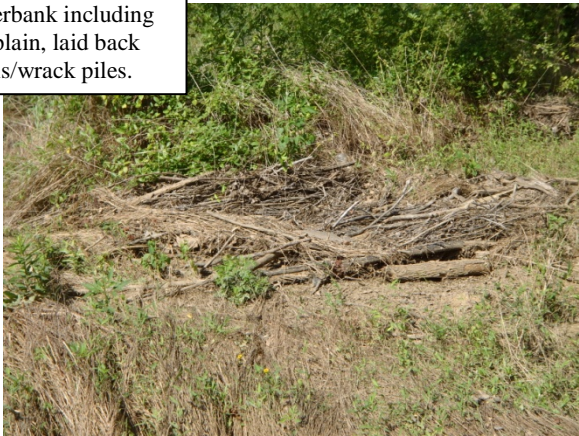
Photos 1-2: Evidence of overbank including flow within adjacent floodplain, laid back vegetation, and large debris/wrack piles.

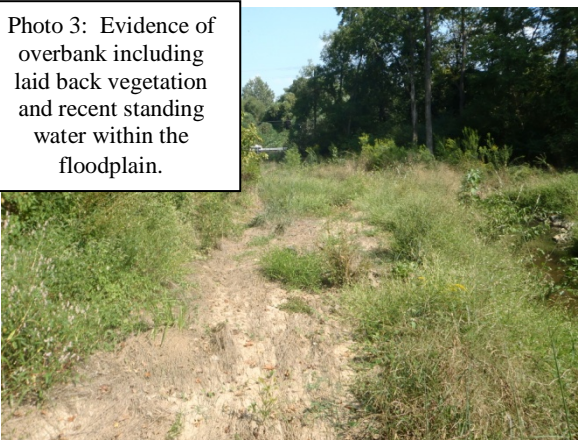
Photo 3: Evidence of overbank including laid back vegetation and recent standing water within the floodplain.

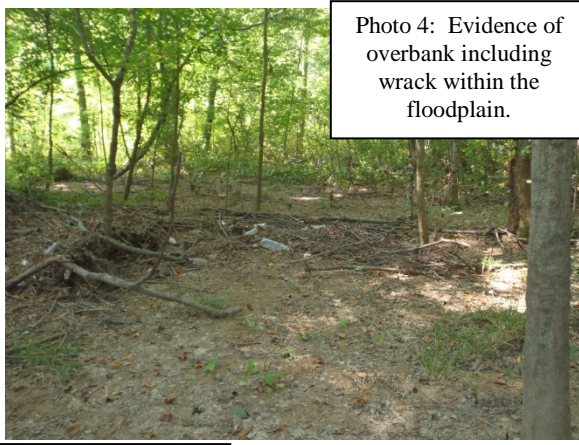
Photo 4: Evidence of overbank including wrack within the floodplain.

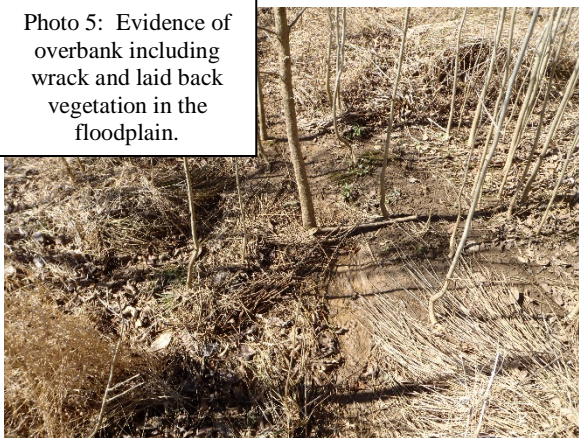
Photo 5: Evidence of overbank including wrack and laid back vegetation in the floodplain.

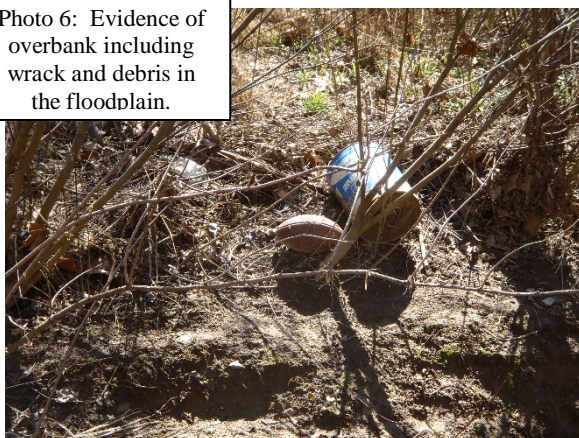
Photo 6: Evidence of overbank including wrack and debris in the floodplain.
