**FINAL  
ANNUAL MONITORING REPORT  
YEAR 5 (2014)  
MCINTYRE CREEK RESTORATION SITE  
AT HORNETS NEST PARK  
MECKLENBURG COUNTY, NORTH CAROLINA  
(EEP Project No. 243, Contract No. 004499)**

December 2014

Prepared by:  
Axiom Environmental, Inc.  
218 Snow Avenue  
Raleigh, North Carolina 27603

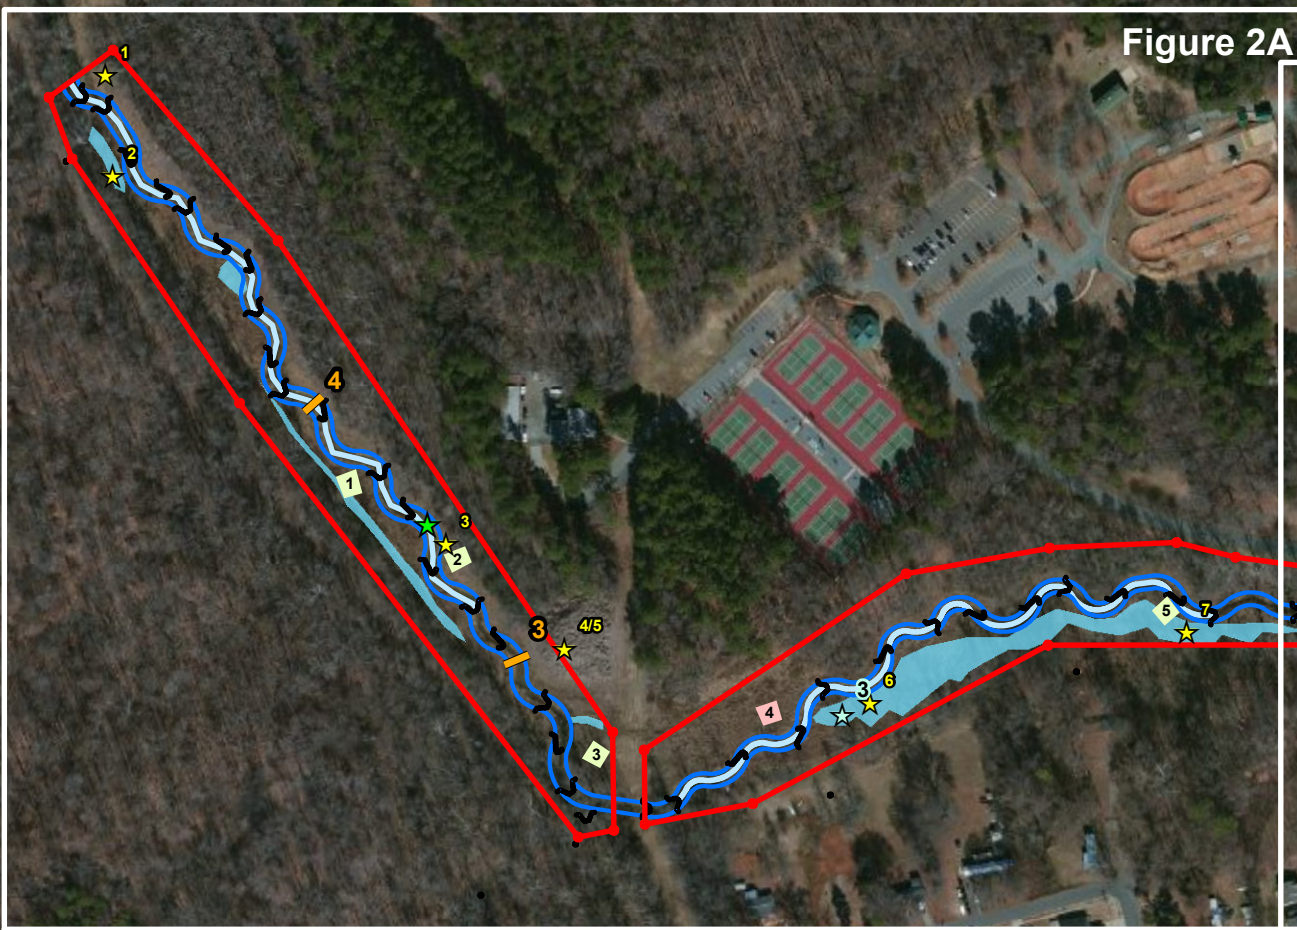
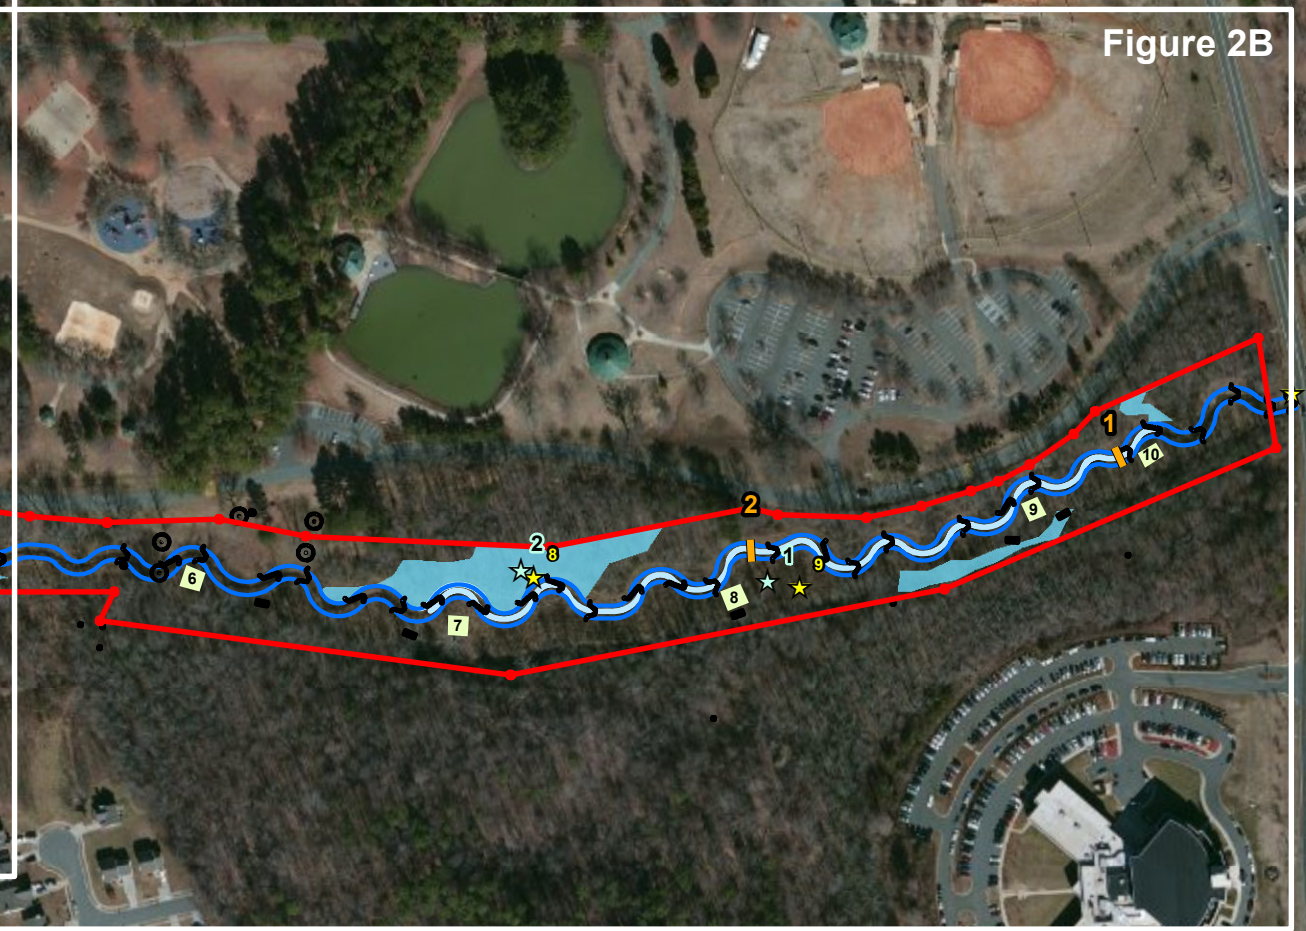
Figure 2A

Additionally, several large patches of Kudzu (*Pueraria lobata*) were observed within the Site (depicted on Figures 2A-2B, Appendix B). A treatment of all invasive species occurred in late October 2013 and again in early 2014; these treatments initially appeared to be successful, however, several areas of kudzu have spread during the 2014 growing season resulting in some tree mortality. EEP will continue to treat invasive species within the Site as needed.

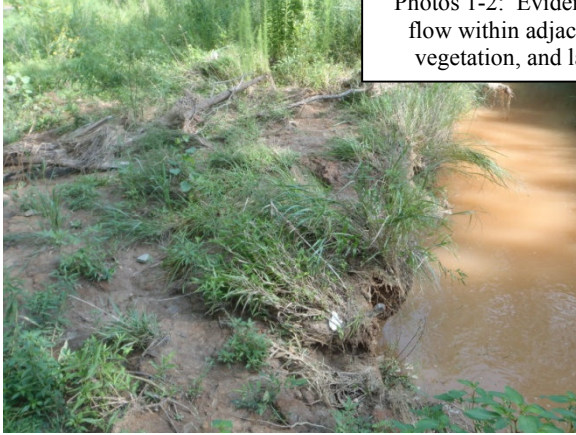
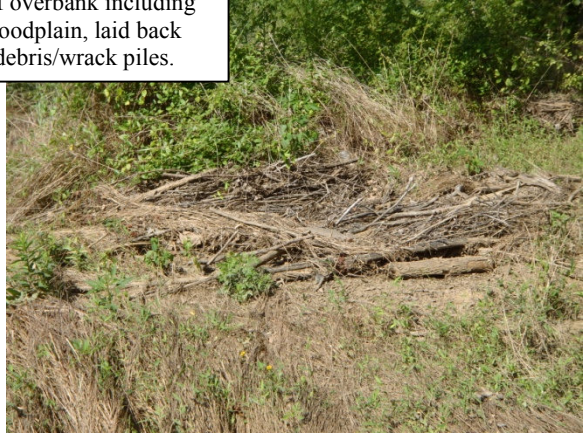
Photos 1-2: Evidence of overbank including flow within adjacent floodplain, laid back vegetation, and large debris/wrack piles.

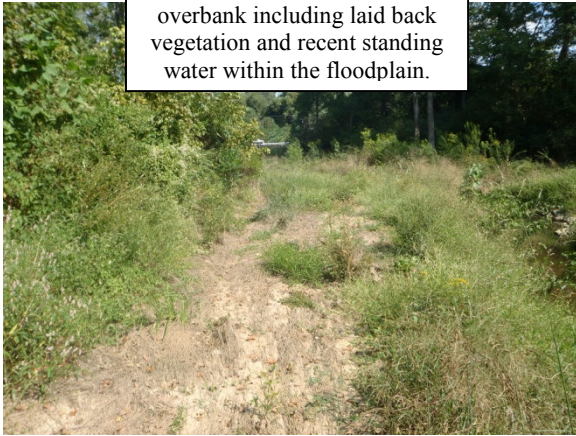
Photo 3: Evidence of overbank including laid back vegetation and recent standing water within the floodplain.

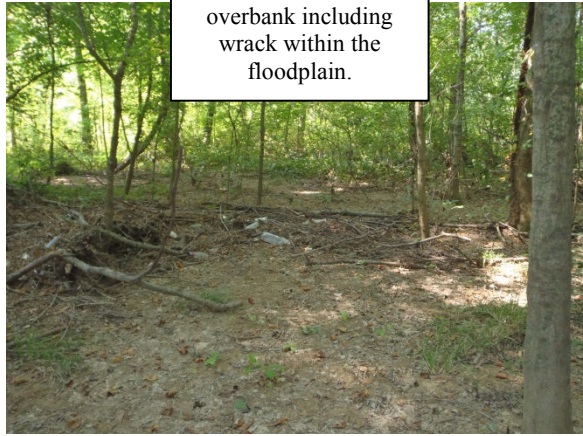
Photo 4: Evidence of overbank including wrack within the floodplain.

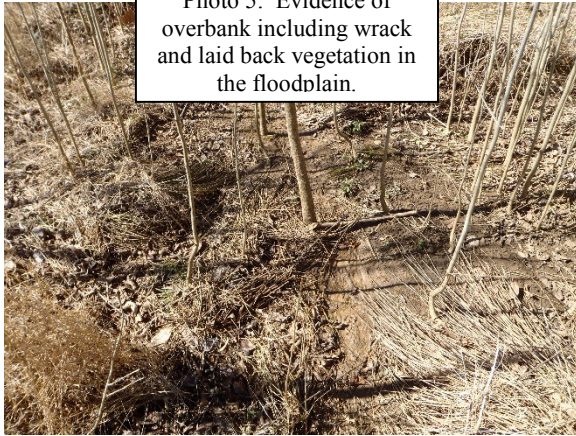
Photo 5: Evidence of overbank including wrack and laid back vegetation in the floodplain.

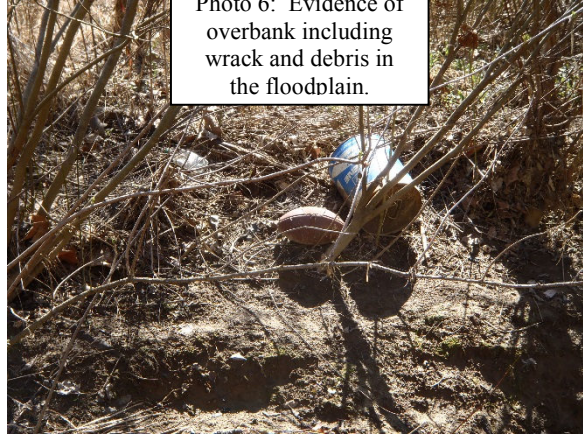
Photo 6: Evidence of overbank including wrack and debris in the floodplain.
