**FINAL
ANNUAL MONITORING REPORT
YEAR 6 (2015)
MCINTYRE CREEK RESTORATION SITE
AT HORNETS NEST PARK
MECKLENBURG COUNTY, NORTH CAROLINA
(DMS Project No. 243, Contract No. 004499)**

April 2016

Prepared by:
Axiom Environmental, Inc.
218 Snow Avenue
Raleigh, North Carolina 27603

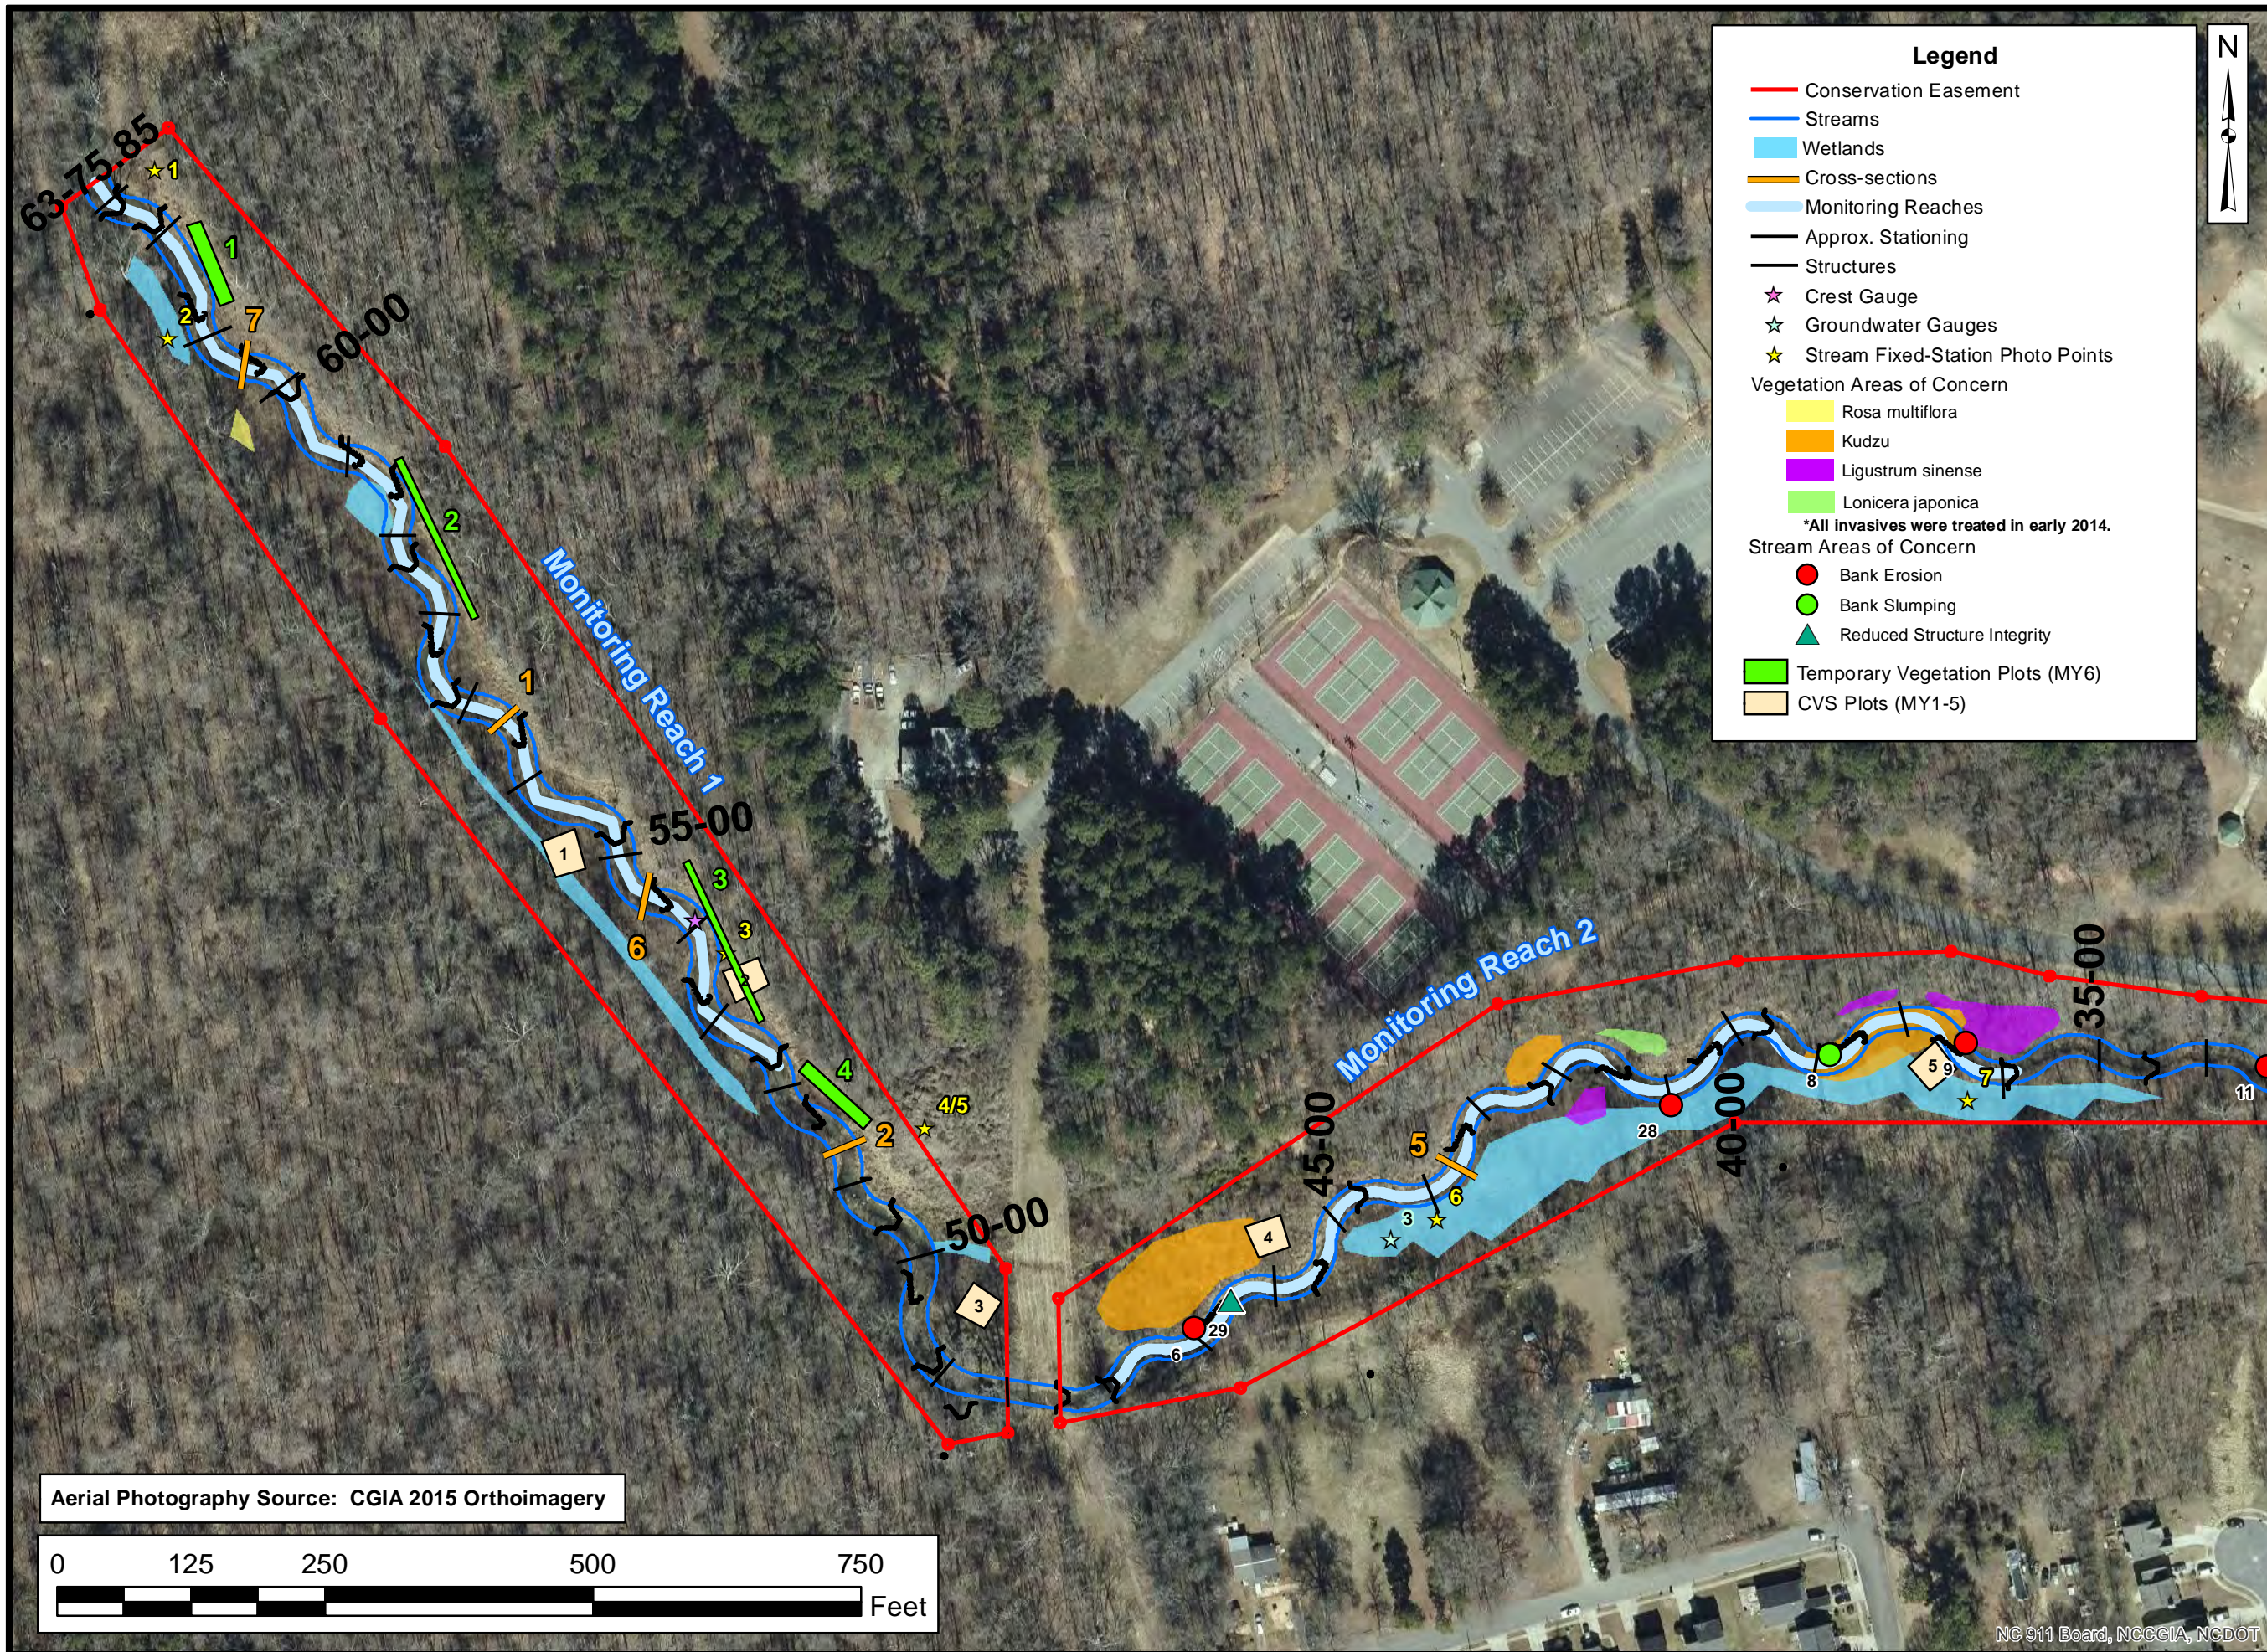
FIGURE
2A

Stream Areas of Concern

- Bank Erosion
- Bank Slumping
- ▲ Reduced Structure Integrity

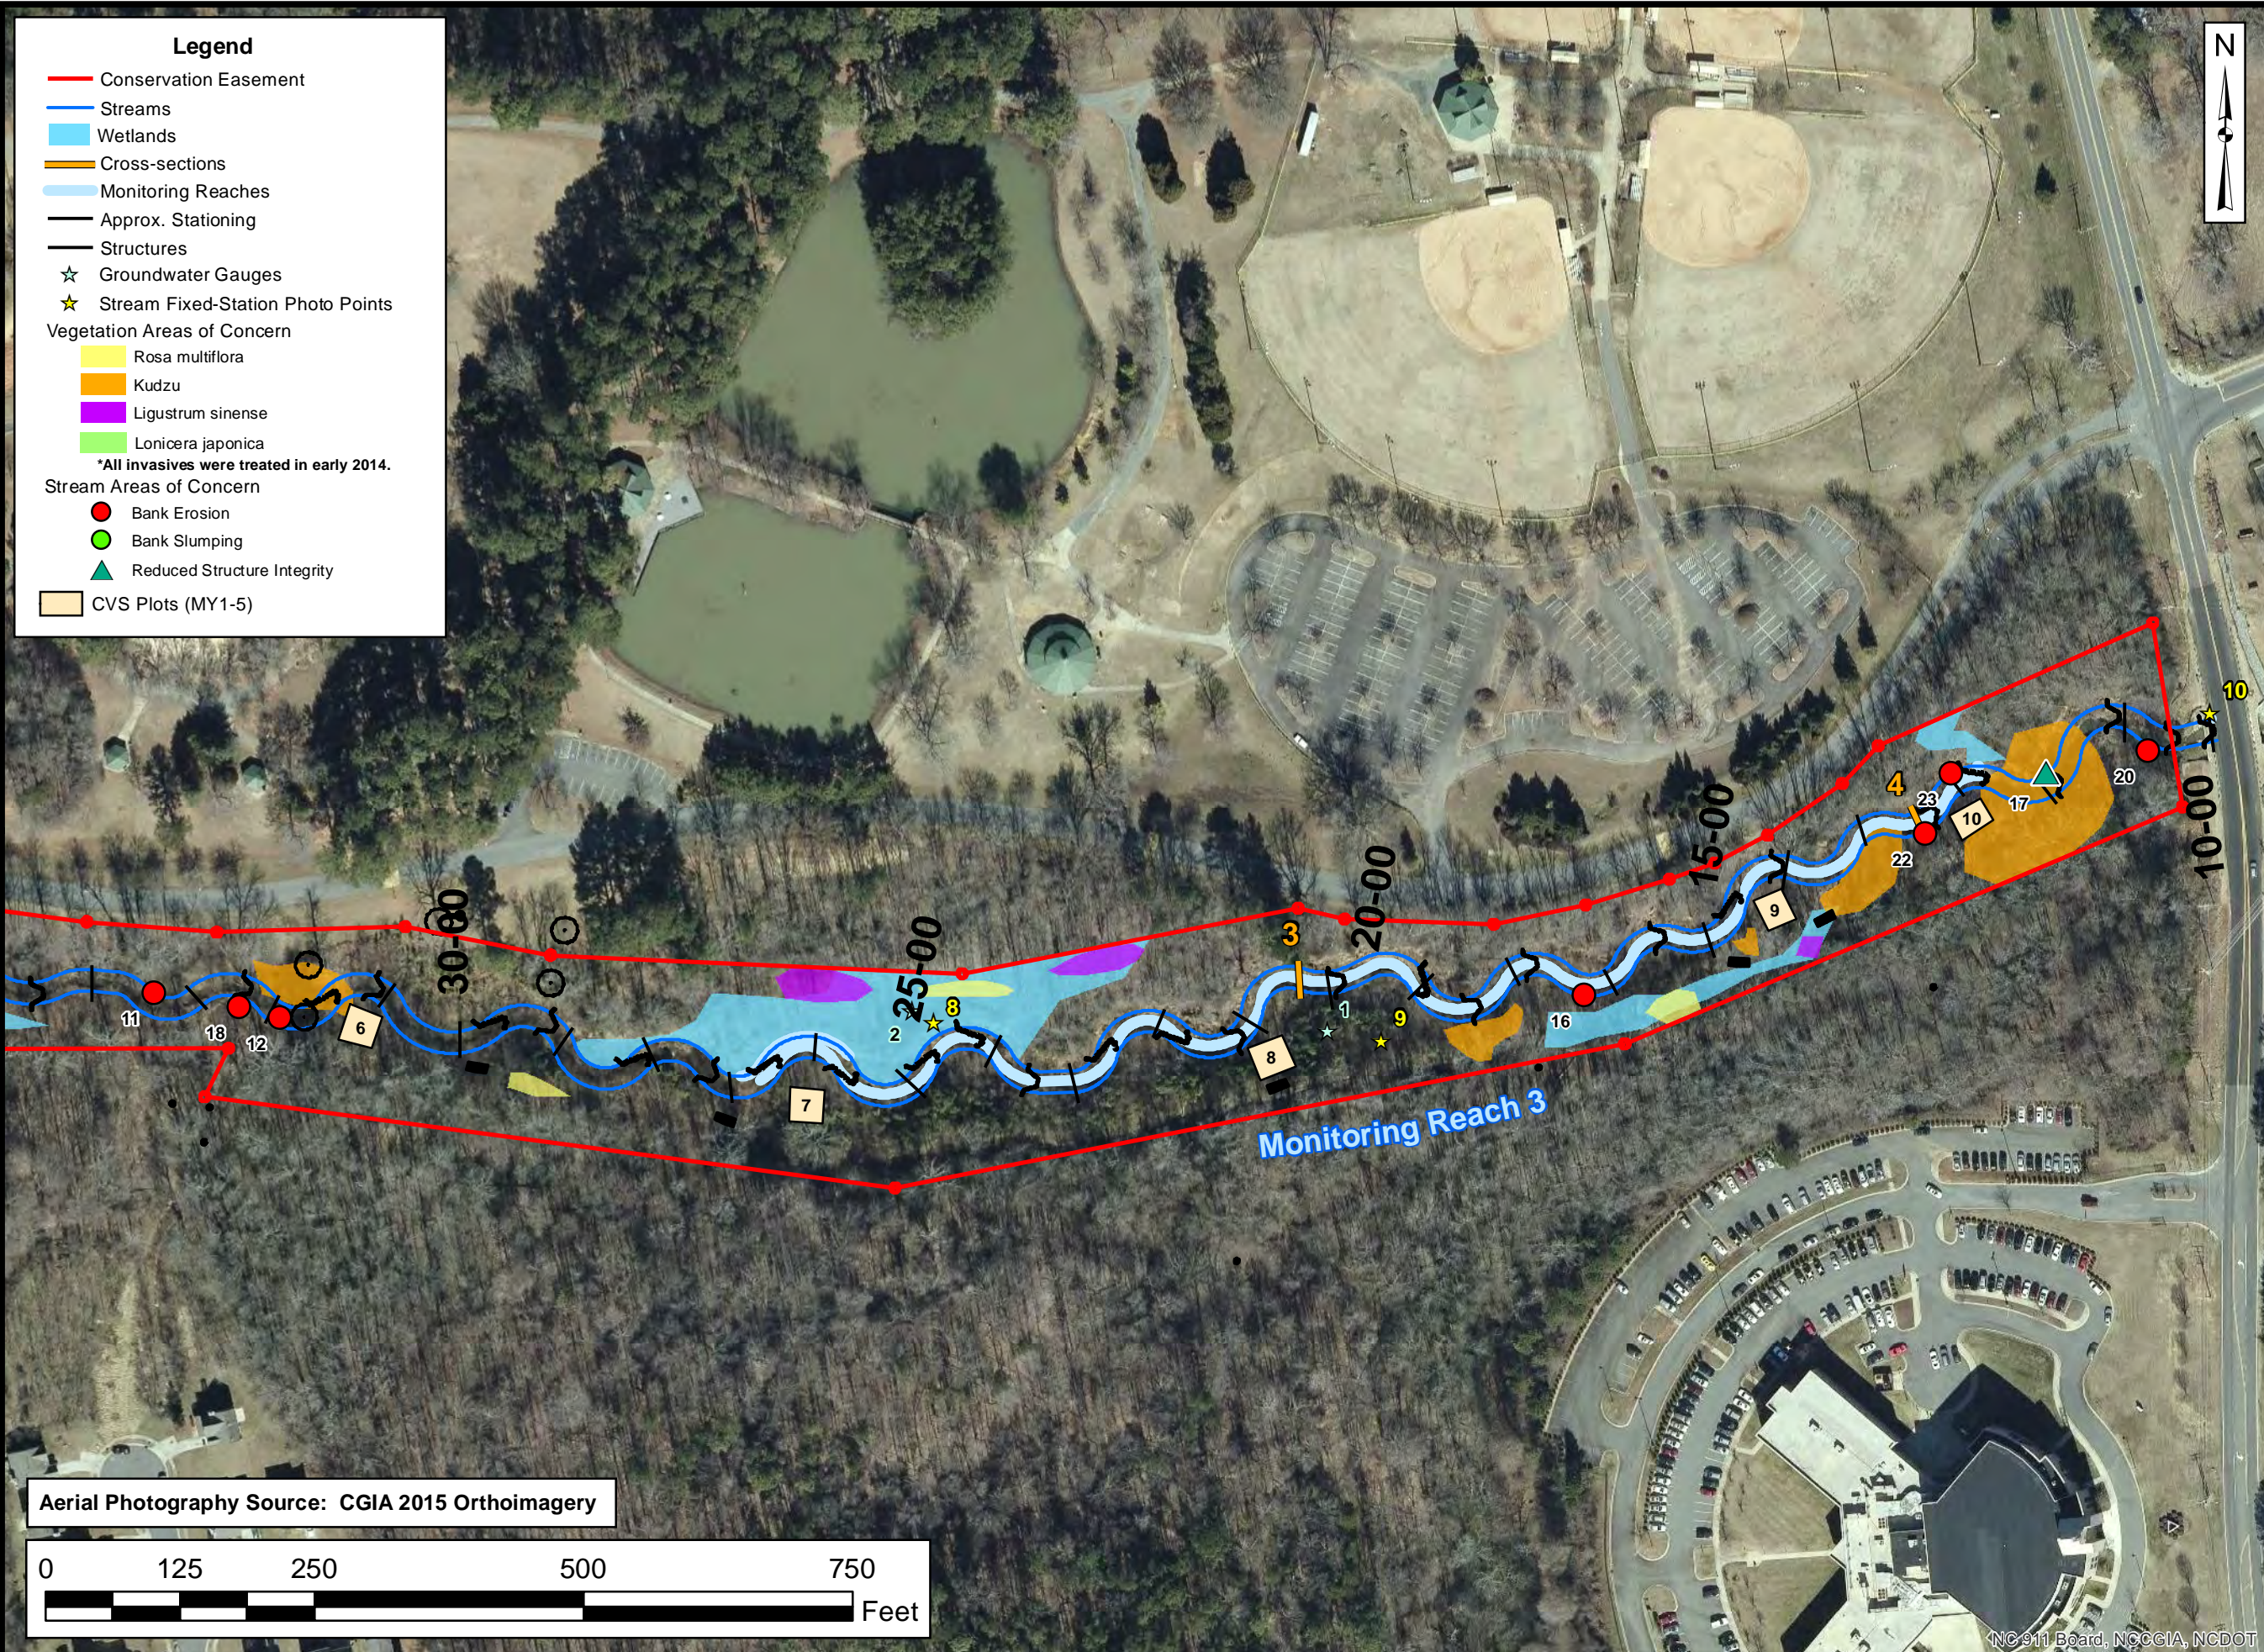
FIGURE 2B

Stream Areas of Concern

- Bank Erosion
- Bank Slumping
- ▲ Reduced Structure Integrity

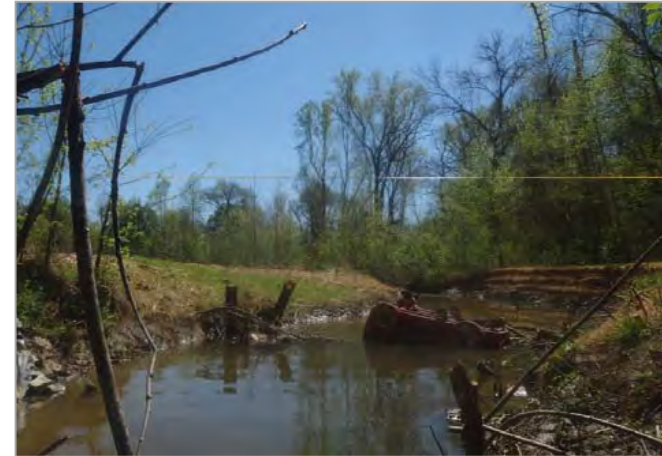
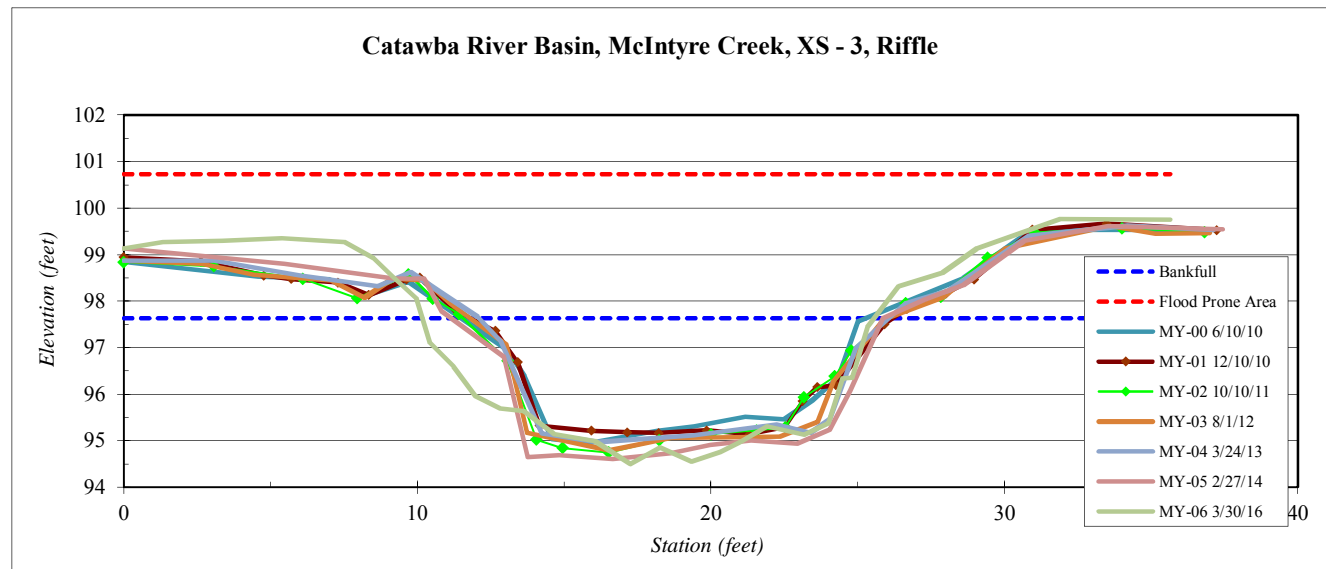
River Basin:	Catawba
Watershed:	McIntyre Creek
XS ID	XS - 3, Riffle
Feature	Riffle
Date:	3/30/2016
Field Crew:	Perkinson, Jernigan

SUMMARY DATA	
Bankfull Elevation:	97.6
Bankfull Cross-Sectional Area:	34.1
Bankfull Width:	15.4
Flood Prone Area Elevation:	100.7
Flood Prone Width:	150.0
Max Depth at Bankfull:	3.1
Mean Depth at Bankfull:	2.2
W / D Ratio:	7.0
Entrenchment Ratio:	9.7
Bank Height Ratio:	1.0

Note: Right bank cross section fixed point was removed during construction and reestablished for Year 6 monitoring.

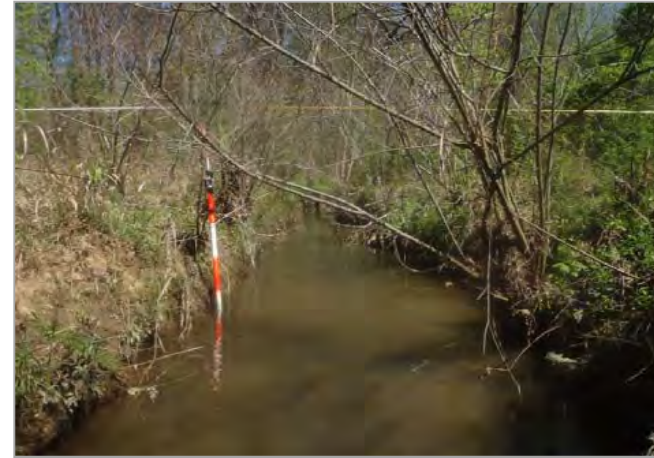
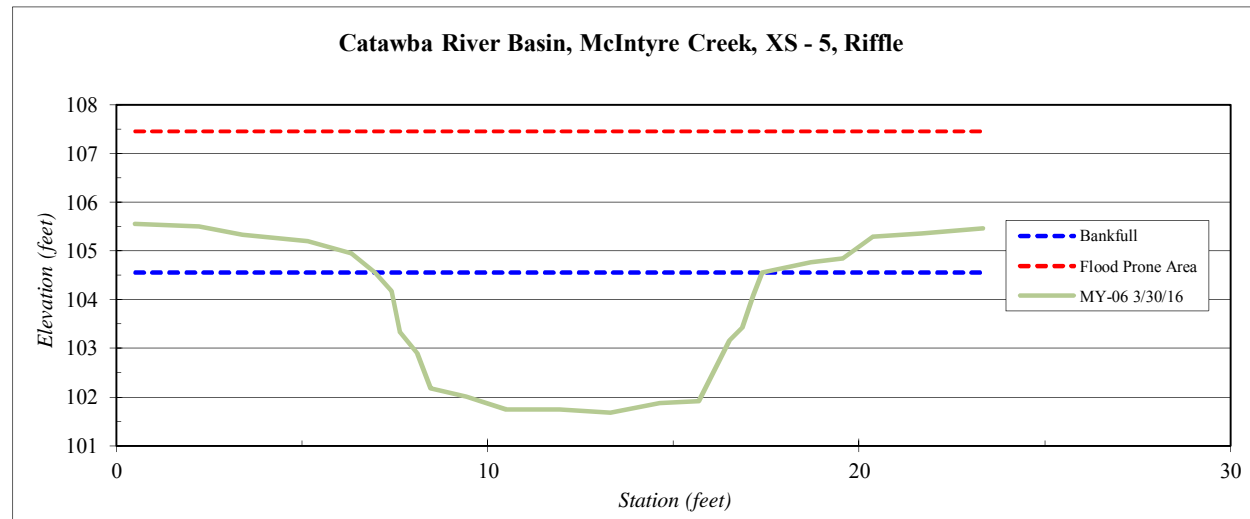
River Basin:	Catawba
Watershed:	McIntyre Creek
XS ID	XS - 5, Riffle
Feature	Riffle
Date:	3/30/2016
Field Crew:	Perkinson, Jernigan

SUMMARY DATA	
Bankfull Elevation:	104.6
Bankfull Cross-Sectional Area:	23.7
Bankfull Width:	10.4
Flood Prone Area Elevation:	107.5
Flood Prone Width:	150.0
Max Depth at Bankfull:	2.9
Mean Depth at Bankfull:	2.3
W / D Ratio:	4.6
Entrenchment Ratio:	14.4
Bank Height Ratio:	1.0

* Note: Cross Section was established after repairs conducted at the Site.
