**FINAL
ANNUAL MONITORING REPORT
YEAR 7 (2016)
MCINTYRE CREEK RESTORATION SITE
AT HORNETS NEST PARK
MECKLENBURG COUNTY, NORTH CAROLINA
(DMS Project No. 243, Contract No. 004499)**

November 2016

Prepared by:
Axiom Environmental, Inc.
218 Snow Avenue
Raleigh, North Carolina 27603

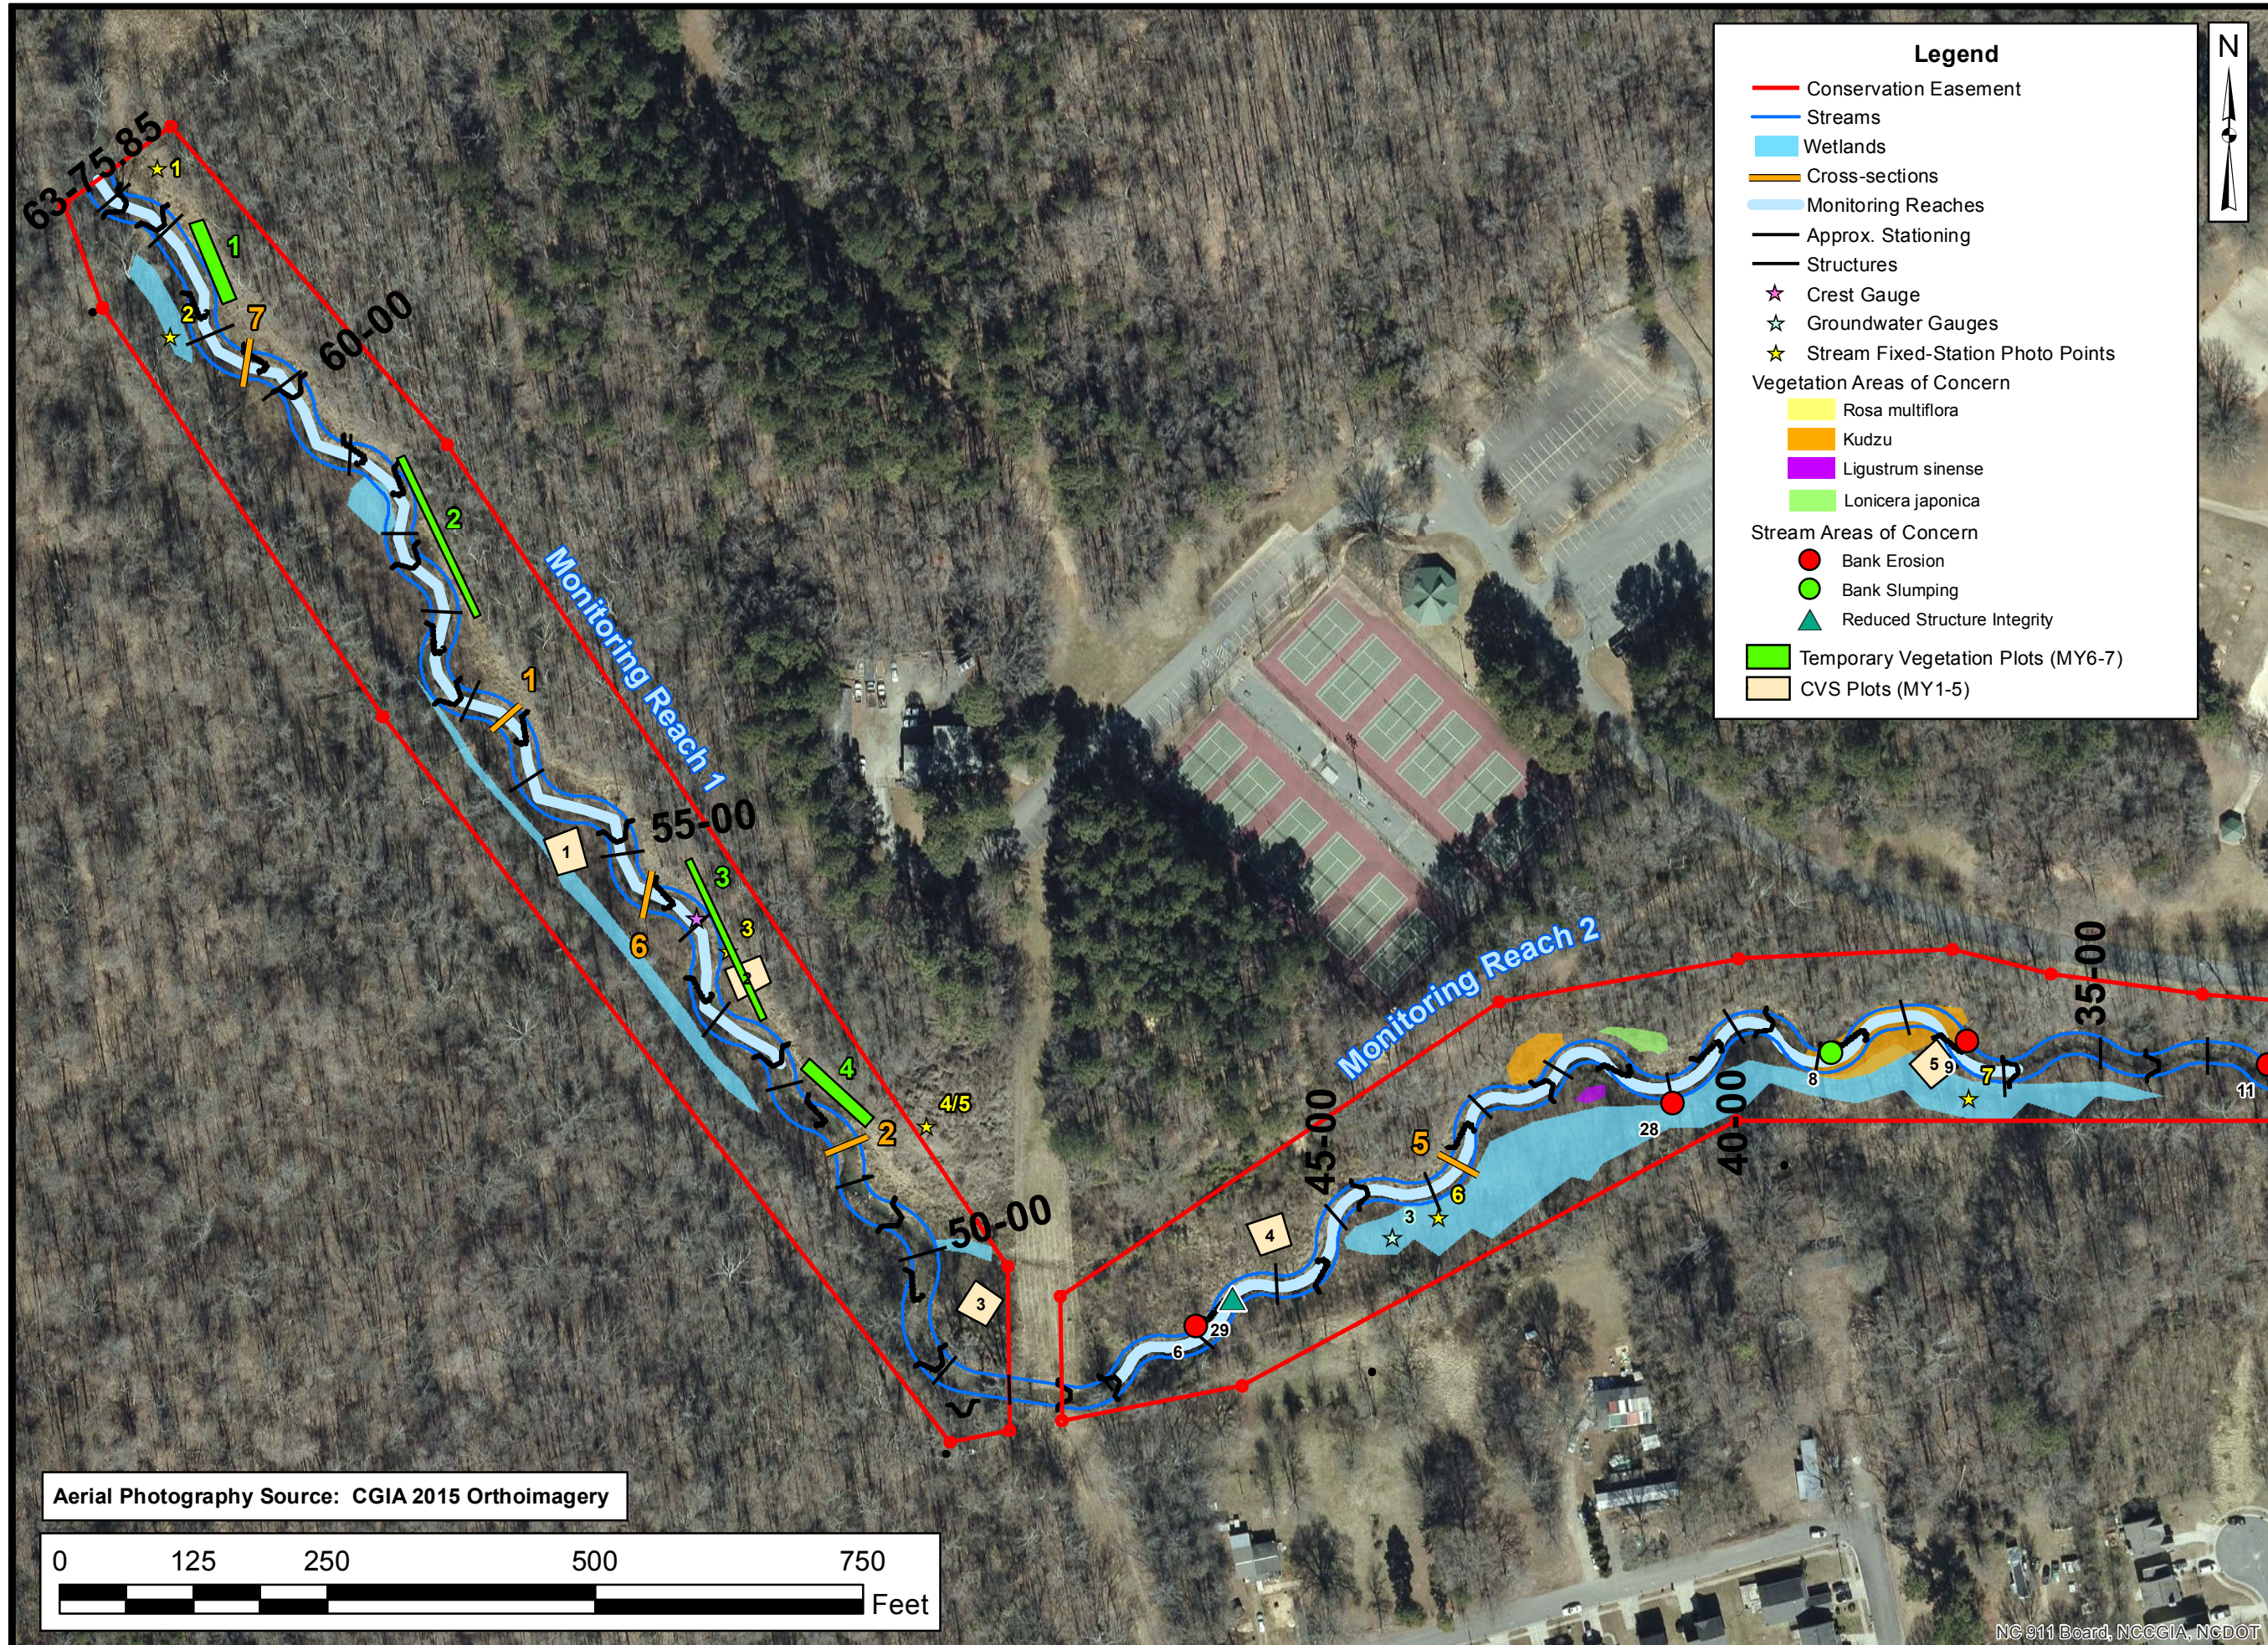
FIGURE
2A

Vegetation areas of concern within the Site include several patches of multiflora rose (*Rosa multiflora*), Chinese privet (*Ligustrum sinense*), Japanese honeysuckle (*Lonicera japonica*), and kudzu (*Pueraria lobata*). These are depicted on Figures 2A-2B (Appendix B). Invasive species treatments have occurred in late October 2013, early 2014, October 2015, December 2015, and September 2016. The most recent treatments appear to be successful with significantly less invasive species populations observed during year 7 (2016) than previous monitoring years (Table 6, Appendix B).

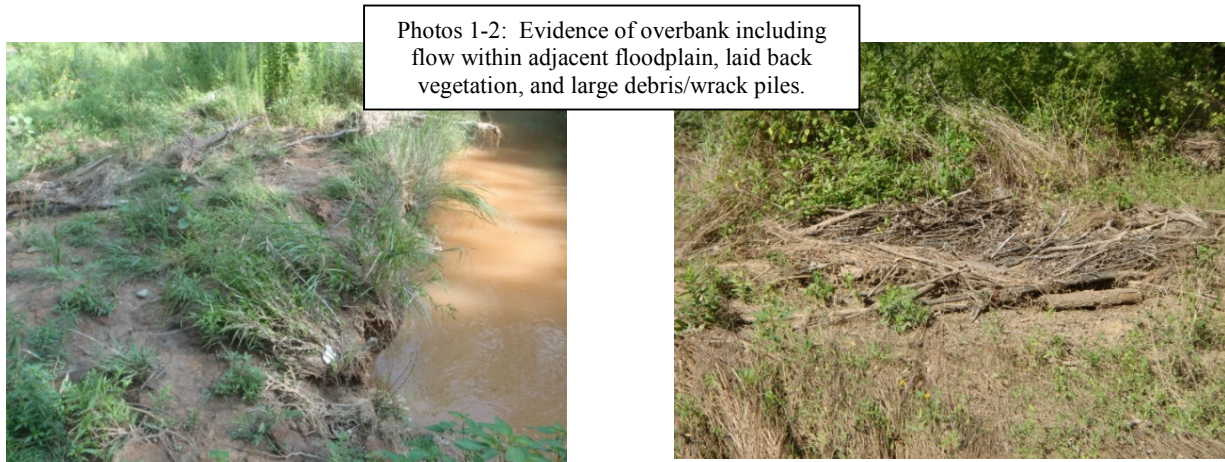
Photos 1-2: Evidence of overbank including flow within adjacent floodplain, laid back vegetation, and large debris/wrack piles.

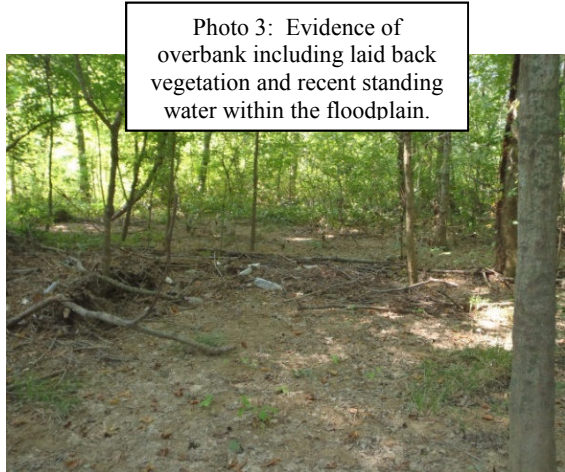
Photo 3: Evidence of overbank including laid back vegetation and recent standing water within the floodplain.

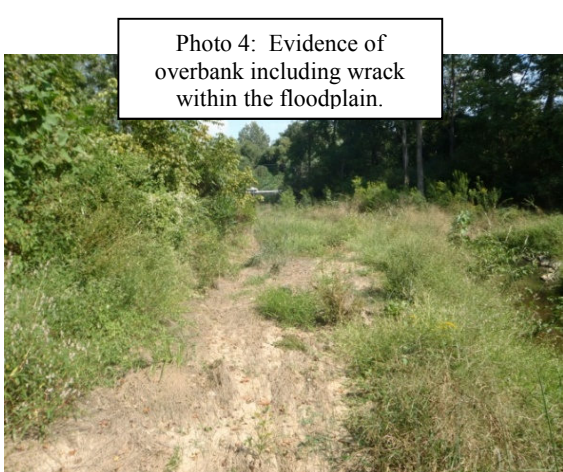
Photo 4: Evidence of overbank including wrack within the floodplain.

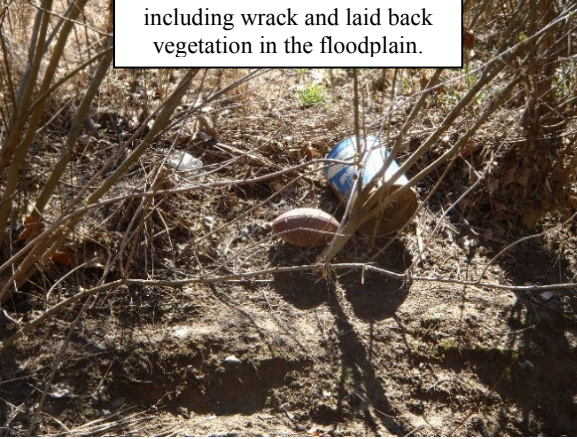
Photo 6: Evidence of overbank including wrack and laid back vegetation in the floodplain.

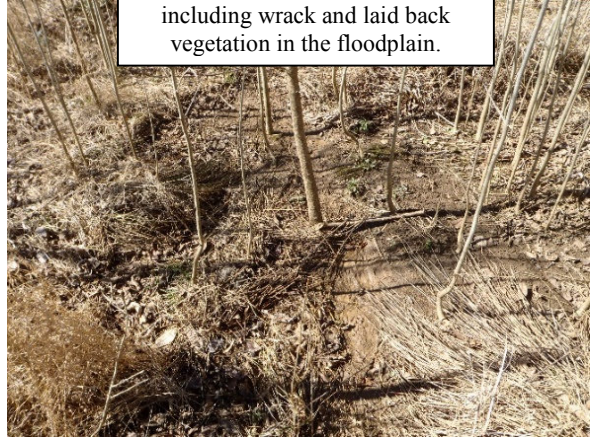
Photo 7: Evidence of overbank including wrack and laid back vegetation on the TOB
