**FINAL  
ANNUAL MONITORING REPORT  
YEAR 8 (2017)  
MCINTYRE CREEK RESTORATION SITE  
AT HORNETS NEST PARK  
MECKLENBURG COUNTY, NORTH CAROLINA  
(DMS Project No. 243, Contract No. 004499)**

December 2017

Prepared by:  
Axiom Environmental, Inc.  
218 Snow Avenue  
Raleigh, North Carolina 27603

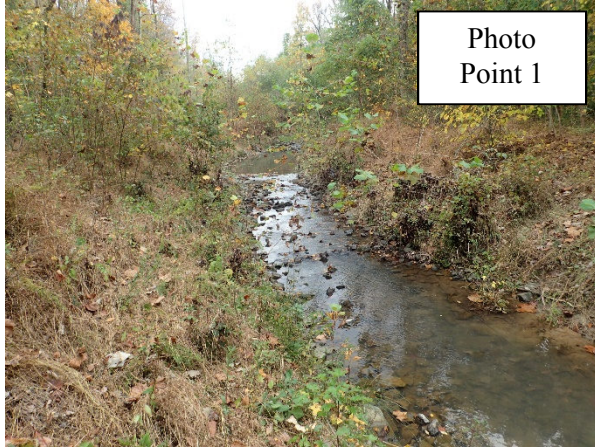
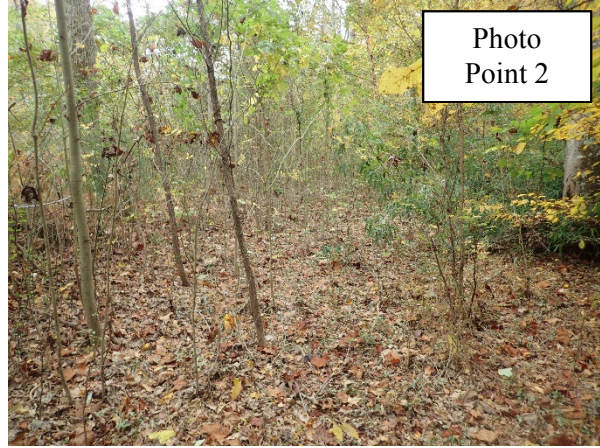
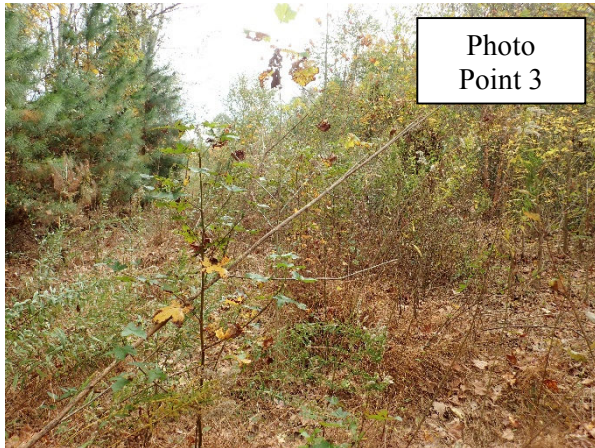
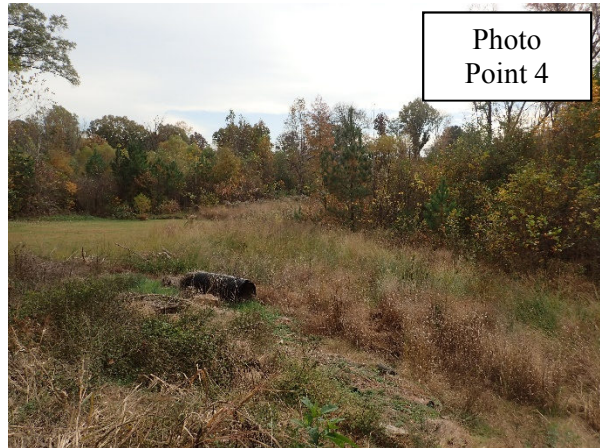
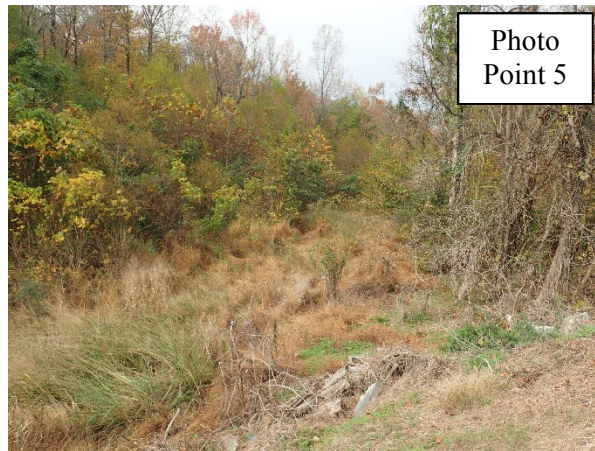
**McIntyre Creek  
Monitoring Reach 1: Stream Fixed-Station Photographs  
Taken November 2017**

Monitoring Reach 1 is stable in year 8 (2017) as evidenced by cross-section 5-7 measurements (Appendix C) and visual assessments of the reach (Table 5, Appendix B). In addition, all repairs completed in early 2016 are functioning as intended.
