**McKee Creek Stream Restoration
Monitoring Report – Year 2 of 5
Final**

**Contract # 004391
EEP Project # 92573
Cabarrus County, North Carolina**

**Collected October 2013
Completed 2013
Report December 19, 2013
Revise January 28, 2014**

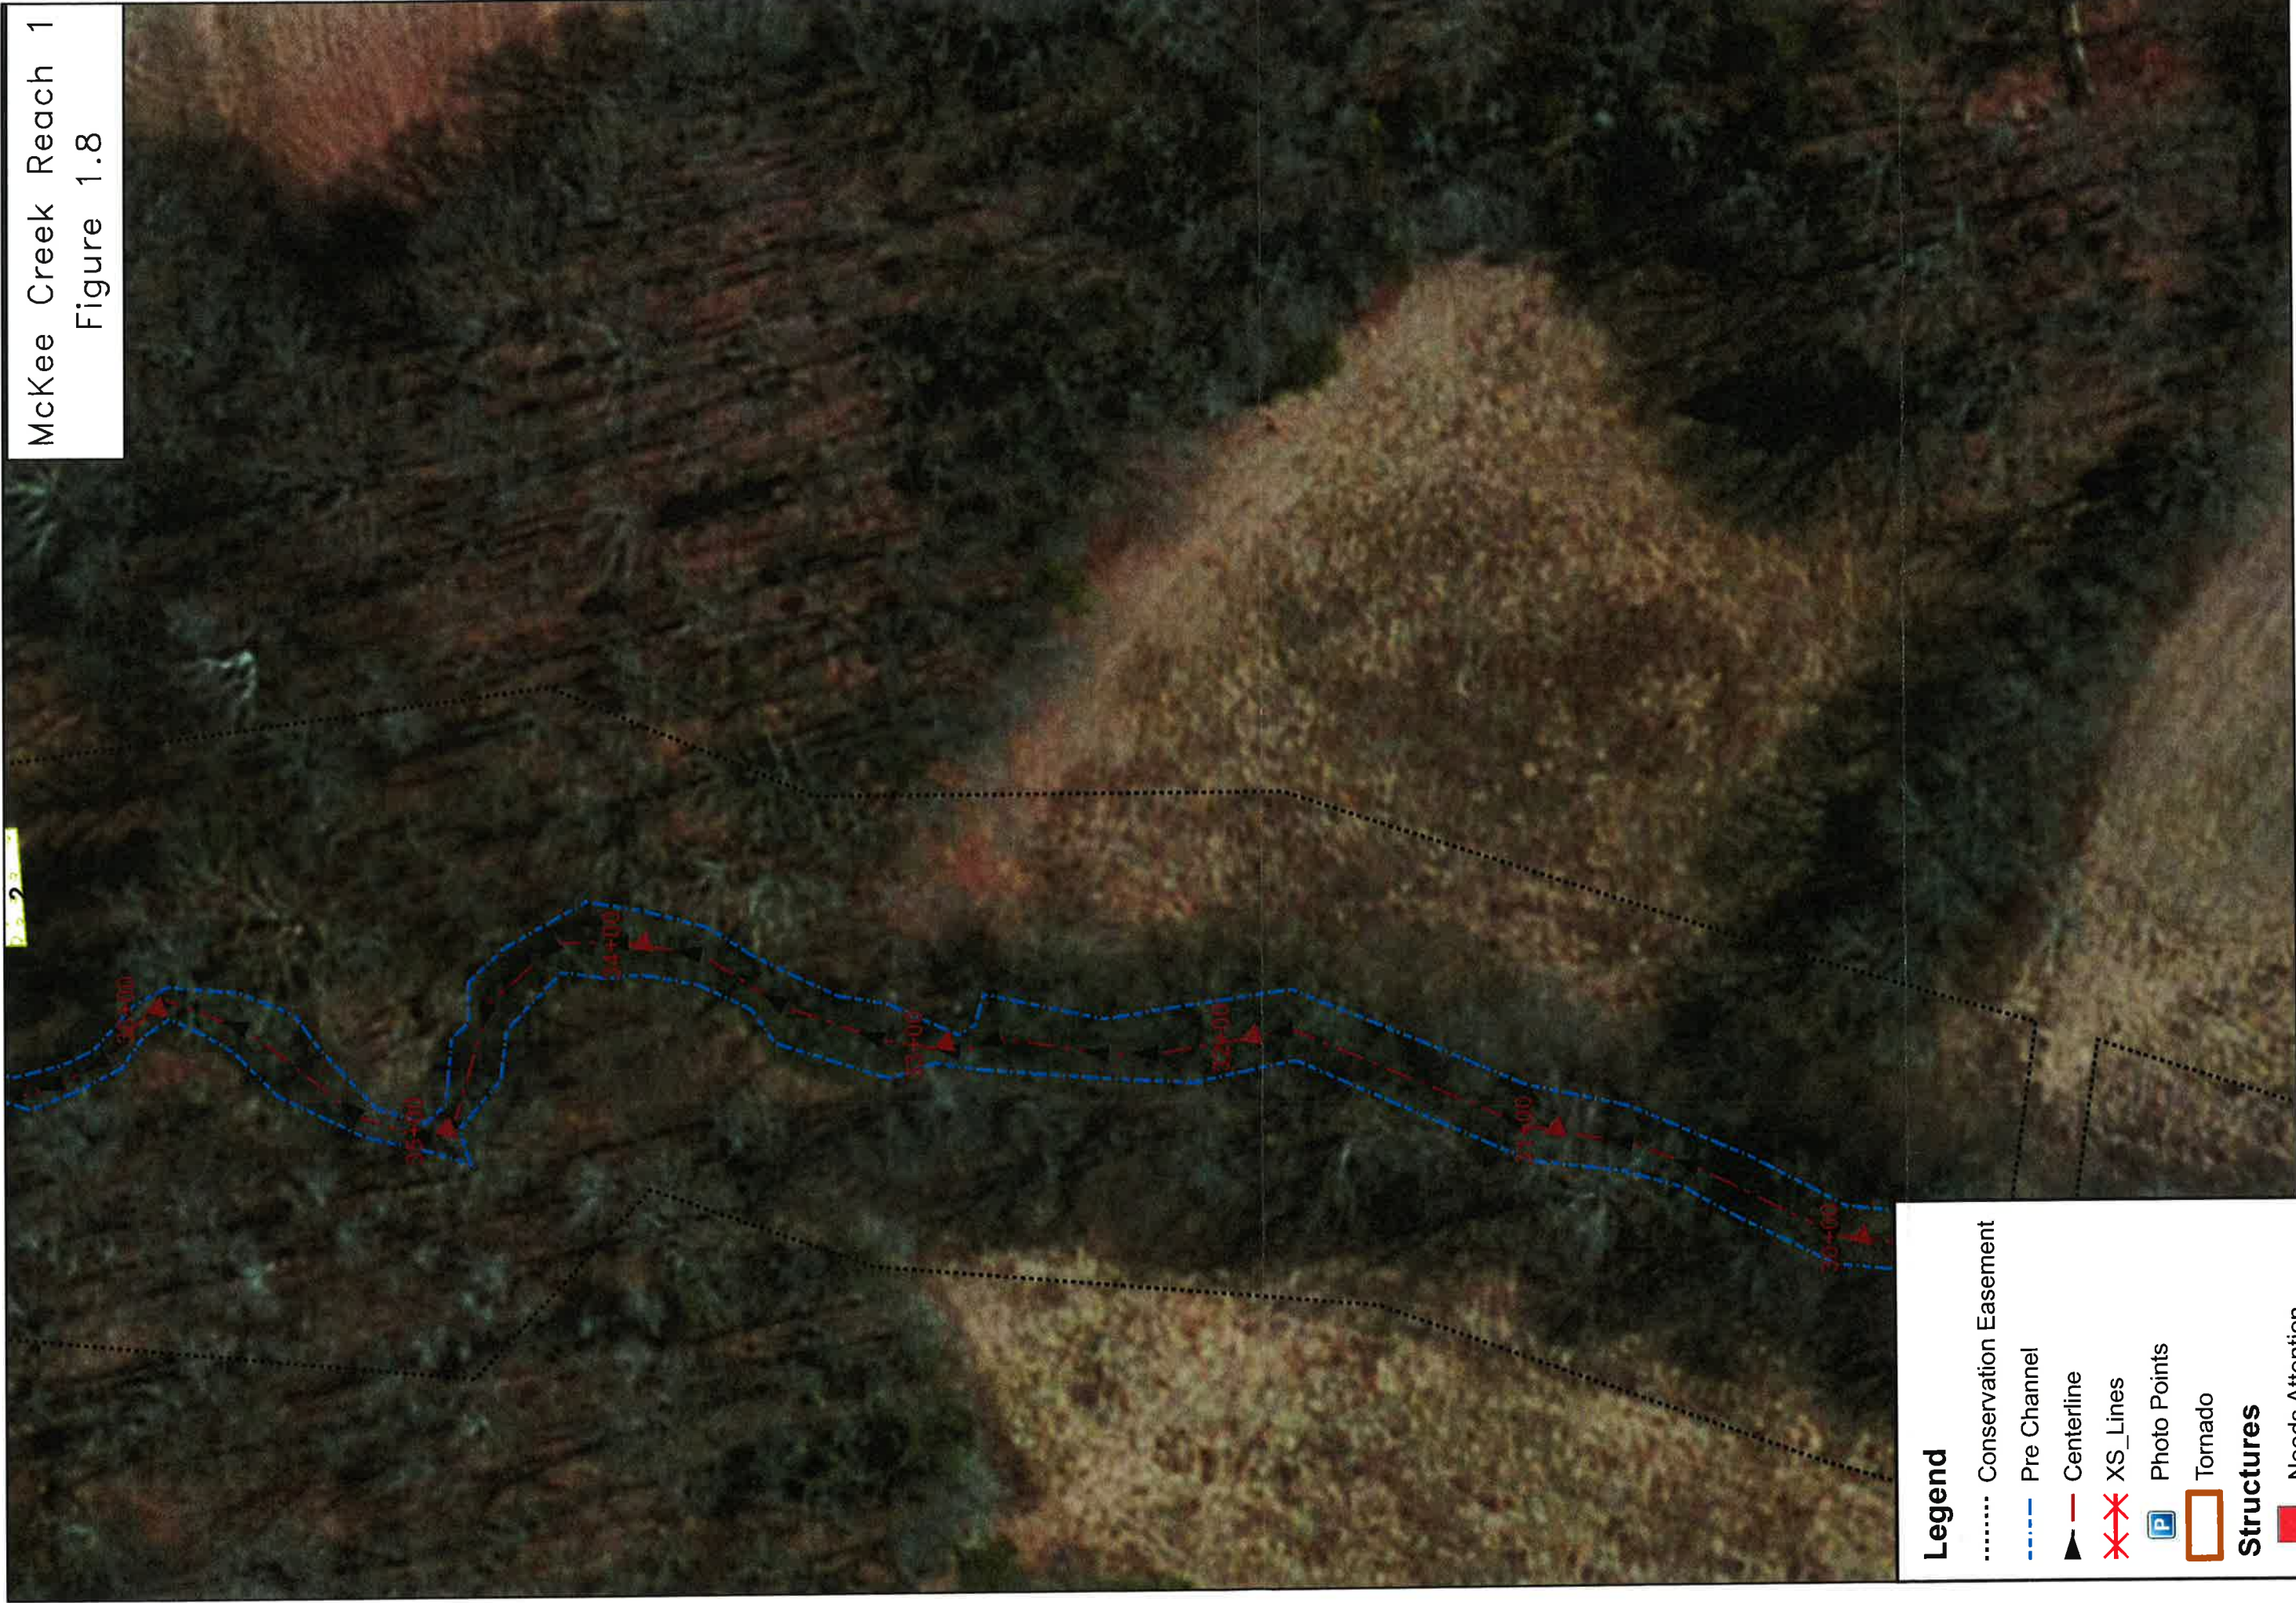
McKee Creek Reach 1
Figure 1.8

- Conservation Easement
- - - - - Pre Channel
- ▲ Centerline
- ✕ XS_Lines
- P Photo Points
- Tornado
- Structures**
- Needs Attention
- Good Structure
- VegetationPlot**
- ▭ BAD
- ▭ GOOD

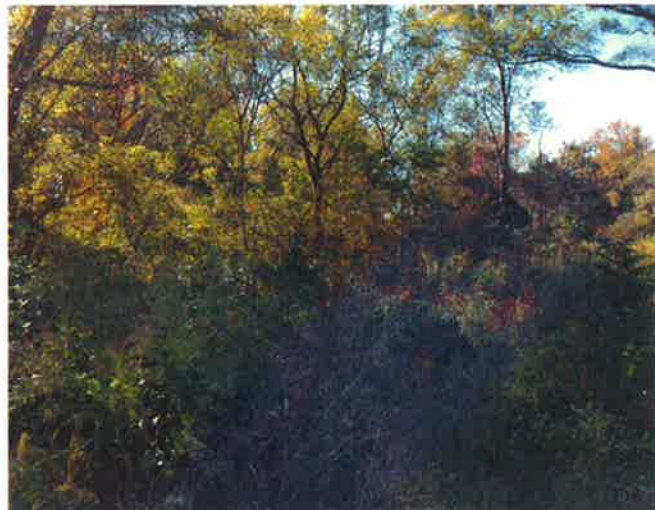
Photo 2
Veg Plot 1- Year 2 (2013)

It was noted in the Spring 2013 Assessment that Vegetation Plot 1 had been mowed over and most, if not all planted live stems had been cut to the ground. Evident was the regeneration of 6 planted stems in the plot which identifies a reduction in stems as compared to data collected in the Fall of 2012 (refer to the Vegetation Results section below for a more detailed description of the effects of this complication).
