**McKee Creek Stream Restoration
Monitoring Report – Year 3 of 5
Final**

**Contract # 004391
EEP Project # 92573
Cabarrus County, North Carolina**

**Construction 2010
Collected October 28, 2014
Report December 30, 2014
Revised February 19, 2014**

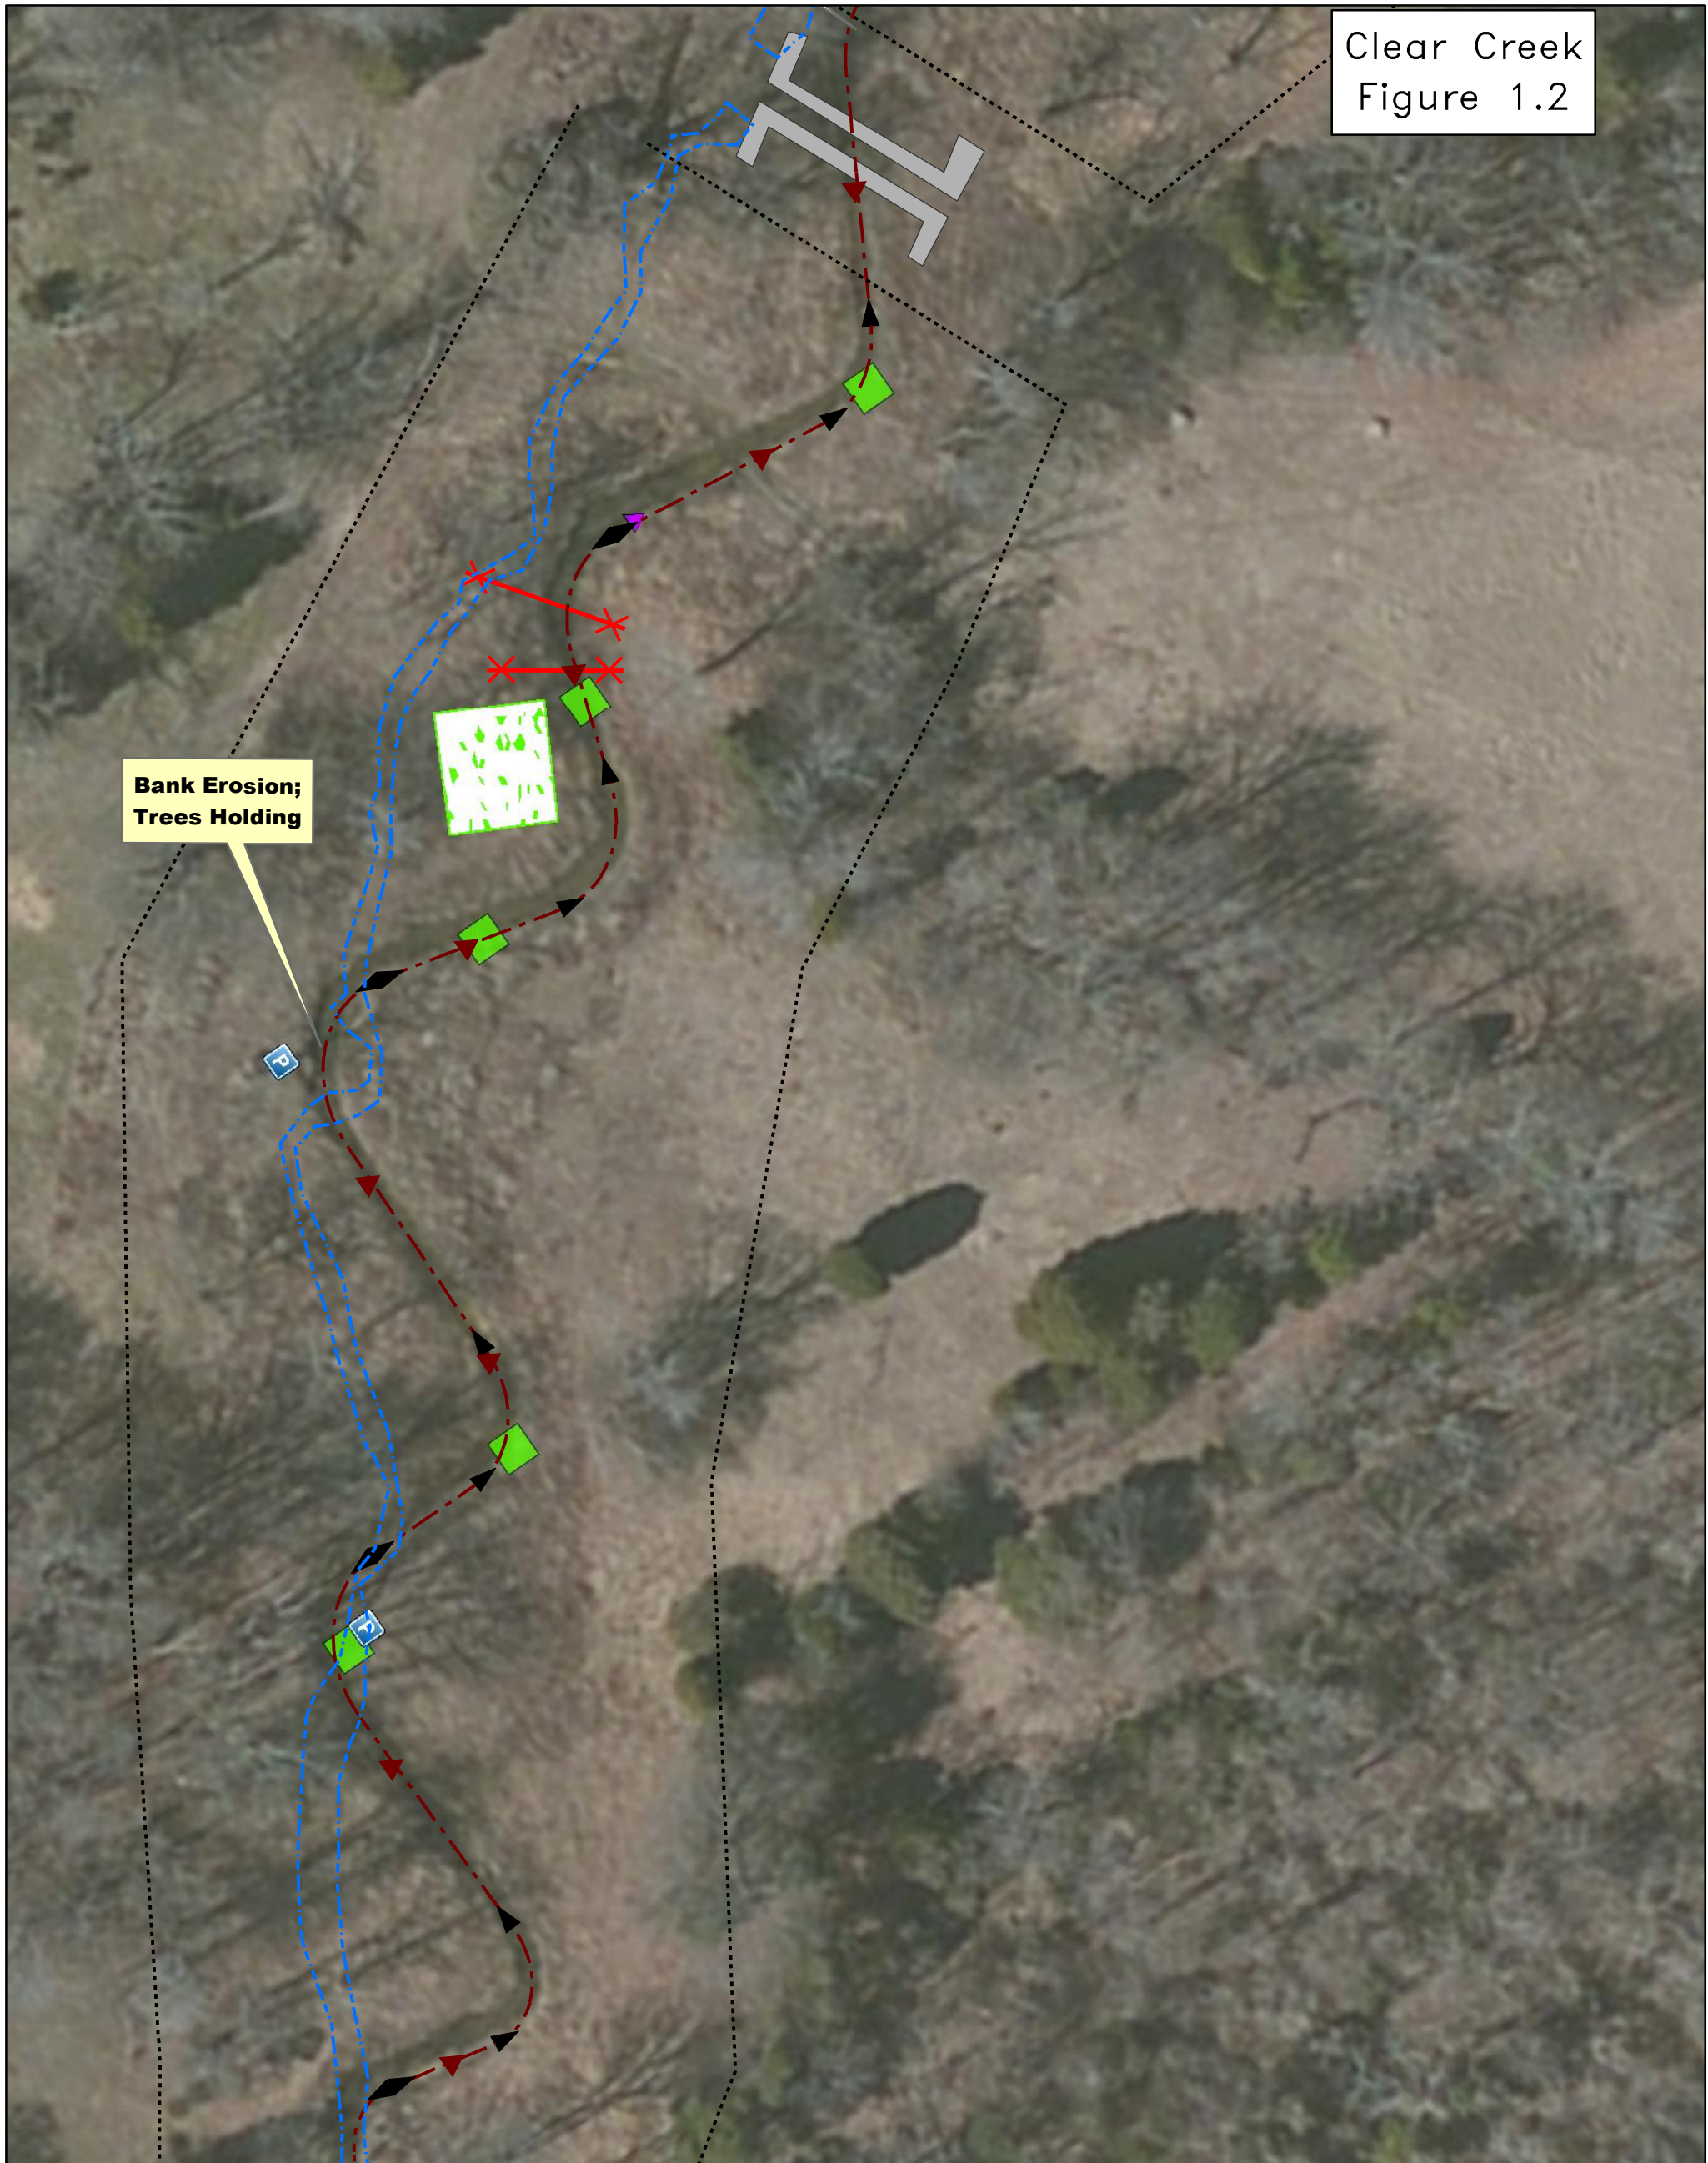
Clear Creek
Figure 1.2

**Bank Erosion;
Trees Holding**

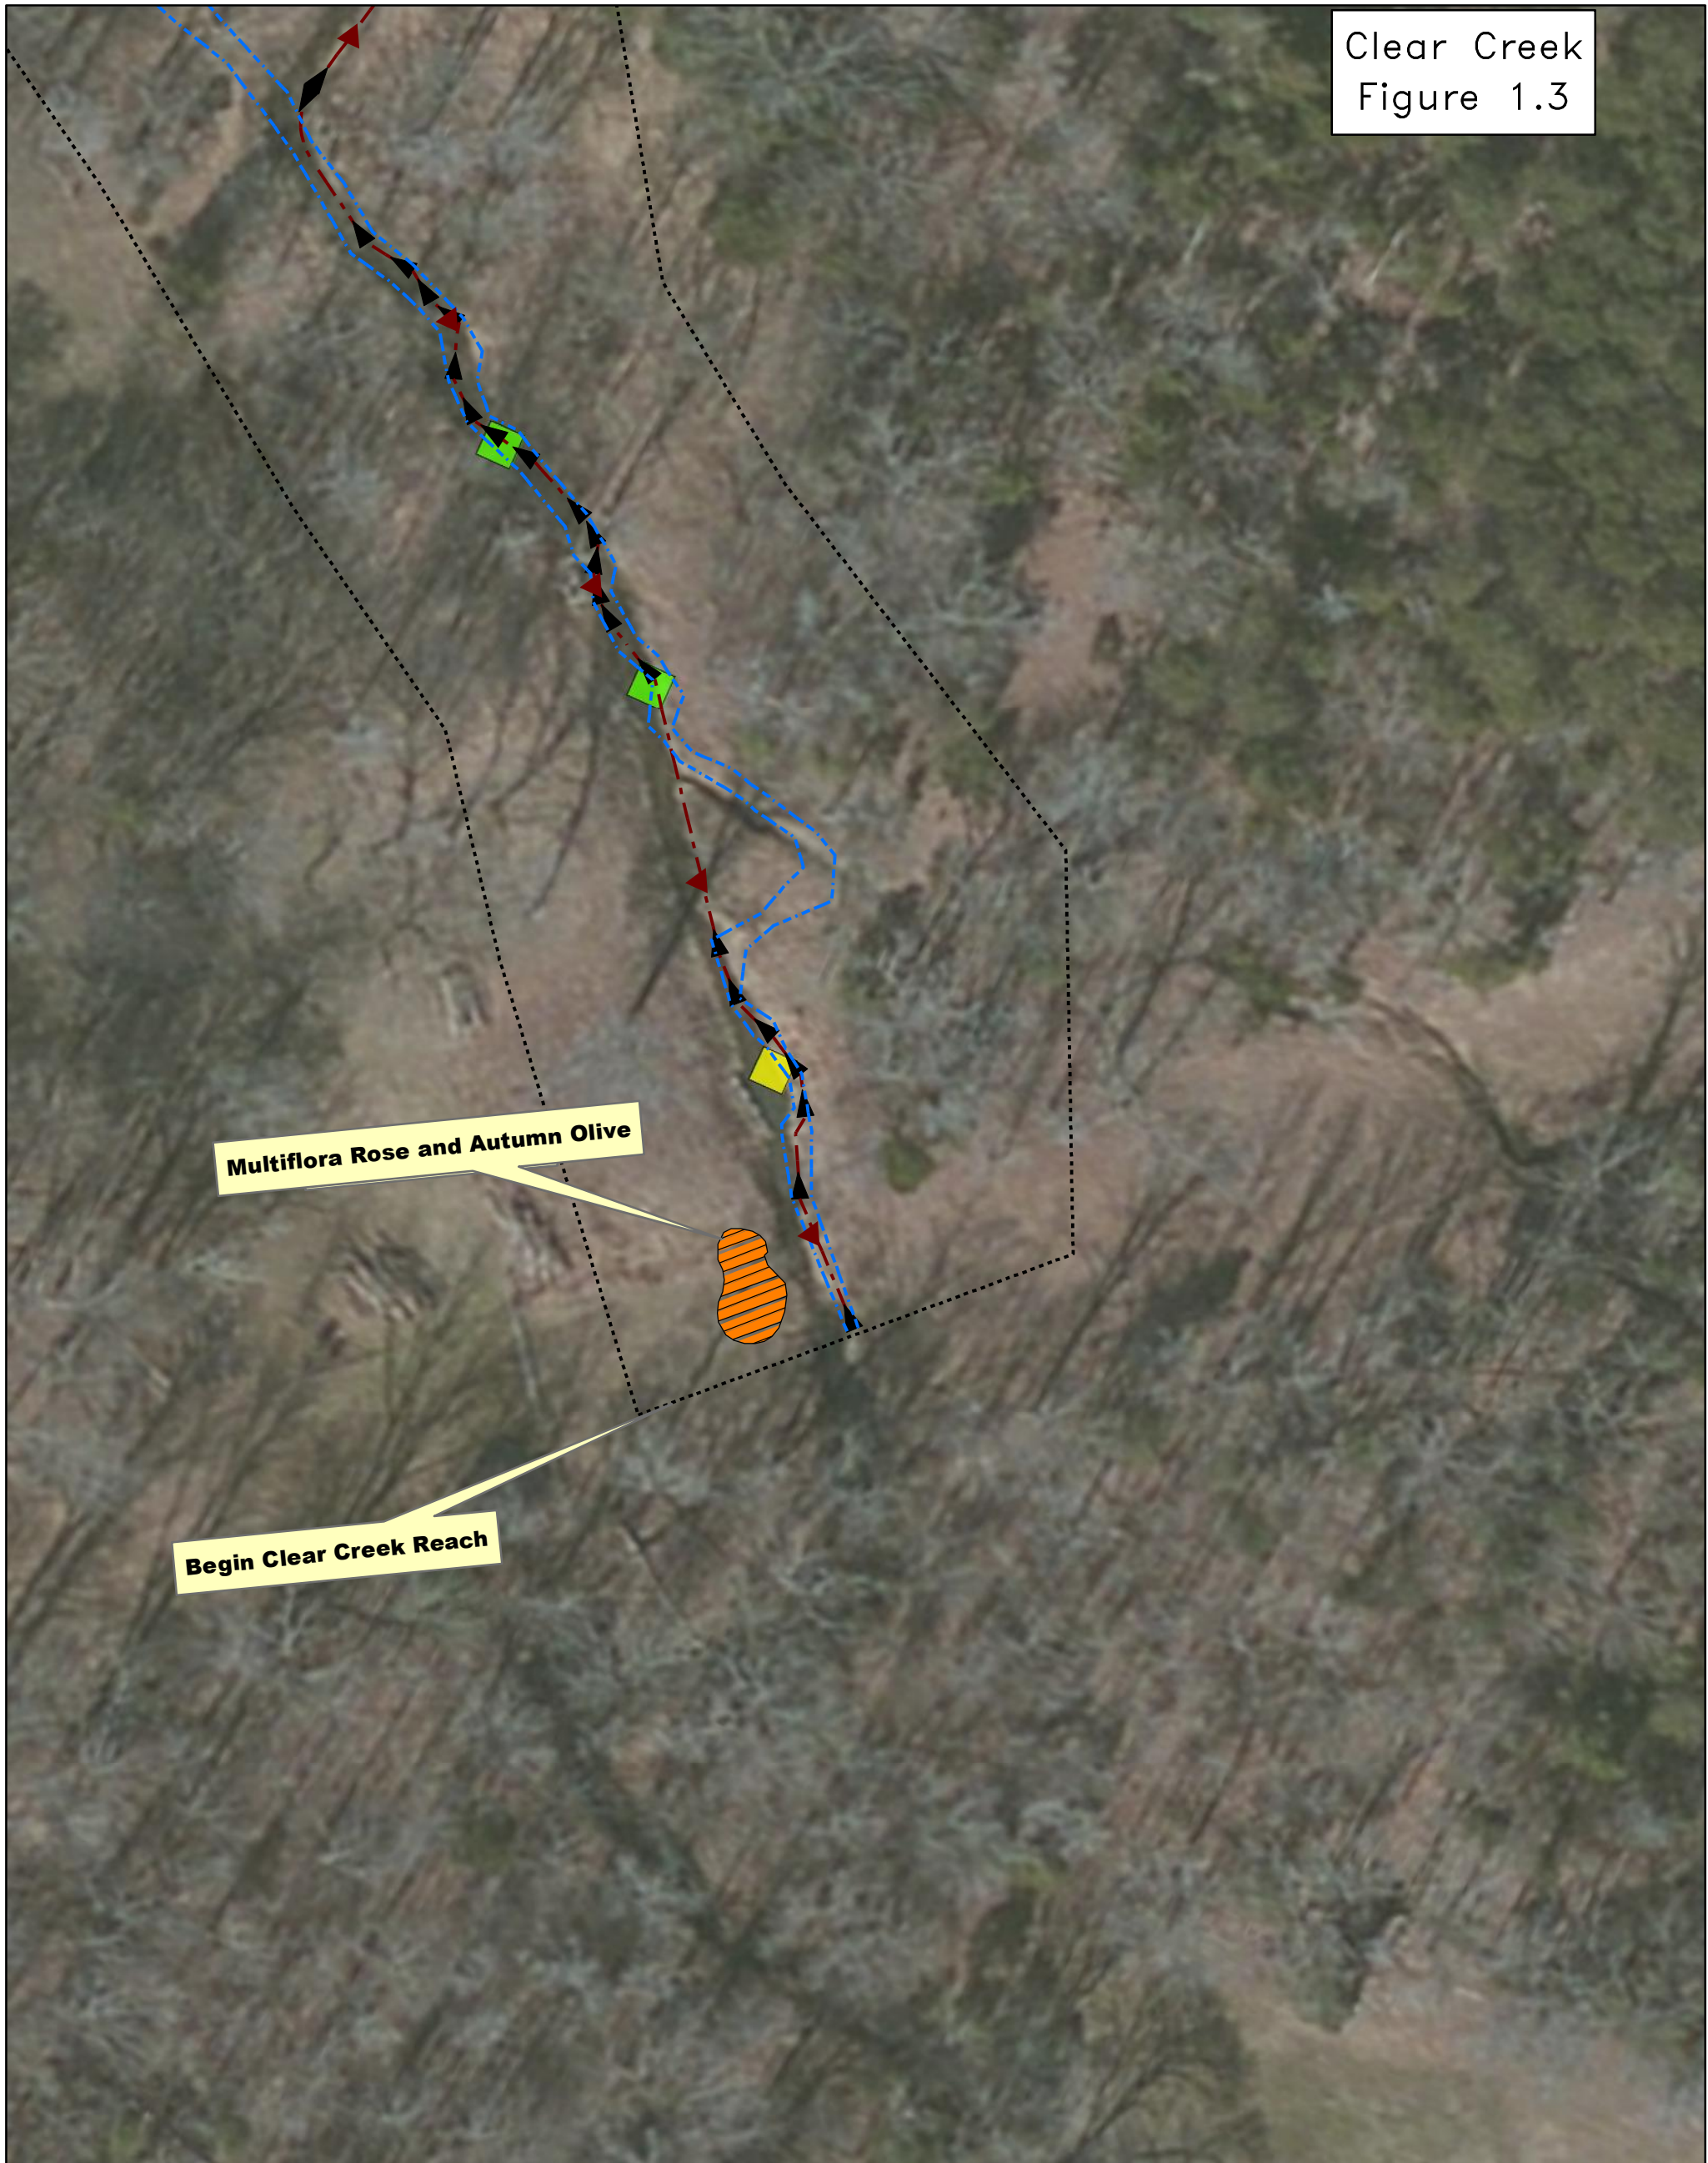
Clear Creek
Figure 1.3

Multiflora Rose and Autumn Olive

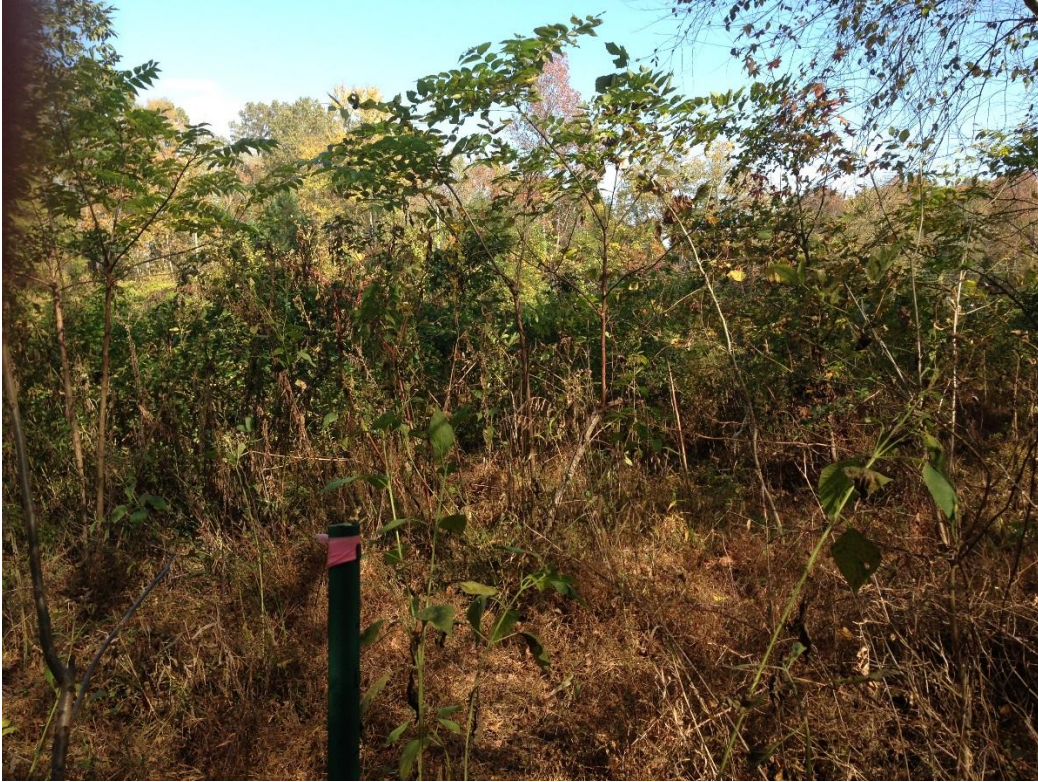
Photo 1: Vegetation Plot 1 – Year 3 (2014)

It was noted in the Spring 2013 Assessment that Vegetation Plot 1 had been mowed over and most, if not all planted live stems had been cut to the ground. It was evident that the regeneration of 6 planted stems in the plot identified a reduction in stems as compared to data collected in the Fall of 2012 (refer to the Vegetation Results section below for a more detailed description of the effects of this complication).

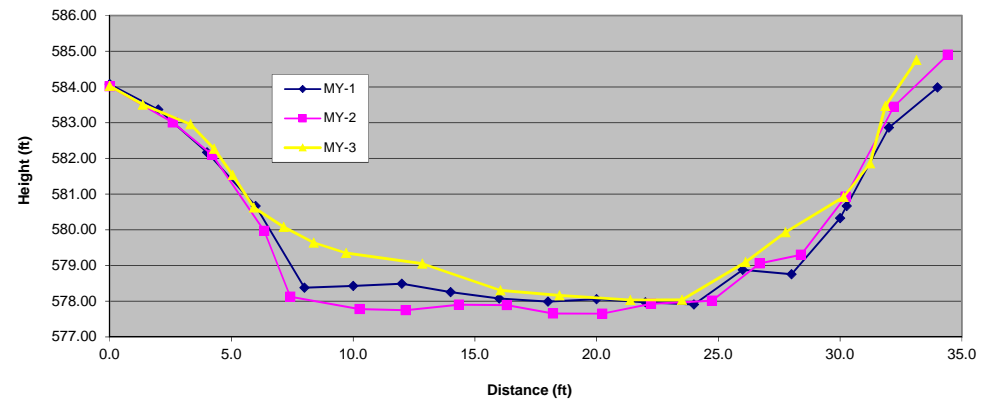
Riffle Cross Section 1

Summary Data	
Bankfull Elevation	580.621
Bankfull Cross-Sectional Area	32.06
Bankfull Width	24.44
Flood Prone Area Elevation	583.495
Flood Prone Width	30.5
Max Depth at Bankfull	2.587
Mean Depth at Bankfull:	1.18
W/D Ratio:	20.72
Entrenchment Ratio:	1.25
Bank Height Ratio:	2.32
