McKee Creek Stream Restoration

Monitoring Report – Year 4 of 5

Contract #004391

DMS Project #92573

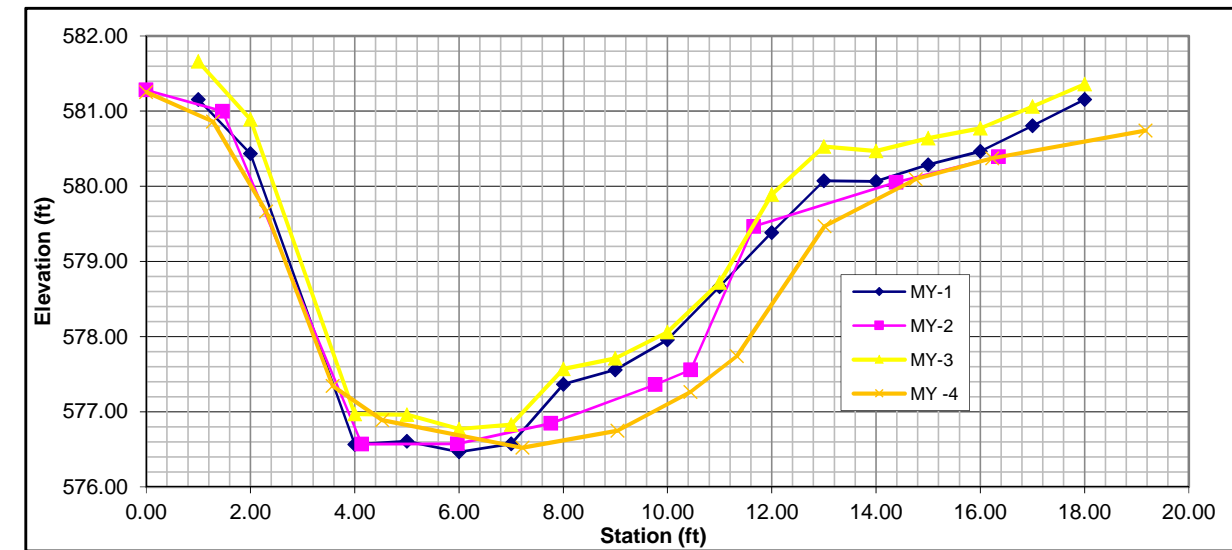
Cross-section Plot Exhibit	
River Basin	Yadkin Pee-Dee
Watershed	Clear MY-04
XS-ID	RXS-3
Drainage Area	0.95
Date	10/25/2015
Field Crew	Richmond/Burley

- ▶ Elevation data from the two cross-sections within the Clear Creek reach (Cross-sections RXS-3 and PXS-3) show variations from previous surveys. A review of raw survey data confirmed the elevations collected during the survey. The variations noted may be the result of stabilization and changes within the channel; however, it should be noted the survey was conducted during high flow, and the data may reflect abnormalities in the in-stream positioning of the equipment. It is anticipated that the variations in data will either be confirmed as changes in the channel or possible data collection abnormalities during the MY5 survey.
