**Meadowbranch Swamp Wetland Restoration
2012 Final Monitoring Report
Monitoring Year One**

**Ecosystem Enhancement Program Project Number 92351
Ecosystem Enhancement Program Contract Number 004800**

Submitted: January 2, 2013

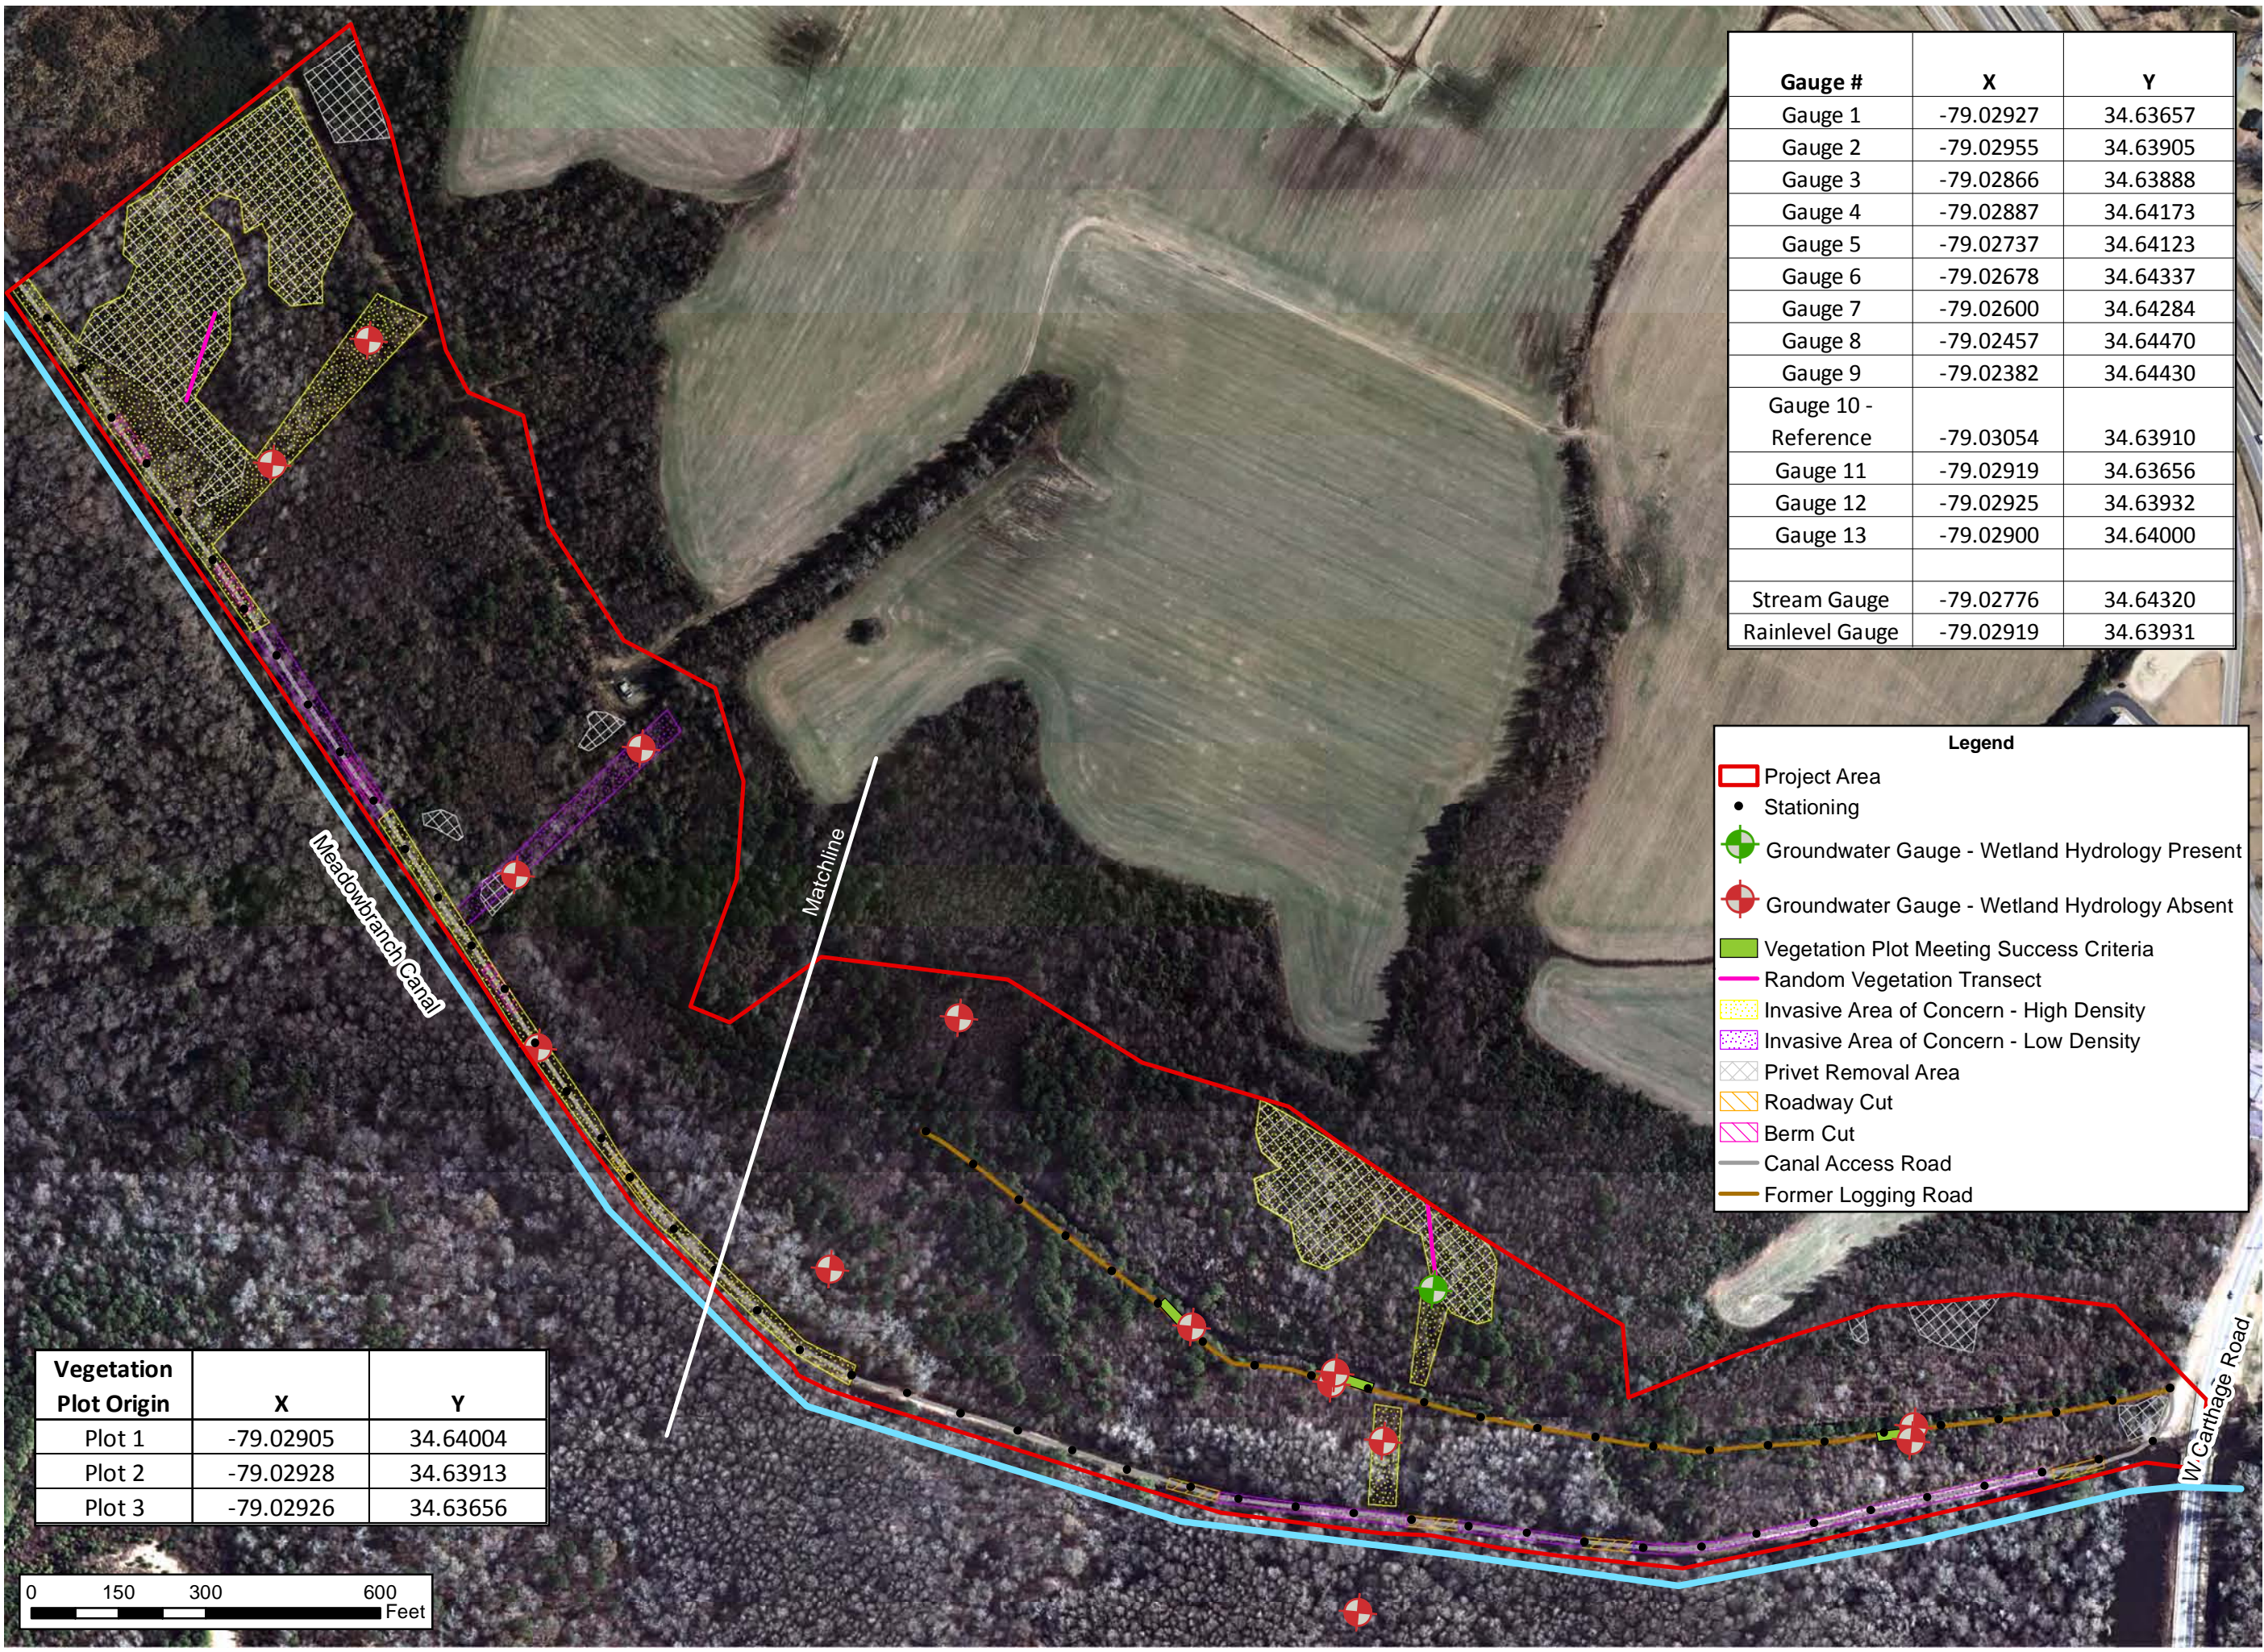
Figure 2
 Current Condition
 Plan View
 Project Overview

Overall, the site is in good condition, with the exception of the presence of Chinese privet. Chinese privet was observed scattered along the entirety of the canal road. It appeared to be most problematic within the transect areas leading to the groundwater gauges. This could be due to the clearing that took place in the transect areas. The northern portions of the site support the largest populations. The Chinese privet is particularly abundant between berm cuts 8 and 9 and along the canal road and removal areas. Very large specimens (20-30 feet) were observed in this area.

Prior erosion was noted at Roadway Cut 1 and Roadway Cut 2. Erosion was evident behind the matting at both sites. It was unclear whether these events had happened prior to the placement of the matting, however, both sites appear to be stable. Photos have been included, but these were not identified as problem areas at this time. These two sites will be monitored for changes during future monitoring events.

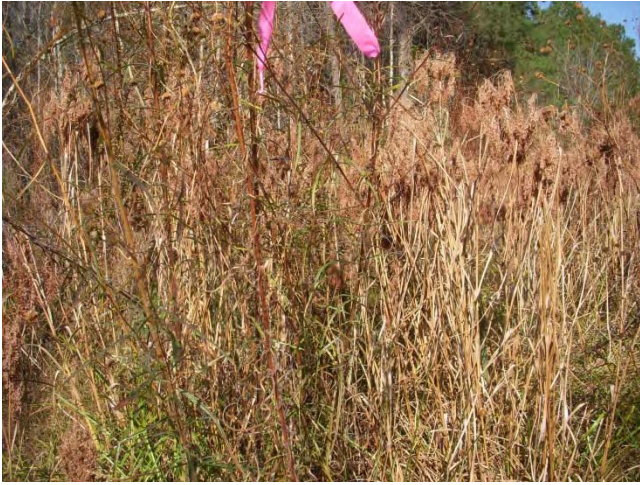
Tract	Vegetation Plot ID	Vegetation Survival Threshold Met?
Meadowbranch	VP1	Yes
	VP2	Yes
	VP3	Yes

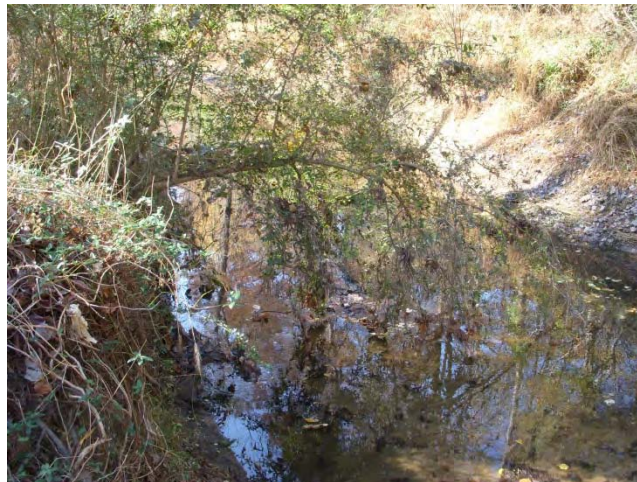
Photo 39. Wrack lines at bankfull along canal
