**Meadowbranch Swamp Wetland Restoration  
2013 Final Monitoring Report  
Monitoring Year Two**

**Ecosystem Enhancement Program Project Number 92351  
Ecosystem Enhancement Program Contract Number 004800**

Submitted: November 11, 2013

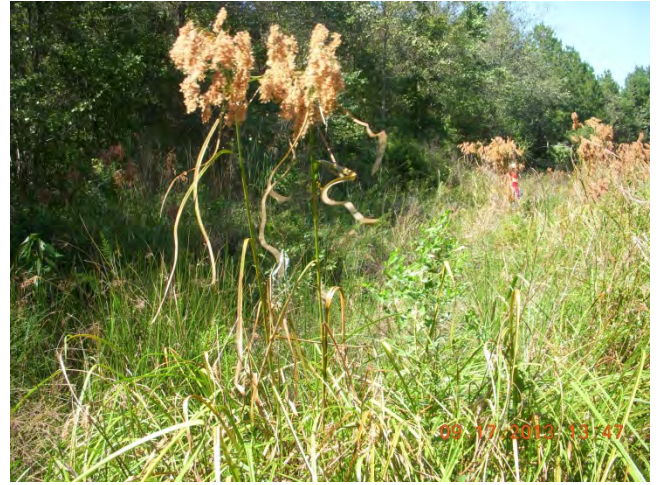
VP2

Monitoring Year 2 (MY2) field investigations took place on September 17, 2013. All vegetation plots were found to be in fair condition and all are meeting vegetative success criteria. However, vegetation plot 2 is beginning to show signs of distress. There was very little vegetative cover (including herbaceous weed growth) in the plot overall, bare ground was visible throughout, and there were many planted stems marked ‘missing.’

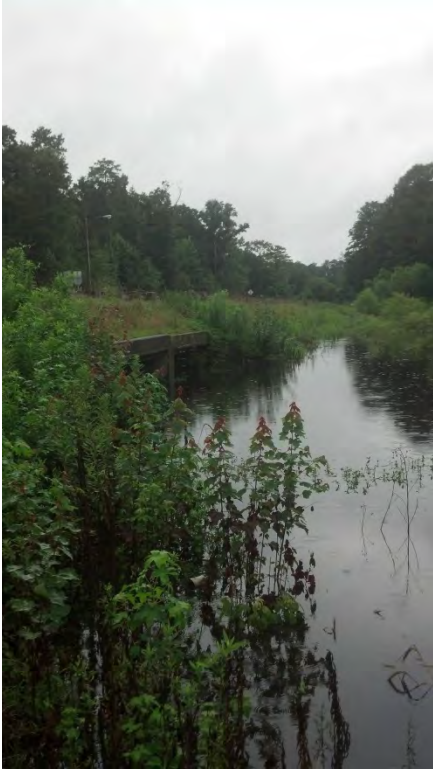
Date of Data Collection	Date of Occurrence	Method	Photo # (if available)
7/2/13	7/2/13	Site photographs (canal over bankful, overtopping banks; logging road submerged)	990, 992
8/30/13	Unknown	Site photographs (flow patterns from canal into wetlands on back side of access road)	276
9/17/13	6/13/13 to 6/15/13; 7/11/13 to 7/15/13	On-site data logger ( <i>Ecotone</i> water level gauge)	
9/17/13	Unknown	Site photographs (sediment within reference wetland indicating water above bankfull)	37, 38
9/17/13	Unknown	Site photographs (sediment at berm cuts indicating water above bankfull)	7, 13
9/27/13	Two between 9/16/12 and 9/16/13	Proximal USGS gauge resource (supports findings of on-site data logger)

Photo 990. Canal above bankful at culvert on West Carthage Road

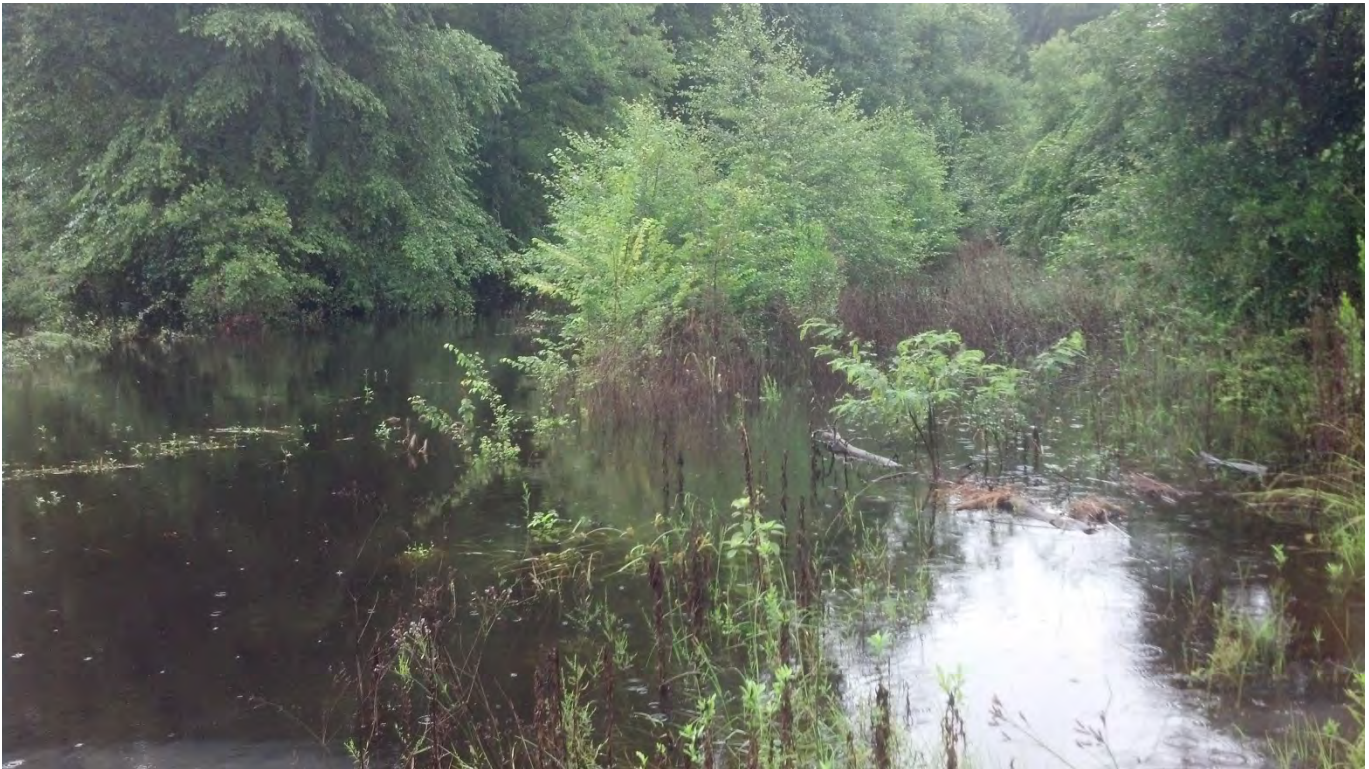
Photo 992. Old logging road submerged

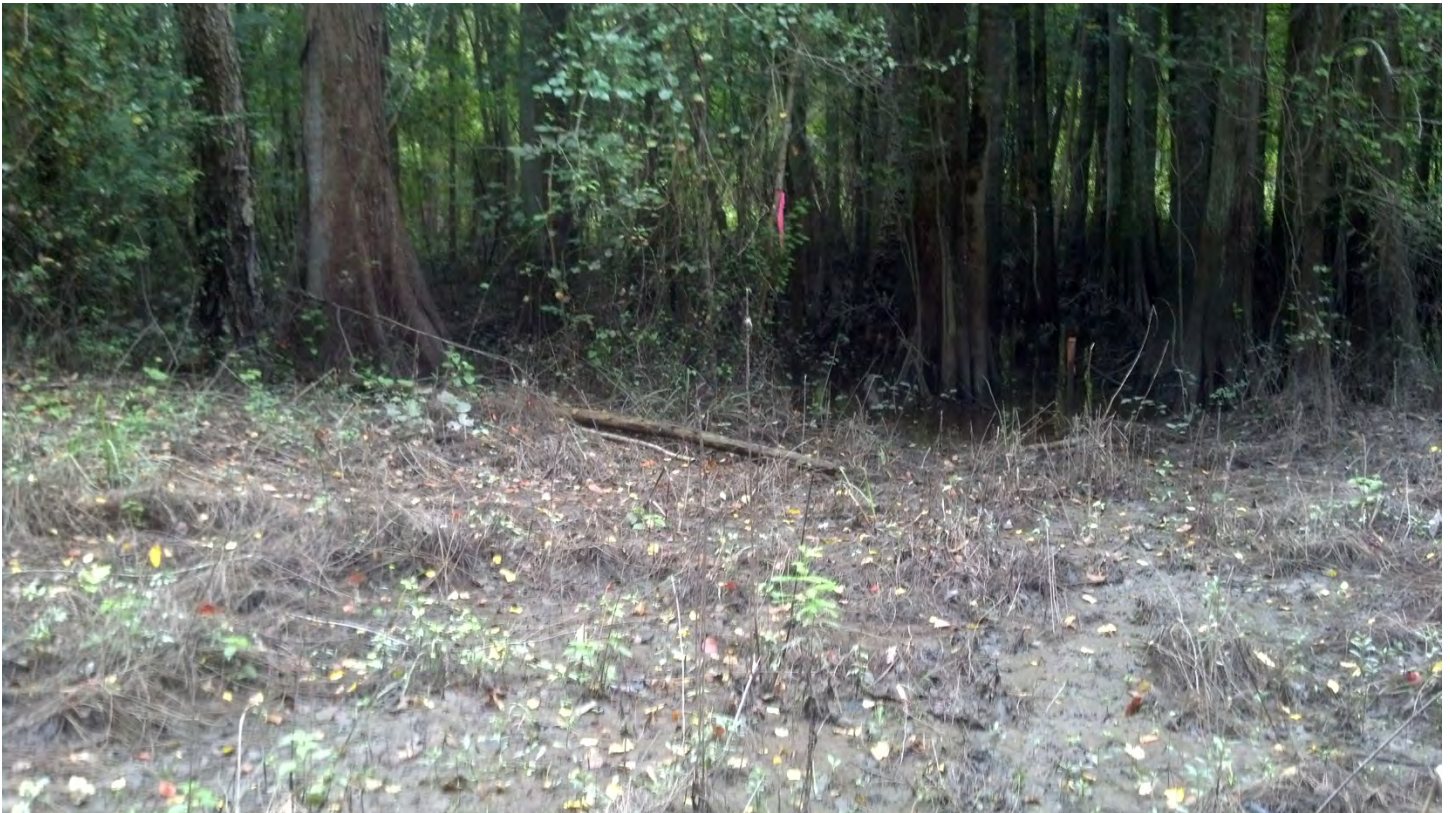
On-site stream gauge data and USGS stream gauge data indicate two bankfull events over the course of the past 12 months (September 2012 to September 2013). Evidence of the bankfull events is present on-site and observed during MY2. There are drainage patterns from the canal into the wetlands on the back side of the access road and vegetation has been matted down in these areas.

Photo 276. Drainage patterns from canal into wetland on backside of access road

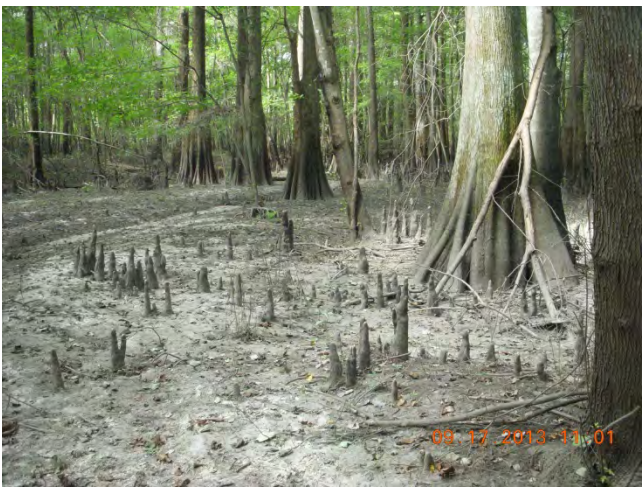
Photo 37. Sediment in reference wetland

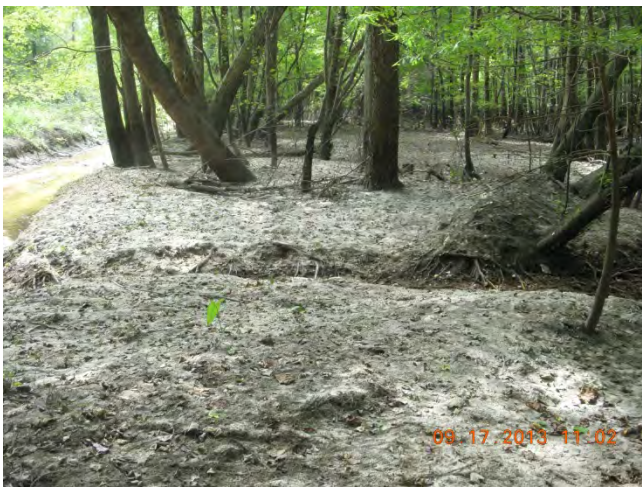
Photo 38. Sediment in reference wetland

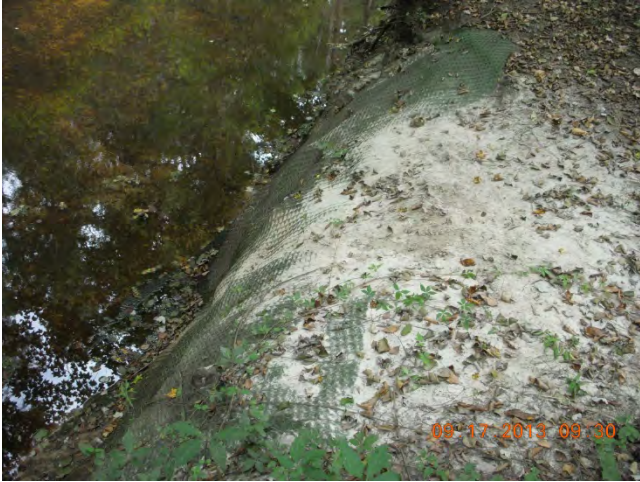
Photo 7. Sediment at berm cut

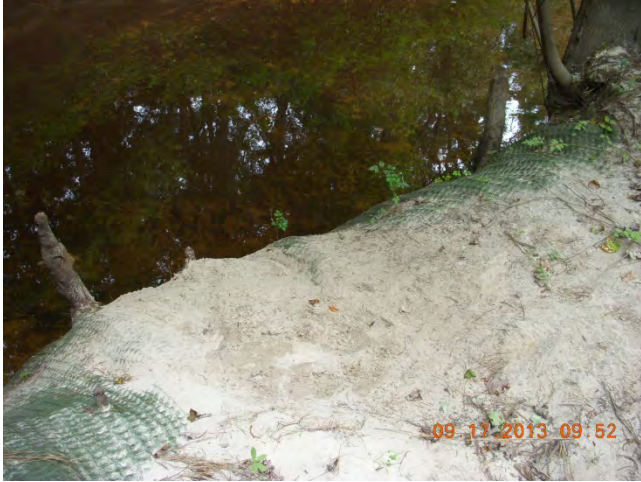
Photo 13. Sediment at berm cut
