**Meadowbranch Swamp Wetland Restoration
2014 Final Monitoring Report
Monitoring Year Three**

**Ecosystem Enhancement Program Project Number 92351
Ecosystem Enhancement Program Contract Number 004800**

Submitted: November 6, 2014

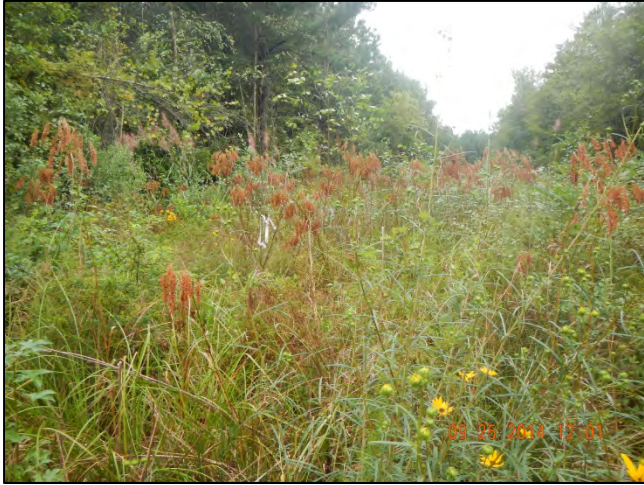
VP1

Monitoring Year 3 (MY3) field investigations took place on September 25, 2014. All three vegetation plots are in fair condition and all are meeting vegetative success criteria. Vegetation plots 1 and 3 are doing especially well and supporting large populations of volunteer stems. Some insect damage was observed on river birch seedlings within vegetation plot 3. Insect activity has been noted and will be monitored for changes in severity over subsequent monitoring events. Damage has not caused visible mortality at the time of observation. Vegetation plot 2 has not been as successful as vegetation plots 1 and 3 in that many of the stems have died, or are unable to be located. Vegetation plot 2 contains a large population of bush clover (*Lespedeza sp.*) which may be contributing to stem mortality due to the nature of the dense thickets of bush clover.

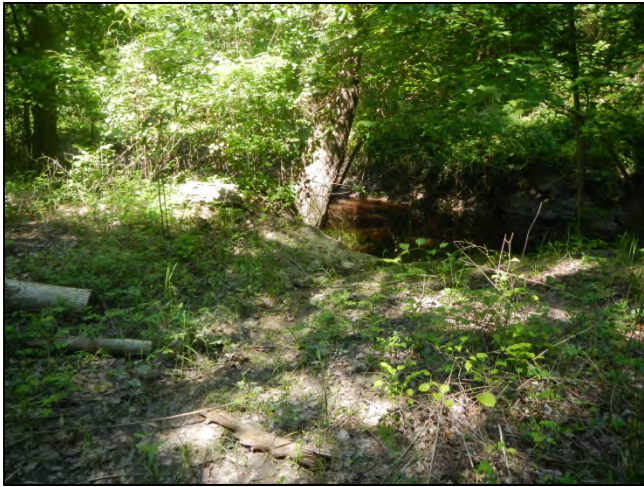
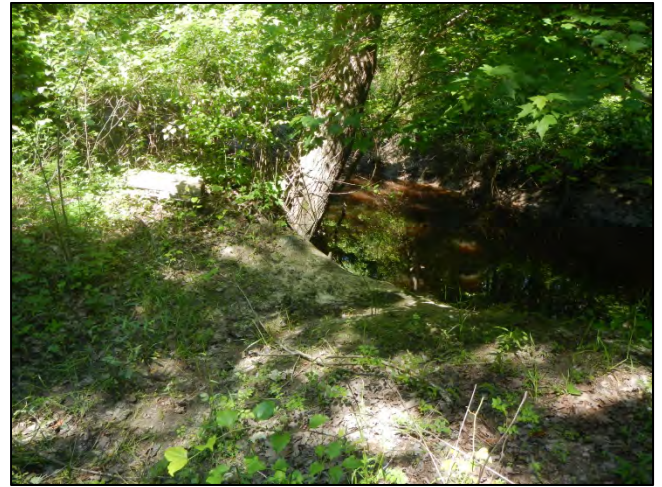
Date of Data Collection	Date of Occurrence	Method	Photo # (if available)
5/6/14	Unknown	Site photographs (evidence of overwash onto canal road)	13, 14
9/25/14	1/13/14 to 1/15/14	On-site data logger (<i>Ecotone</i> water level gauge)	
9/25/14	5/16/14	On-site data logger (<i>Ecotone</i> water level gauge)	
9/25/14	Unknown	Site photographs (water marks and sediment within reference wetland indicating water above bankfull)	2, 4
10/3/14	One between 9/25/13 and 9/25/14	Proximal USGS gauge resource (supports findings of on-site data logger)

Photos 13 and 14. Evidence of overwash from canal and drainage pattern from wetland to canal

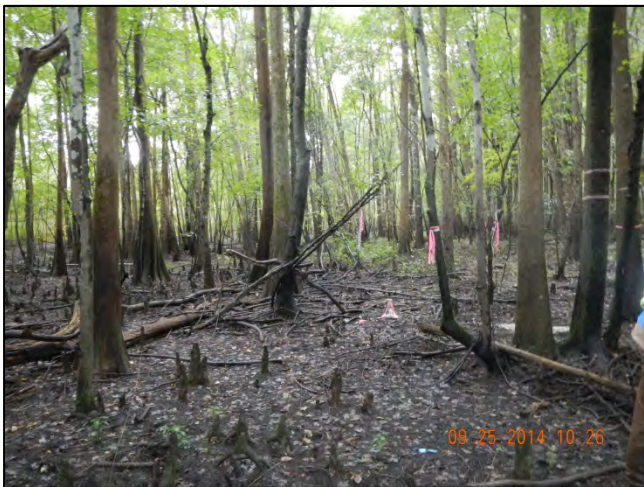
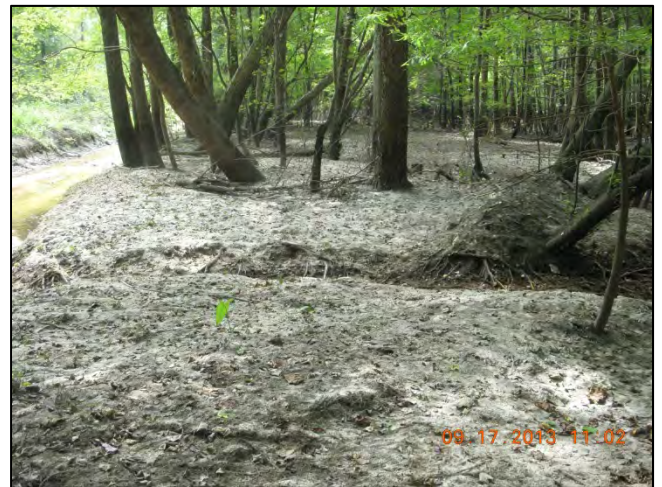
Photos 2 and 3. Water marks and sediment in reference wetland

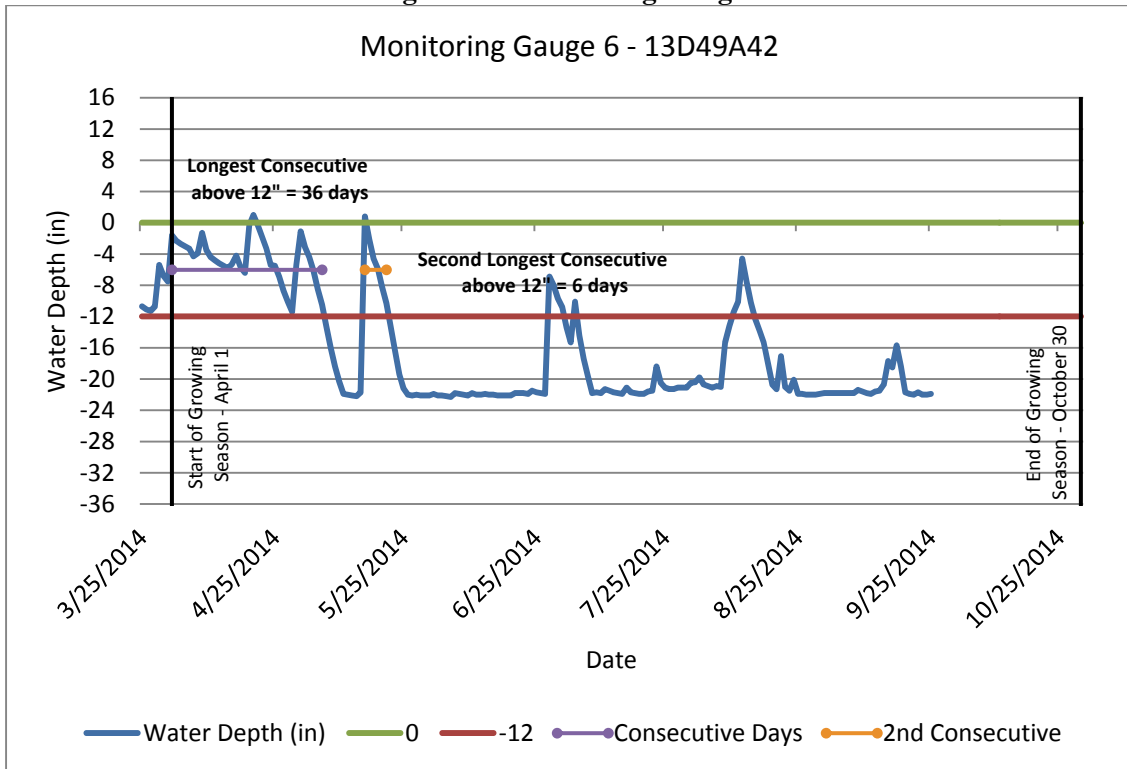
Figure 10: Monitoring Gauge 6

*Note: Water depths were adjusted seven inches, calibration point was seven inches above ground surface.

** Gauges 6 and 10 were both protruding from the ground. The elevations were adjusted to compensate for the distance between the calibration level and the ground surface. Gauge 6 was 7 inches above the ground, and gauge 10 was 6 inches above the ground.

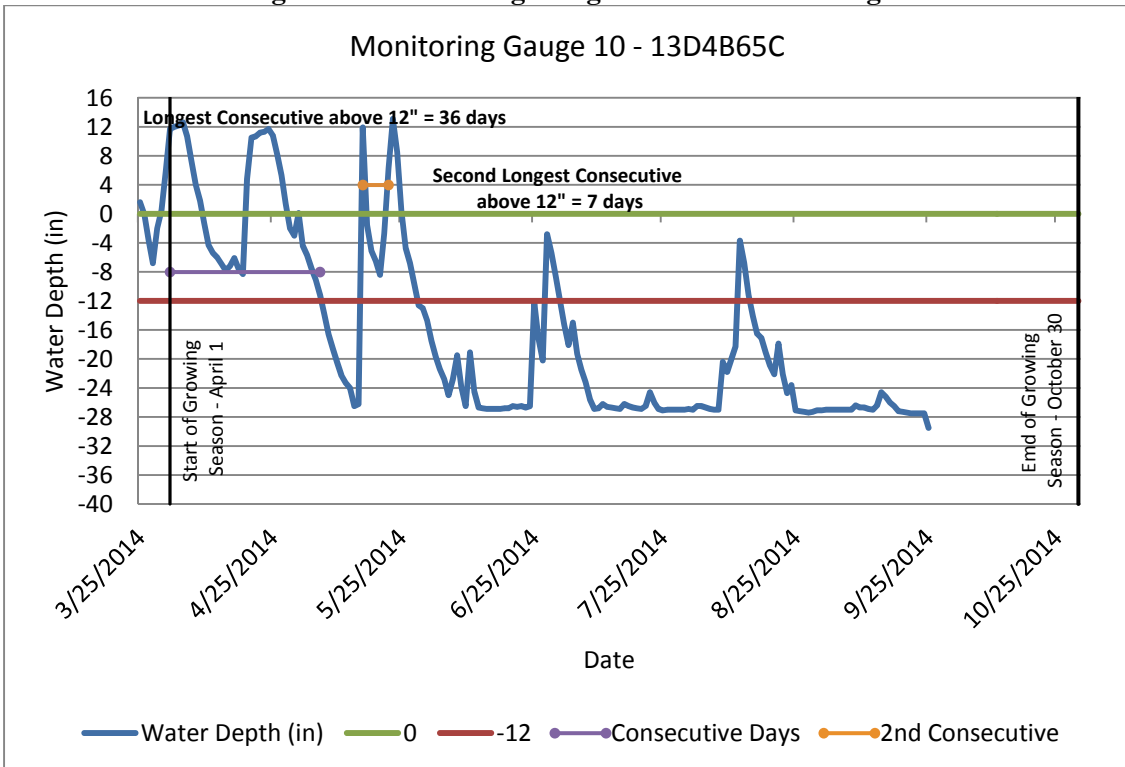
Figure 14: Monitoring Gauge 10 – Reference Gauge

*Note: Water depths were adjusted six inches, calibration point was six inches above ground surface. Gauge 13D4B65C was replaced with Gauge 13D491C5 on September 25, 2014.

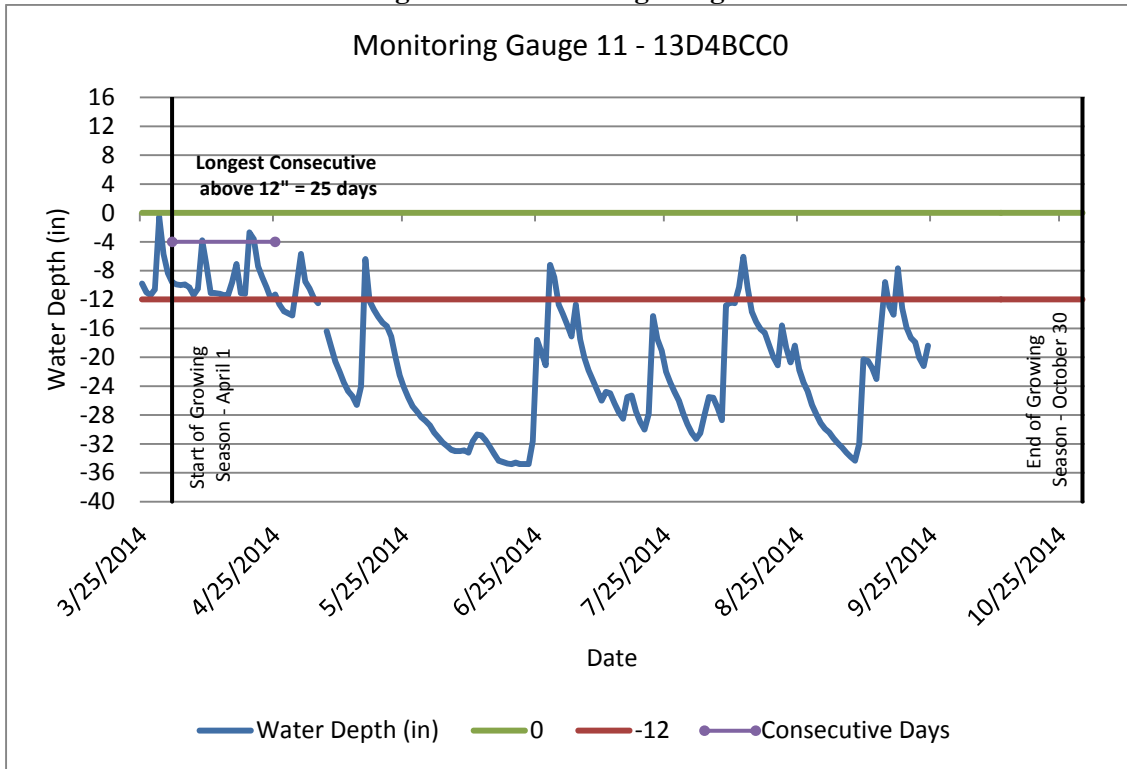
Figure 15: Monitoring Gauge 11

*Note: Gauge was replaced on May 6, 2014. No readings were taken that day, as seen by the gap in the graph above.

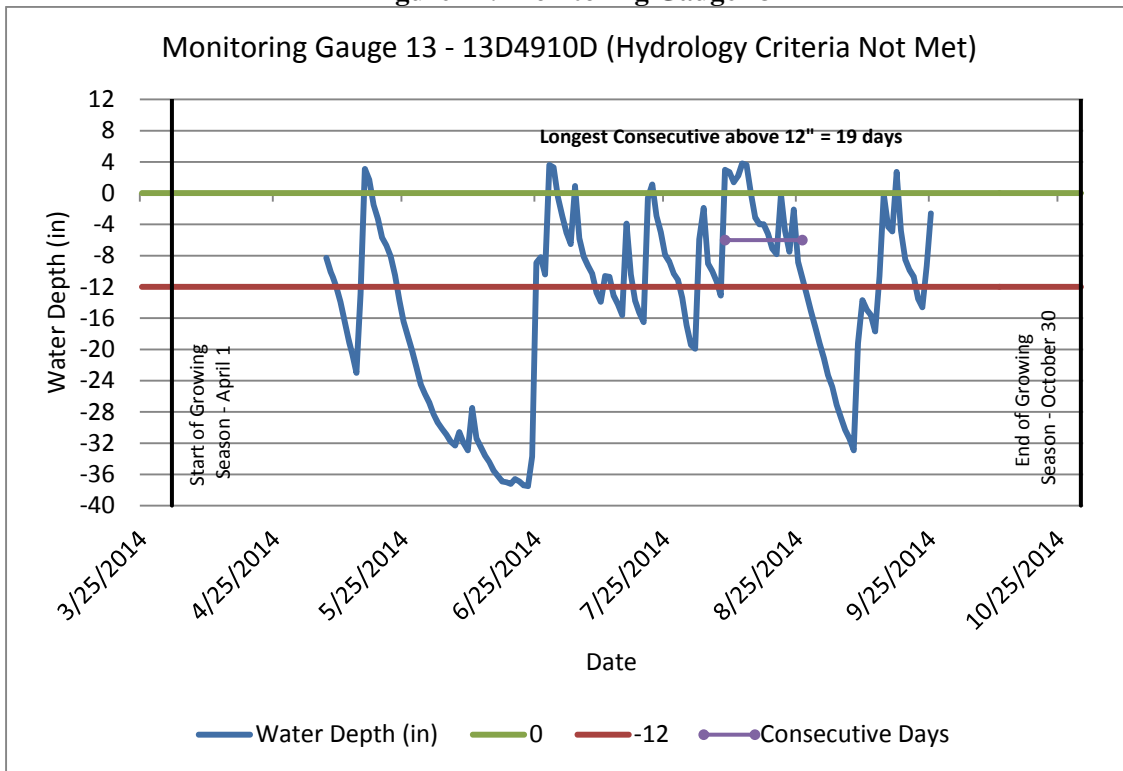
Figure 17: Monitoring Gauge 13

*Note: Gauge was replaced on May 6, 2014. The previous gauge was damaged and readings were not retrieved. Readings for the 2014 growing season begin May 7, 2014.
