**Meadowbranch Swamp Wetland Restoration
2015 Monitoring Report
Monitoring Year Four**

**DMS Project Number 92351
DMS Contract Number 004800**

Submitted: March 14, 2016

URS Corporation – North Carolina
701 Corporate Center Drive, Suite 475
Raleigh, NC 27607

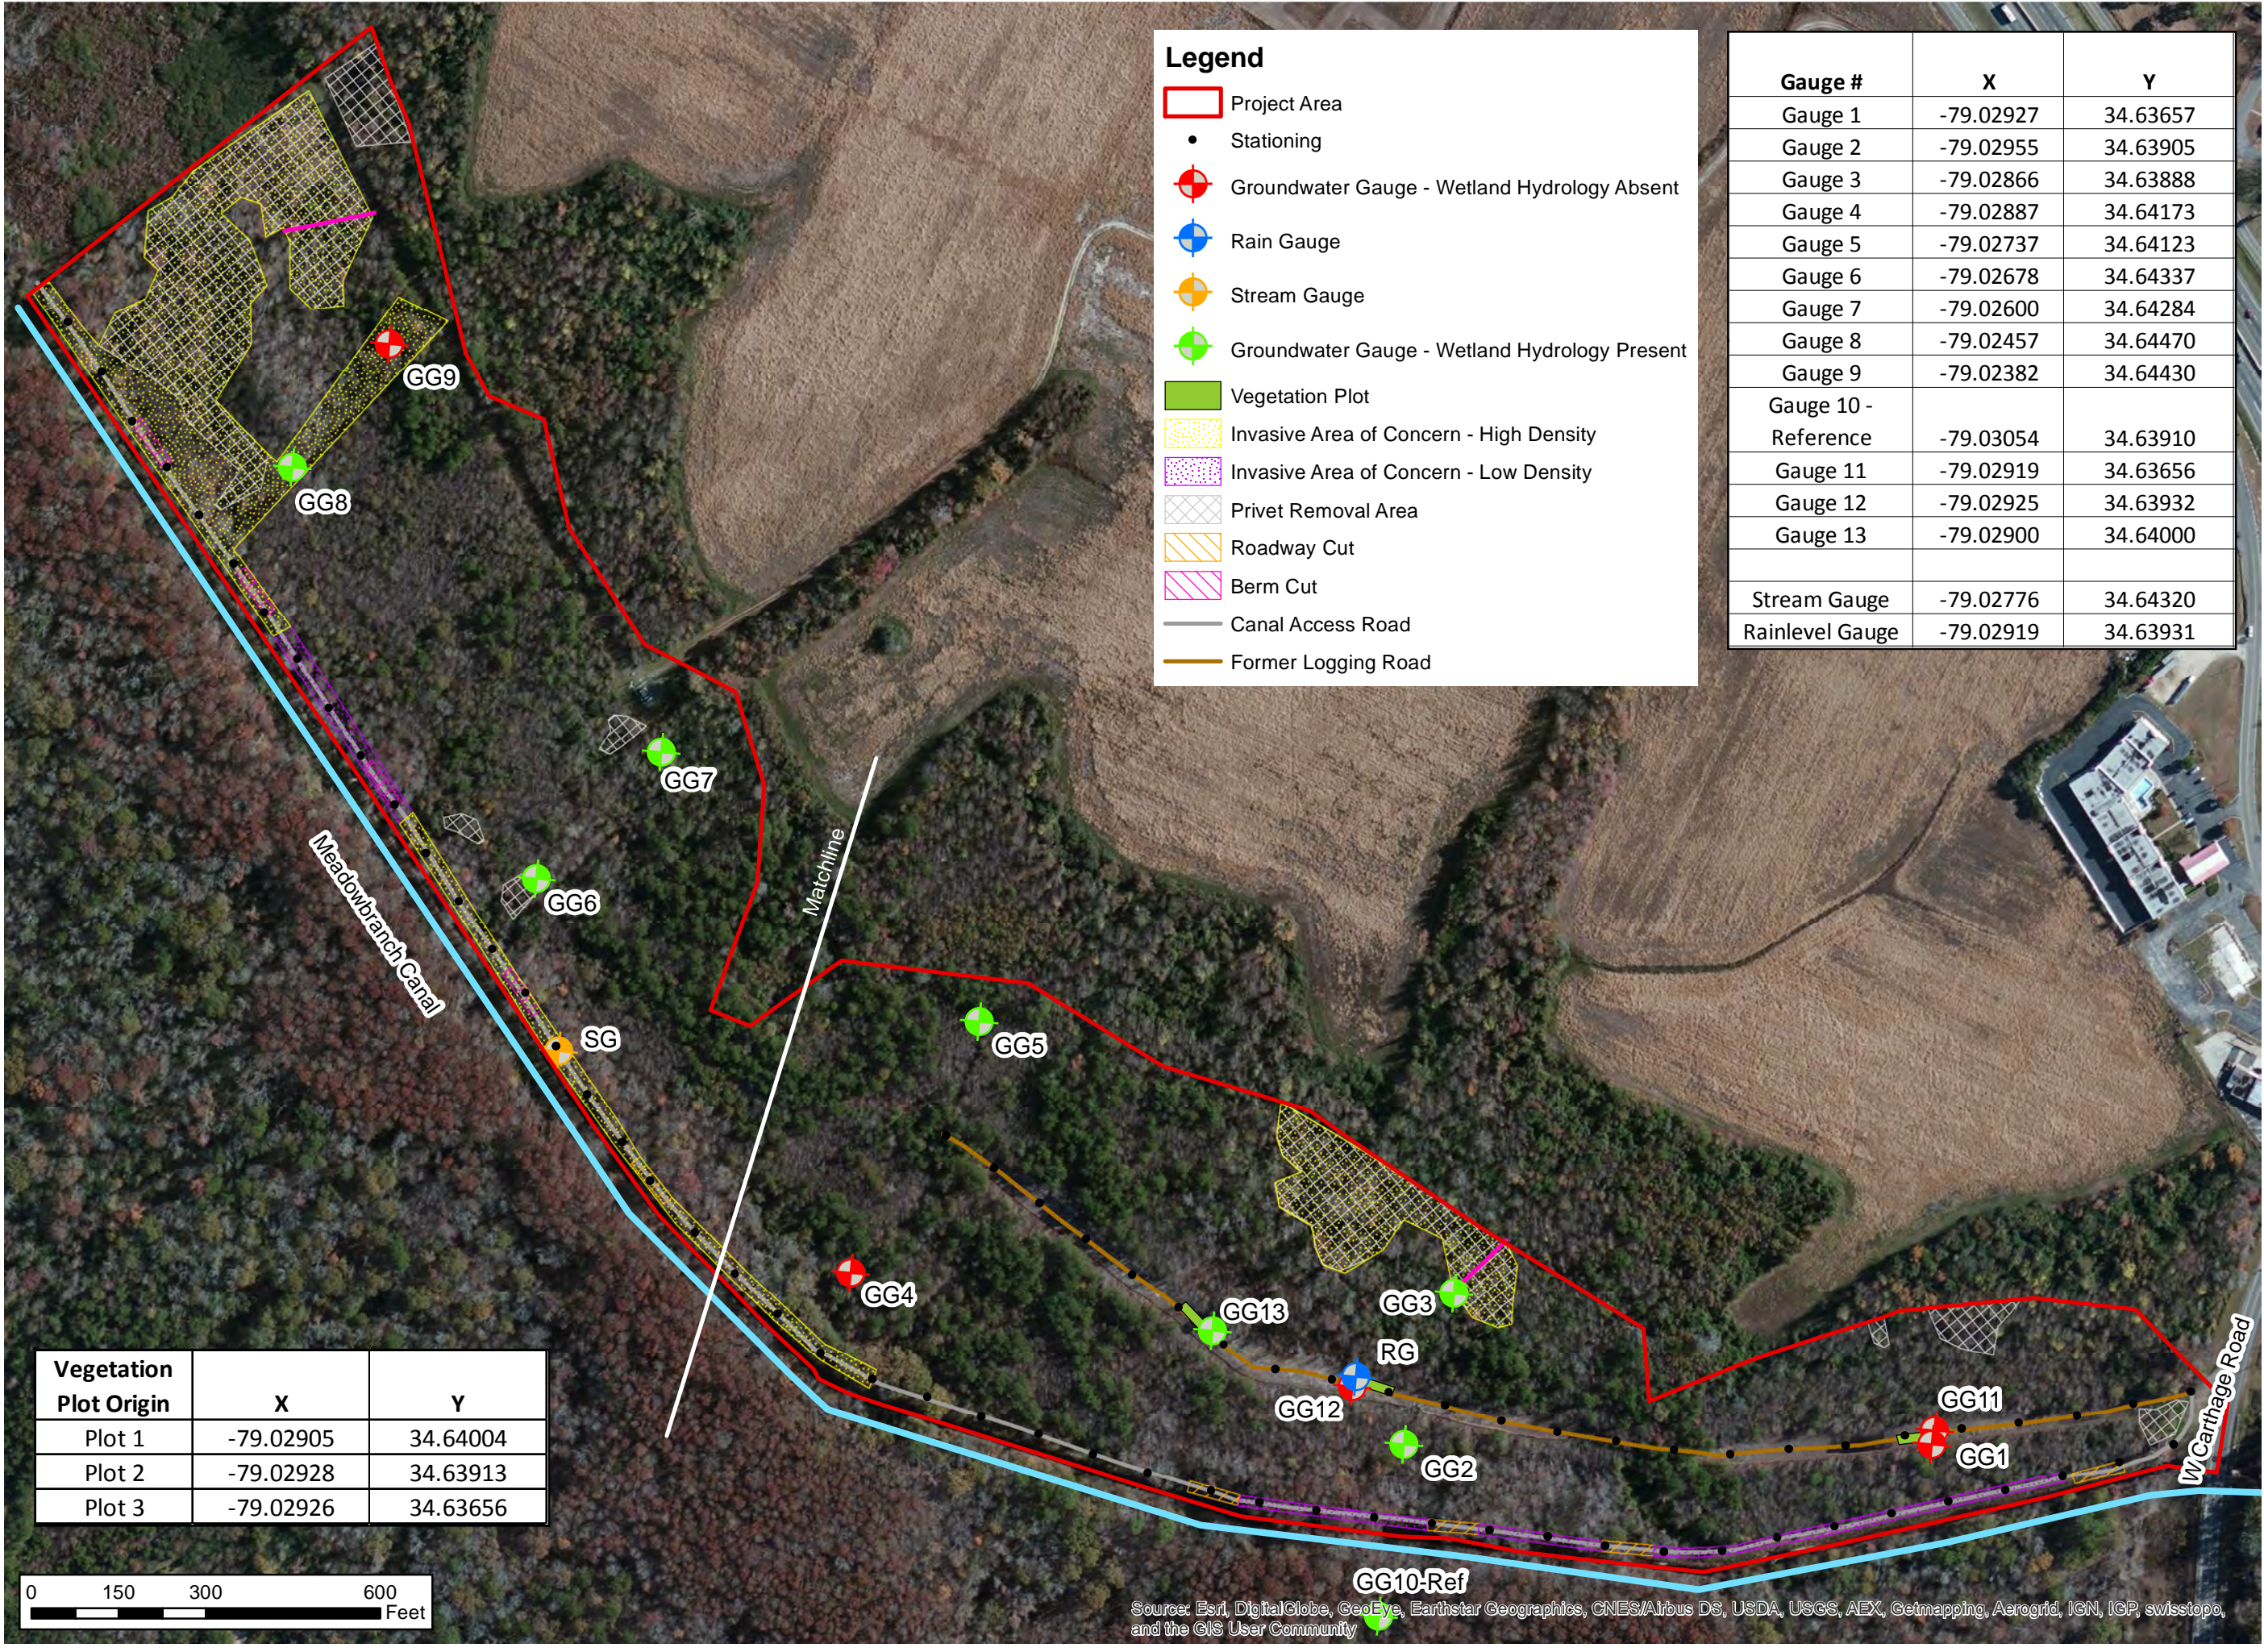
Figure 2
 Current Condition
 Plan View
 Project Overview

The presence of Chinese privet continues to be a problem at the site, especially along the canal access road and in the cut lines leading to the groundwater gauges between the former logging road and the canal access road. Treatment areas are notable in that there are large patches of stems that appear dead; however, upon closer observation, new growth is present on some of these stems. Treatment was successful in some areas, but not all. Chinese privet is still present in very dense patches along the canal access road in the northern portions of the site. Areas identified as invasive areas of concern during previous monitoring years remain on the Current Condition Plan View.

Erosion was first noted behind the matting at Roadway Cuts 1 and 2 during MY1. The erosion in these areas is still present, but has not changed since MY1. More recent erosion has been noted along the banks of Meadowbranch Canal in the vicinity of Roadway Cuts 3 and 4 during MY2. Erosion is still evident behind the matting at both of these areas. A new area of bank erosion was noted during the annual site assessment in May of 2014. This area is located just downstream of the stream gauge and was present during MY3 monitoring. During the annual site assessment (May 2015) a washout area was observed along the bank of the canal between stations 25+00 and 30+00, which appears to be due to water movement over the canal access road. Bank erosion was observed behind the matting of Berm Cut 2 and Road Cut 2. The roadway cuts and bank condition will continue to be monitored for changes during future monitoring events.

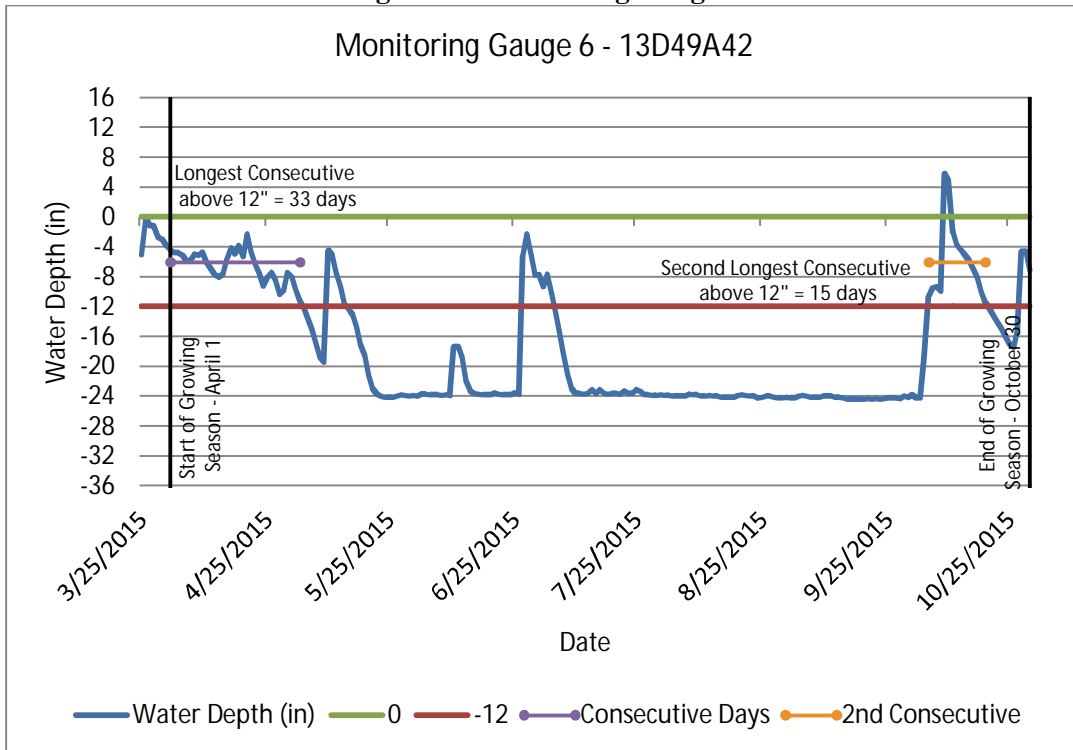
Figure 10: Monitoring Gauge 6

*Note: Water depths were adjusted five inches, calibration point was five inches above ground surface.

** Gauges 6 and 10 both protrude from the ground. The elevations have been adjusted to compensate for the distance between the calibration level and the ground surface. Gauge 6 is 5 inches above the ground, and gauge 10 is 6 inches above the ground.

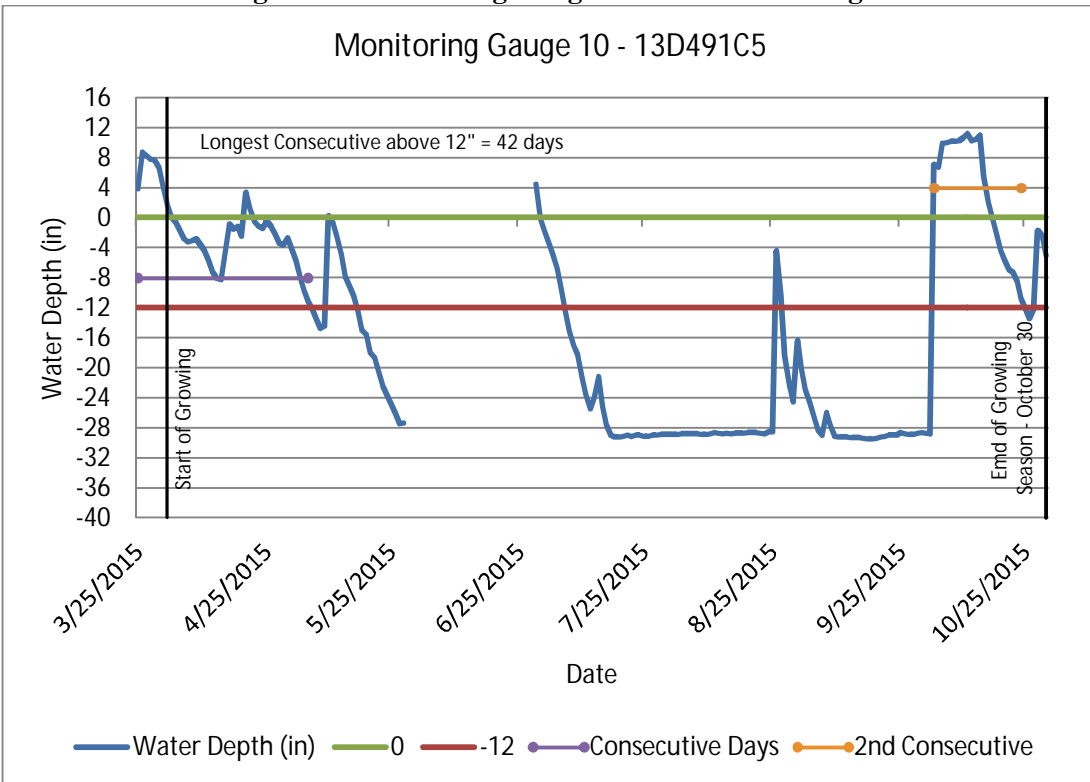
Figure 14: Monitoring Gauge 10 – Reference Gauge

*Note: Water depths were adjusted six inches, calibration point was six inches above ground surface.

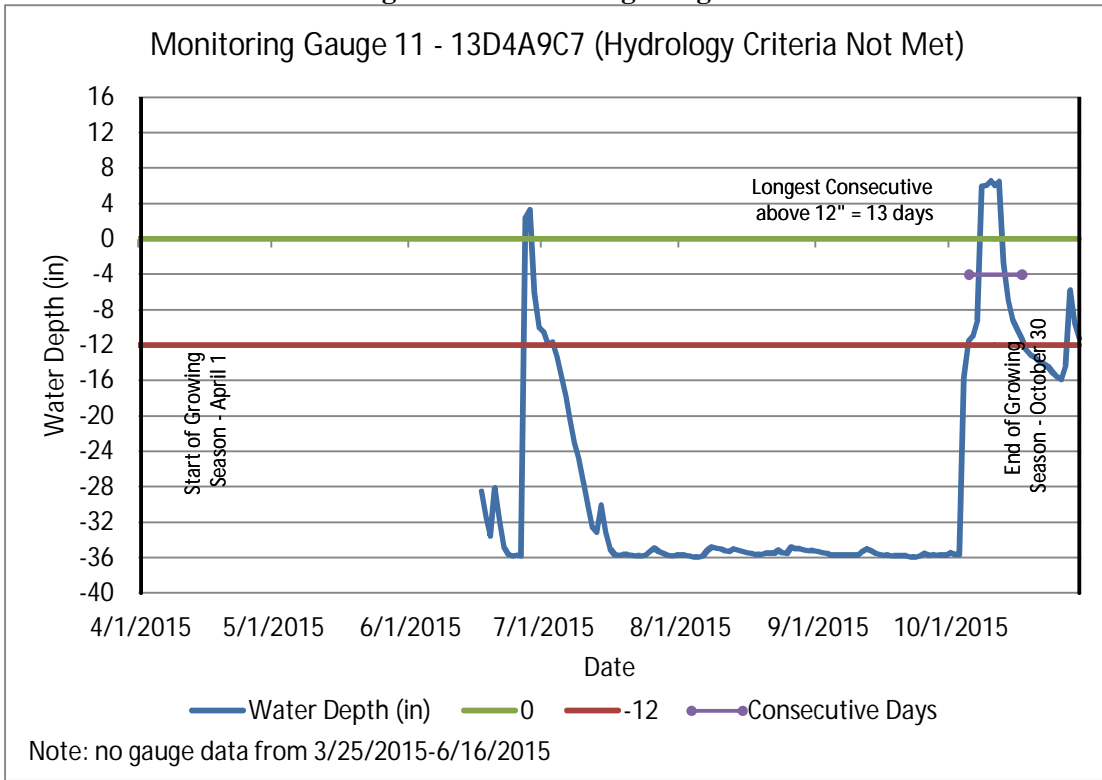
Figure 15: Monitoring Gauge 11

*Note: Gauge was replaced on June 16, 2015.

11	N/A	No/4 (1.9%)	Yes/49 (23.0%)	Yes/25 (11.7%)	No/13 (6.1%)	
12	N/A	No/12 (5.6%)	Yes/27 (12.7%)	No/7 (3.3%)	No/13 (6.1%)	
13	N/A	No/15 (7%)	Yes/126 (59.2%)	No/19 (8.9%)	Yes/52 24.4%
