**Meadowbranch Swamp Wetland Restoration
2016 Monitoring Report
Monitoring Year Five**

DMS Project Number 92351

USACE Action ID#: SAW2007-0400-078 DWR Project# N/A

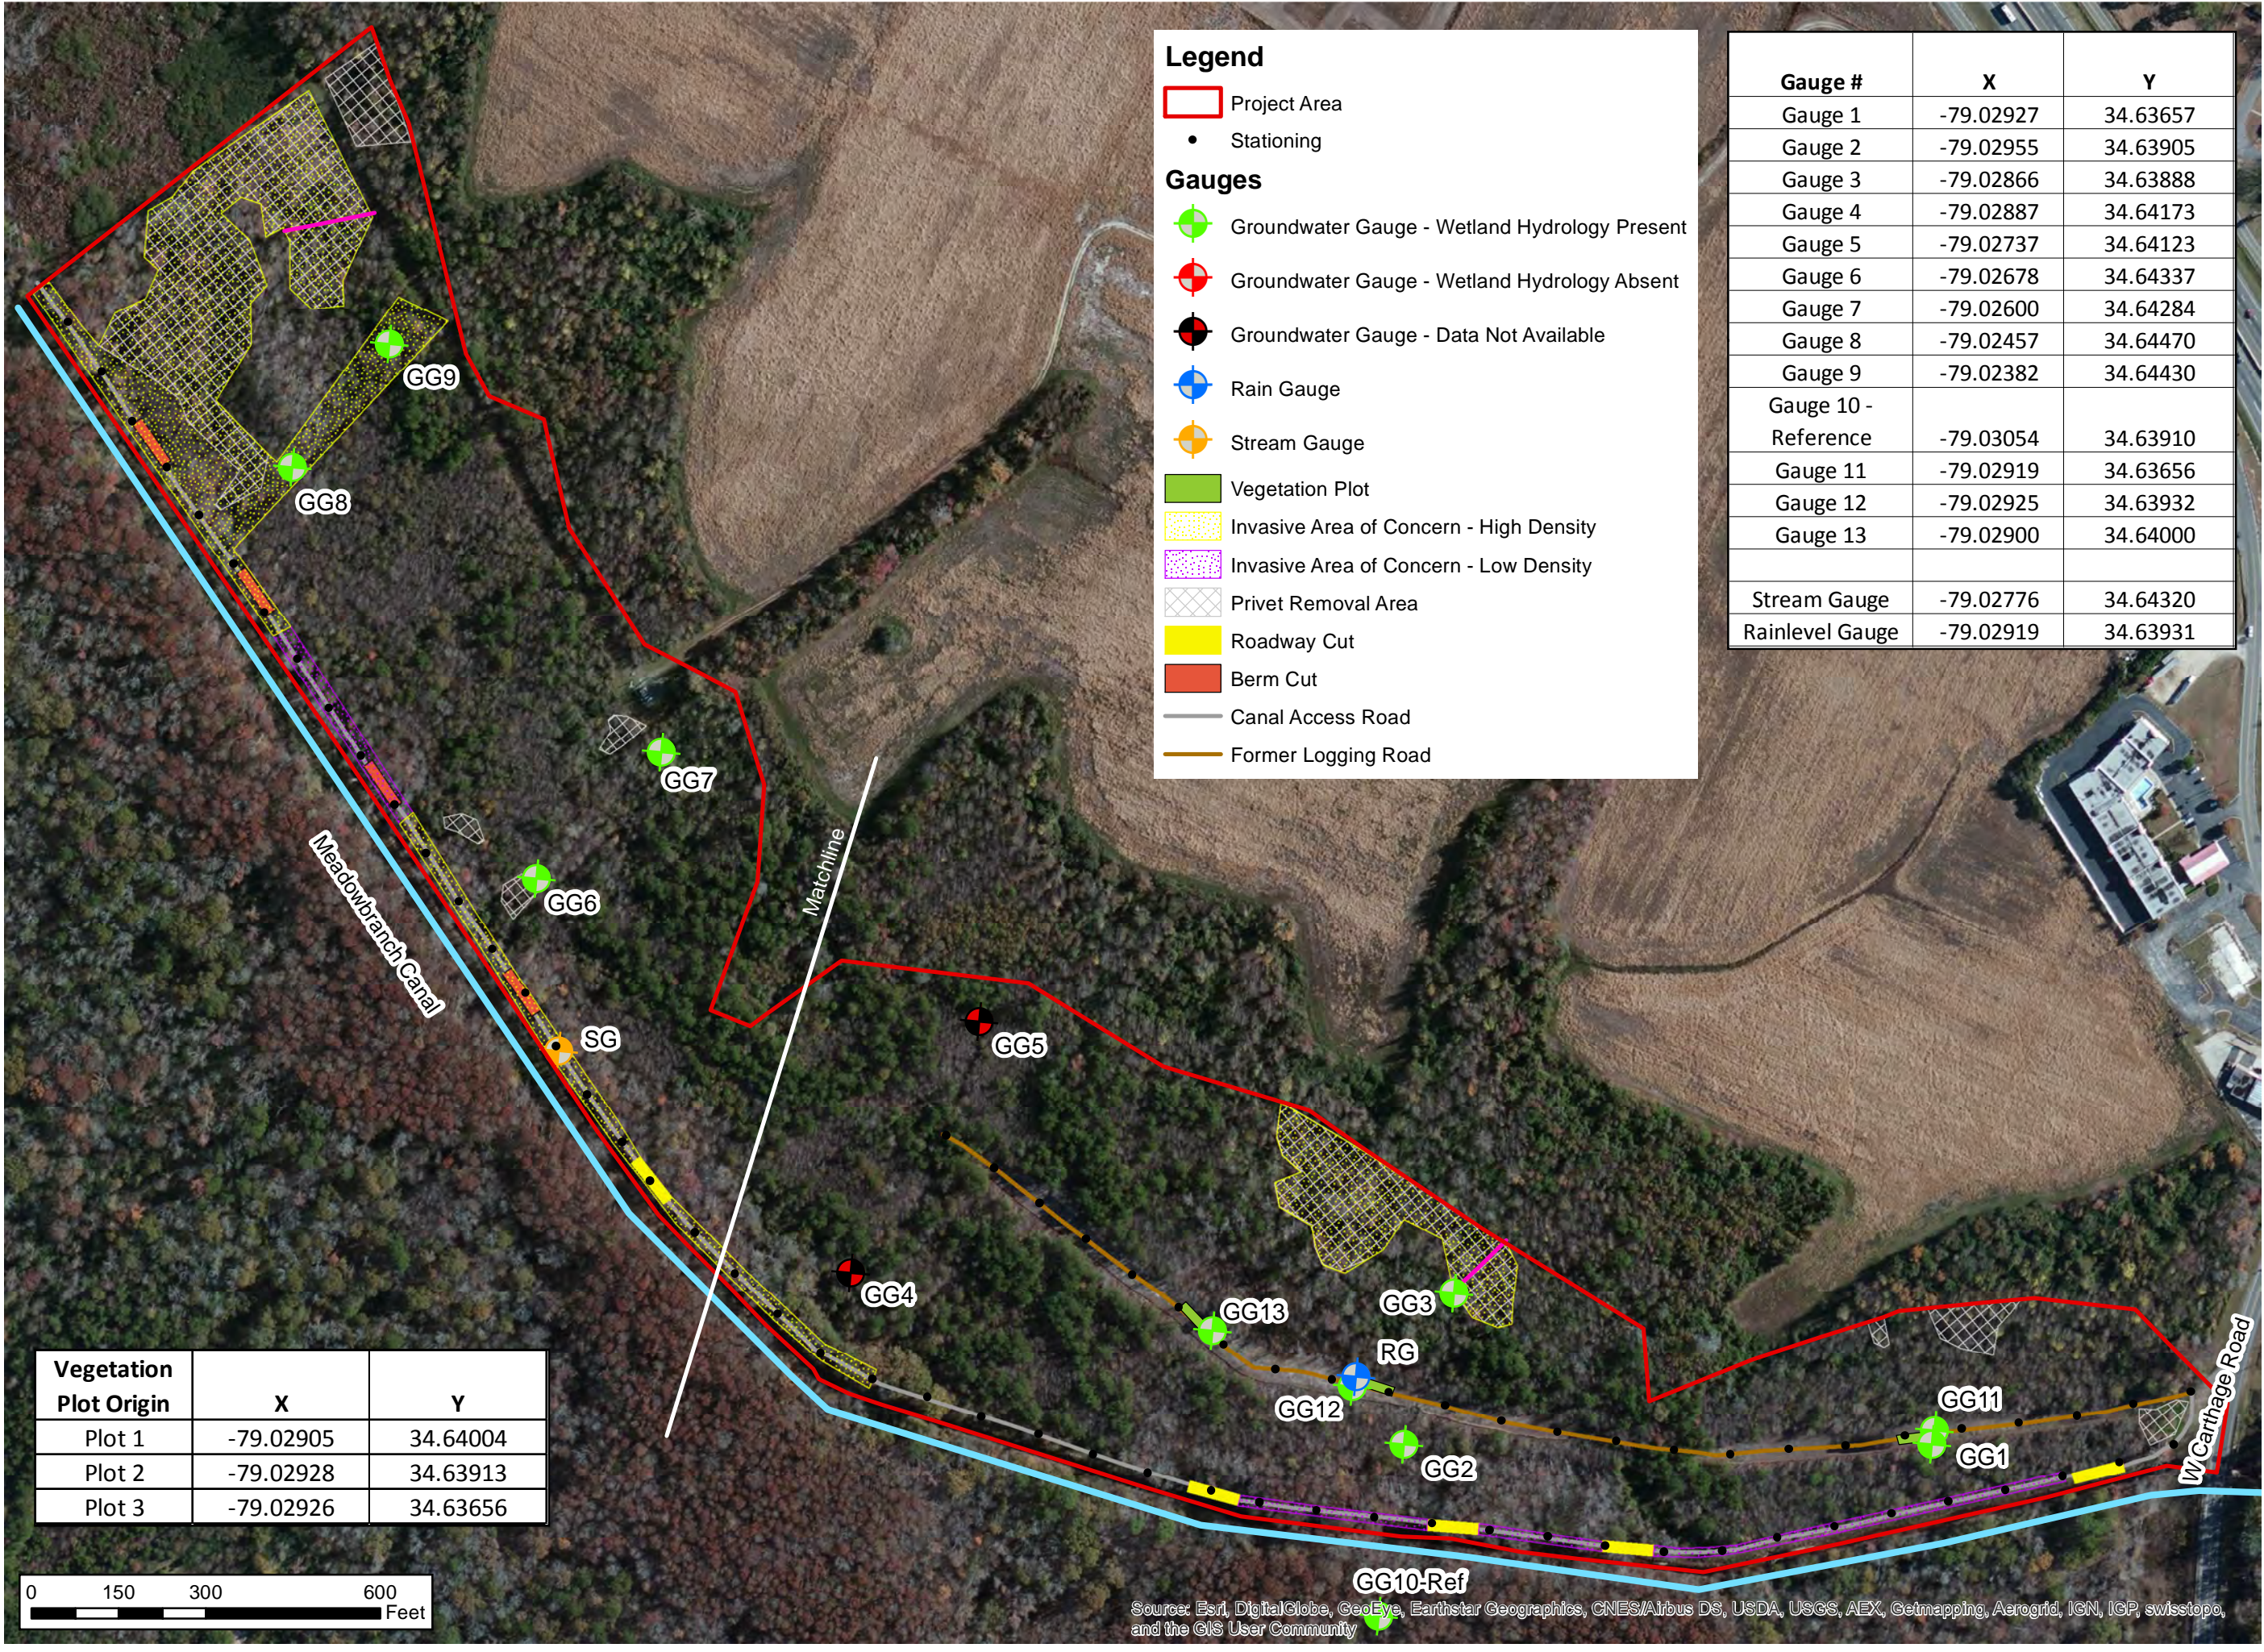
Figure 3
 Current Condition
 Plan View
 Project Overview

The presence of Chinese privet continues to be a problem at the site, especially along the canal access road and in the cut lines leading to the groundwater gauges between the former logging road and the canal access road. Treatment areas are notable in that there are large patches of stems that appear dead; however, upon closer observation, new growth is present on some of these stems. Treatment was successful in some areas, but not all. Chinese privet is still present in very dense patches along the canal access road in the northern portions of the site. Areas identified as invasive areas of concern during previous monitoring years remain on the Current Condition Plan View.

Overall, the site is in good condition, with the exception to the presence of Chinese privet. While the Chinese privet is still present, the limits do not appear to be expanding. The northern portions of the site continue to support the largest populations.

Erosion was first noted behind the matting at Roadway Cuts 1 and 2 during MY1. The erosion in these areas is still present, but has not changed since MY1. More recent erosion was noted along the banks of Meadowbranch Canal in the vicinity of Roadway Cuts 3 and 4 during MY2. A new area of bank erosion was noted during the annual site assessment in May of 2014. This area is located just downstream of the stream gauge and was present during MY3 monitoring. During the MY4 site assessment (May 2015) a washout area was observed along the bank of the canal between stations 25+00 and 30+00, which appears to be due to water movement over the canal access road. Bank erosion was observed behind the matting of Berm Cut 2 and Road Cut 2. None of these areas appear to have become significantly worse during 2016.

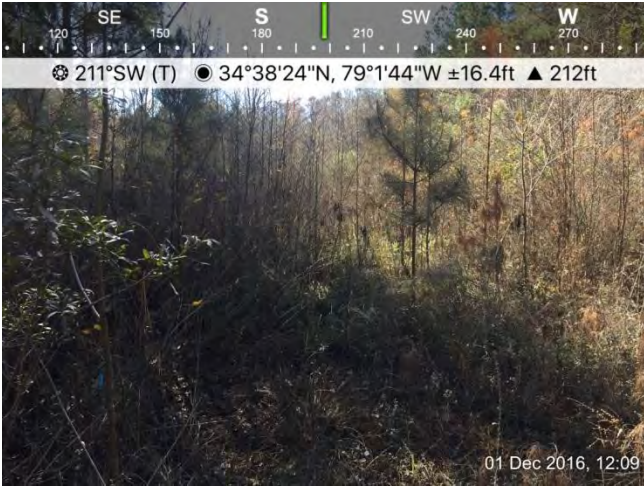
VP1

Monitoring Year 5 (MY5) field investigations took place on December 1, 2016. All three vegetation plots are in good condition and all are meeting vegetative success criteria with a project average of 486 stems per acre. Large numbers of volunteer stems, primarily river birch are present in all three plots.

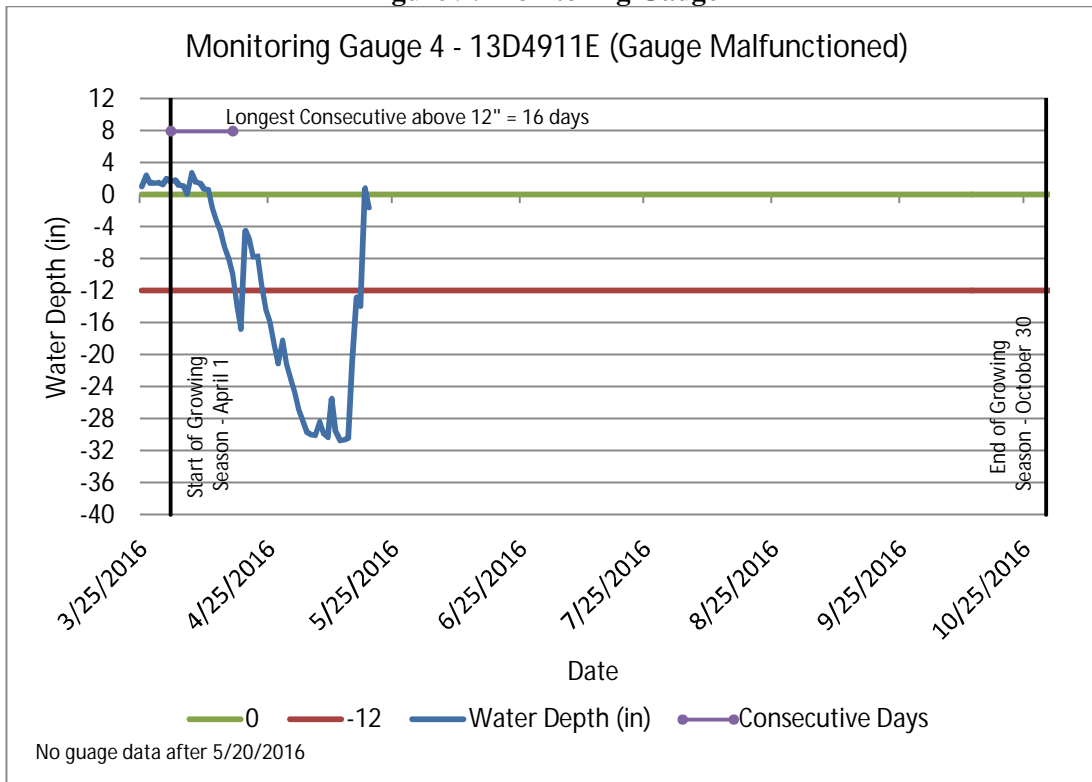
Figure 10: Monitoring Gauge 5

gauges installed on-site met the hydrologic success criteria described above during the timeframe between April 1 and October 30 of 2016 (Table 11). The reference wetland gauge also met the wetland criteria. Gauge 5 appears to have malfunctioned early in the year and the readings were determined to be non-reliable. Two gauges were not able to be downloaded in the fall (Gauge 4 and 13), due to damage from flooding or from vandalism. However, data for the early part of the growing season had been obtained during the May site visit.

Gauge did not record reliable readings in 2016
