Monitoring Year 1 Report
FINAL
Meadow Brook Stream Restoration Project
Yadkin County, North Carolina
Yadkin River Basin, Hydrologic Unit Code (HUC) 03040101

Data Collection Period:
September 2020 -October 2020

Submission Date:
December 2020

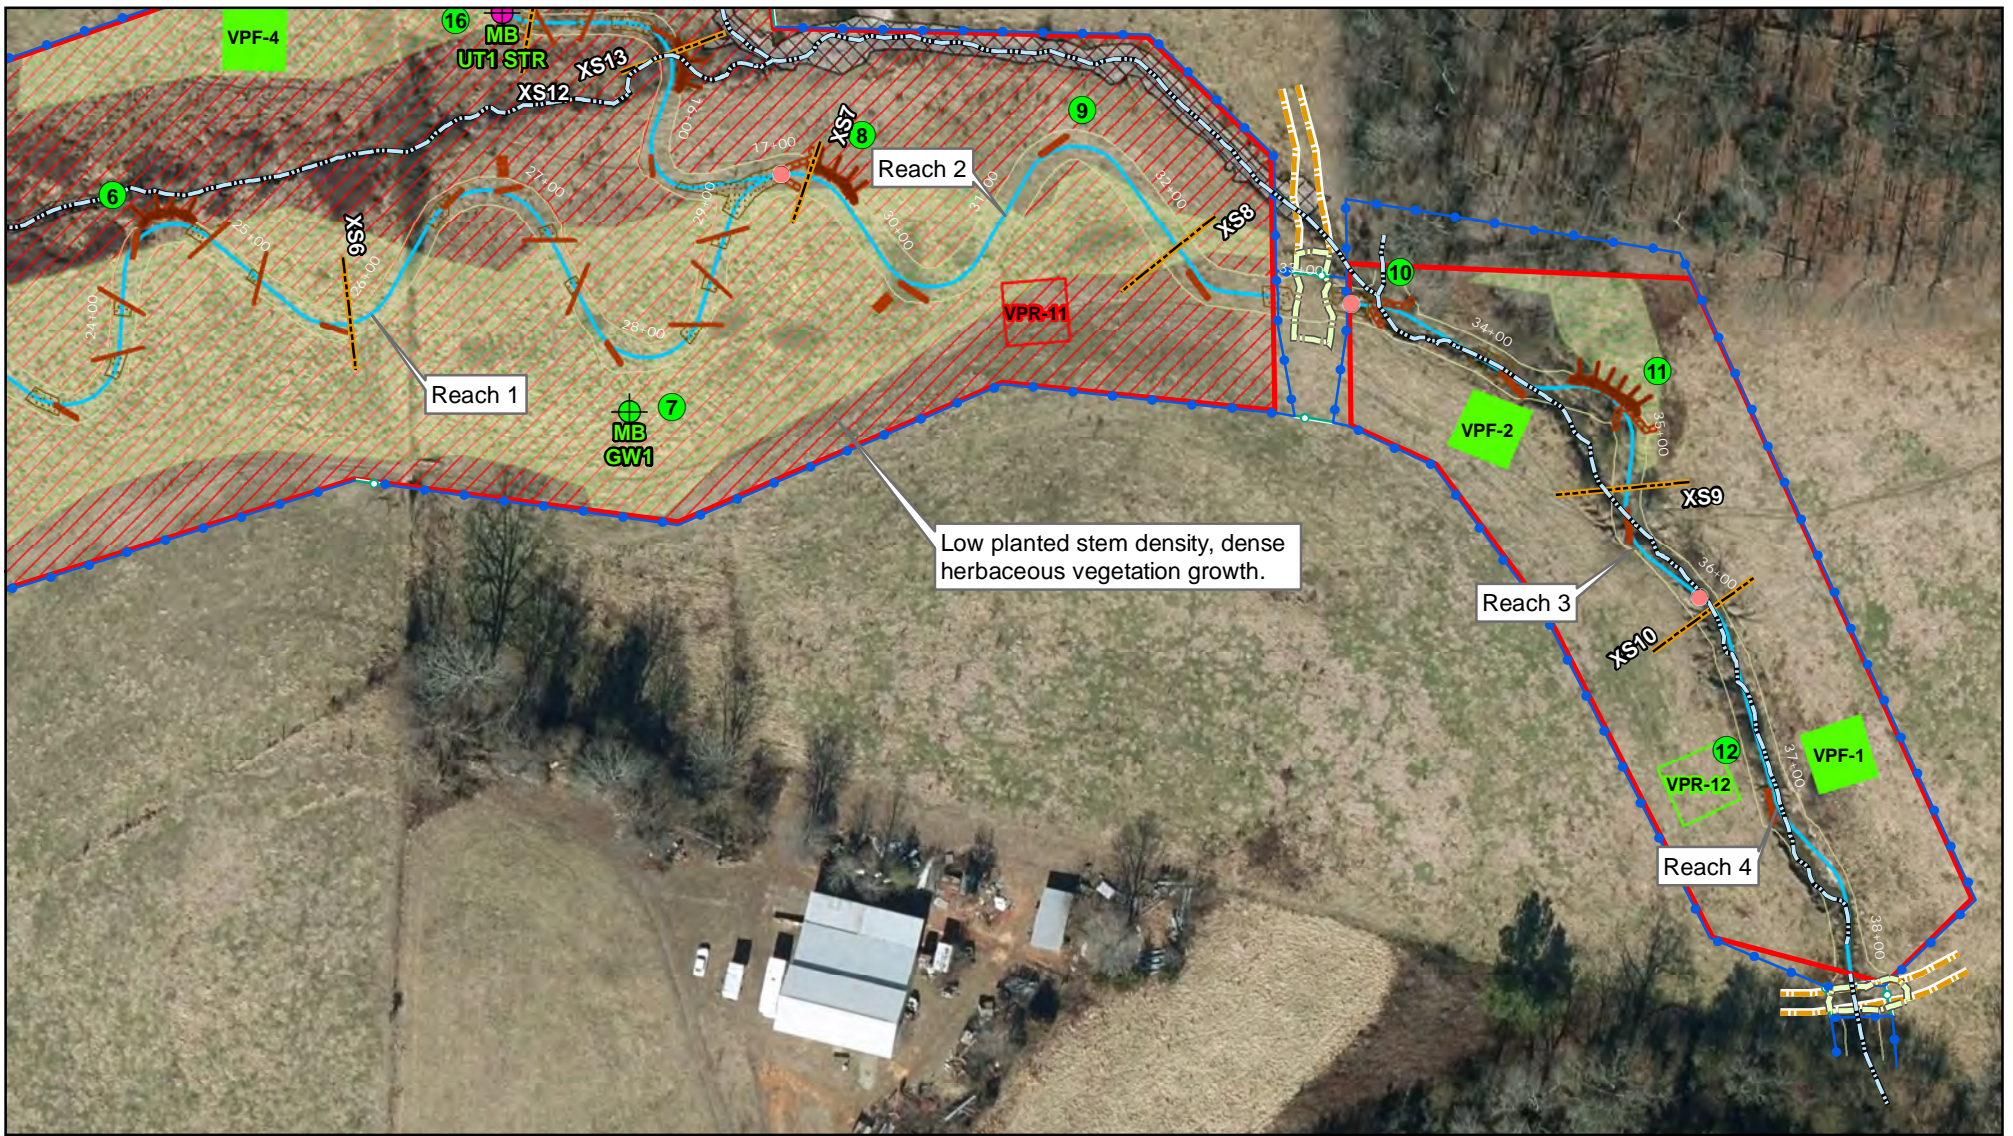
CURRENT CONDITION PLAN VIEW: ASSET MAP
MY1: 2020

Low planted stem density, dense herbaceous vegetation growth.

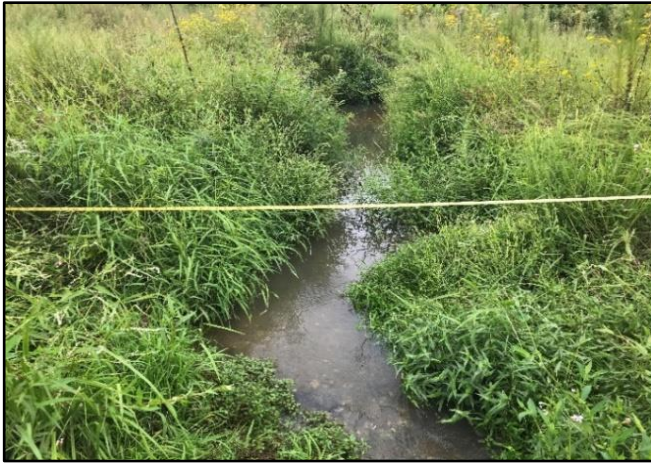
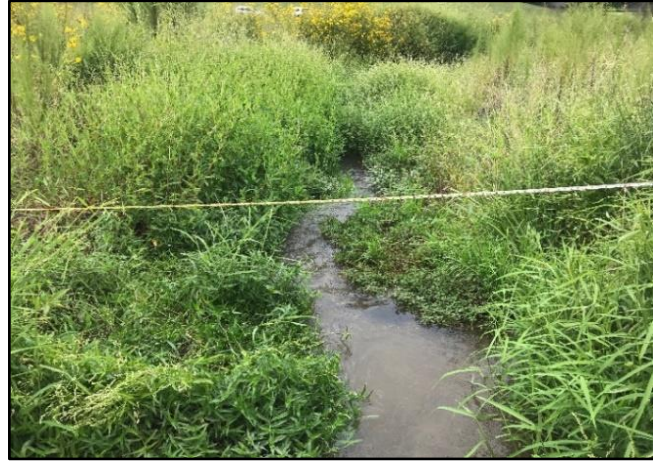
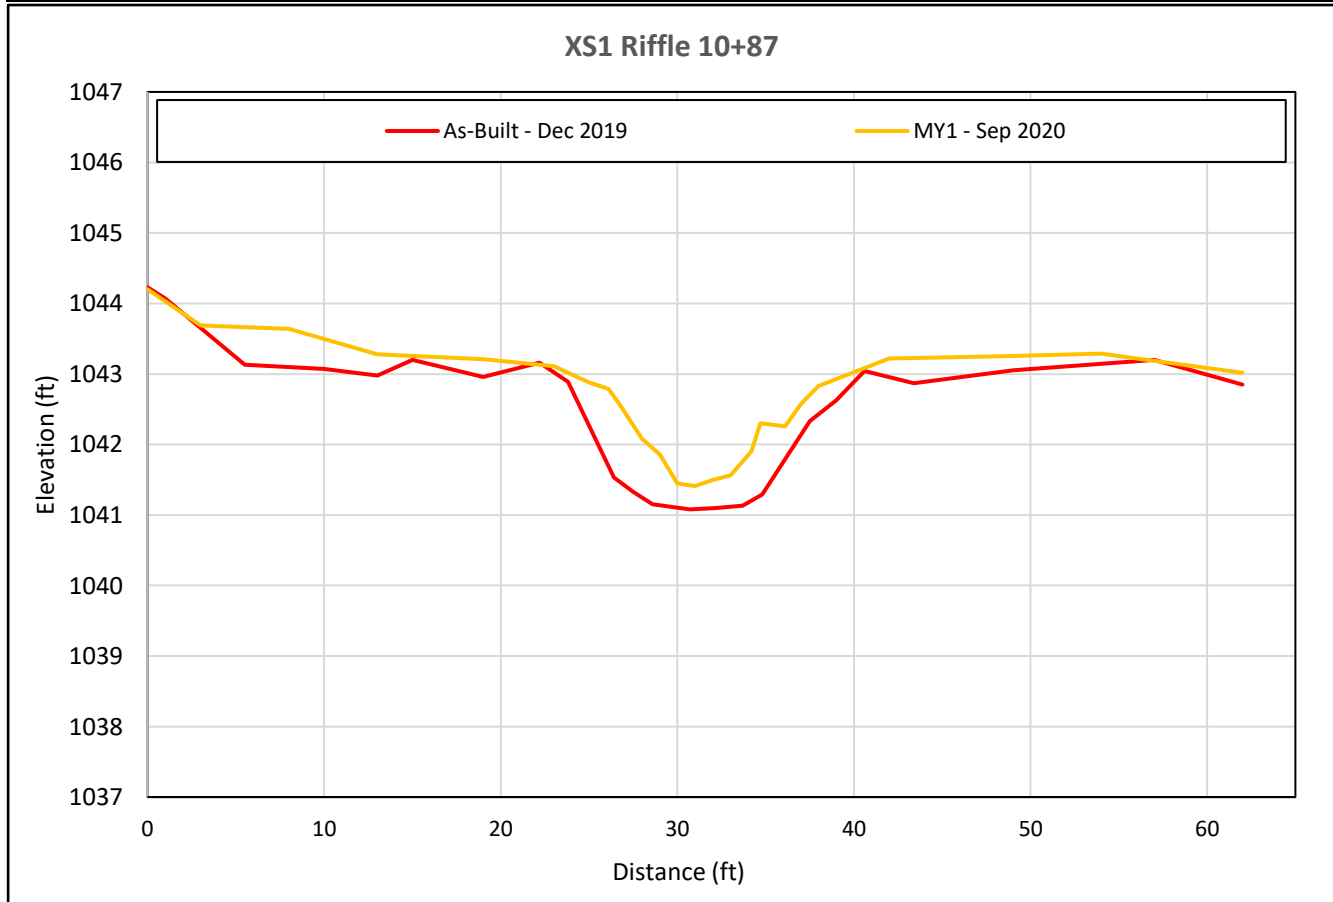
Cross Section Plot - MY1
XS1 - Reach 1
Station 10+87 - Riffle

- Cross sections 1, 2, 3, and 4 show signs of aggradation primarily due to herbaceous vegetation laying in the stream channel. This vegetation did not appear to be rooted in the channel for the most part. Recent large flood events have cleared much of this out and EPR expects these cross sections to improve as streambank vegetation matures.
- Cross section 8 (riffle) has downcut about 0.5 feet, but is still meeting the success criteria. This cross section, and Reach 2 overall, will be observed for possible further degradation in the next monitoring year.
- Cross section 13 (pool) has filled about 1 foot. A high sediment load on the UT is expected in this monitoring year since the Greenbrier Project construction was occurring upstream of this reach. This cross section will also be monitored to determine whether adaptive management is needed to provide pool habitat within the UT.

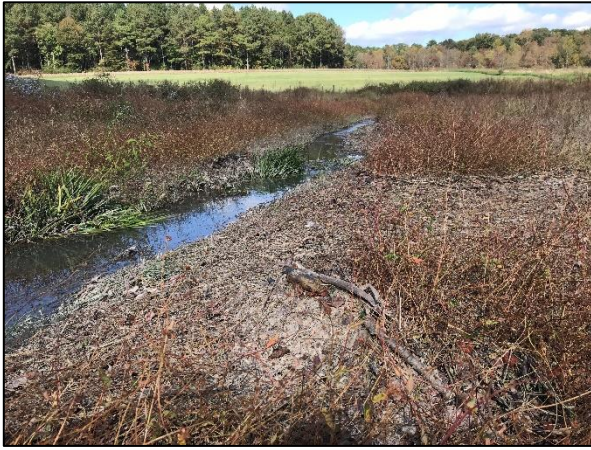
Photo 1 – Meadow Brook Bankfull Wrack Line
(10/27/2020)
