**Submission Date:**  
December 2021

NCDEQ Contract No. 7184  
DMS ID No. 100024  
RFP No. 16-006993  
USACE Action ID No. SAW-2017-01509  
NCDWR ID: 2018-0919

DMS Project ID #100024

**MEADOW BROOK STREAM MITIGATION PROJECT**  
 CURRENT CONDITION PLAN VIEW: OVERVIEW  
 MY2: 2021

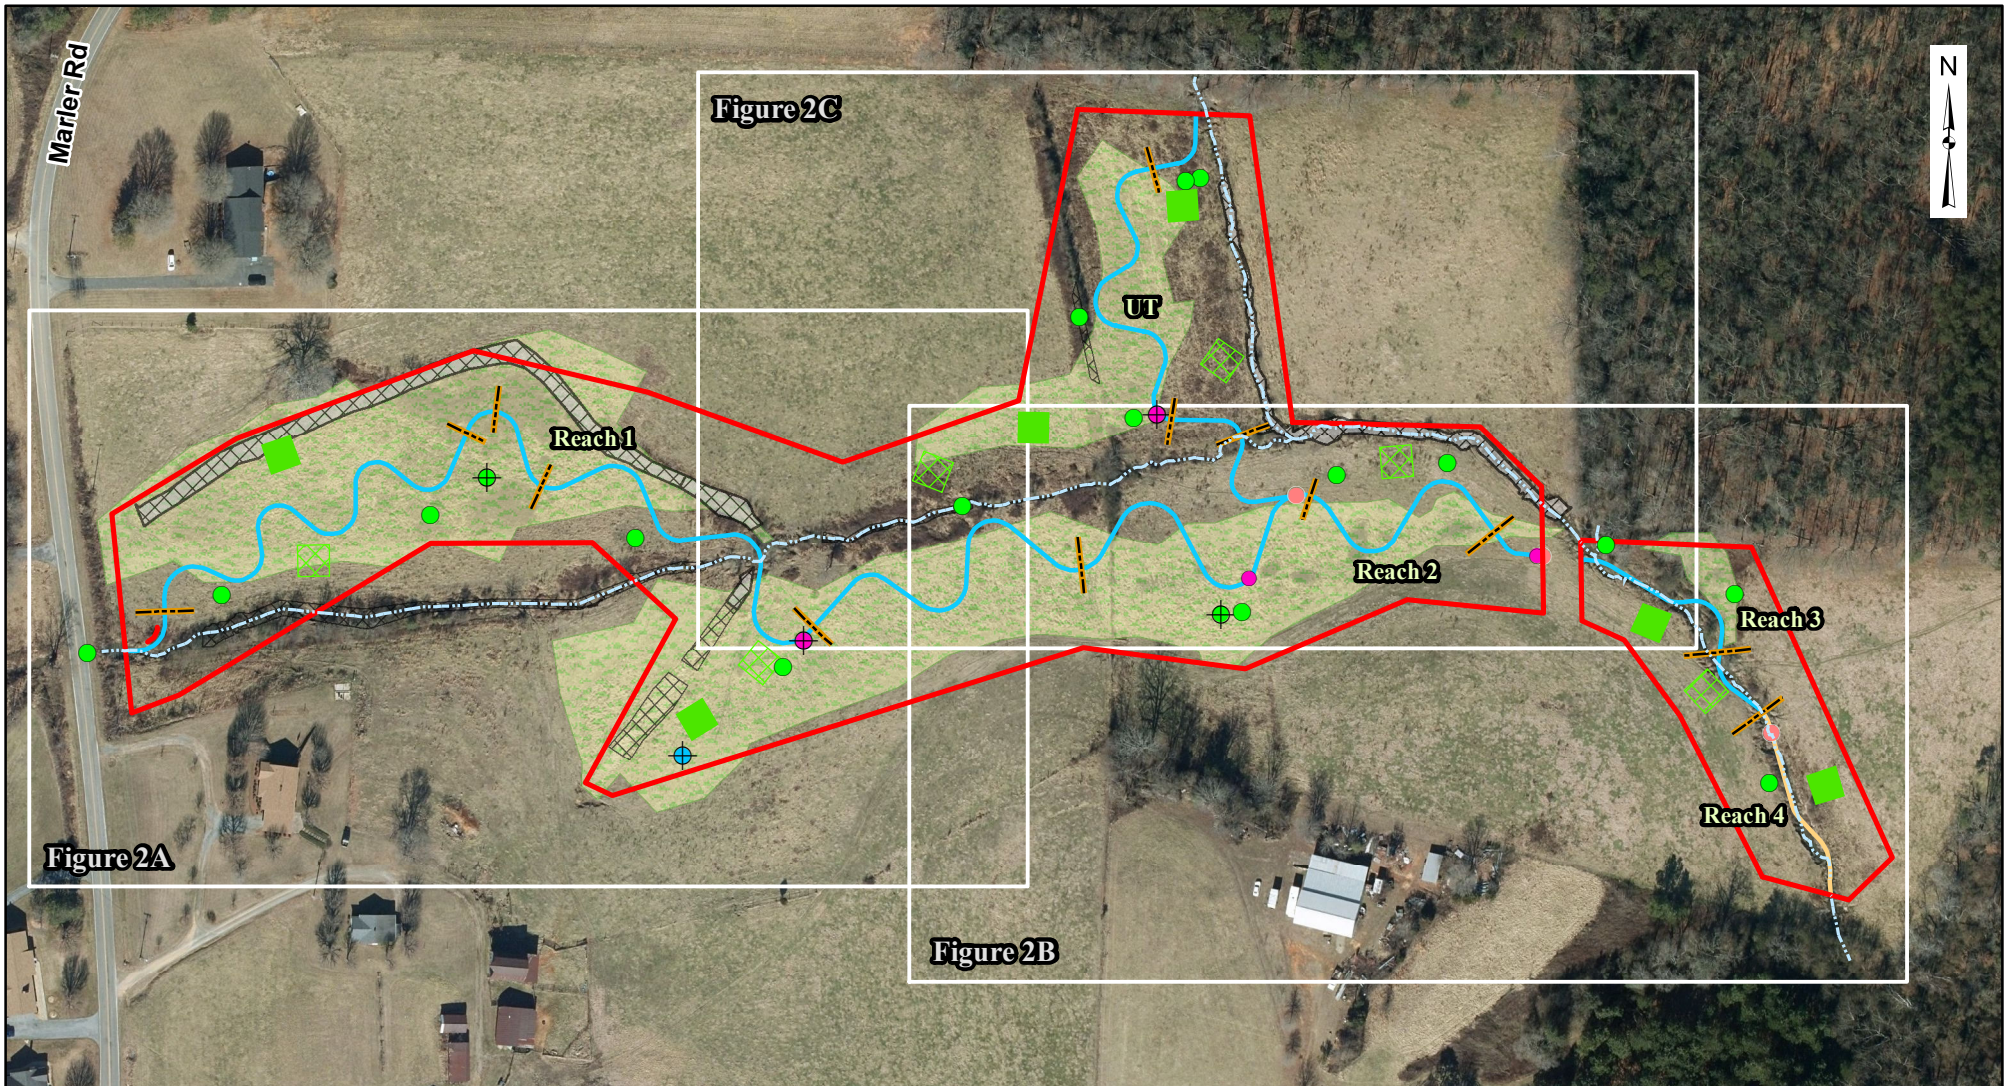
- *Please submit point features representing where beaver dams had existed.*
  - **A shapefile showing the locations of the two beaver dams that were removed in 2021 has been added to the electronic submittal. The points have been added to the CCPV.**

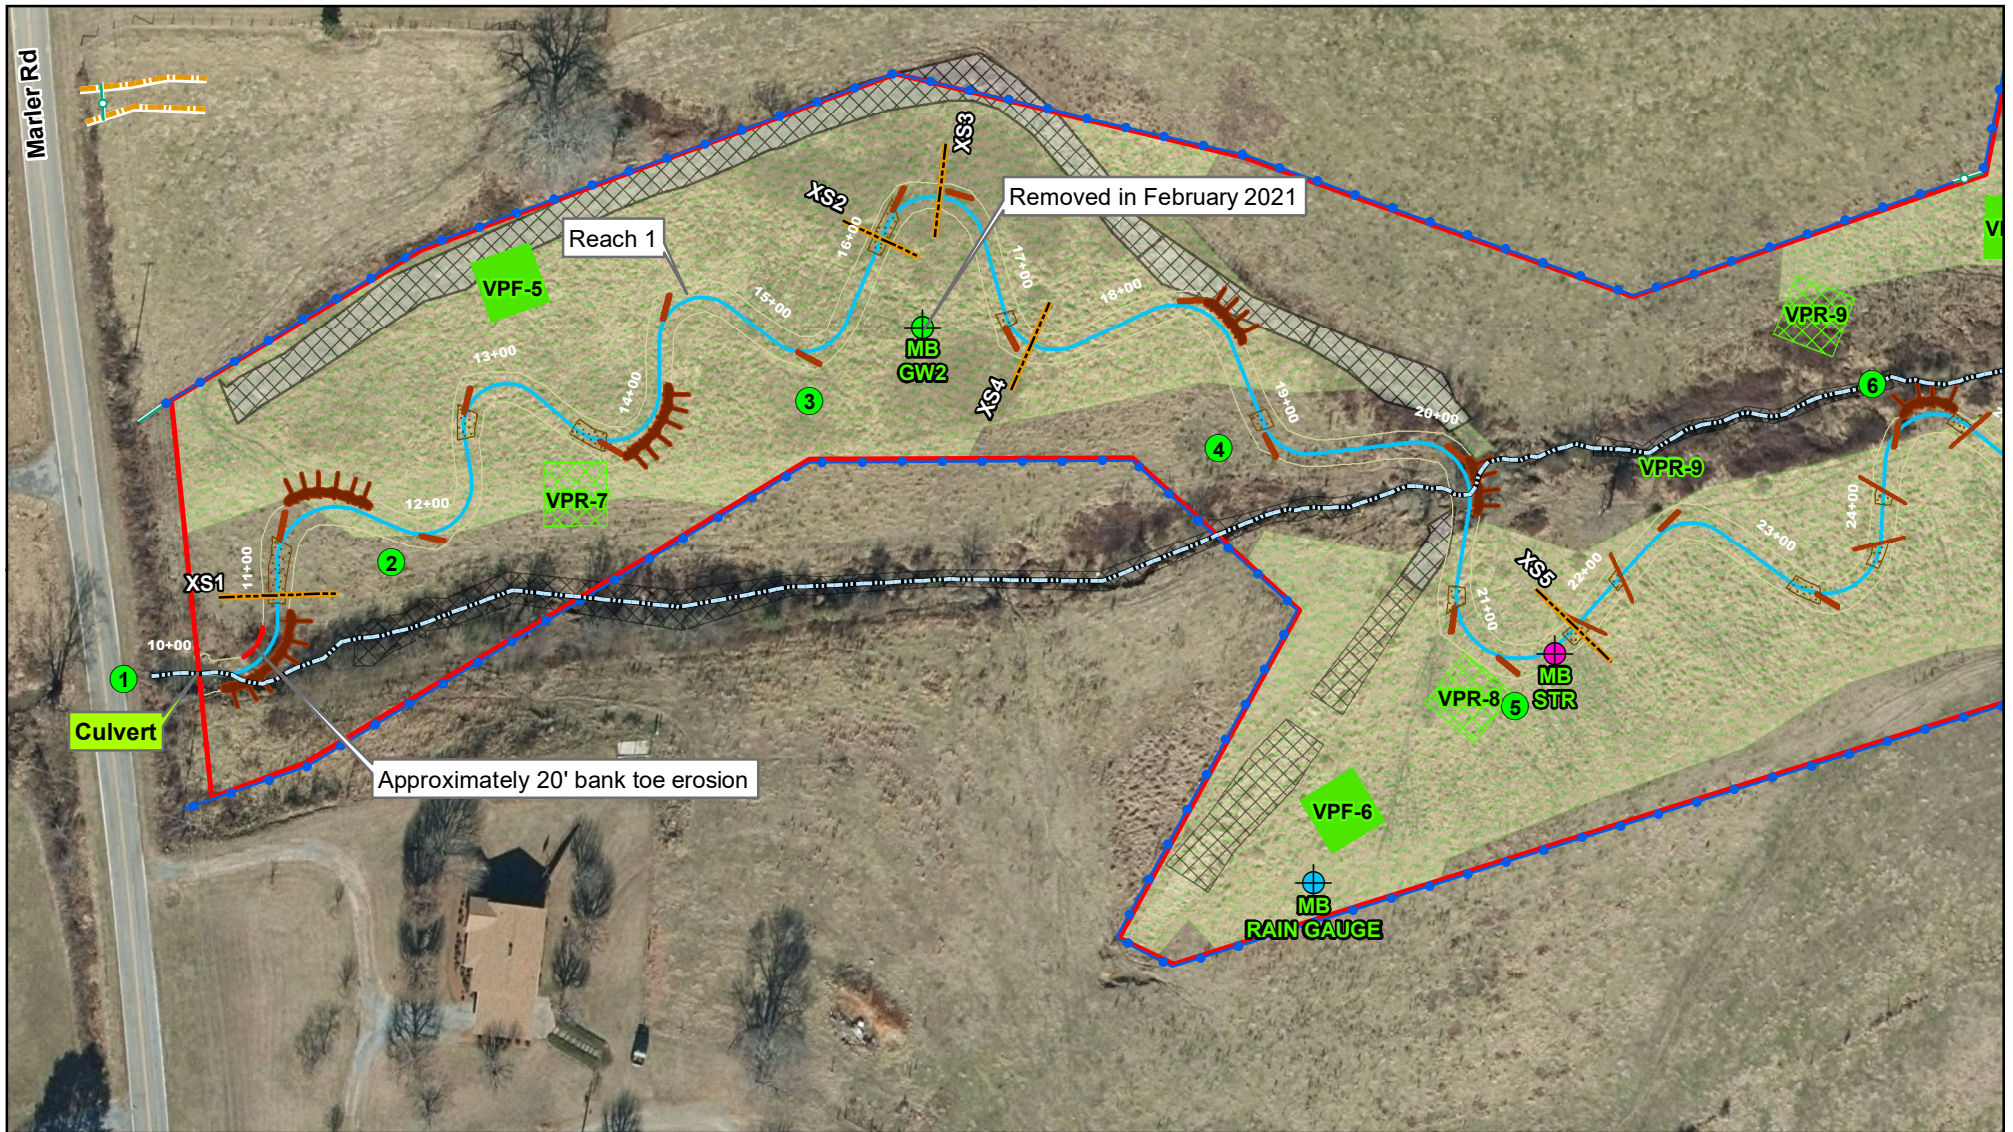
**MEADOW BROOK STREAM MITIGATION PROJECT**  
CURRENT CONDITION PLAN VIEW: ASSET MAP  
MY2: 2021

There is a short reach of bank erosion noted in Table 4, Appendix A. The point bar has scoured and there is localized bank erosion. This area was first noticed after a storm event in April 2020 but appeared to be healing during MY1 monitoring. This area is visible in Photo Point 1 and will be observed during the next monitoring year. This area is shown in the CCPV.

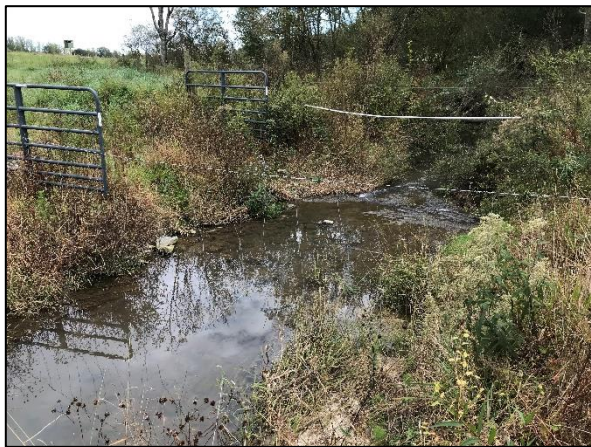
Stream crossing fence repairs near Sta. 38+00 facing  
downstream (3/11/2021)

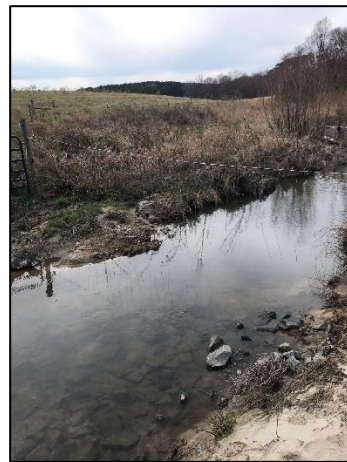
Stream crossing fence repairs near Sta. 33+00 facing  
upstream (3/11/2021)

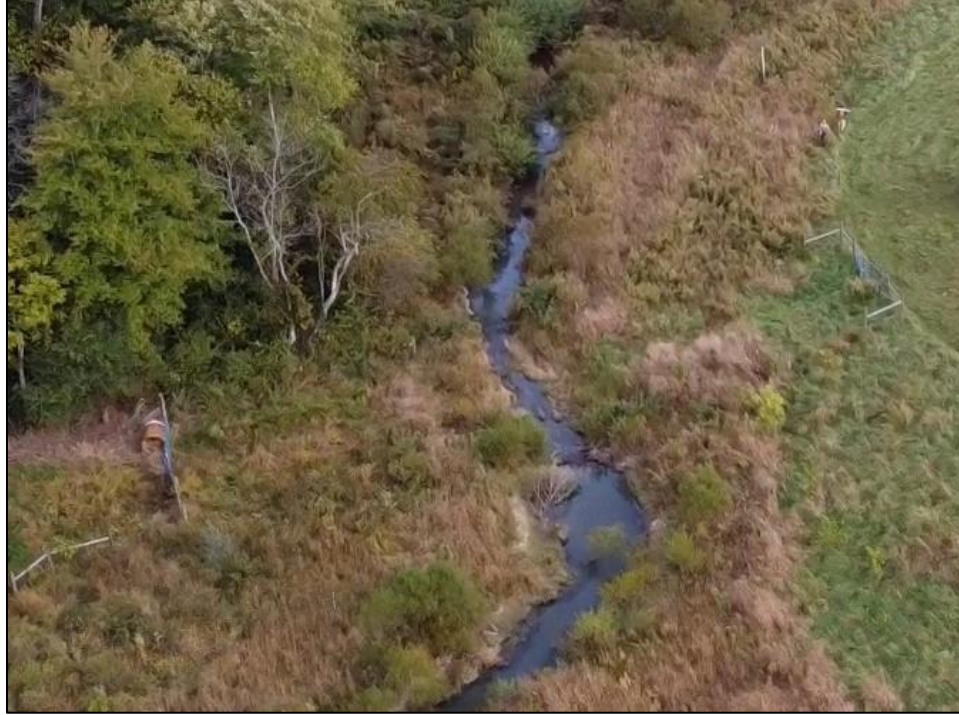
Stream crossing on Meadow Brook Reach 2, near Sta. 33+00 facing downstream (10/21/2021)

- **Note: Additional photos of the stream crossing located near Sta. 33+00 have been added to the photolog per the IRT comments and requests from 2021. An additional Photo Point will be added in MY3 to show this crossing.**

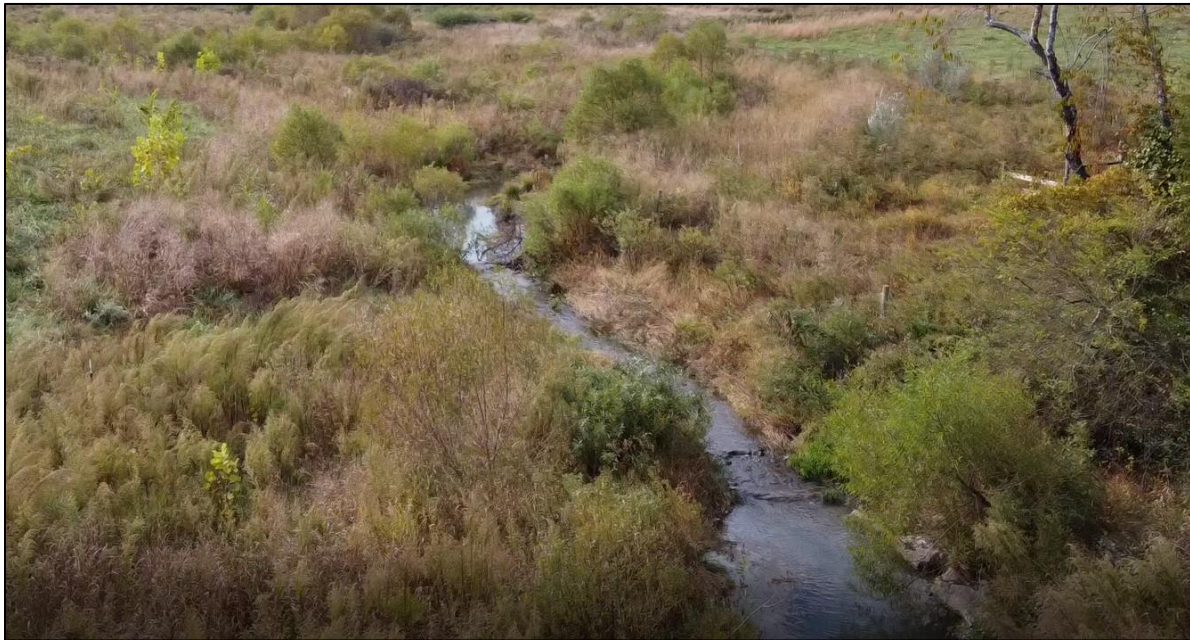
Stream crossing on Meadow Brook Reach 2, near Sta. 33+00 facing upstream (10/21/2021)

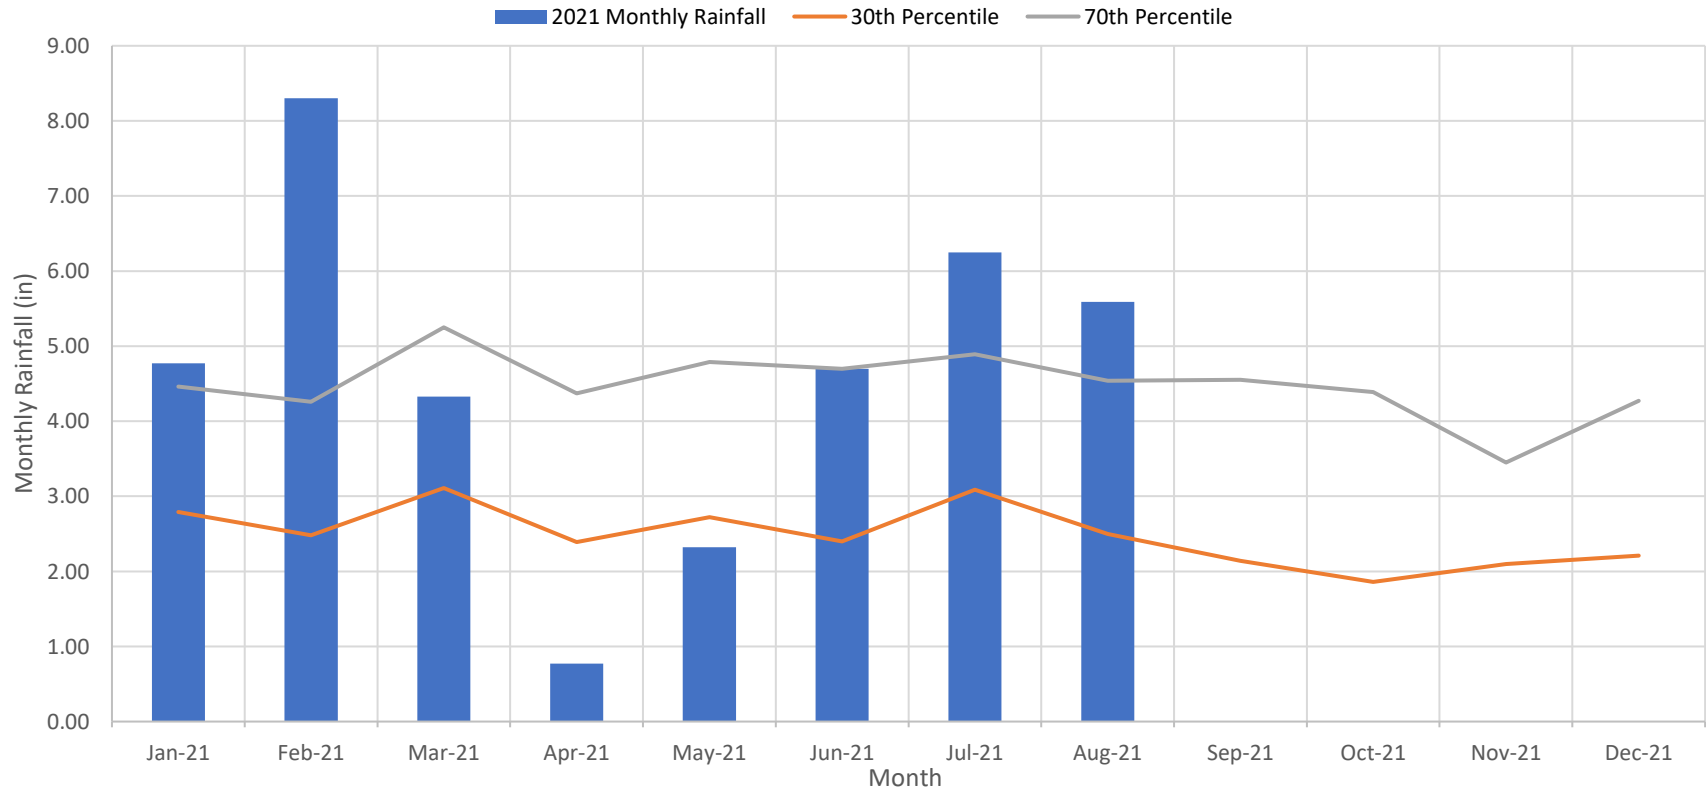
Meadow Brook Stream Restoration Project  
 Figure 3. Monthly Rainfall Data  
 Monitoring Year 2 - 2021

Rain gauge data from September 2, 2021 to the time of data collection is unavailable because the batteries in the data logger had expired. The batteries were replaced in November 2021 and the instrument is fully functioning.
