**Monitoring Year 3 Report**  
**FINAL**  
**Meadow Brook Stream Restoration Project**  
**Yadkin County, North Carolina**  
**Yadkin River Basin, Hydrologic Unit Code (HUC) 03040101**

**Submission Date:**  
December 2022

**Meadow Brook Stream Restoration Project**

Monitoring Year 3 Report - FINAL

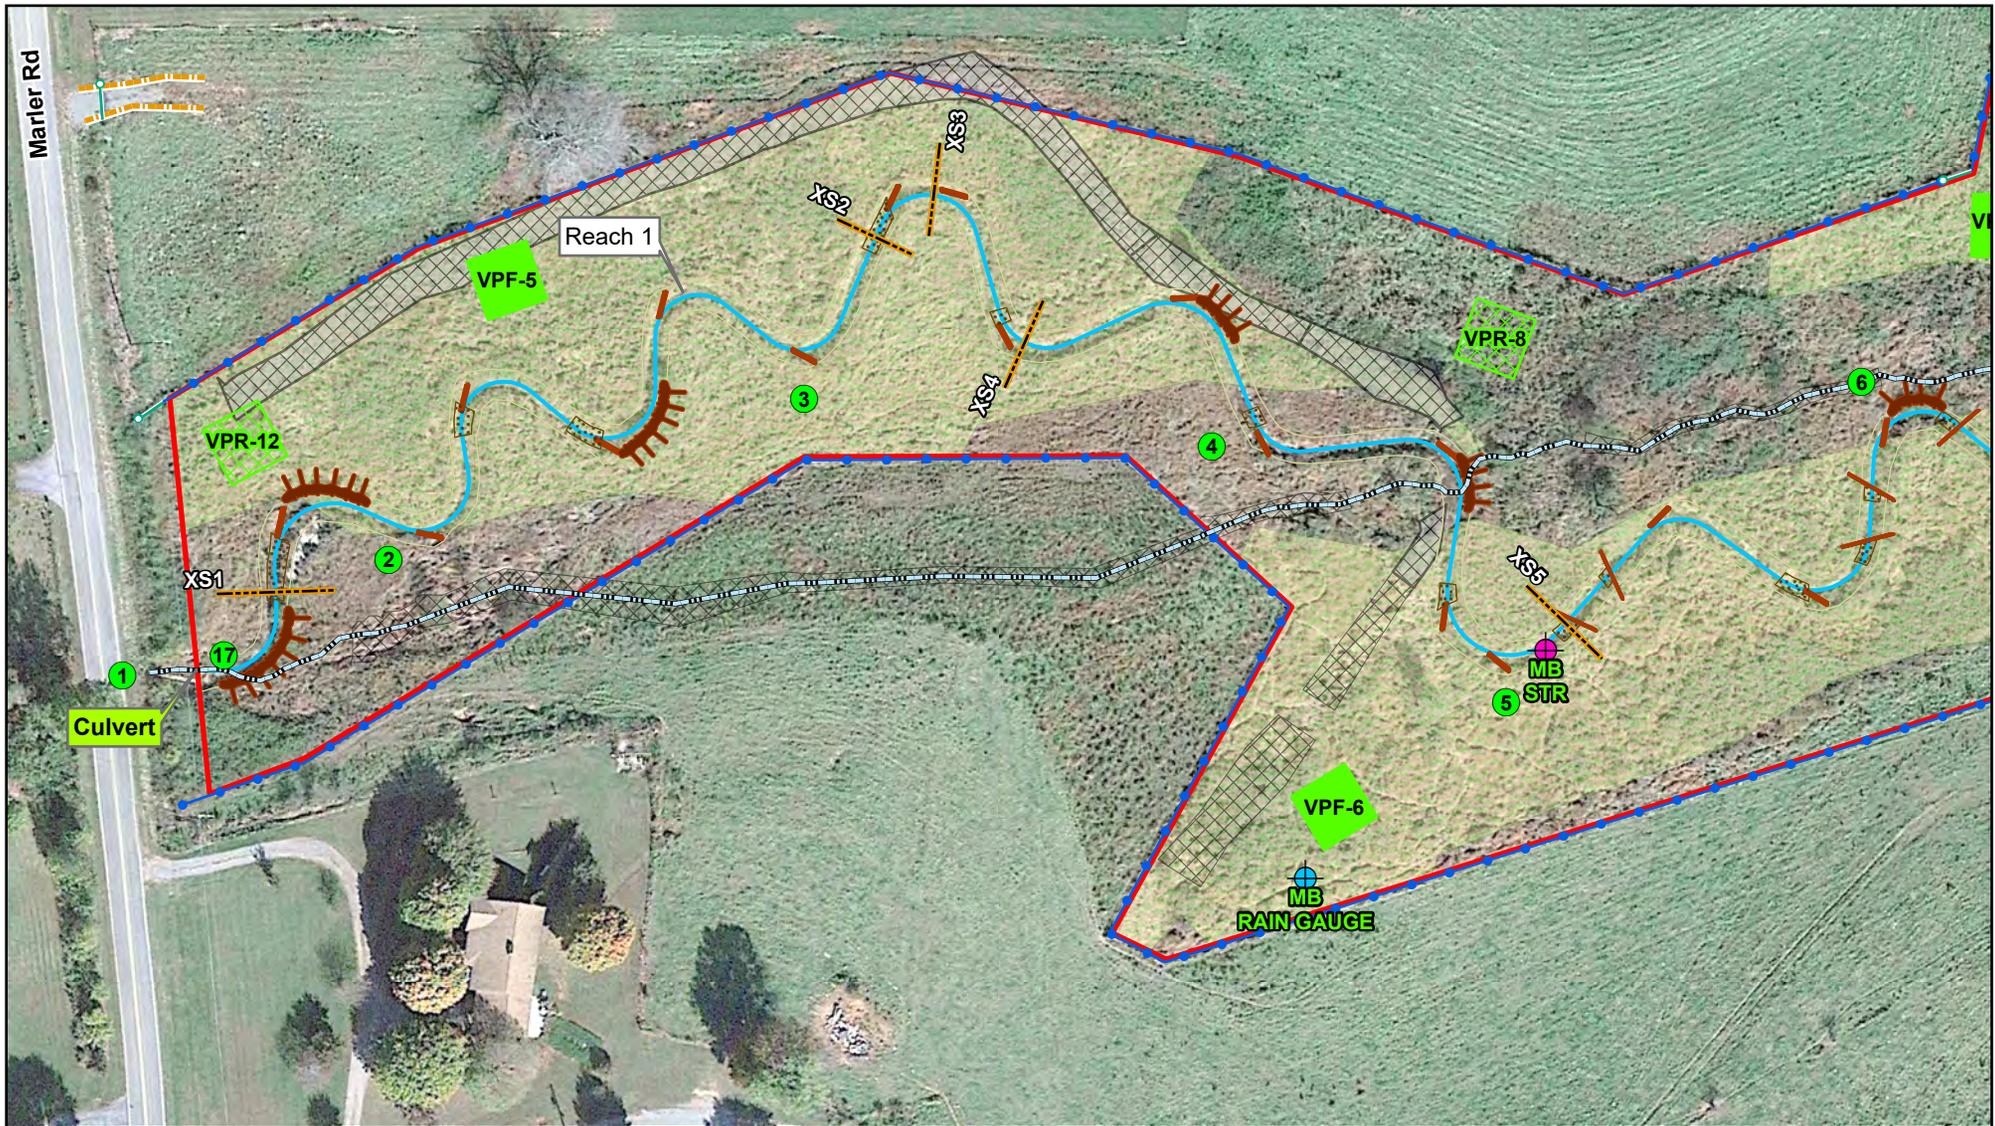
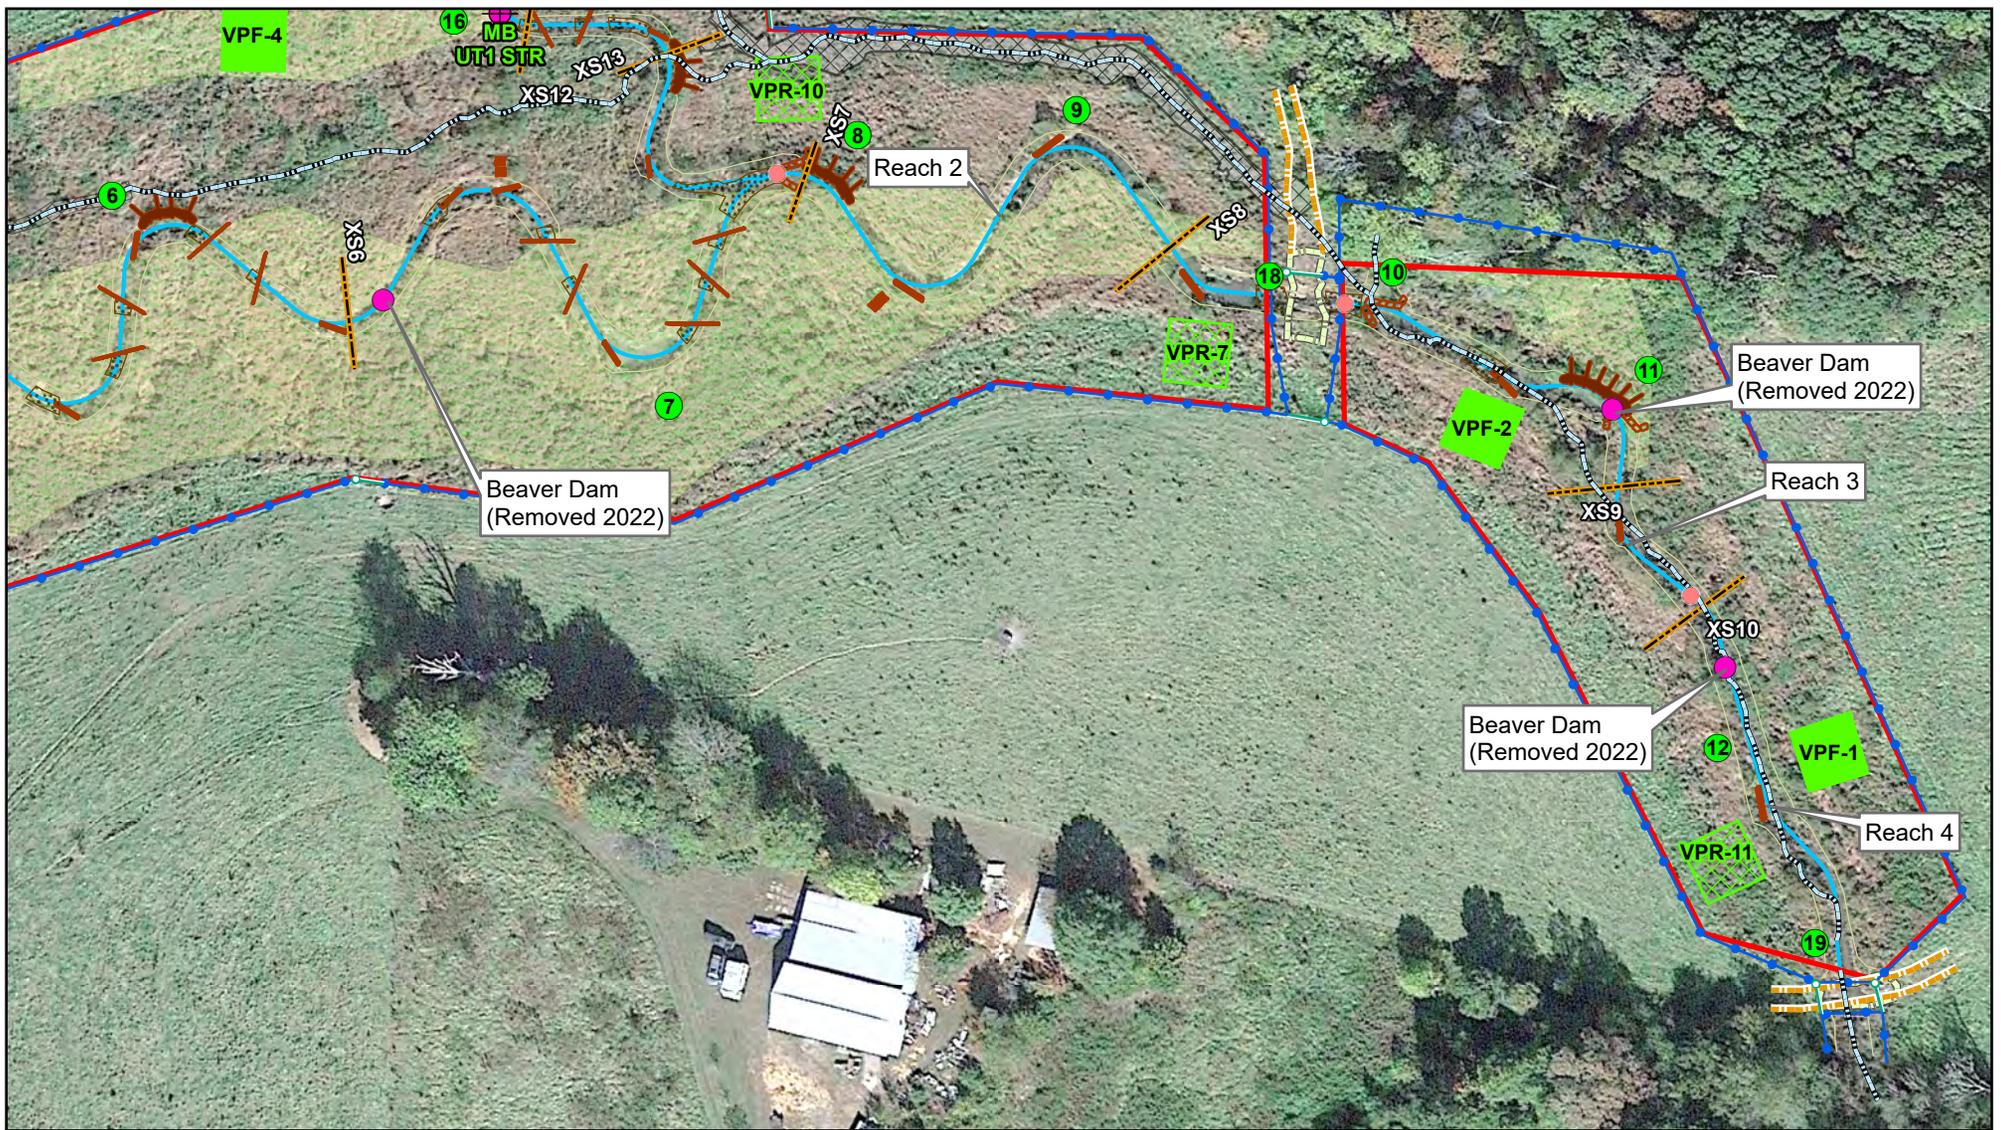
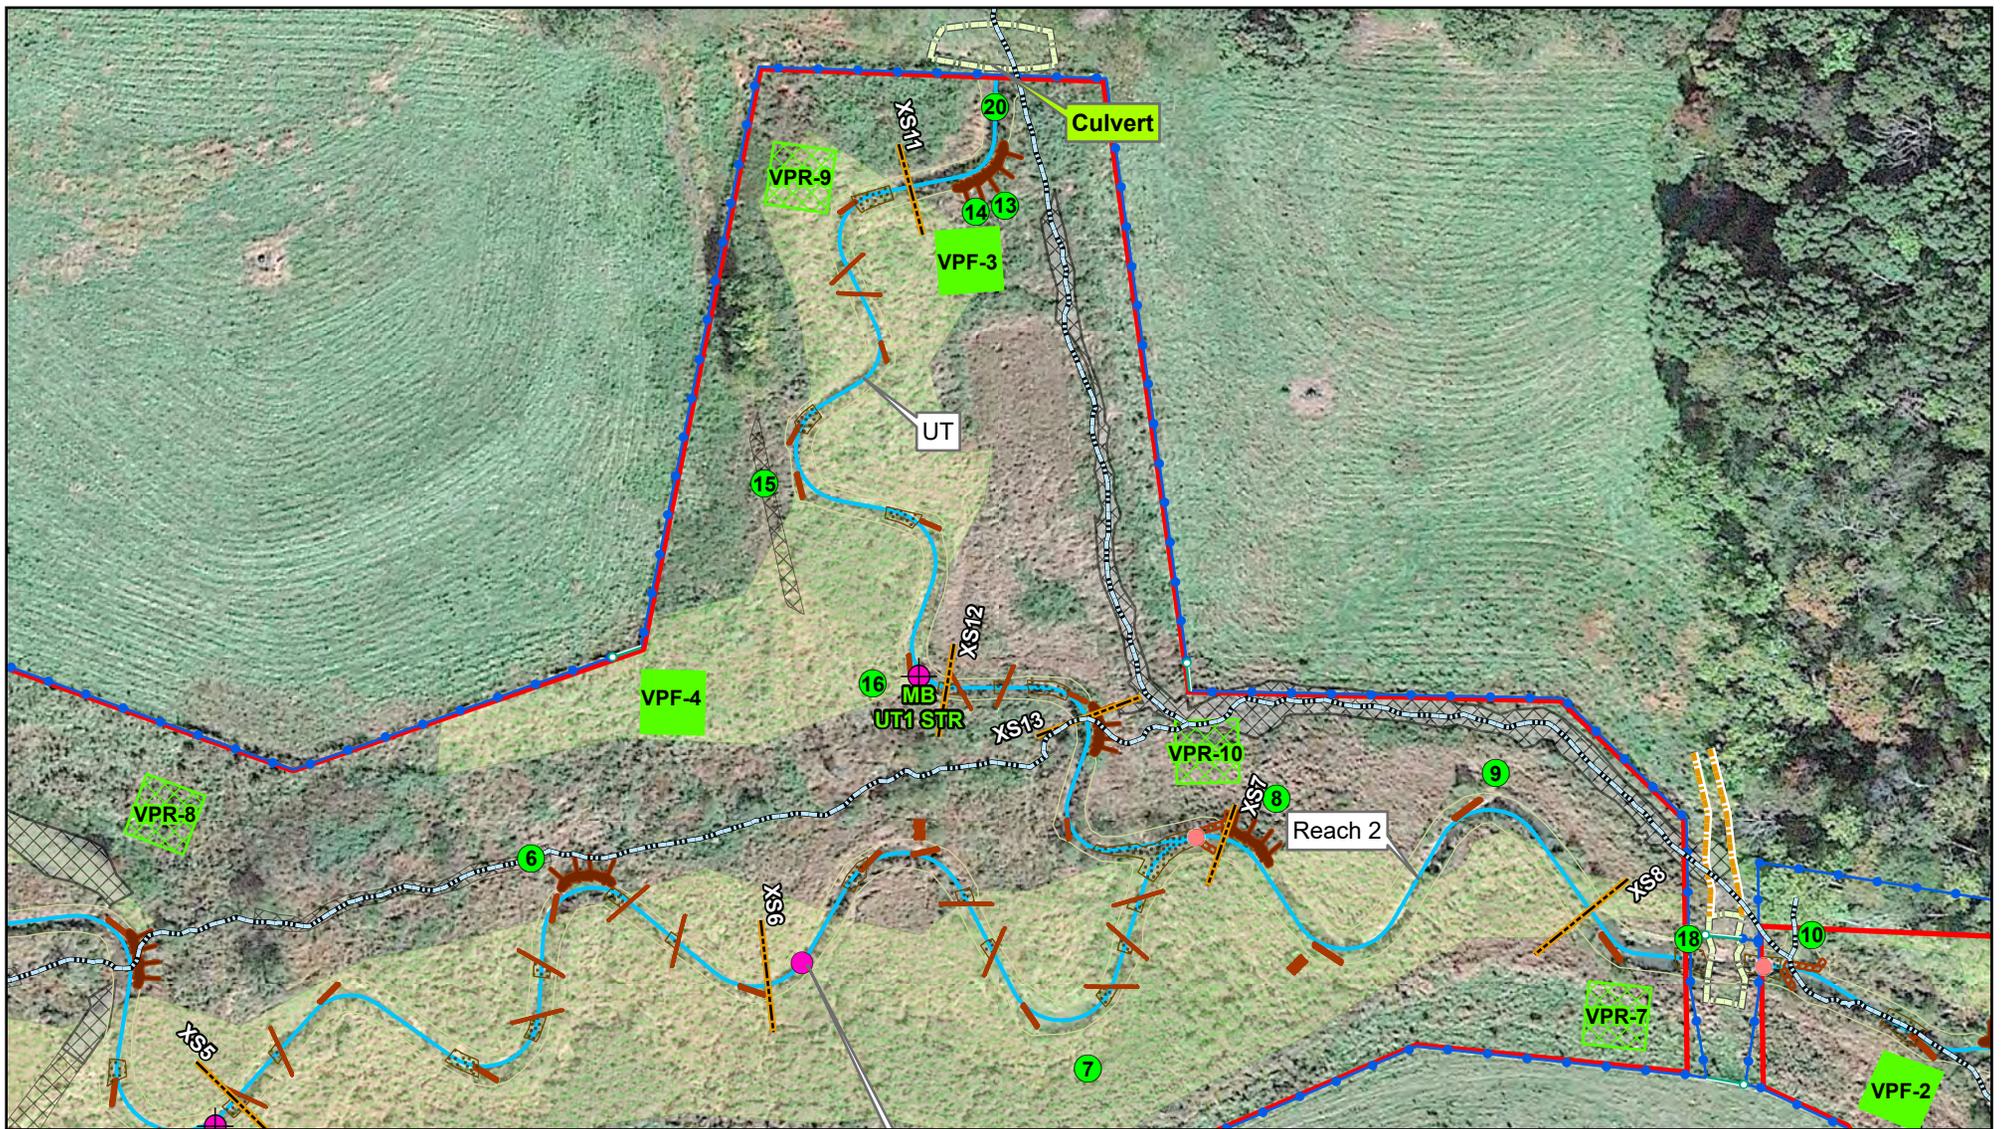
Three beaver dams were found over the course of MY3. These dams backed up water and caused very minor bank scour and channel widening in pools. One dam was found on Reach 1 and two dams were found on Reach 3. These dams were removed and the beavers were trapped and removed from site. Meadowbrook will be continued to be monitored for beaver activity to ensure that no new dams are constructed. Exact locations of dams can be found in the CCPV (Figure 2).

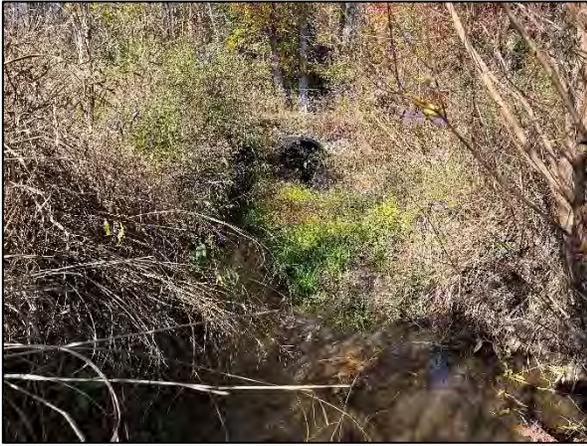
- *Photo point 13 shows the UT culvert crossing in the background; is there a clearer photo of the culvert available? If not, could EPR provide this in the next monitoring report?*

Photo Point 13 – UT, Sta. 10+90  
Facing Upstream (11/4/2022)

- **Photo point 20 was added to show the culvert at the upstream end of the UT more clearly. This photo will be replicated in future monitoring years.**

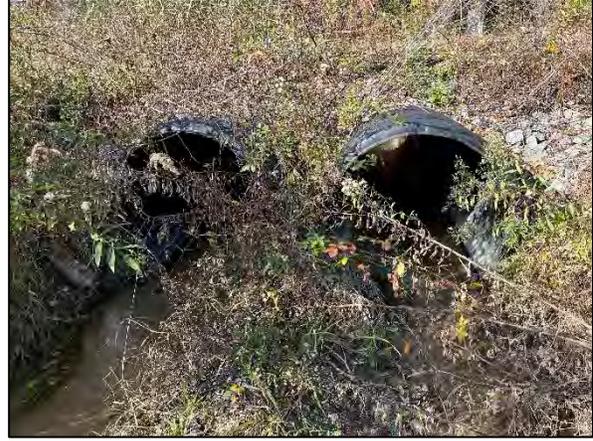
Photo Point 20 – UT, Sta 10+20  
Facing Upstream (11/4/2022)
