Monitoring Year 4 Report
Final
Meadow Brook Stream Restoration Project
Yadkin County, North Carolina
Yadkin River Basin, Hydrologic Unit Code (HUC) 03040101

Monitoring Year 4 Report – Final

DMS Project ID #100024

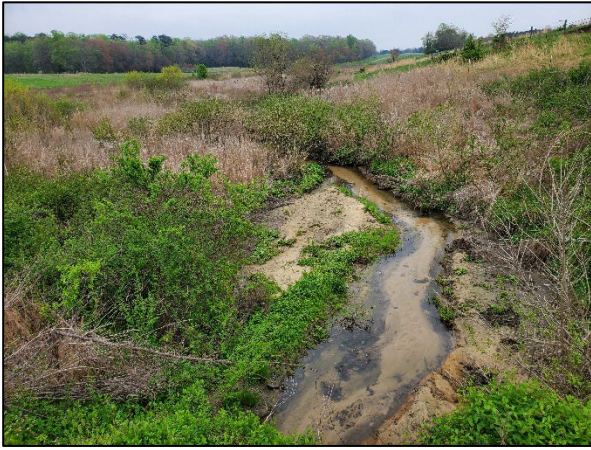
Photo Point 1 – Reach 1, Sta. 0+00
Facing Downstream (04/05/2023)

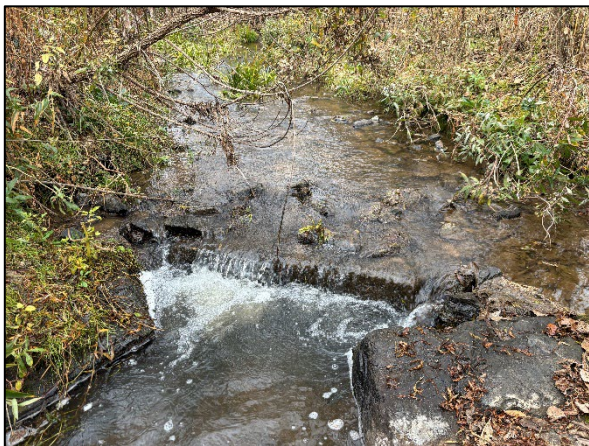
Representative Photo, Reach 1
Offset rock vane, facing Upstream (10/31/2023)

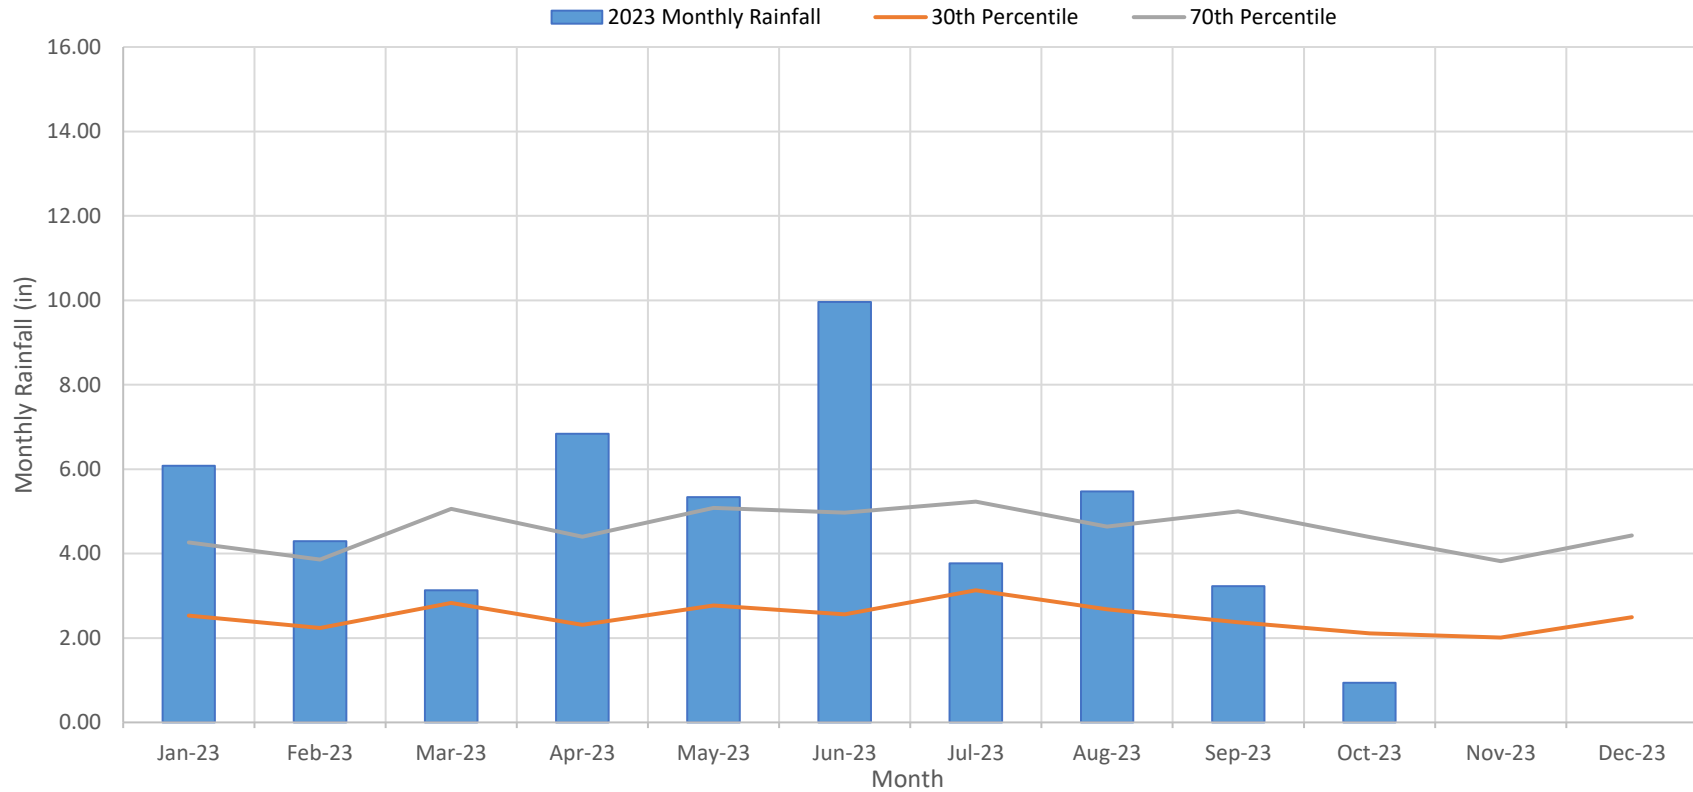
Figure 3. Monthly Rainfall Data

*Rain Gauge was not operational 3/1/2023-4/13/2023 due to a low battery. Rainfall data was supplemented these dates from AcAGIS station YADKINVILLE 0.2 E, NC
