Meredell Farm Draft Monitoring Report Year 2 of 5 (2009)

Randolph County, North Carolina

Project ID No. 247

Submitted November 2009

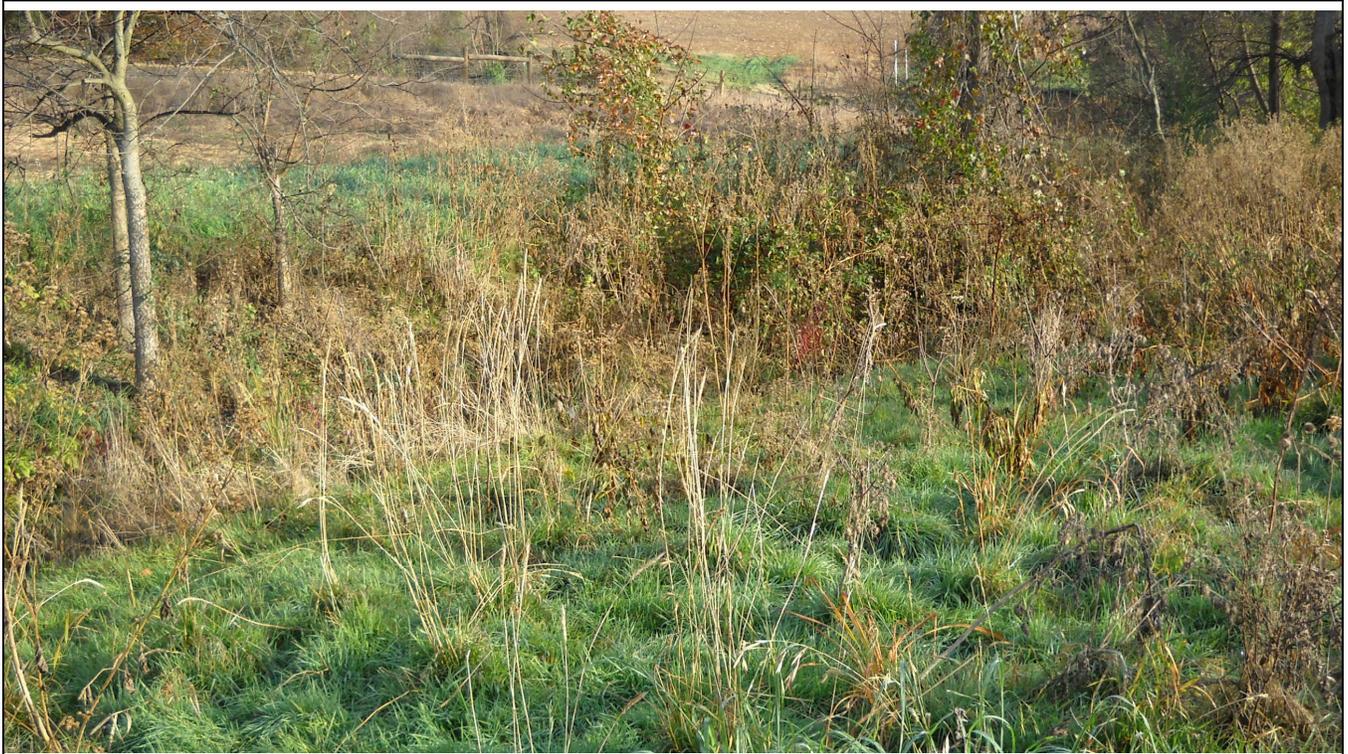
VP1: UT4 Weak Growth
Taken: 11-09-2009

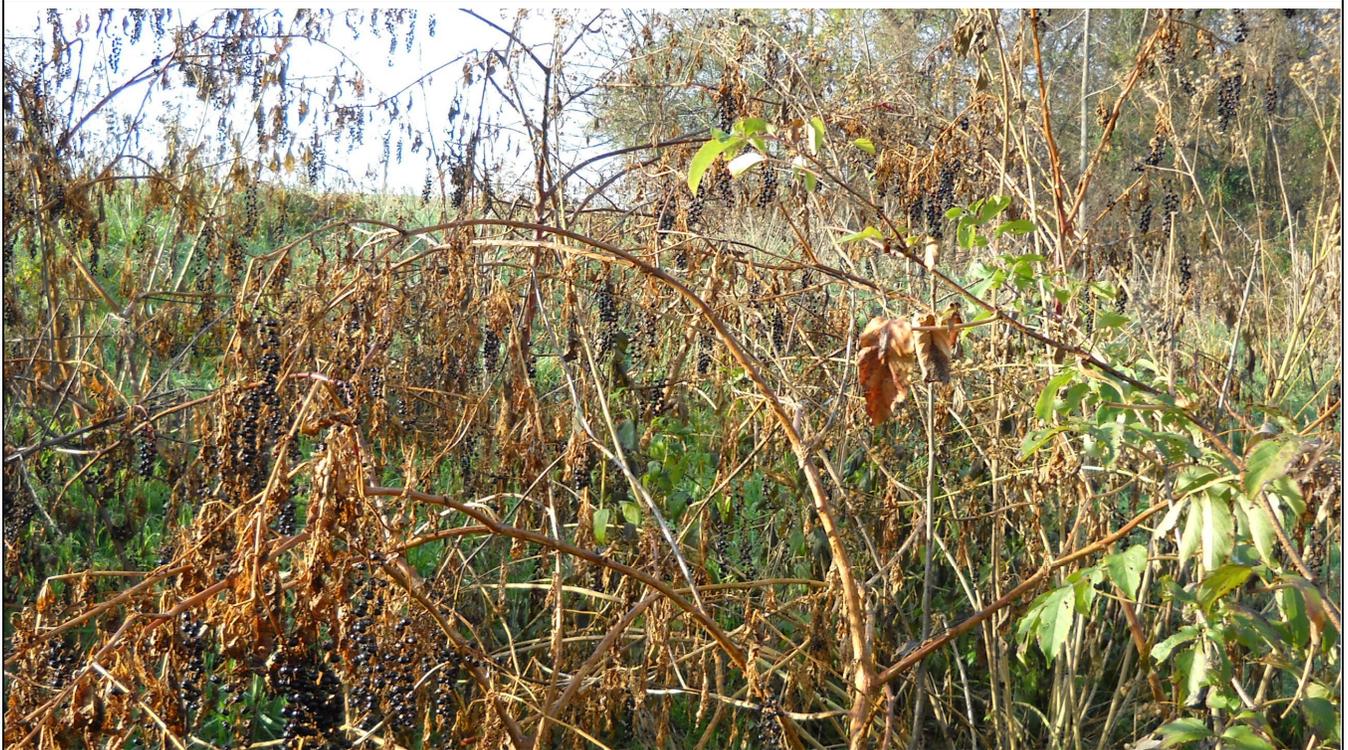
VP2: UT4 Invasives - Pokeweed
Taken: 11-09-2009

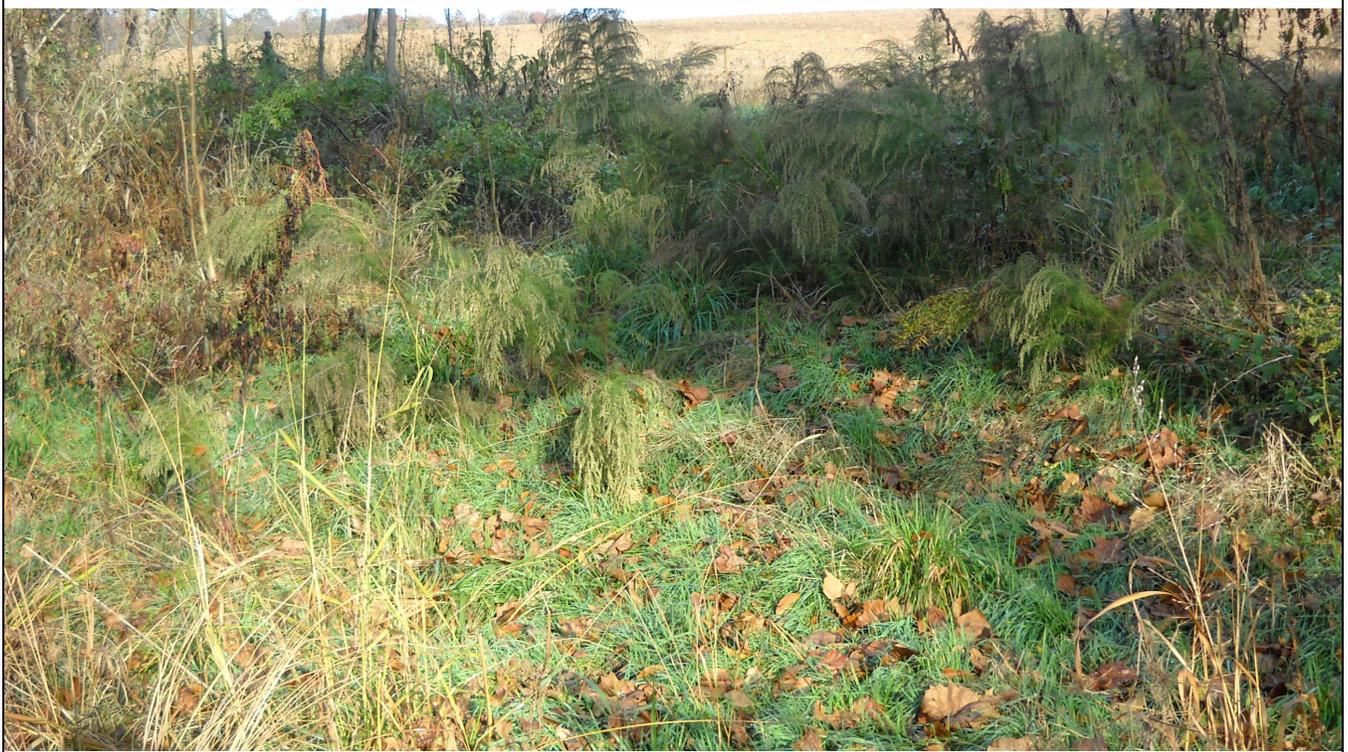
VP3: UT3 Weak Growth
Taken: 11-09-2009

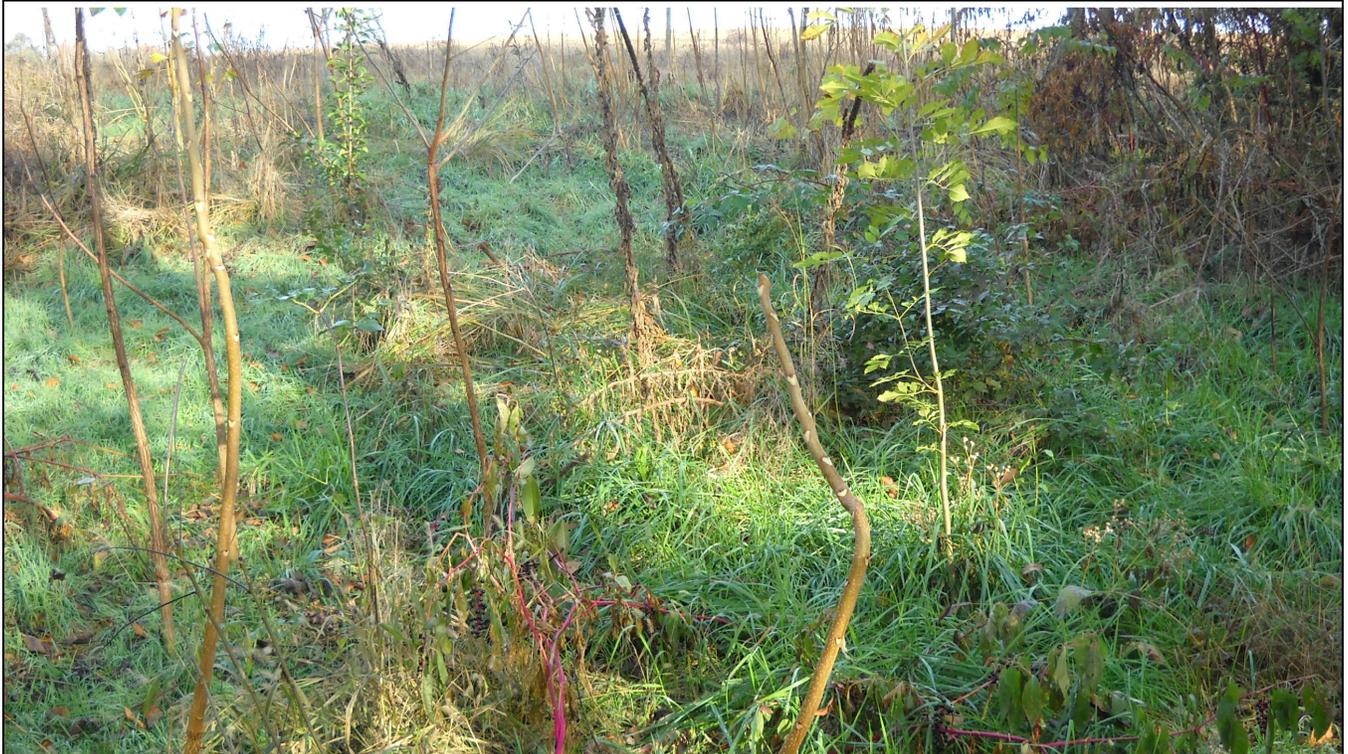
VP4: UT3 Weak Growth
Taken: 11-09-2009

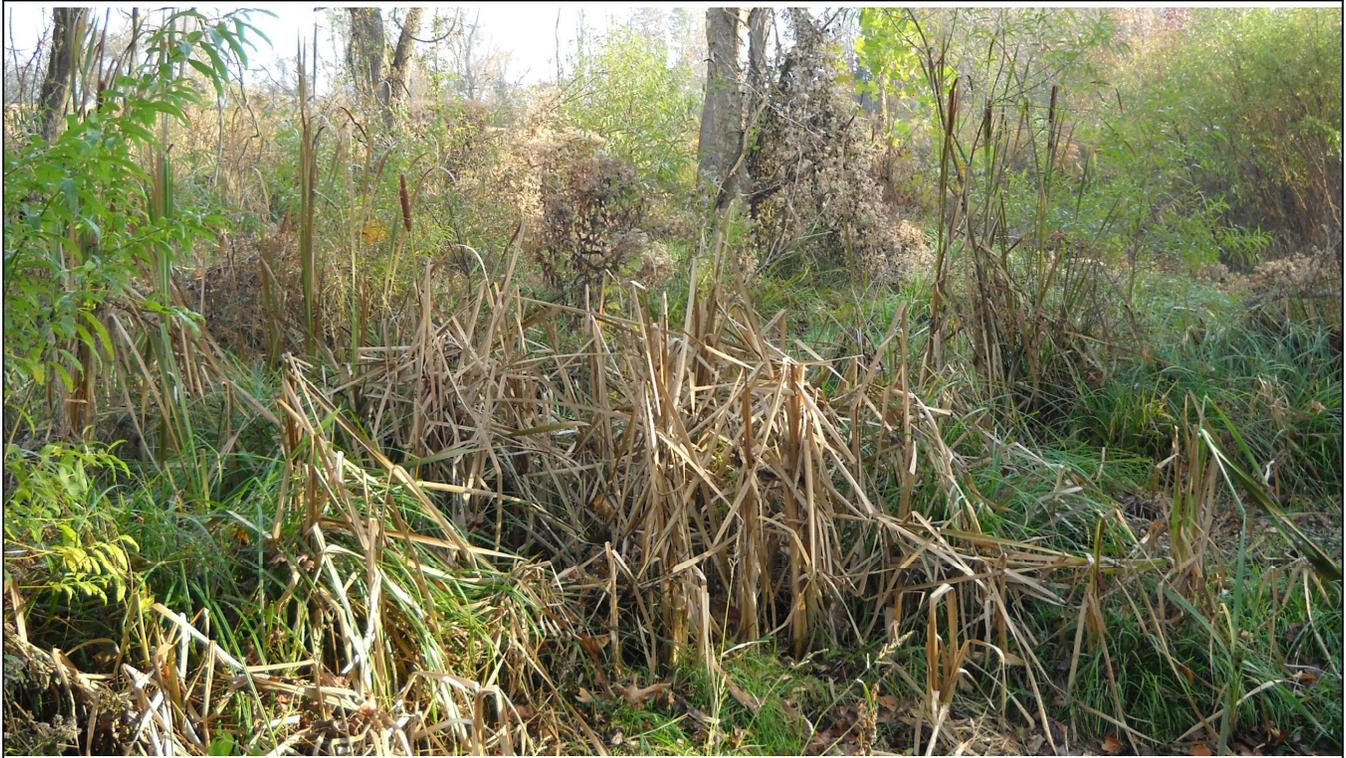
VP5: UT3 Invasives: Cattails
Taken: 11-09-2009

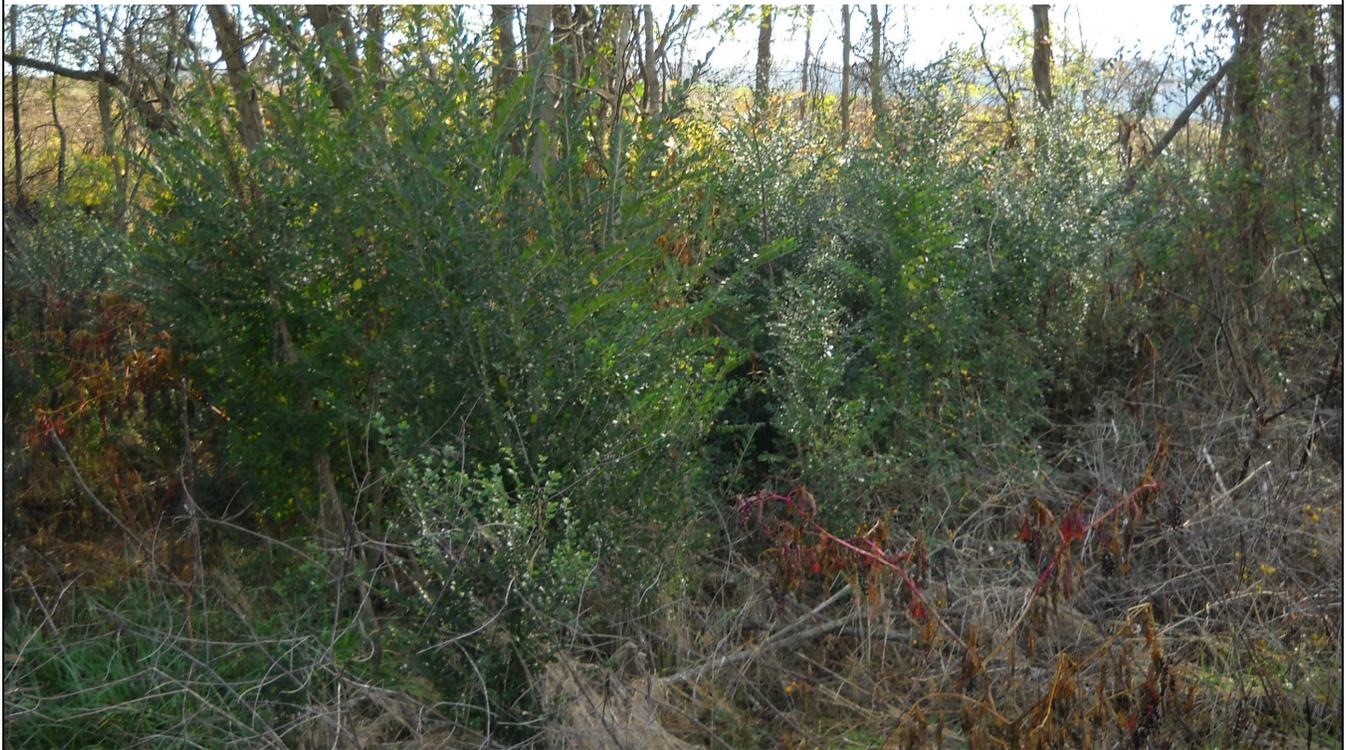
VP6: UT5 Invasives: Privet
Taken: 11-09-2009

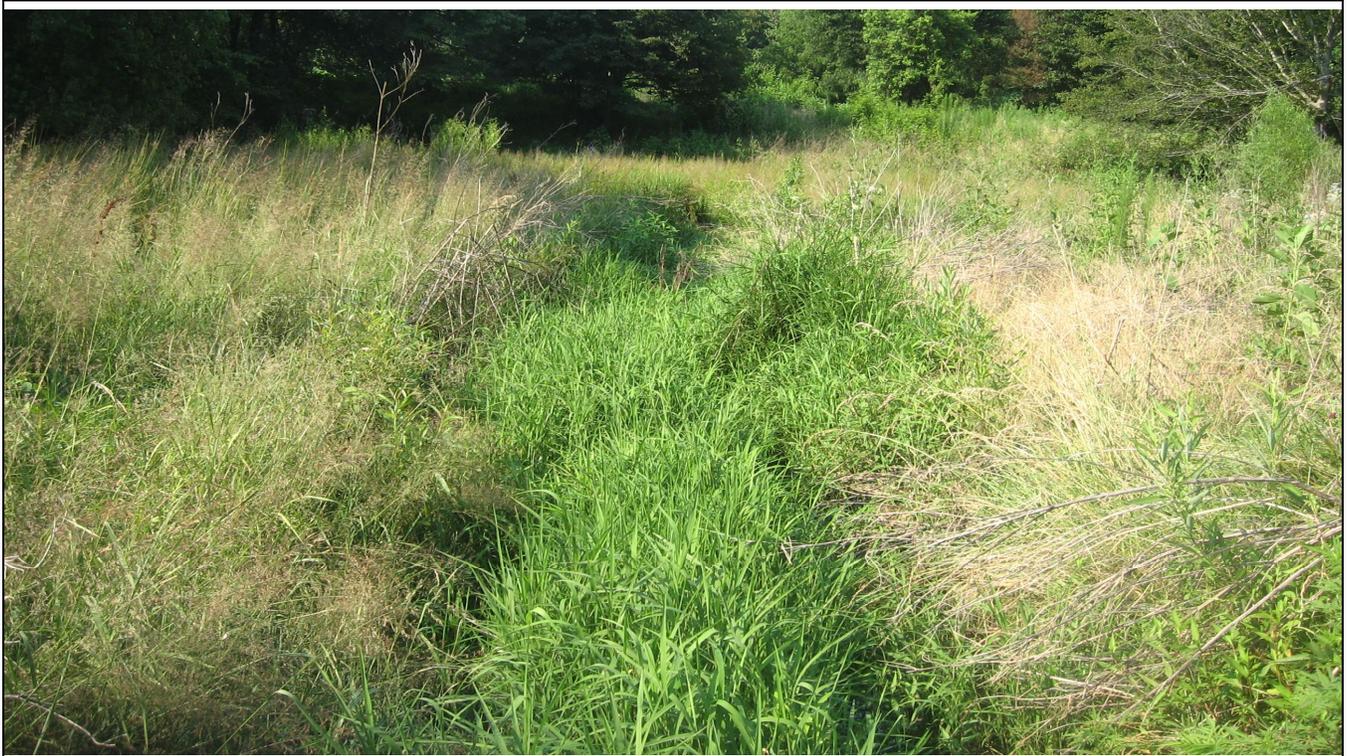
Table B1. Stream Problem Areas Meredell Farm Stream Restoration Site (EEP Project #247)					
Feature Issue	Reach	Stations	Description	Suspected Cause	Photo number
2009					
Aggradation/Bar Formation	M1	30,800-30,870	Split Channel Flow	Vegetation growing in Channel	
Aggradation/Bar Formation	M1	31,165-31,230	Split Channel Flow	Vegetation growing in Channel	
Bank scour	N/A

M1 – Vegetation Growing in Channel
Taken: 06-25-2009

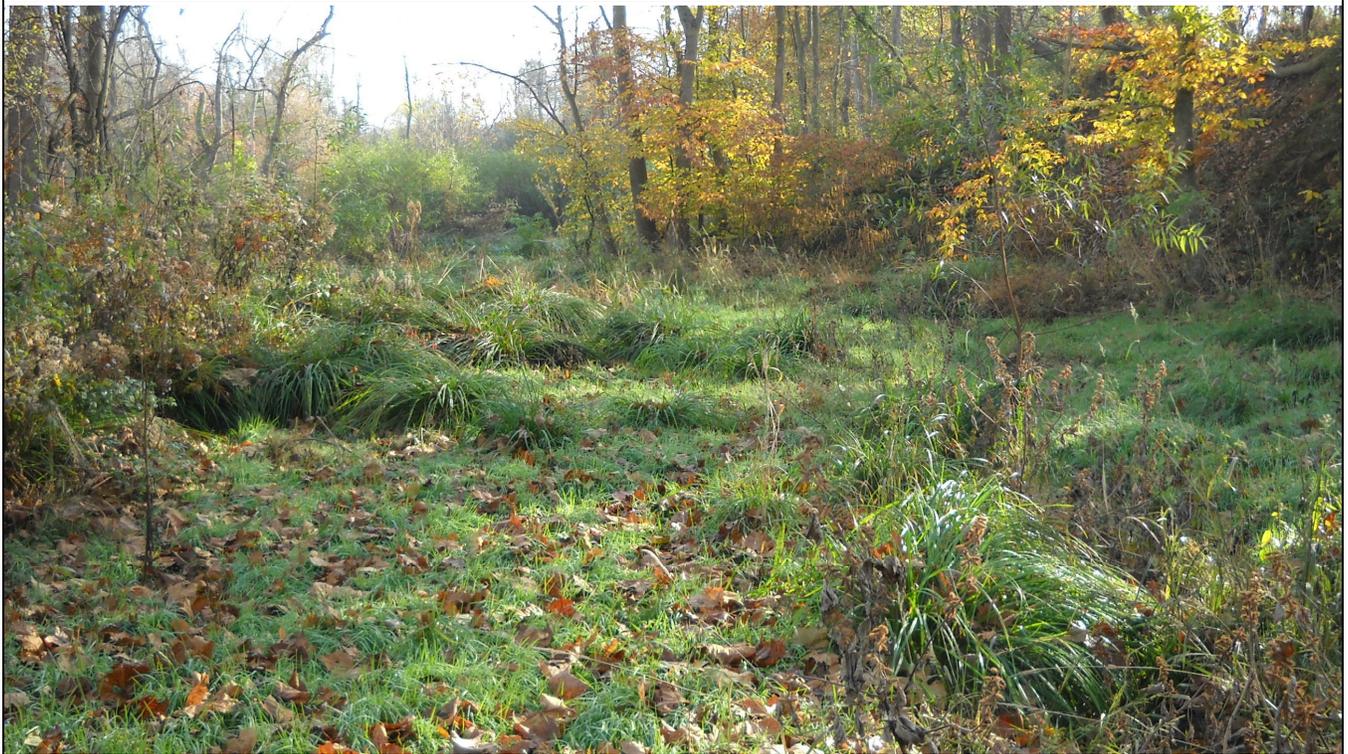
UT3 – Saturated Floodplain
Taken: 06-25-2009
