Meredell Farm Monitoring Report Year 3 of 5 (2010)

Randolph County, North Carolina

Project ID No. 247

Submitted November 2010

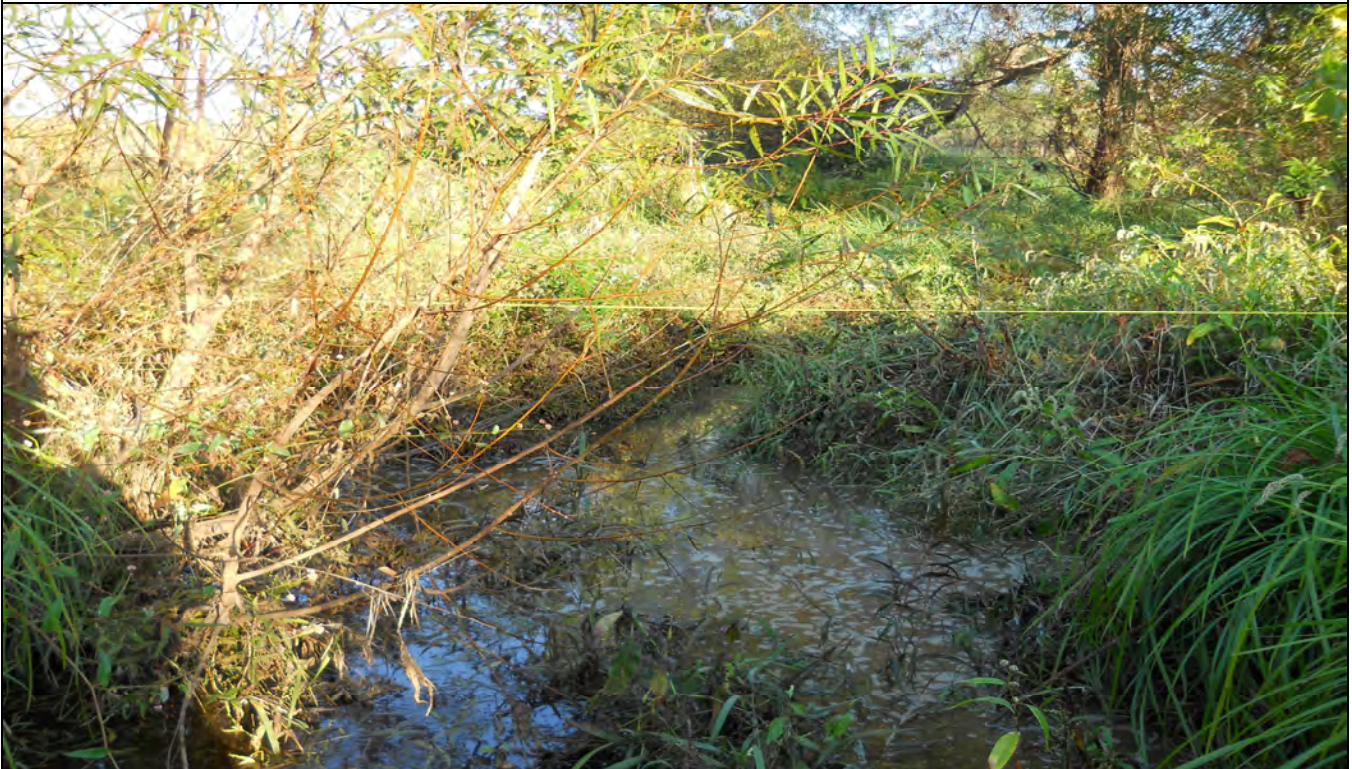
SP2: Vegetation growing in Channel
Taken: 8-4-2010

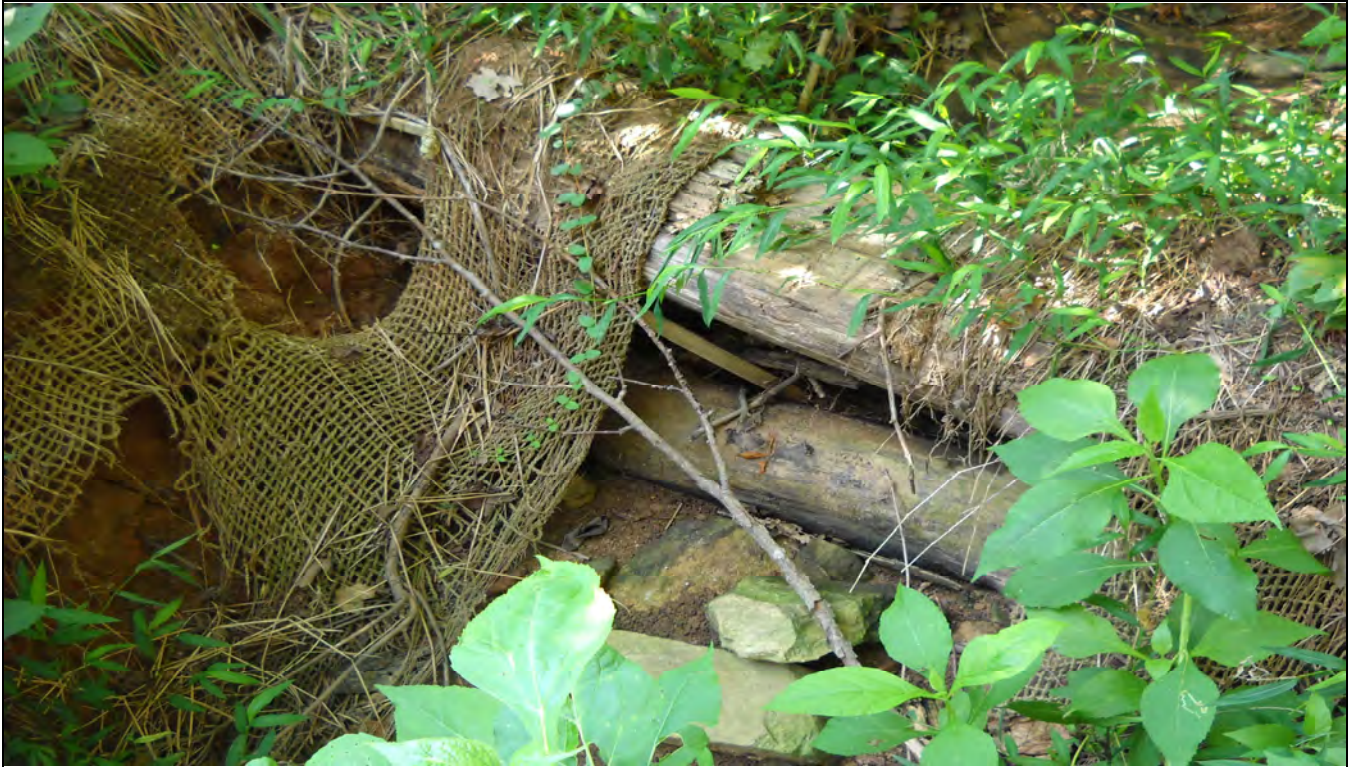
SP3: Compromised log sill structure on UT5
Taken: 8-4-2010

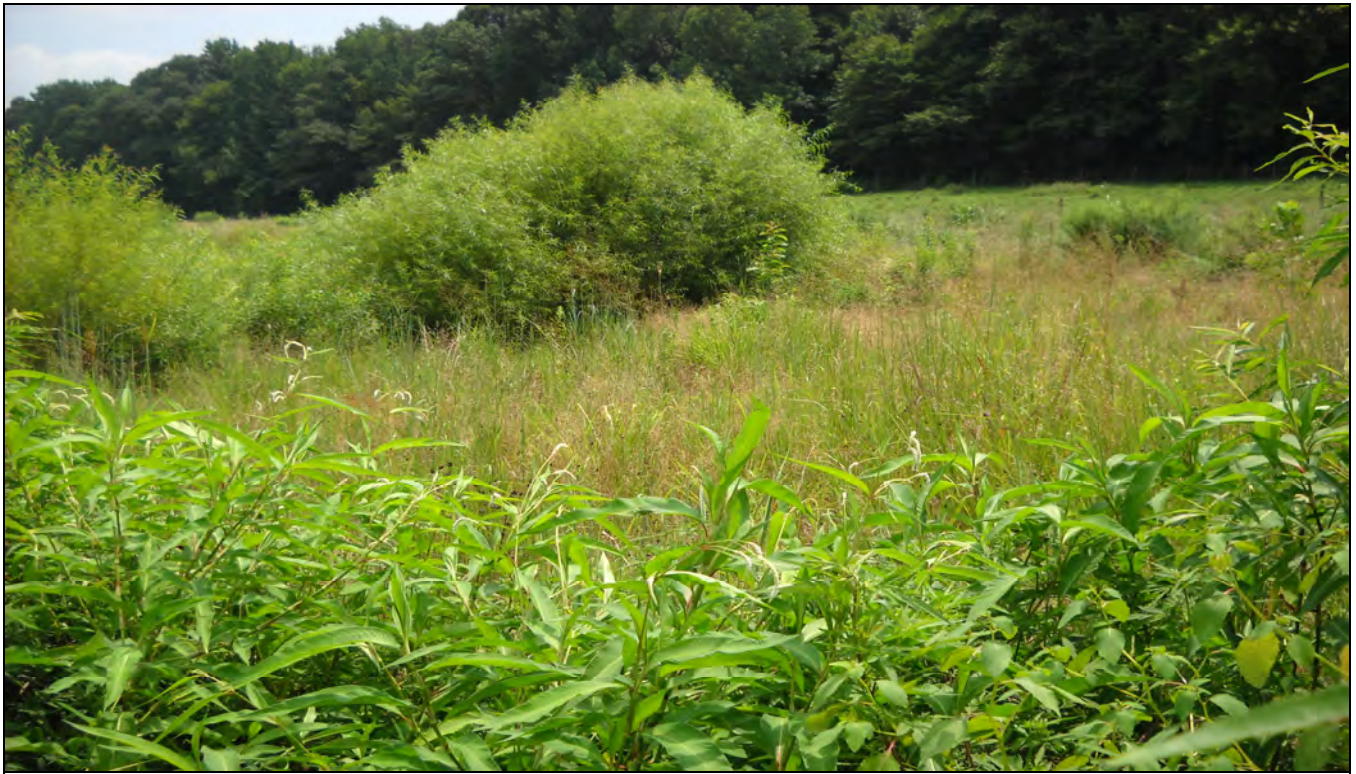
VP1: M1 Weak Growth
Taken: 8-4-2010

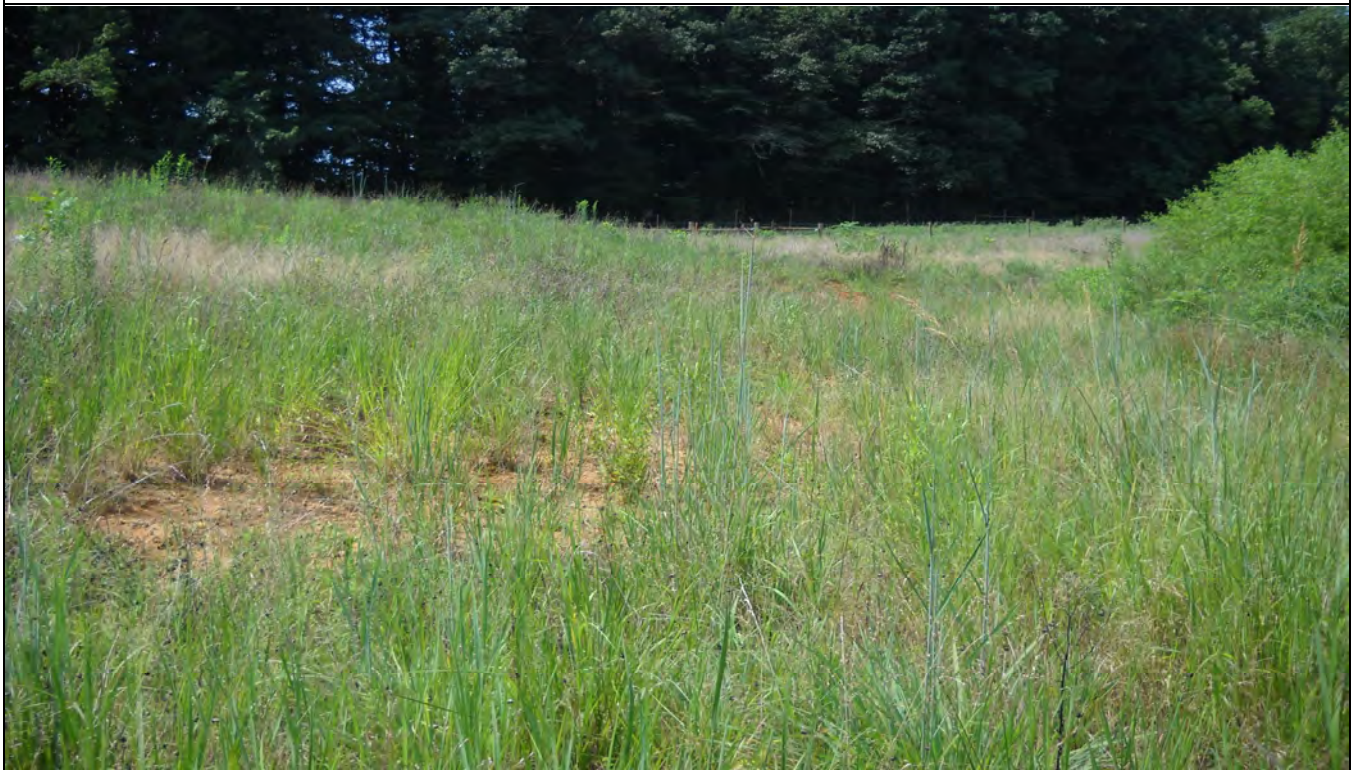
VP2: M1 Weak Growth (Bare Bench)
Taken: 8-4-2010

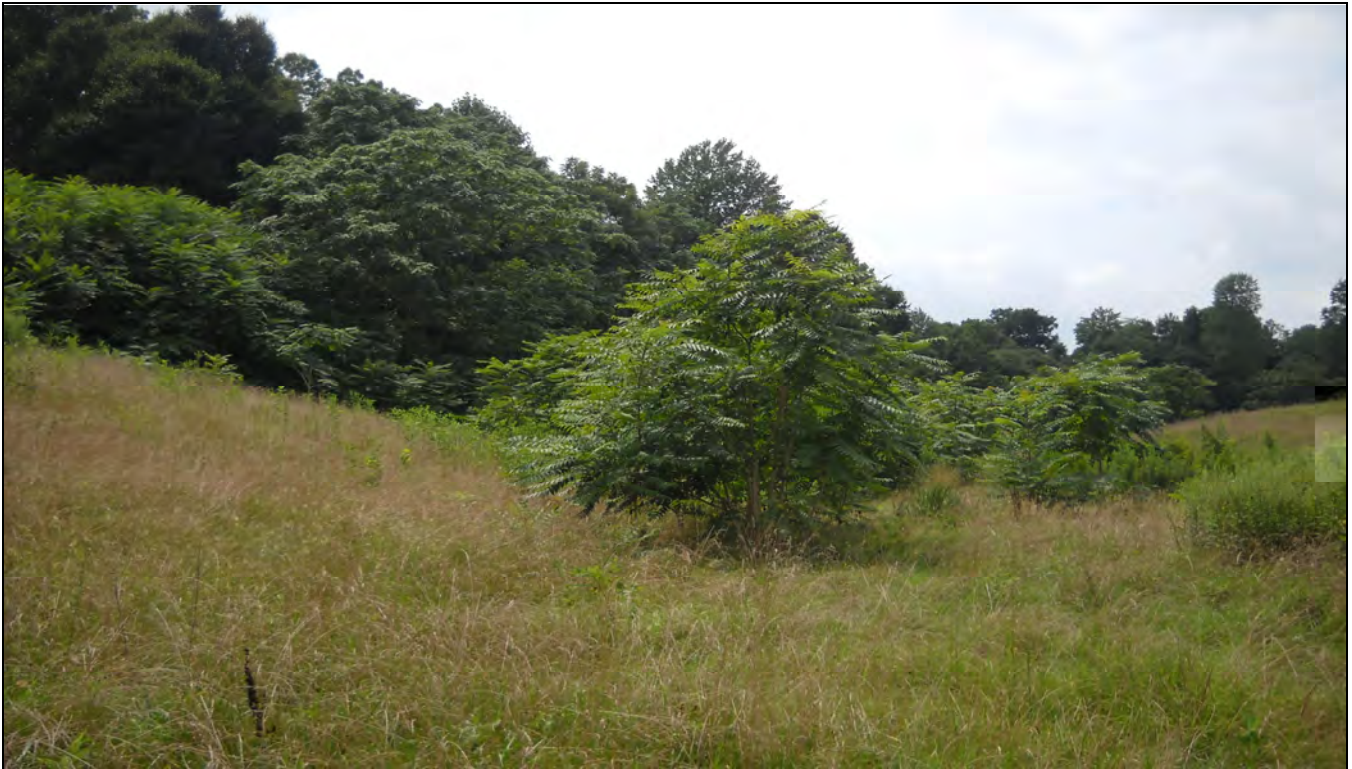
VP3: UT1 Invasives (Tree of Heaven)
Taken: 8-4-2010

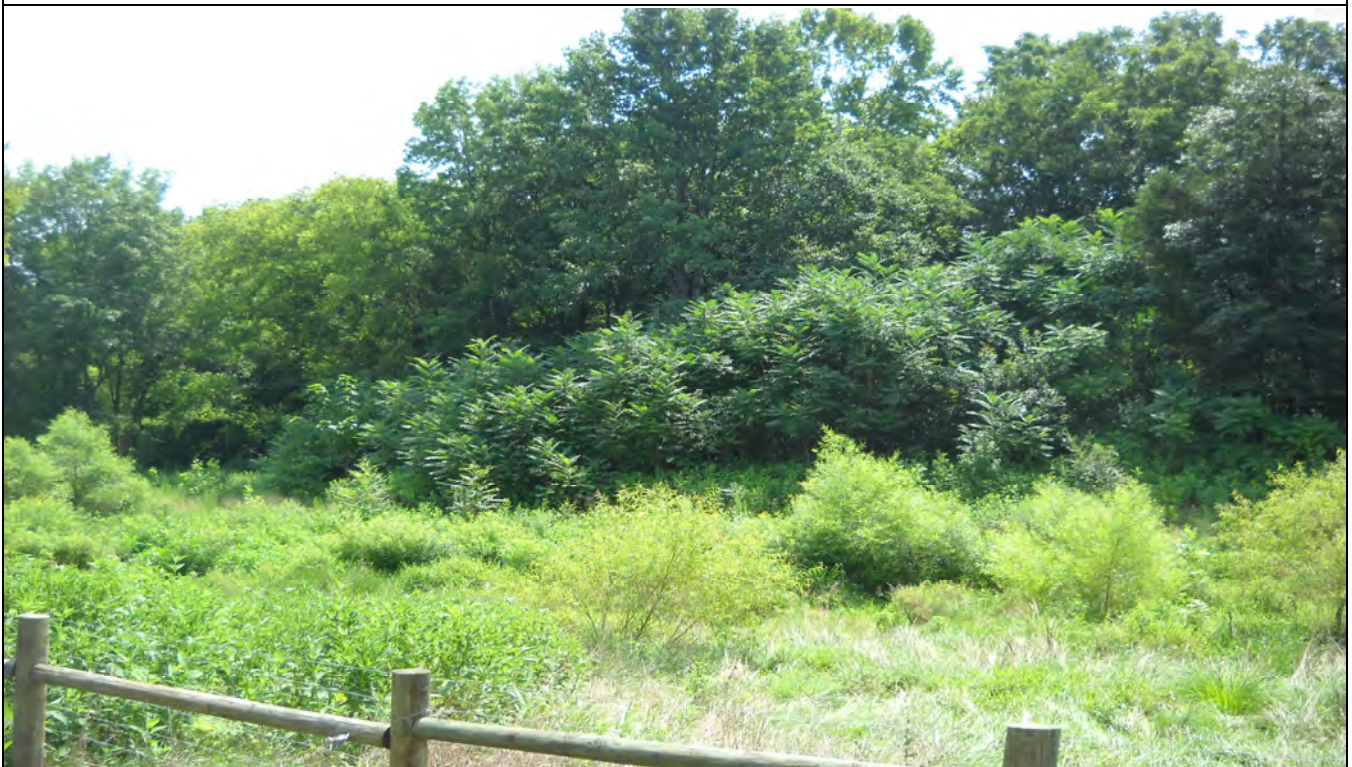
VP4: M1 Invasives (Tree of Heaven)
Taken: 8-4-2010

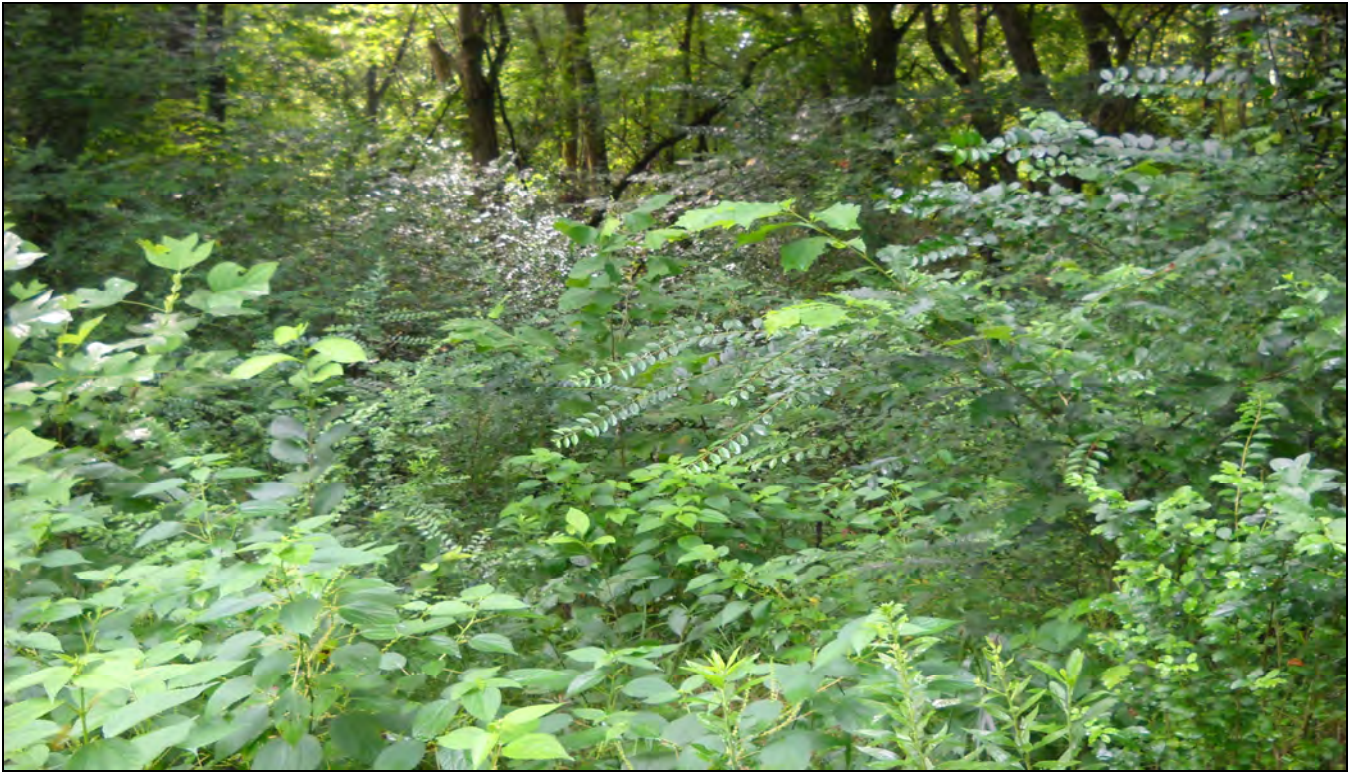
VP5: M1 Invasives (Privet)
Taken: 8-4-2010
