Meredell Farm
Monitoring Report
FINAL
Year 4 of 5 (2011)

Randolph County, North Carolina

Project ID No. 247

Executive Summary

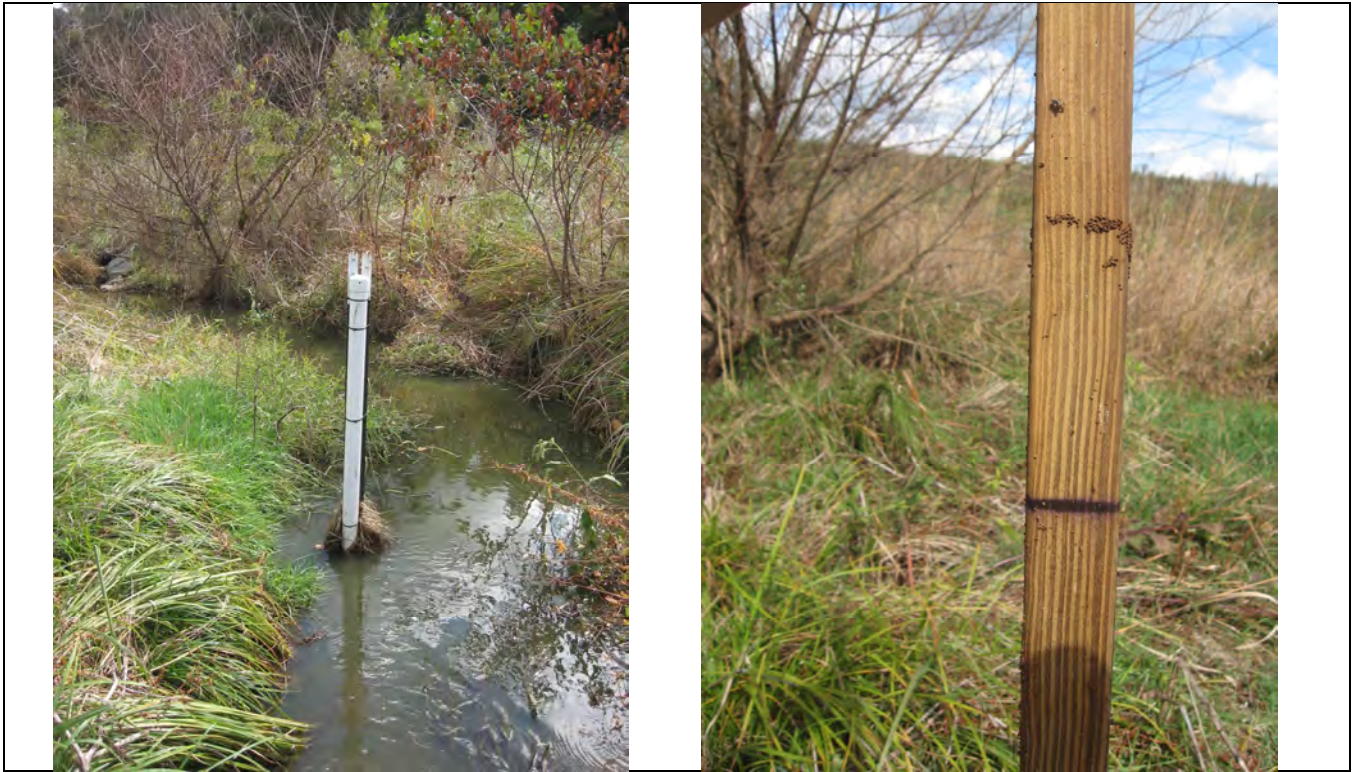
SP1: Crest Gage
Taken: 10-20-2011

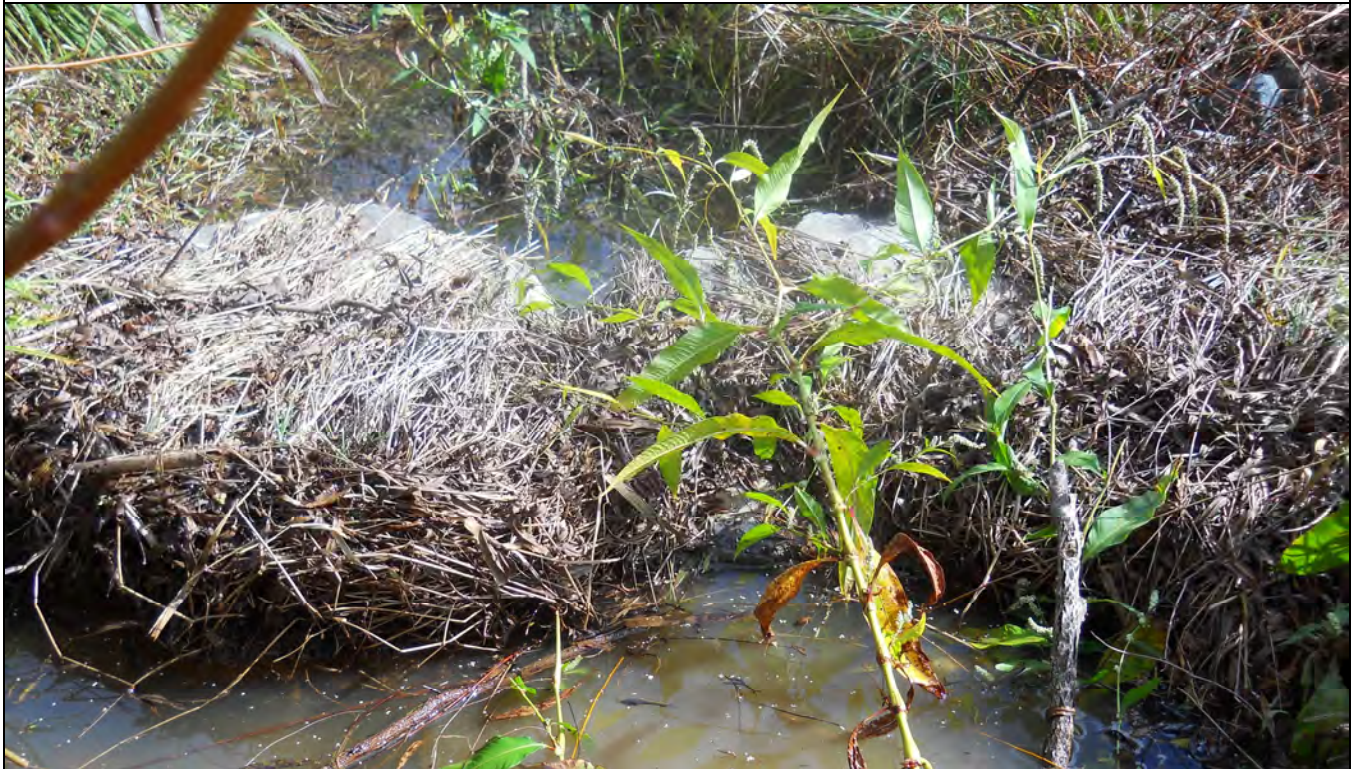
SP2: Bankfull Wracklines on UT1
Taken: 10-20-2011

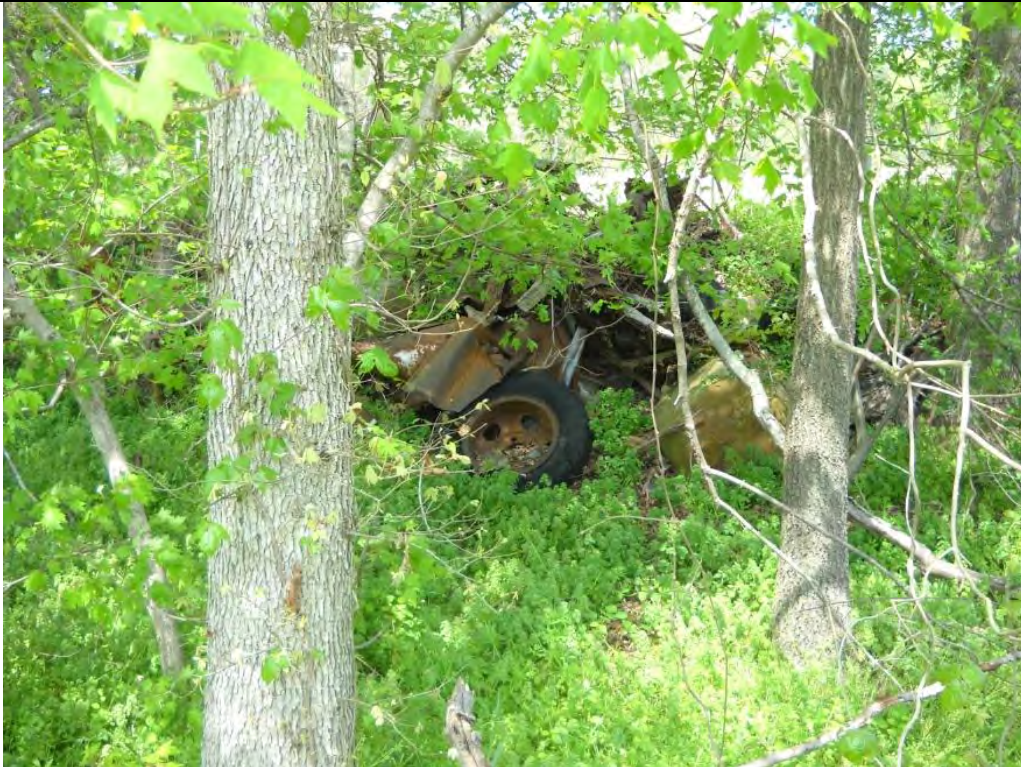
SP3: Trash found on upper UT5 (not recent)
Taken: 4-19-2011

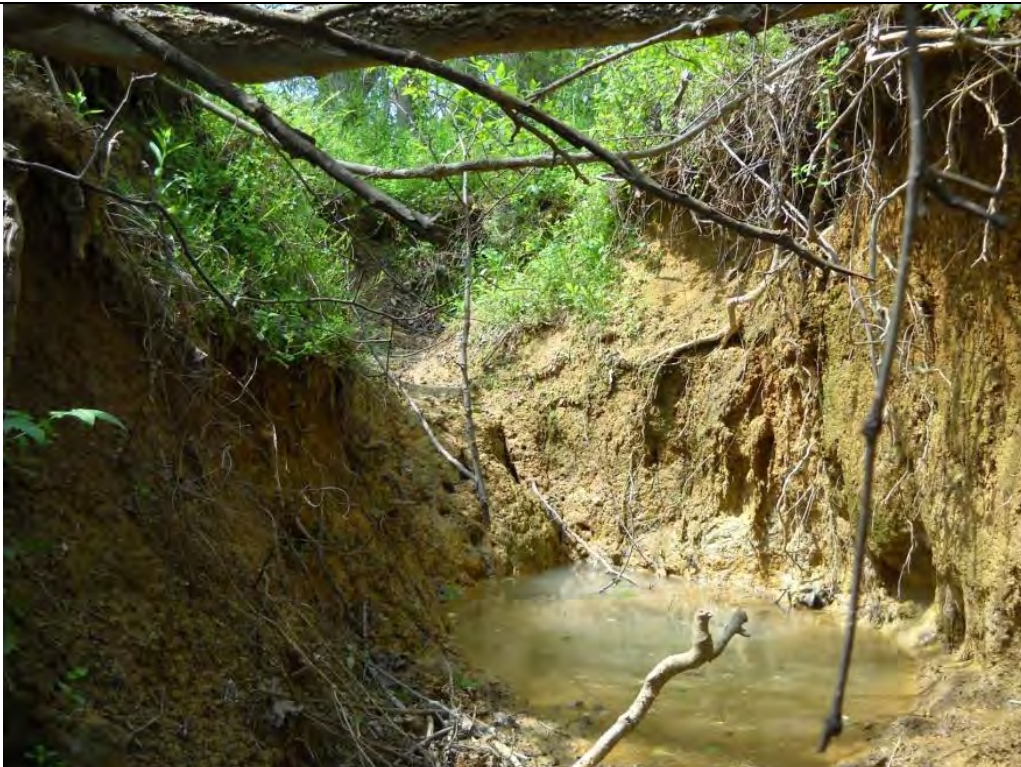
SP4: 2 foot headcut on upper UT5 (stable)
Taken: 4-19-2011

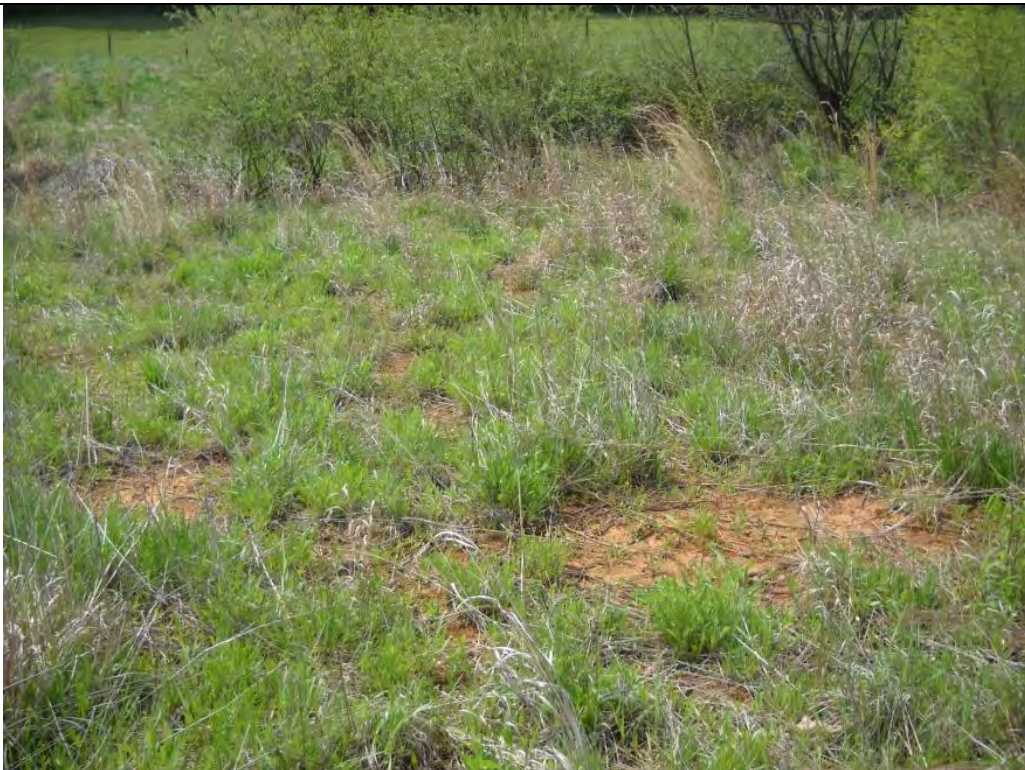
VP1: Weak growth on M1 (STA 14+00)
Taken: 4-19-2011

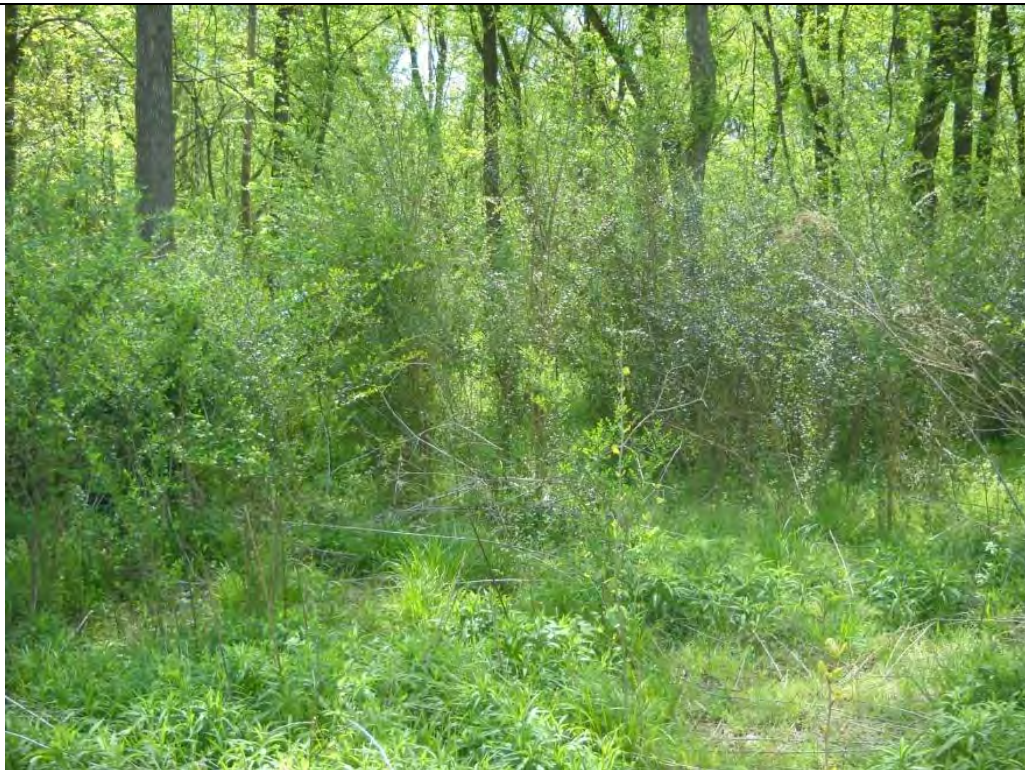
VP2: Invasive Privet on M1 (STA 29+00)
Taken: 4-19-2011

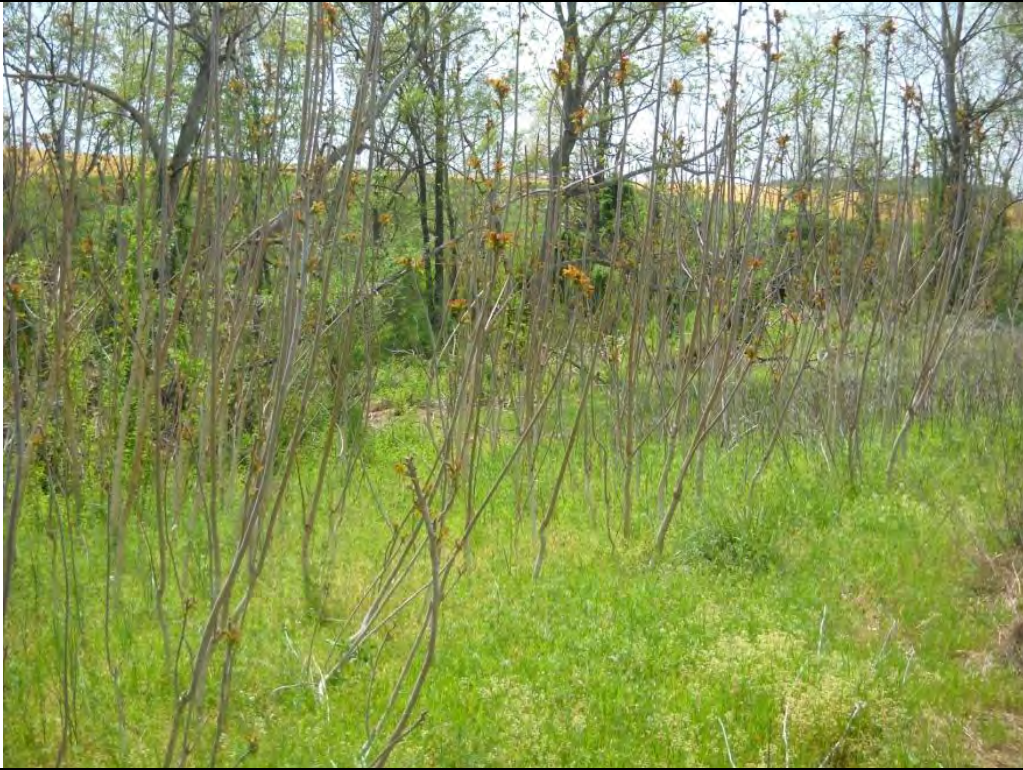
VP3: Invasive Tree of Heaven on UT3a (STA 14+50)
Taken: 4-19-2011

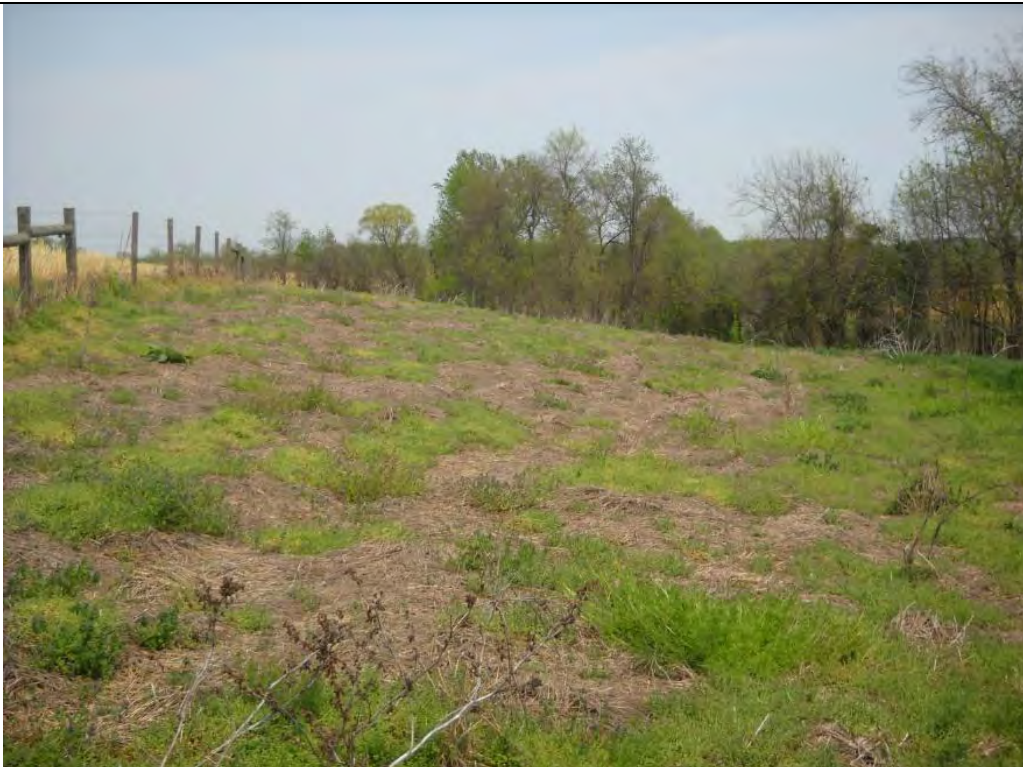
VP4: Weak growth on UT4
Taken: 4-19-2011
