Meredell Farm Monitoring Report

Year 5 of 5 (2012)

Randolph County, North Carolina

Project ID No. 247

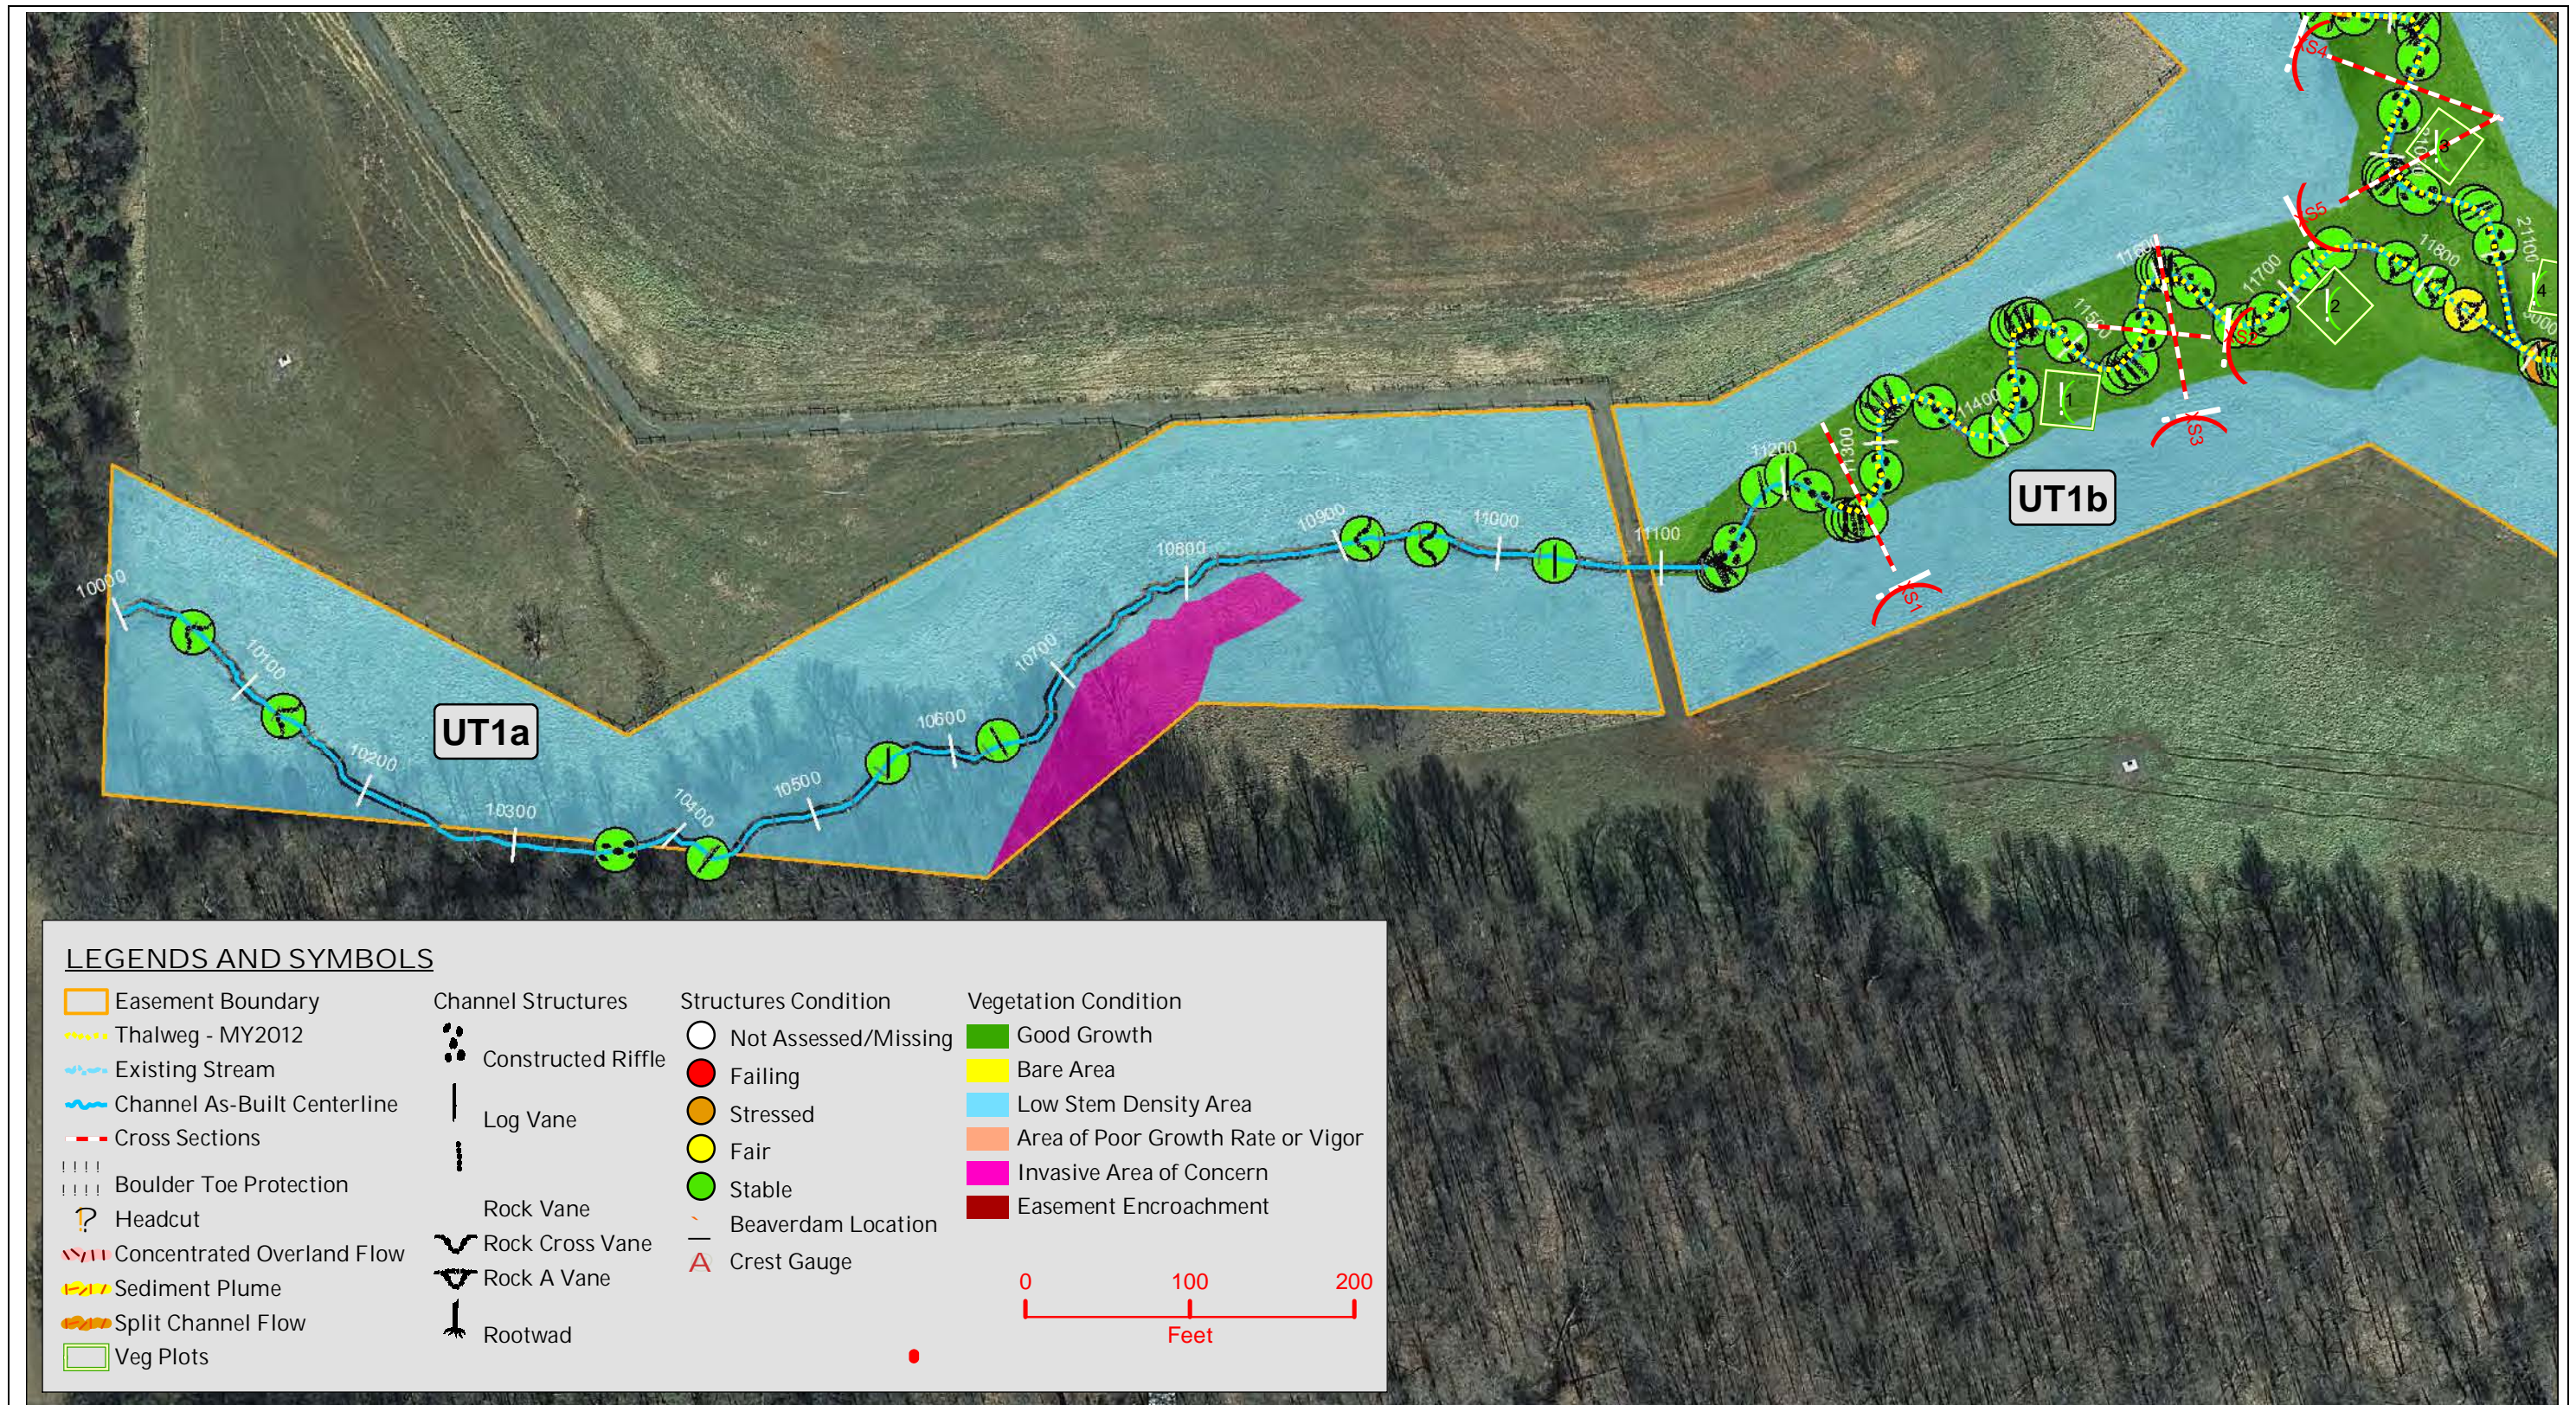
Title	Current Conditions Plan View UT1a and UT1b		
Prepared For:	Project	Meredell Farm Stream Restoration Monitoring Year 5 – 2012 Randolph County, North Carolina	
	Date	Project Number	Figure
	11/15/12	247	2

- The conservation easement area surrounding stream reaches UT1, UT2, M1, and UT5 continue to have large areas that lack significant counts of visible planted woody stems. It was visually observed that the vegetation established within the buffer and outside of the bankfull bench area primarily consists of grasses and herbaceous species. Good vegetation growth was primary observed within the bankfull bench area for each of these reaches.
- The lower M1 area (downstream of the stream crossing) continues to have a significant invasive species population consisting of Tree of Heaven, Chinese Privet, and Cattails.

- Three in-stream structures (UT1 and M1) had flow going between the header rocks, but no further instability was observed as a result of the conditions.

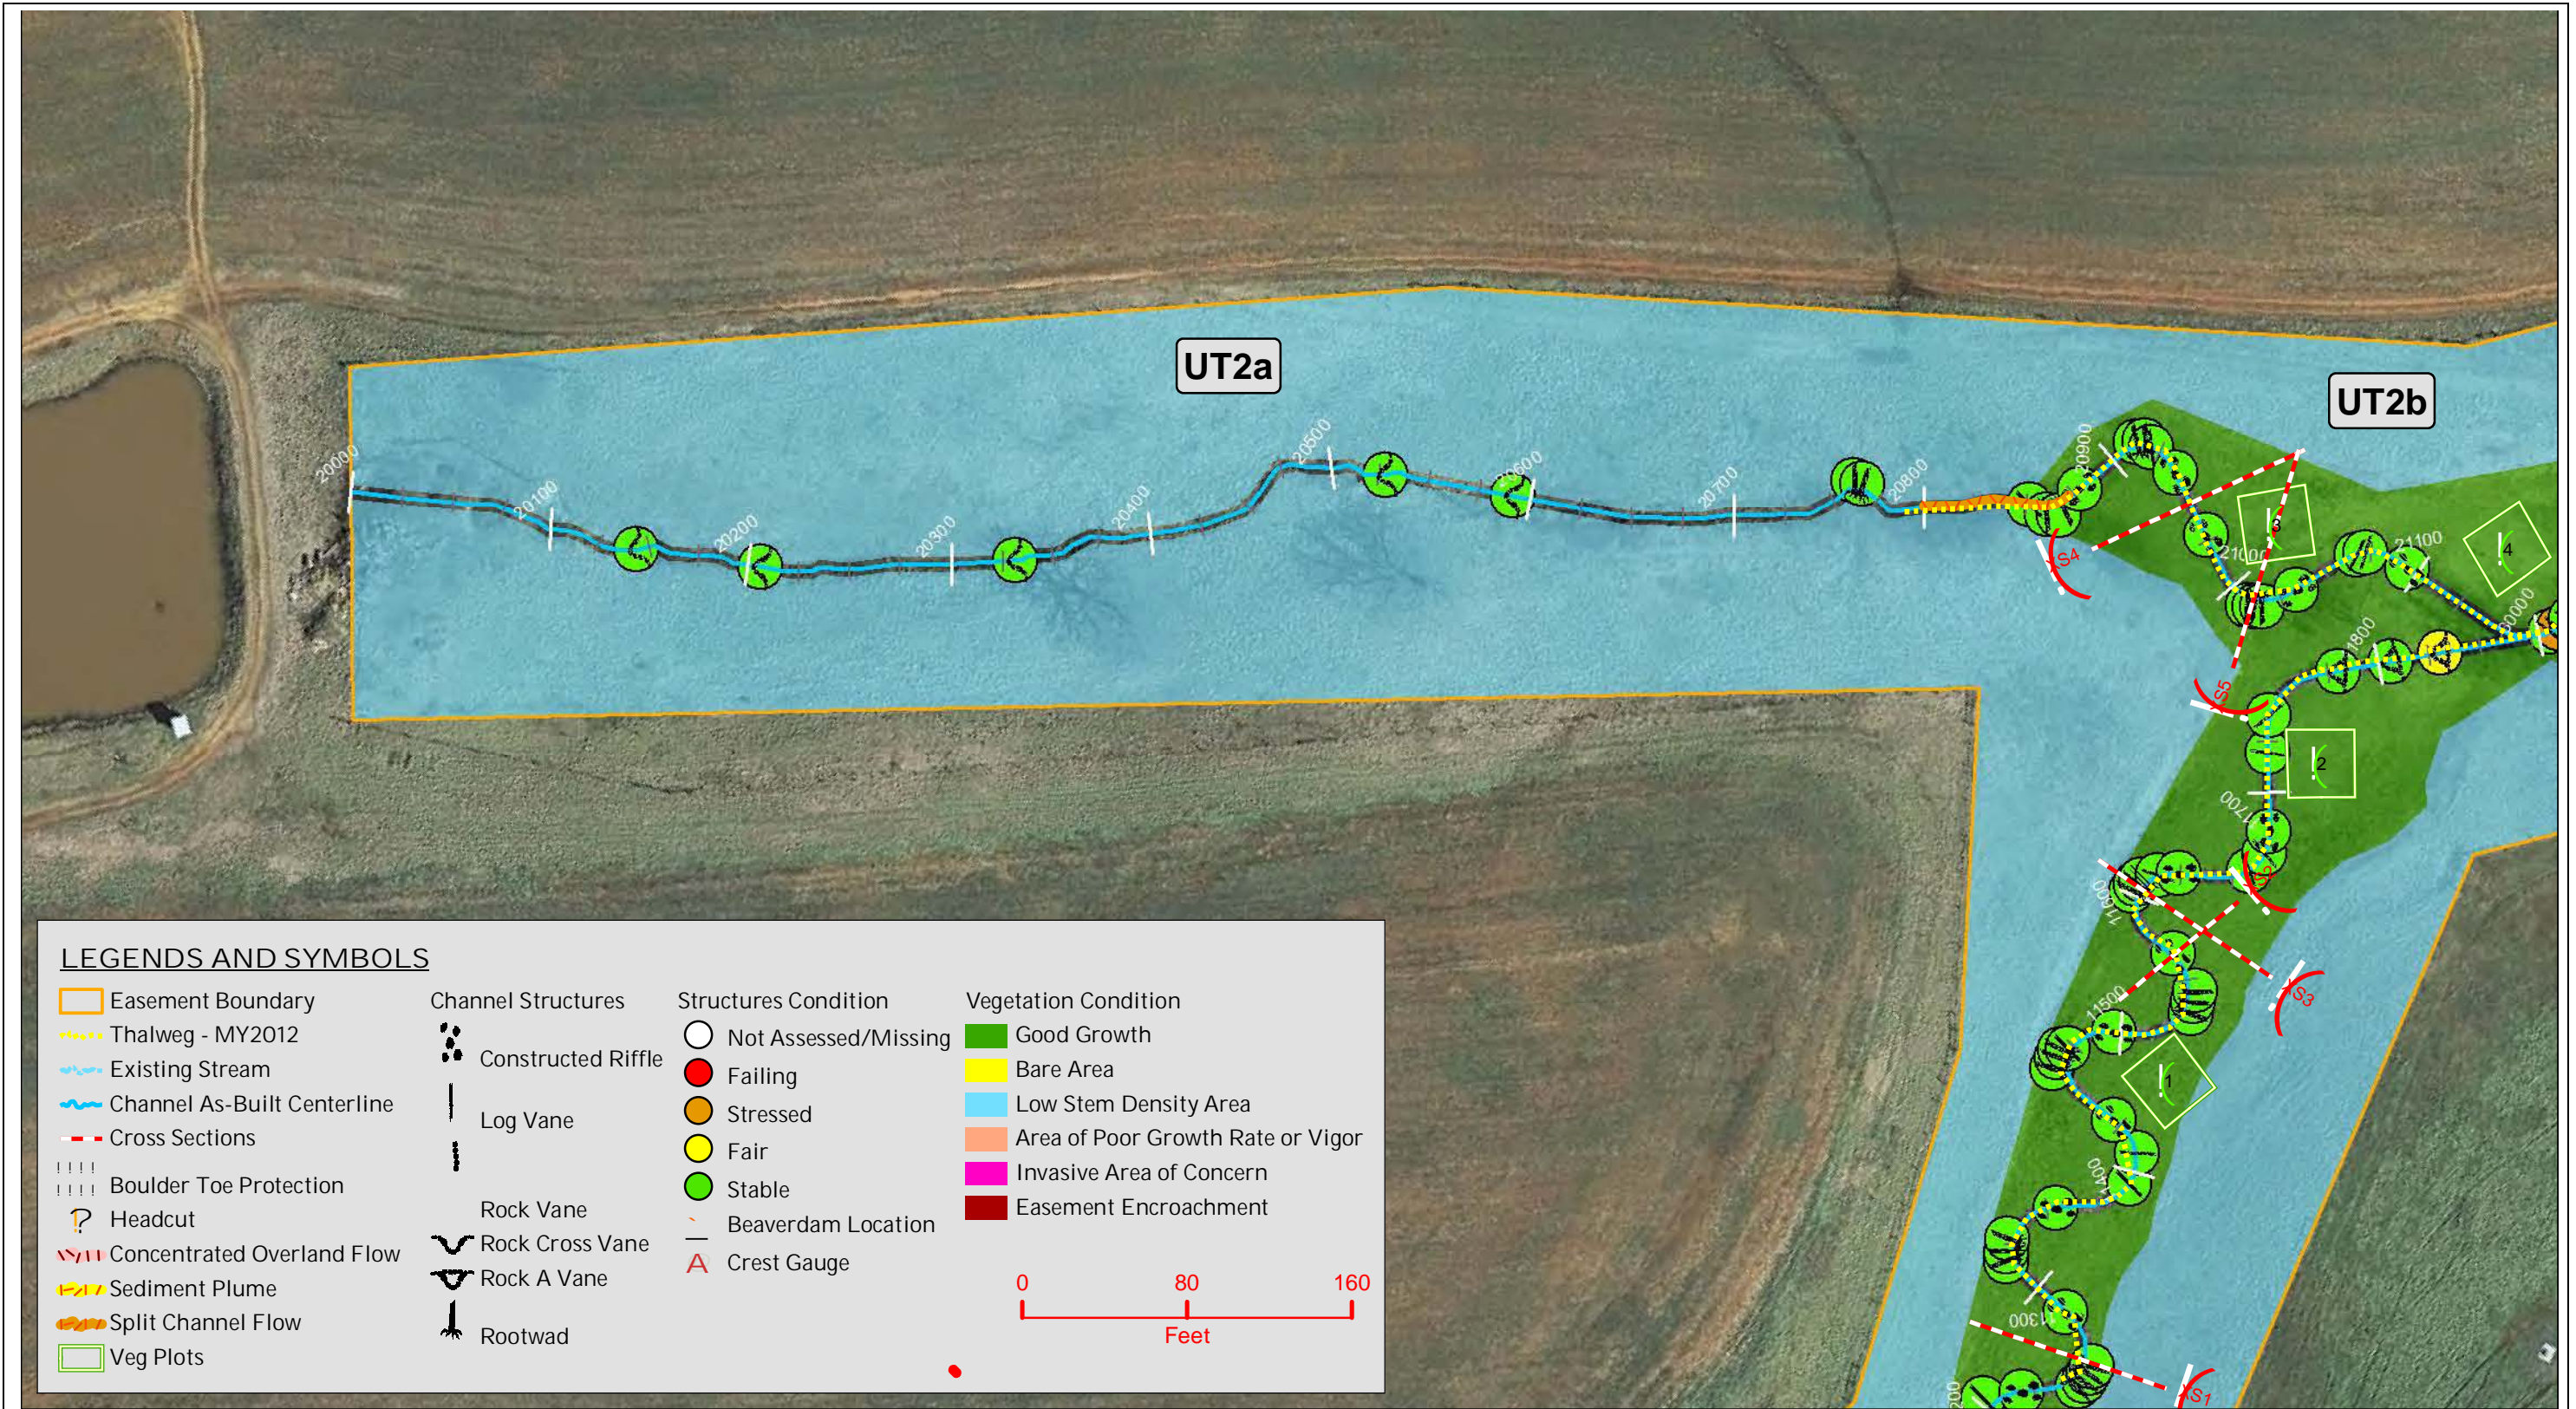
Title		Current Conditions Plan View UT2a and UT2b		
Prepared For:	Project	Meredell Farm Stream Restoration Monitoring Year 5 – 2012 Randolph County, North Carolina		
		Date	Project Number	Figure

- UT2 contained a section of braided stream flow between Stations 20+800 to 20+900.
- There is a sediment plume present in the lower portion of UT3b from station 21+25 – 23+00.

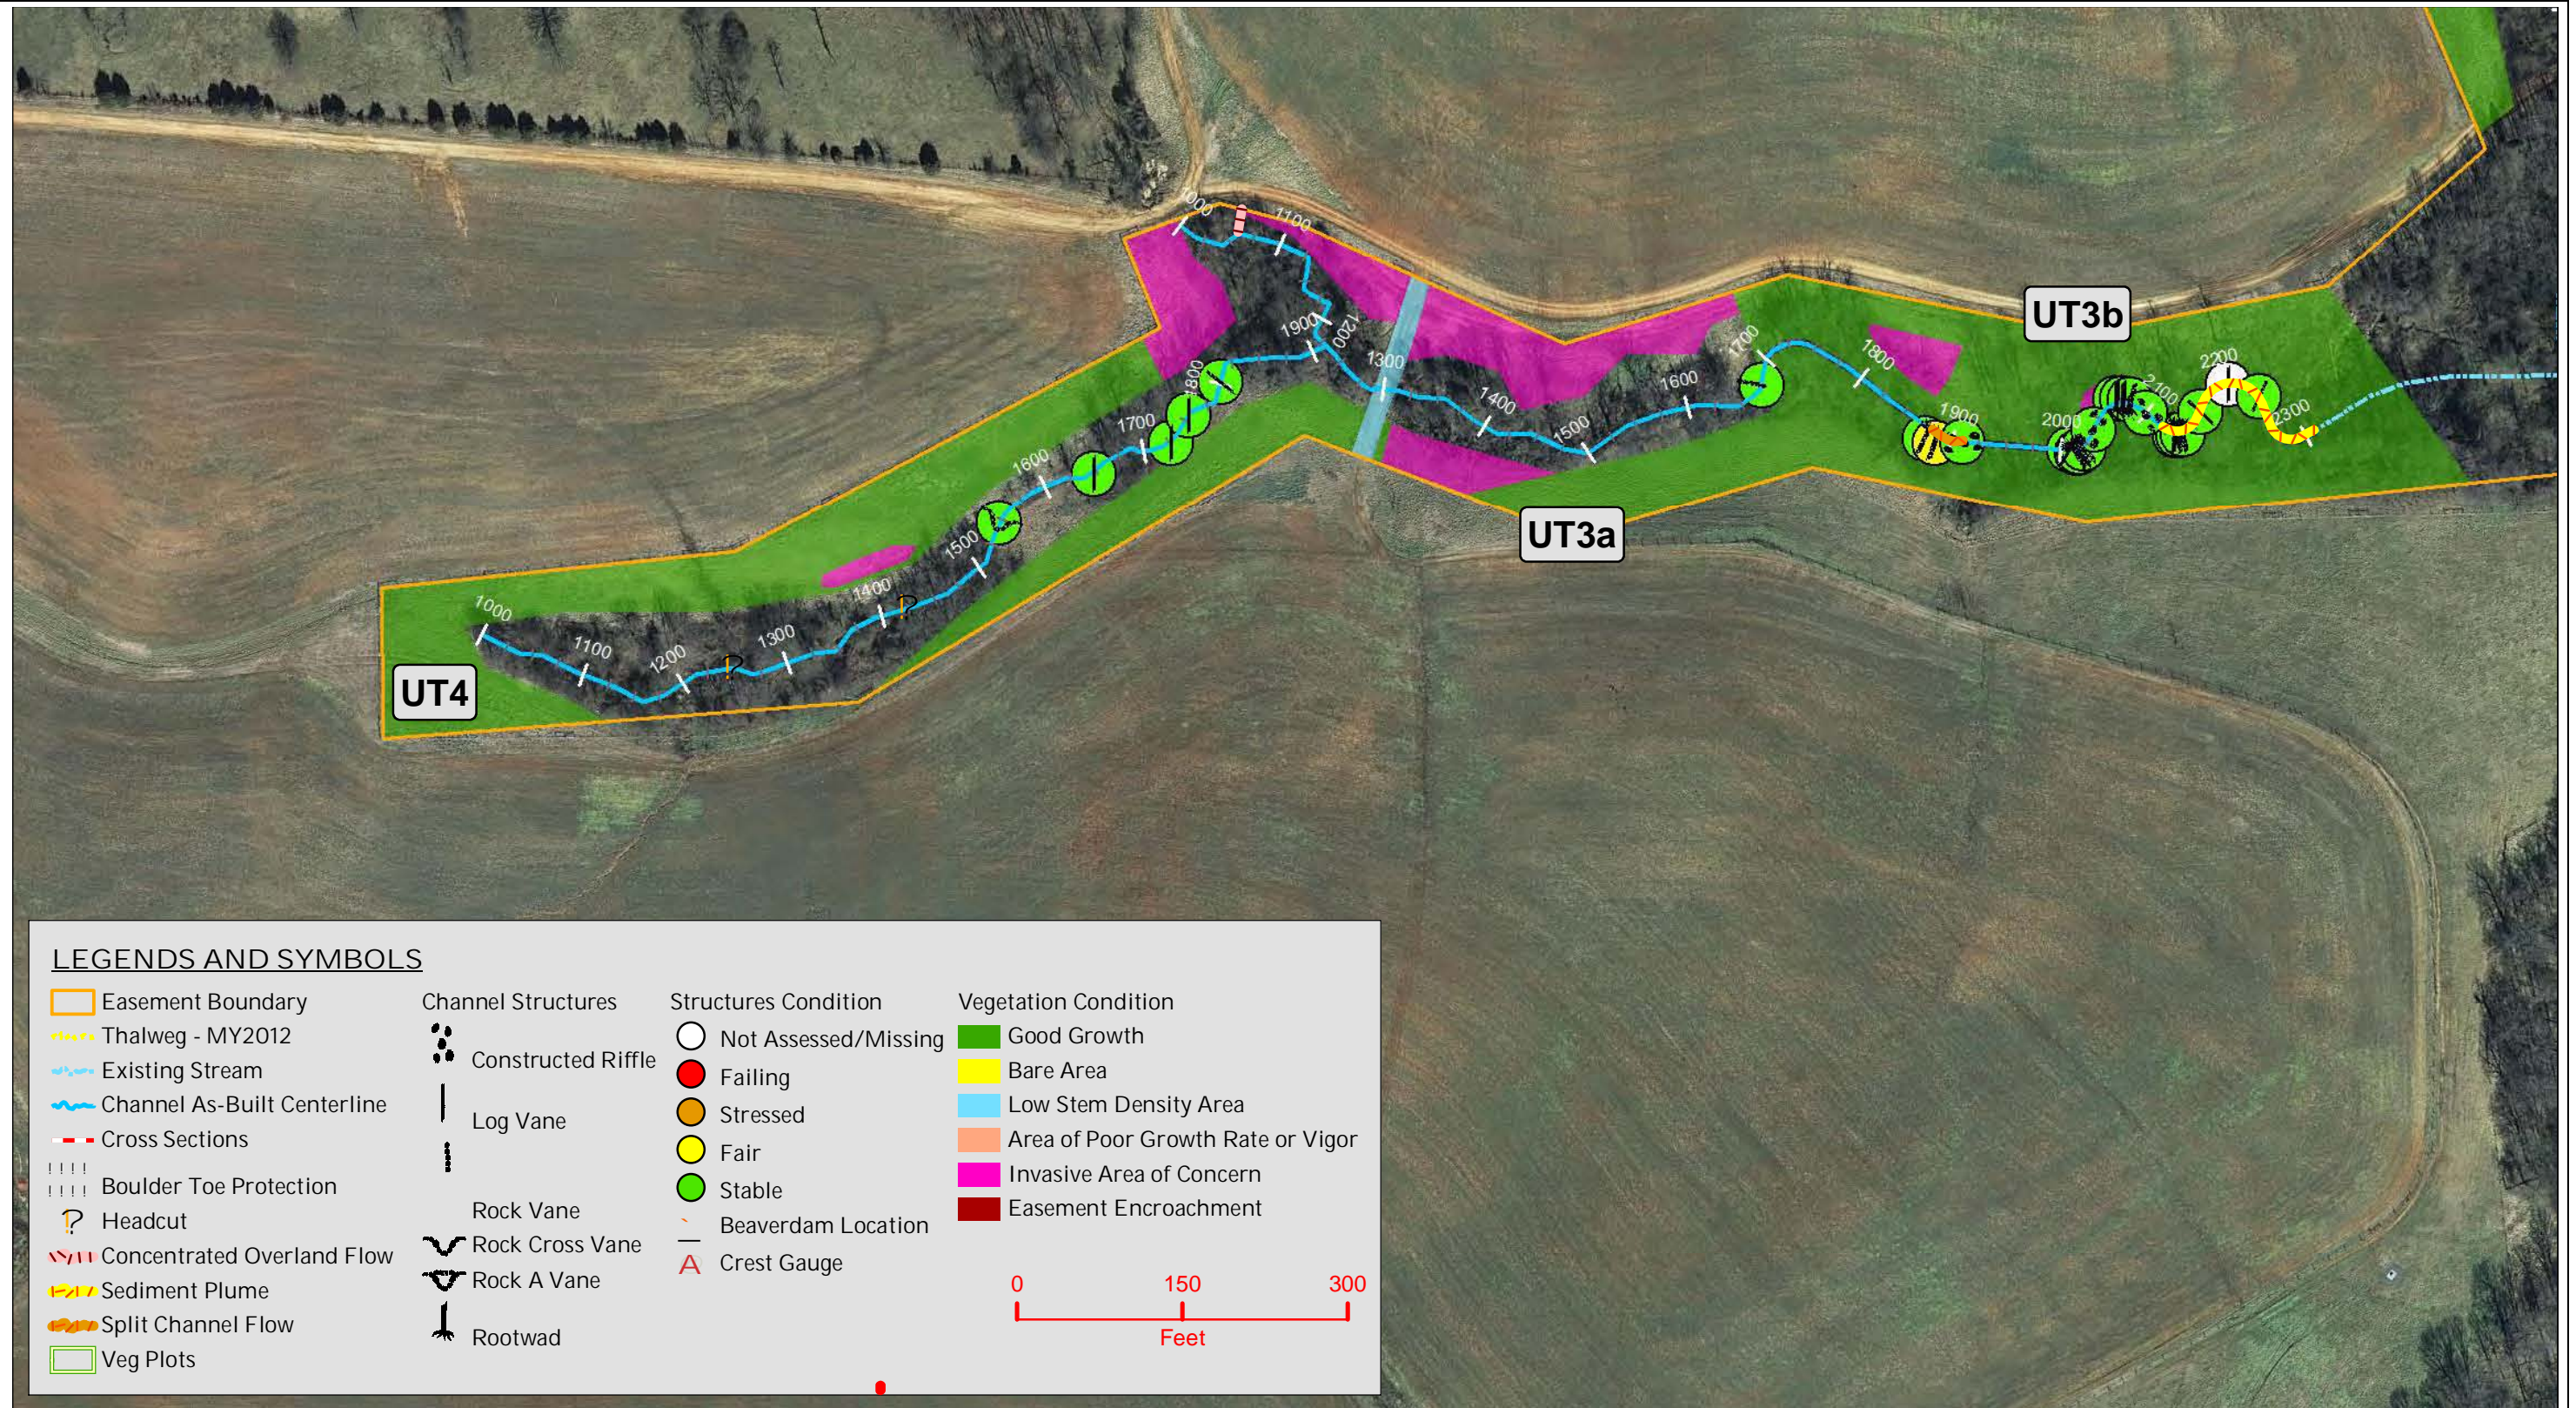
Title		Current Conditions Plan View UT3a, UT3b, and UT4		
Prepared For: 	Project	Meredell Farm Stream Restoration Monitoring Year 5 – 2012 Randolph County, North Carolina		
	Date	11/15/12	Project Number	247
			Figure	5

- Two log structures on UT3b and UT5 were in fair condition or failing condition due to the lack of water in the channel, which is causing the structures to rot. The rotting structure has water flowing behind and under the structures.

- Five instances of headcut were recorded on UT4 and UT5.
- There was a small area of concentrated overland runoff through the buffer on UT3a near Station 10+50 that was causing erosion to the stream bank.

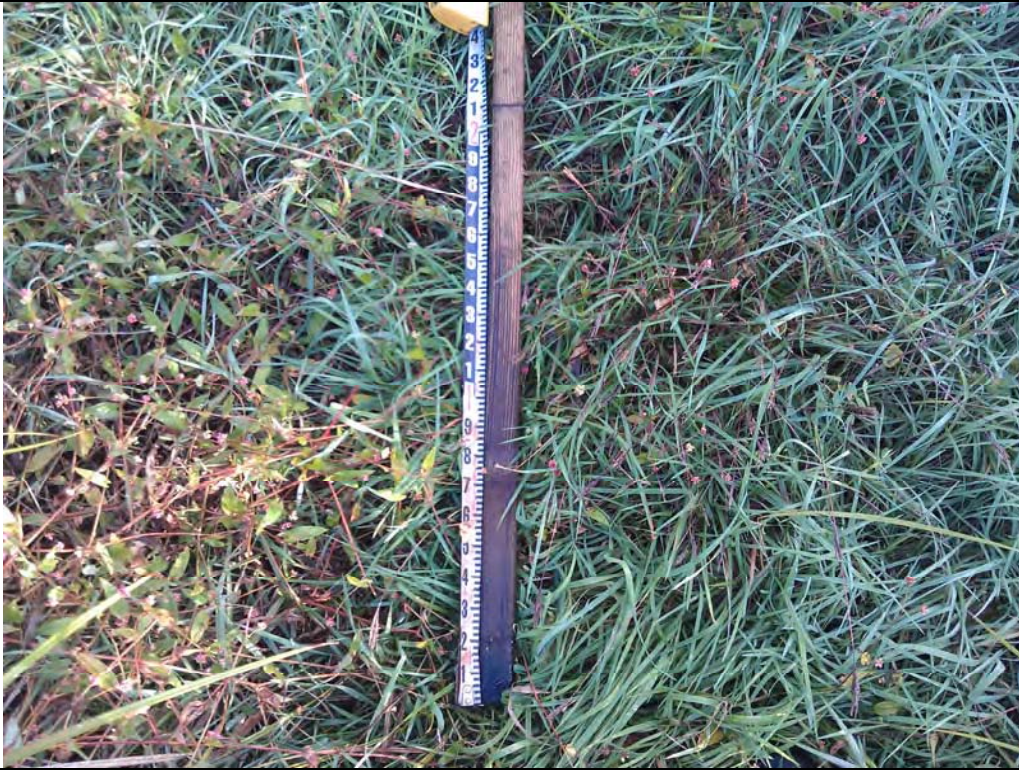
- Wracklines were noted above the bankfull bench and within the floodplain during the initial site assessment field visit conducted on March 26, 2012. At the time the wracklines appeared to have occurred recently, indicating a bankfull event had occurred. Refer to photograph SP2 within **Appendix B** of this report.
- A crest gauge reading of 1.17 feet was recorded during the annual monitoring field visit conducted on October 18, 2012. The baseline bankfull design maximum depth range for reach M1 is 1.0 feet (min) to 1.3 feet (max); therefore, the crest gauge reading indicates that a bankfull event had occurred recently onsite. Refer to photograph SP1 within **Appendix B** of this report.

SP1: Crest Gage reading = 1.17'
Taken: 10-18-2012

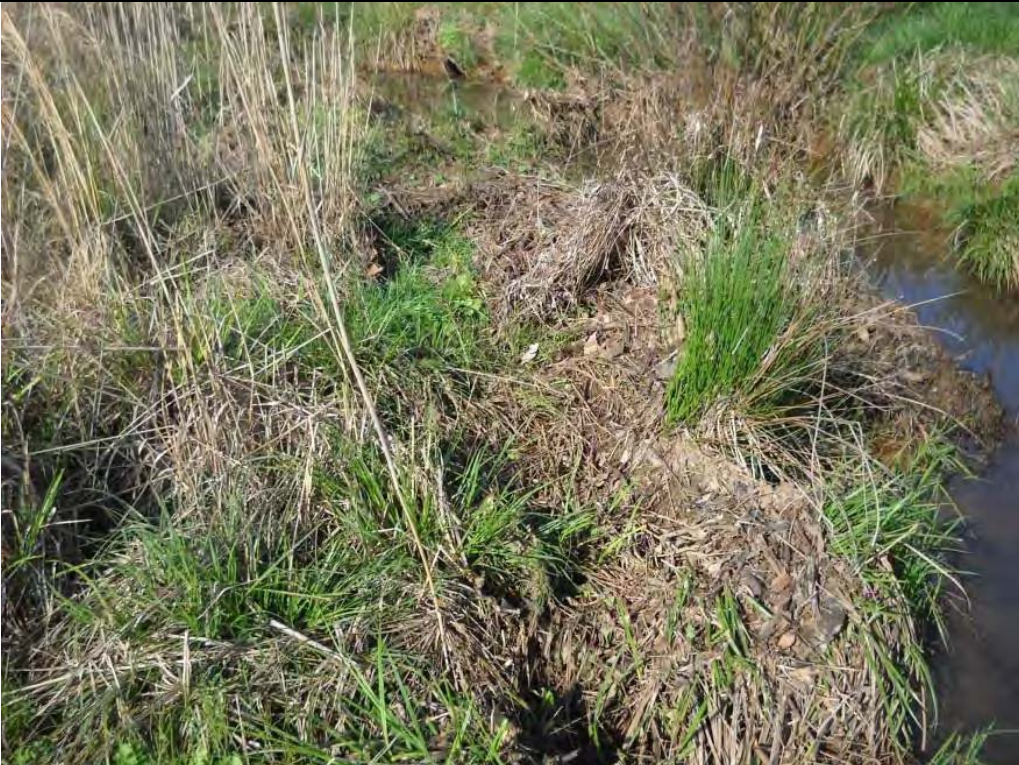
SP2: Bankfull indicator on UT1b (STA 22+25)
Taken: 3-26-2012

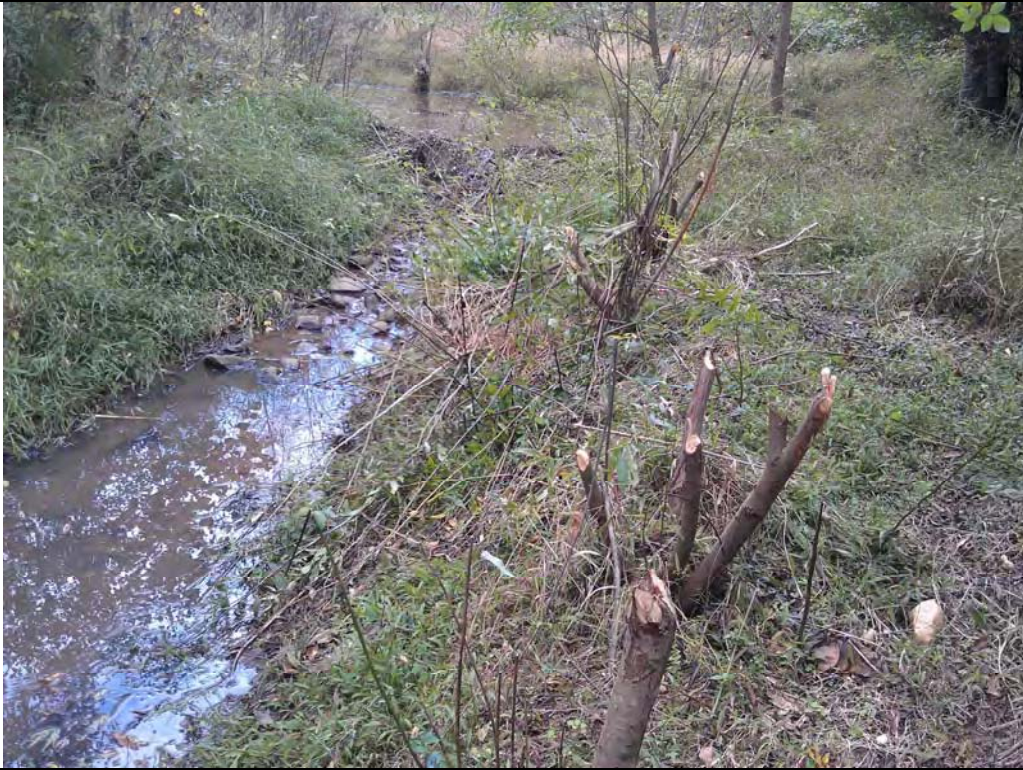
- The lower portion of M1 (STA 31+600 – 32+200) downstream of the crossing has been impacted by beaver activity. Refer to photographs SP3 through SP6 contained in Appendix B, herein. Four (4) beaver dams have been established in the channel ranging from 2-5 feet in height, and a significant portion of the established bank vegetation has been removed in the adjacent area.

SP3: Beaver dam on lower M1 (STA 31+770)
Taken: 10-18-2012

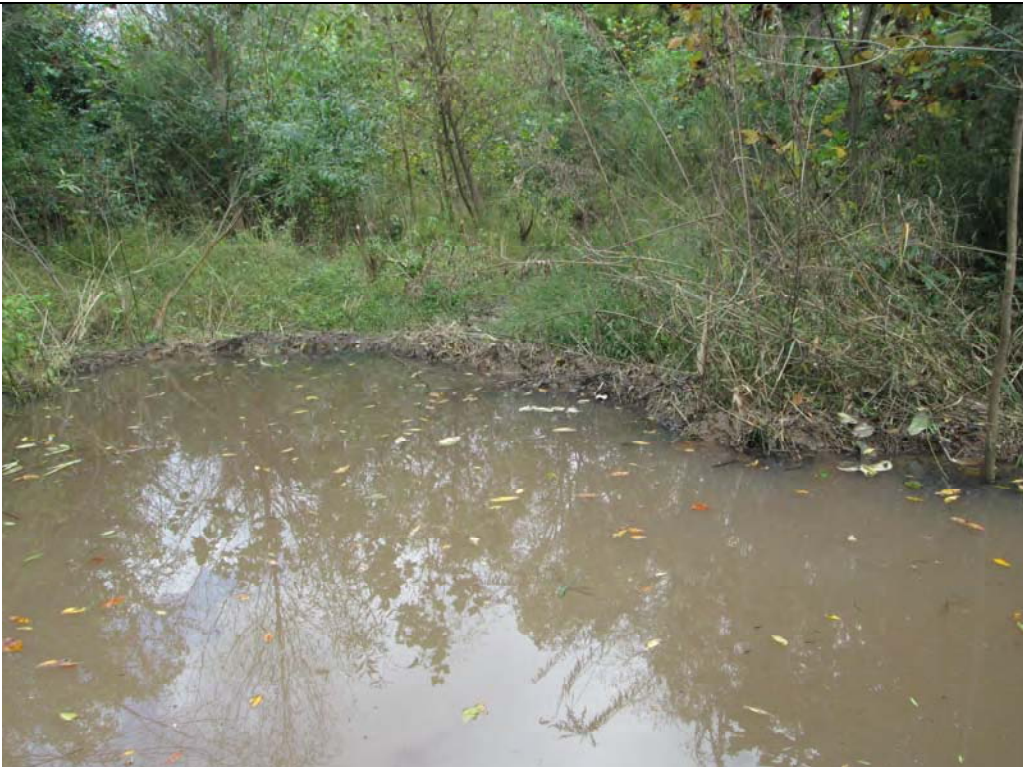
SP4: Beaver dam on lower M1 (STA 31+880)
Taken: 10-18-2012

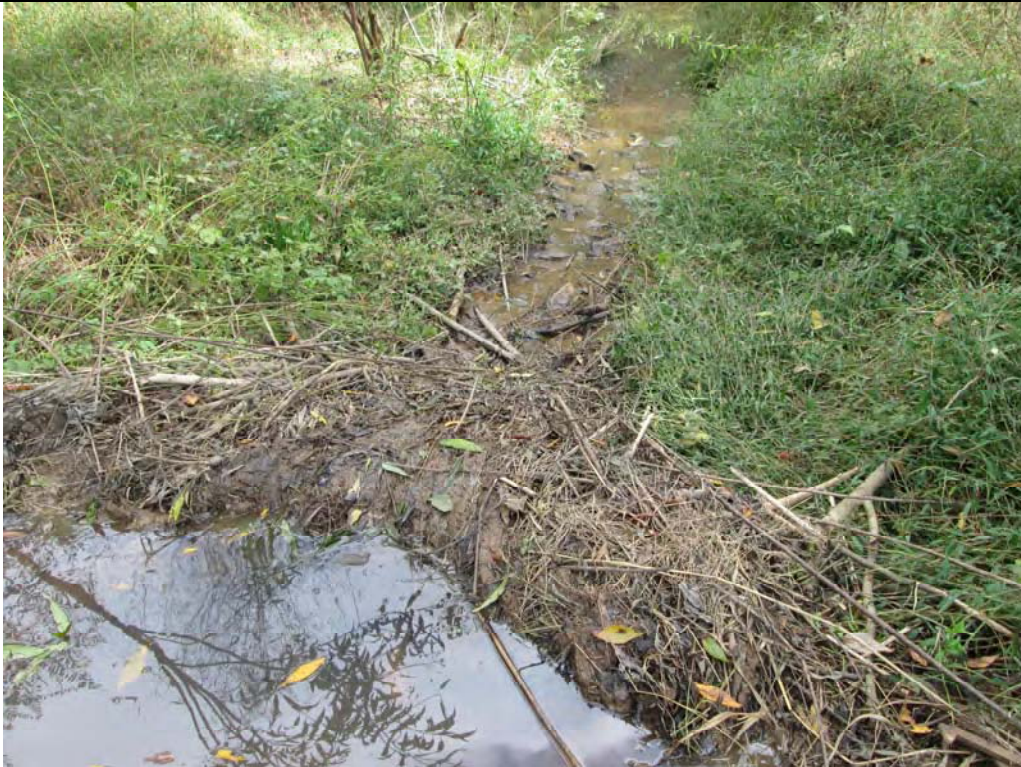
SP5: Beaver dam on lower M1 (STA 31+965)
Taken: 10-18-2012

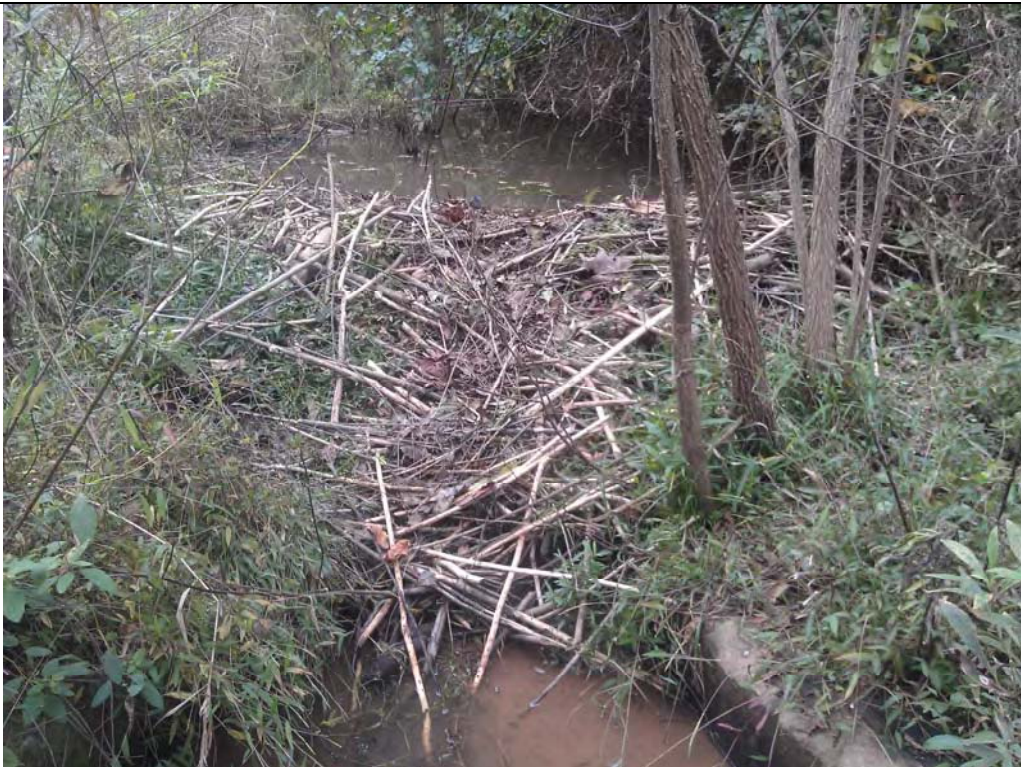
SP6: Beaver dam on lower M1 (STA 32+105)
Taken: 10-18-2012
