**MEREDELL FARM  
ANNUAL MONITORING REPORT  
YEAR 6 OF 7**

EEP Project #247  
Randolph County, North Carolina  
Completed Construction: 2008  
Submitted January 2014

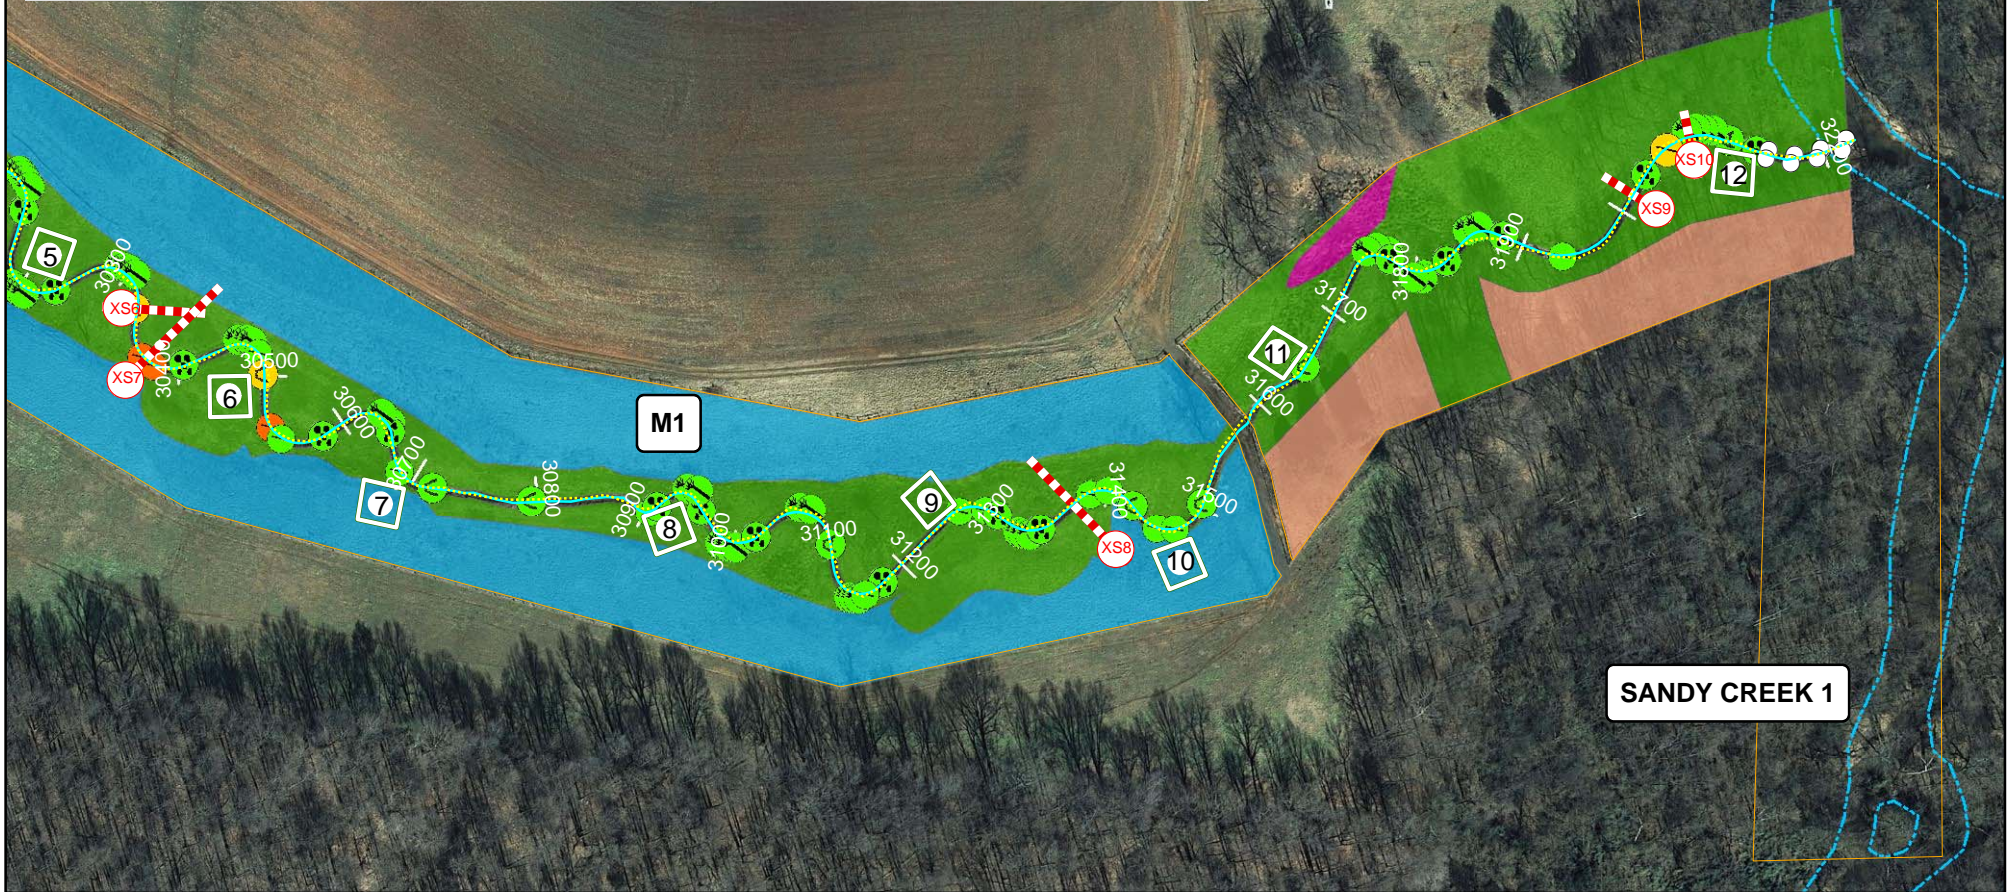
**Figure**  
4

- Two instream structures (Stations M1: 303+25 and 305+00) had flow going between the sill and arm boulders, but no further instability was observed as a result of the conditions
- One instream structure (Station M1: 303+75) had approximately 15% bank erosion
- Six instances of headcut were observed
- There continues to be a small area of concentrated overland runoff through the buffer on the UT3a near Station 10+50 that is causing erosion to the stream bank
- Two areas of split channel flow were identified along the existing stream at the upstream and downstream section of UT5

**Title** Current Conditions Plan View M1 and SC1

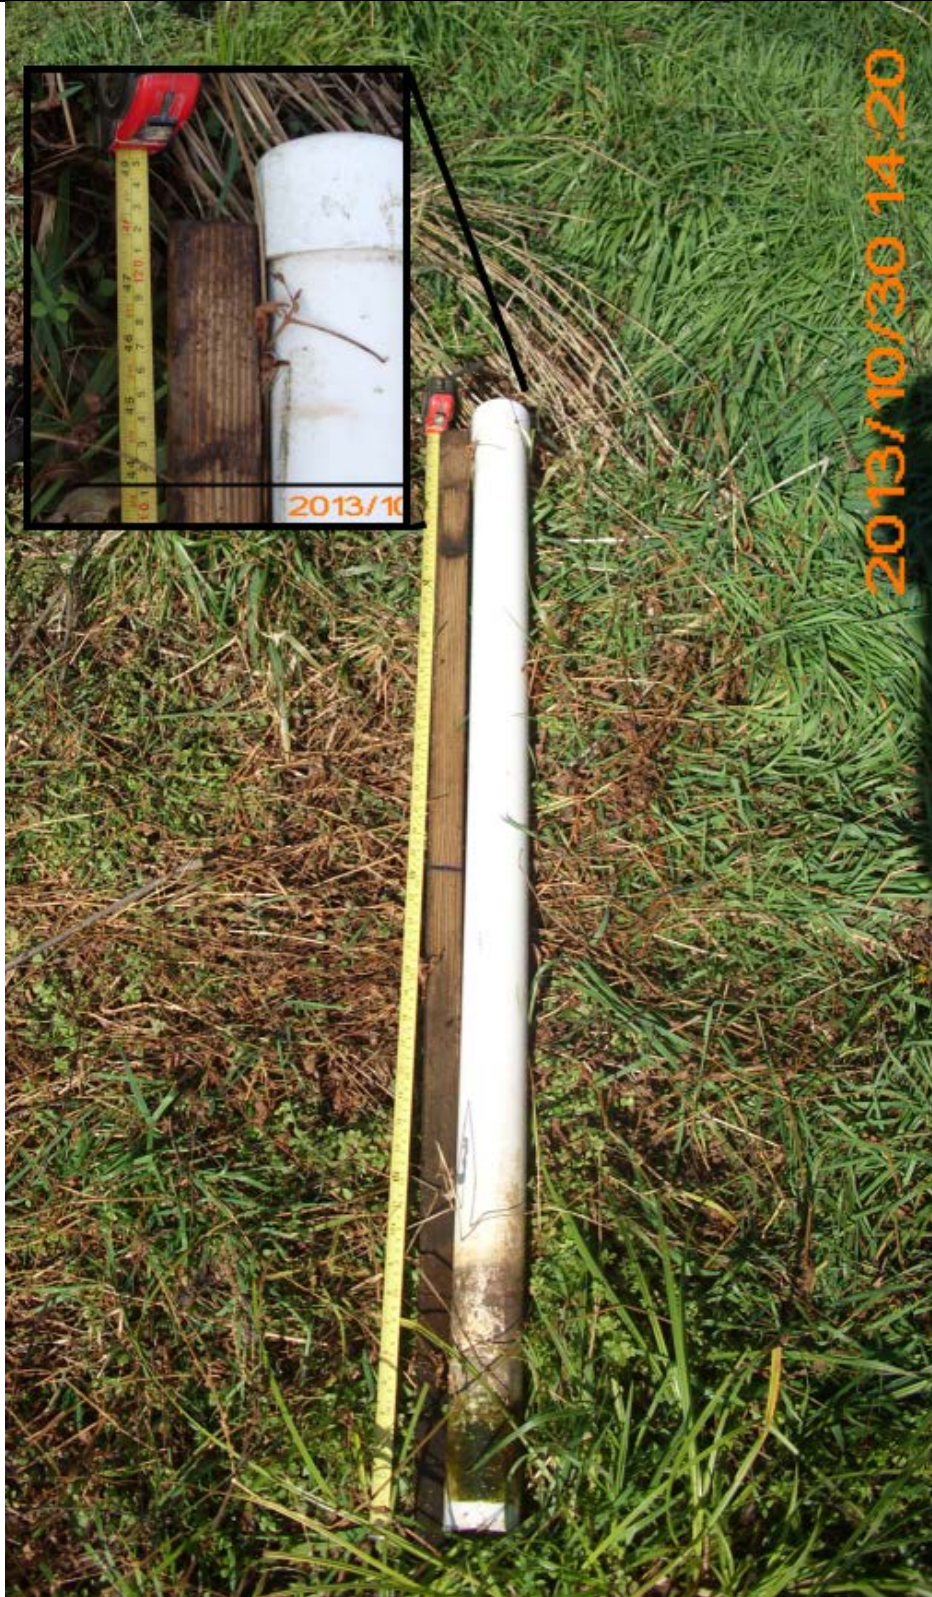
- Wracklines were noted above the bankfull bench and within the floodplain during the initial site assessment field visit conducted on October 30, 2013. Refer to photograph SP2 within **Appendix B** of this report.
- A crest gage reading of 3.6 feet was recorded during the annual monitoring field visit conducted on October 30, 2013. The baseline bankfull design maximum depth range for reach M1 is 1.0 foot (min) to 1.3 feet (max); therefore, the crest gage reading indicates that a bankfull event had occurred onsite. Refer to photograph SP1 within **Appendix B** of this report.

SP1: Crest gage reading = 3.6'  
Taken: 10-30-2013

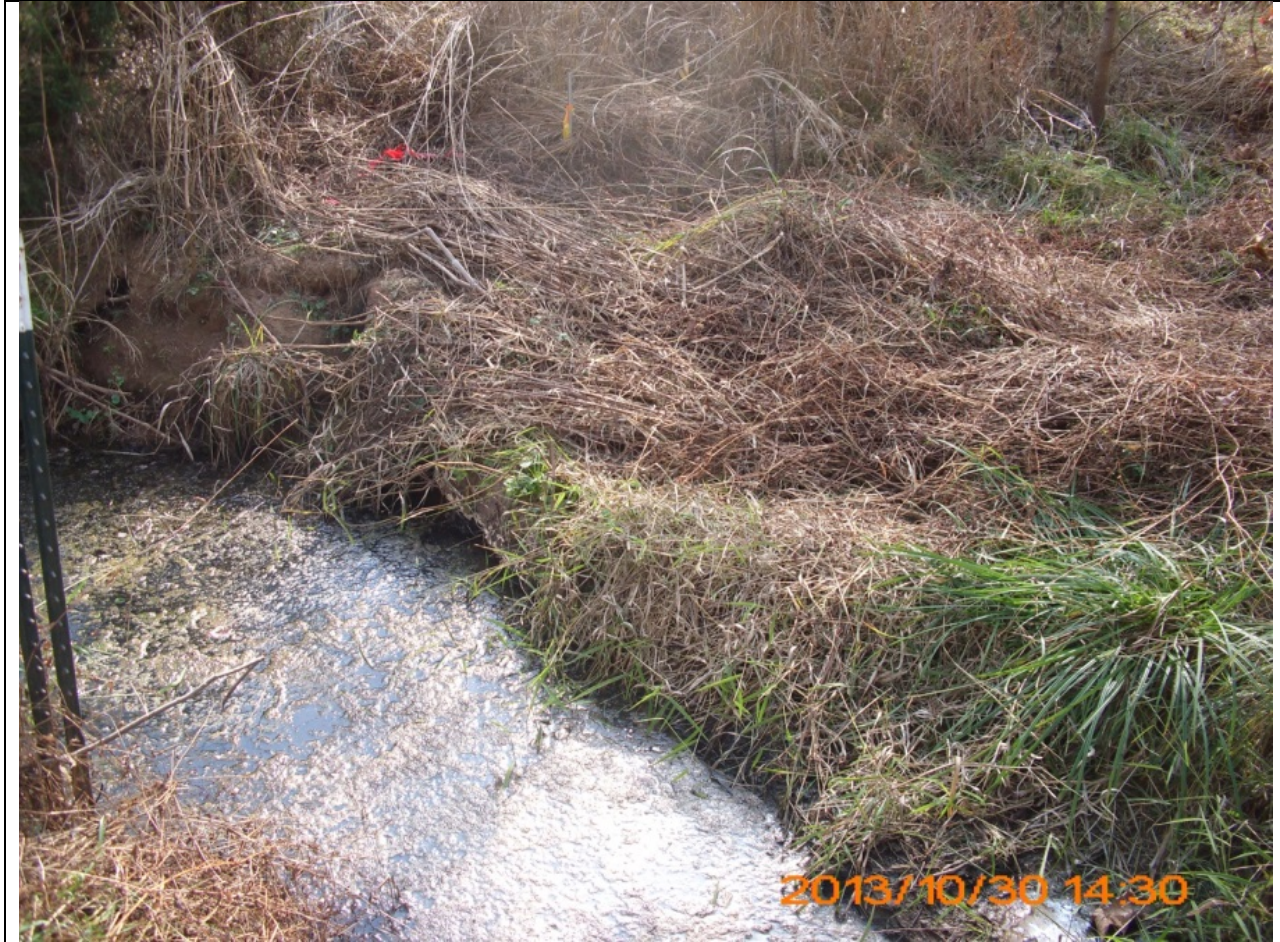
SP2: Bankfull indicator on M1 (STA 307+00)  
Taken: 10-30-2013
