**MEREDELL FARM  
ANNUAL MONITORING REPORT  
YEAR 7 OF 7**

EEP Project #247  
Randolph County, North Carolina  
Completed Construction: 2008  
Submitted November 2014

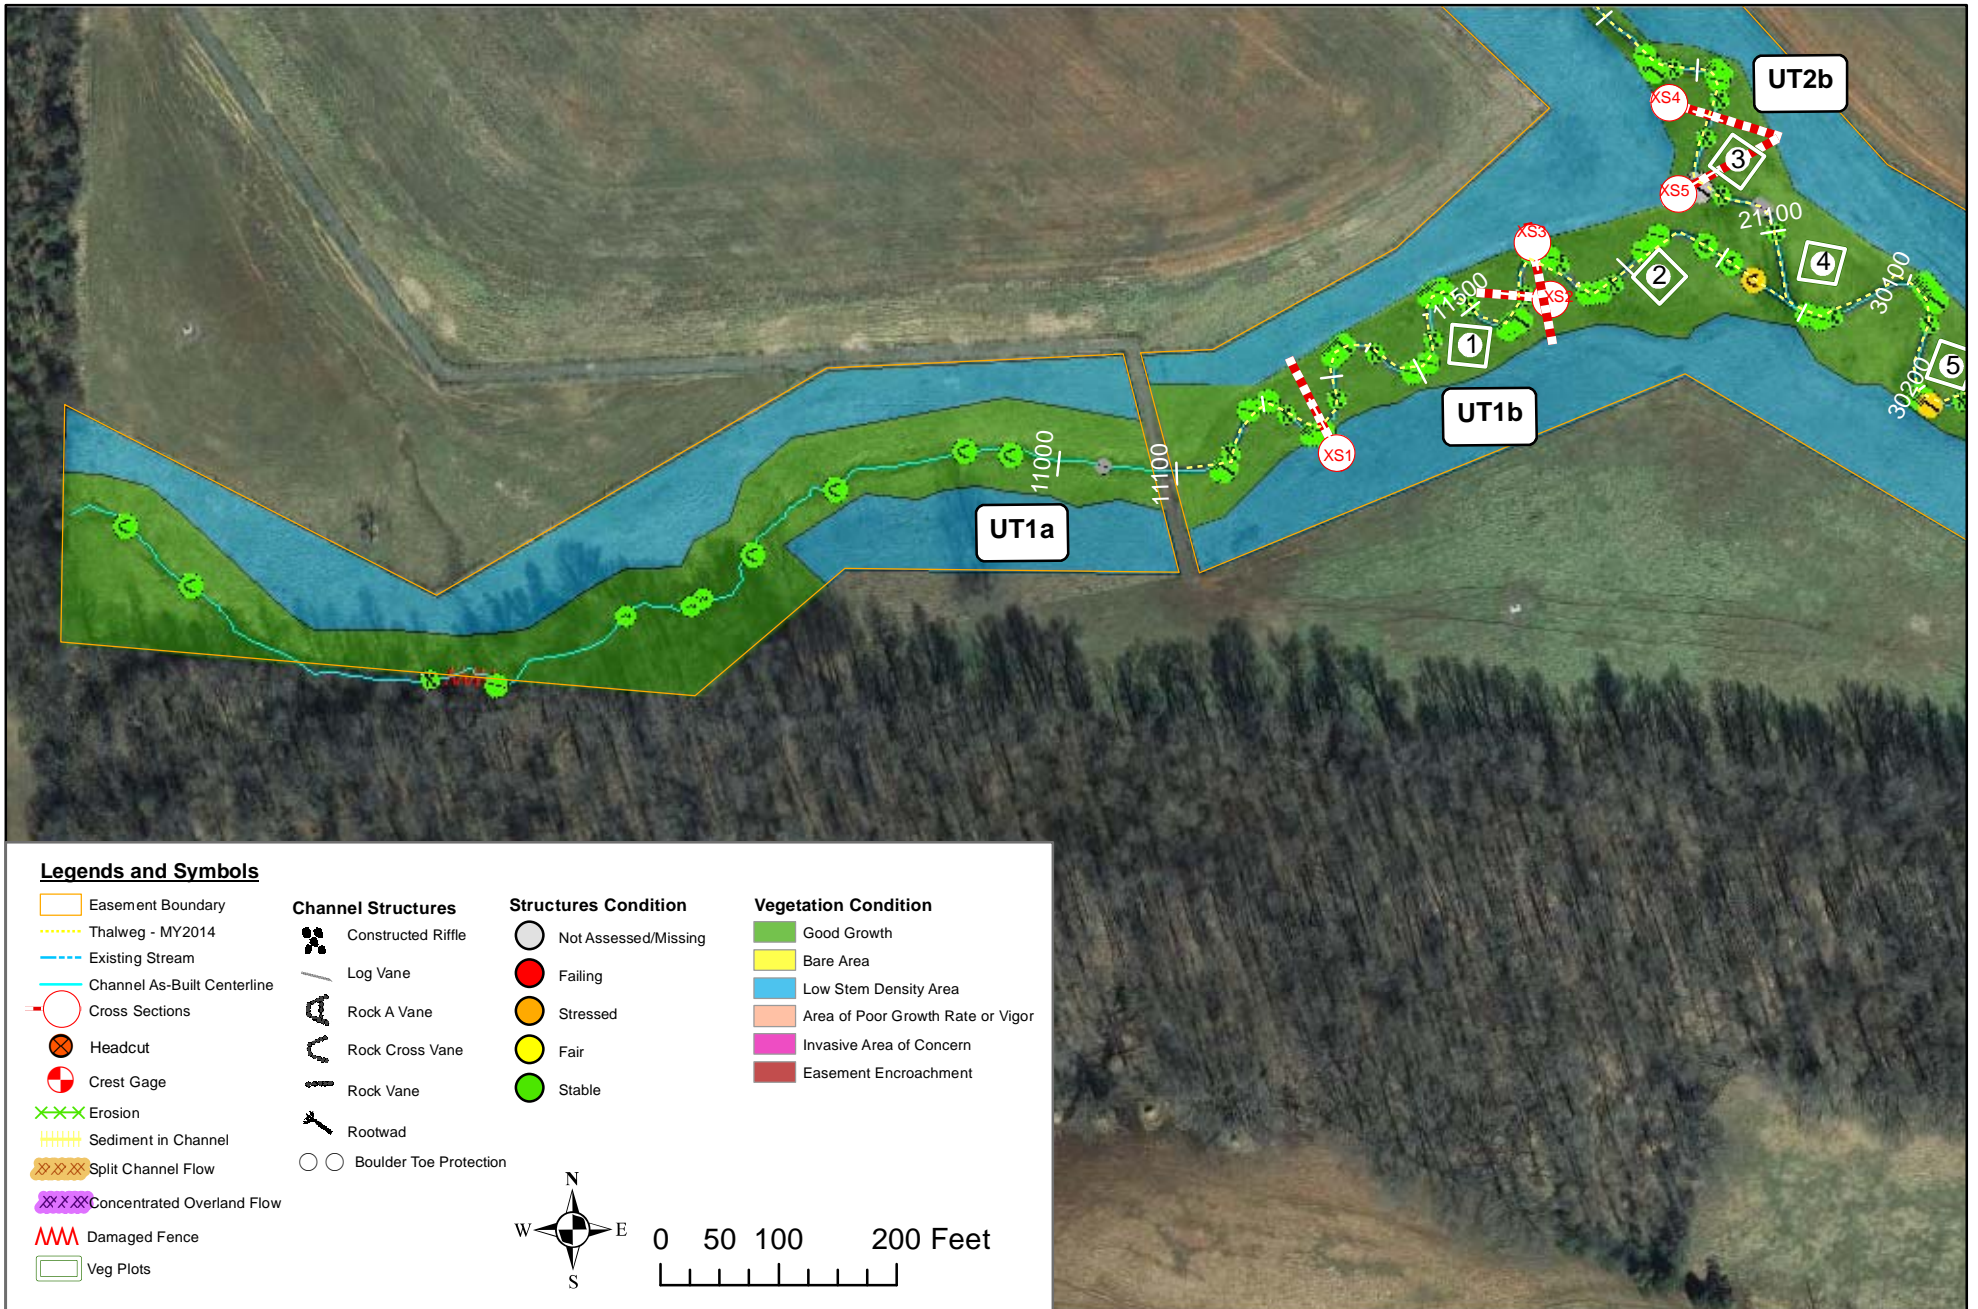
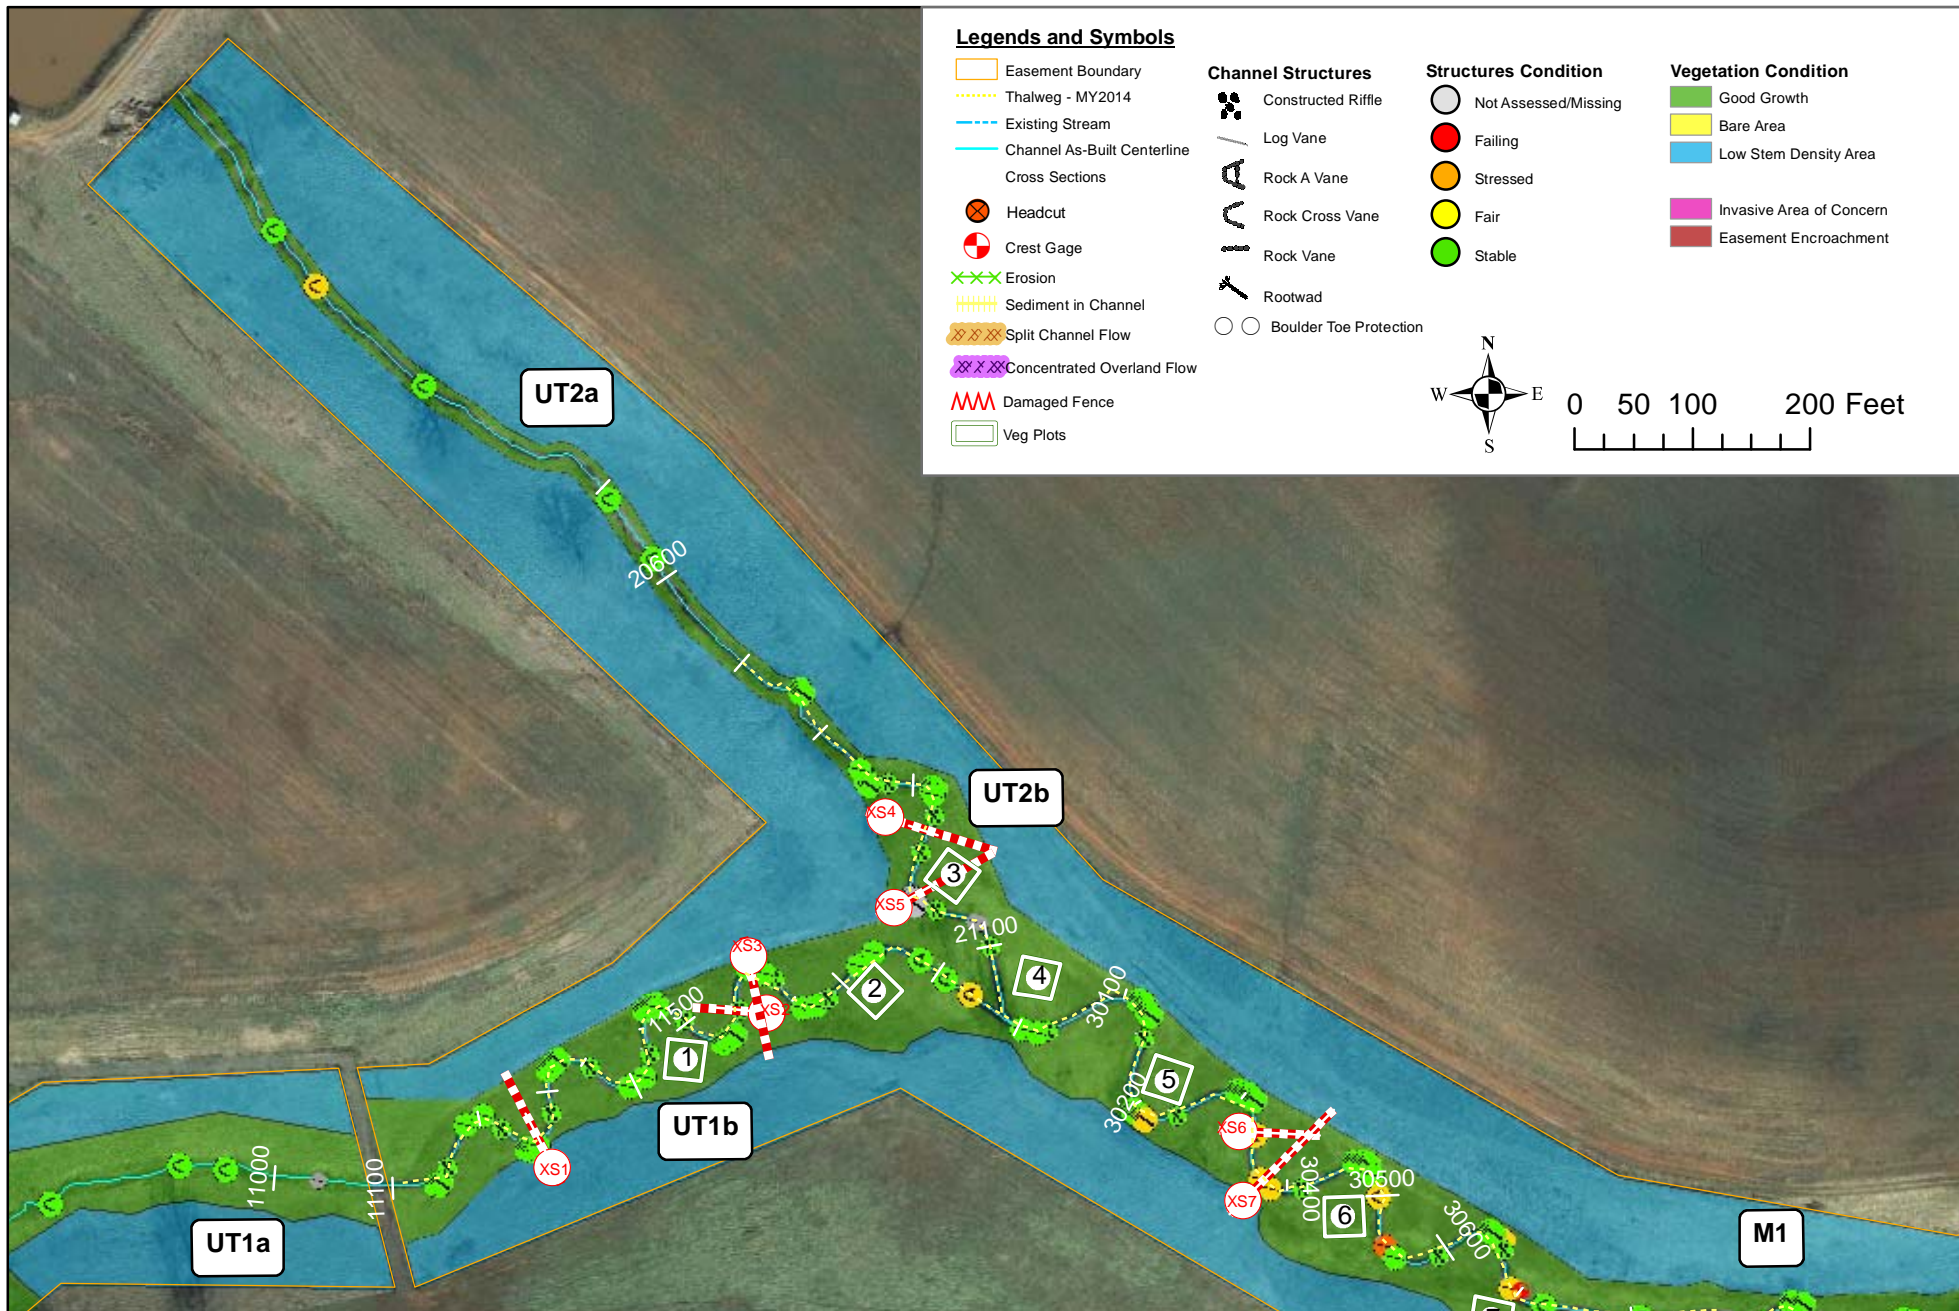
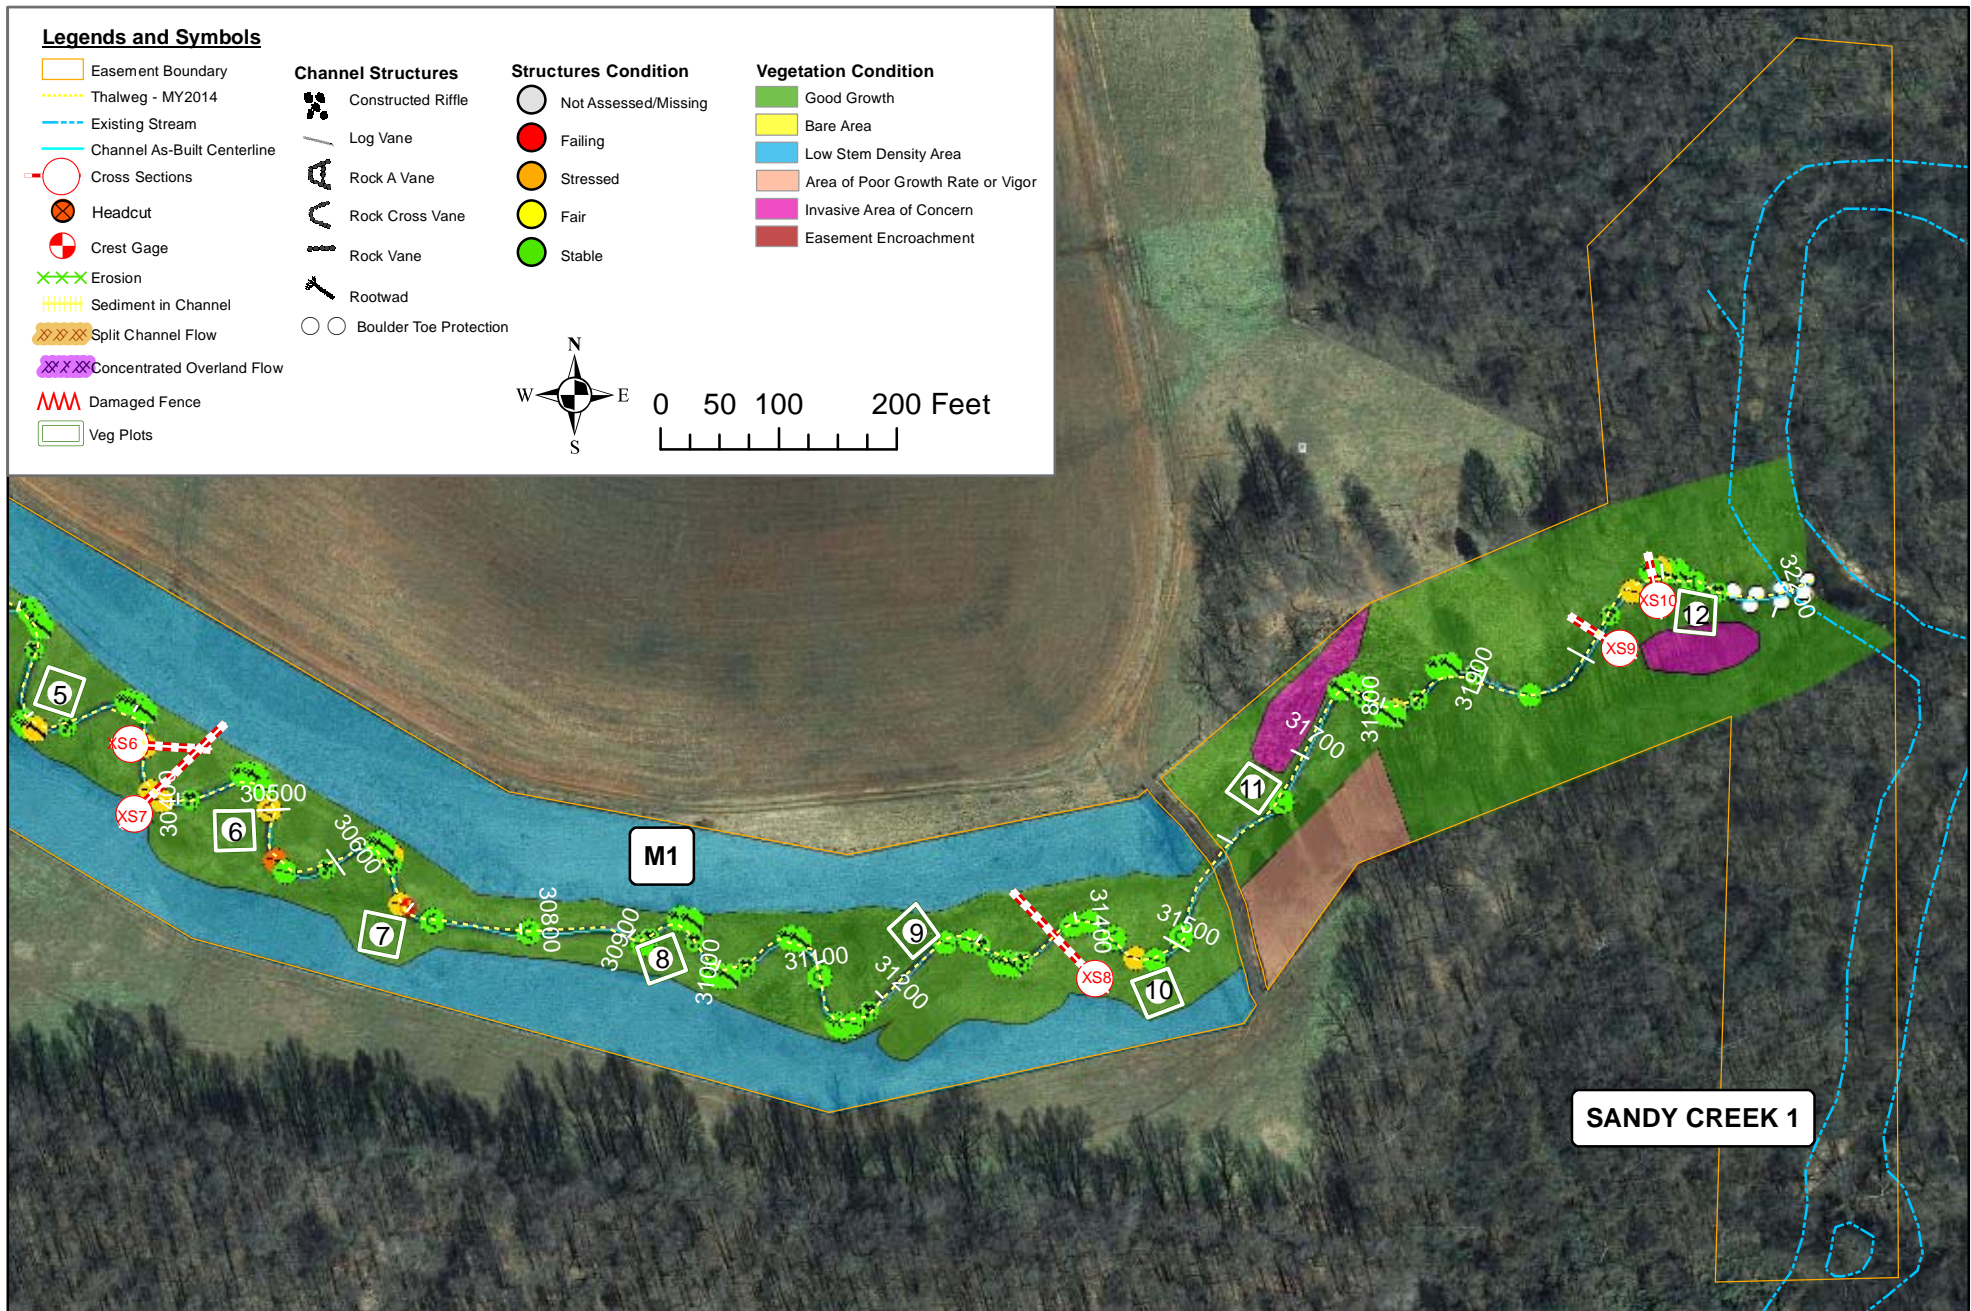
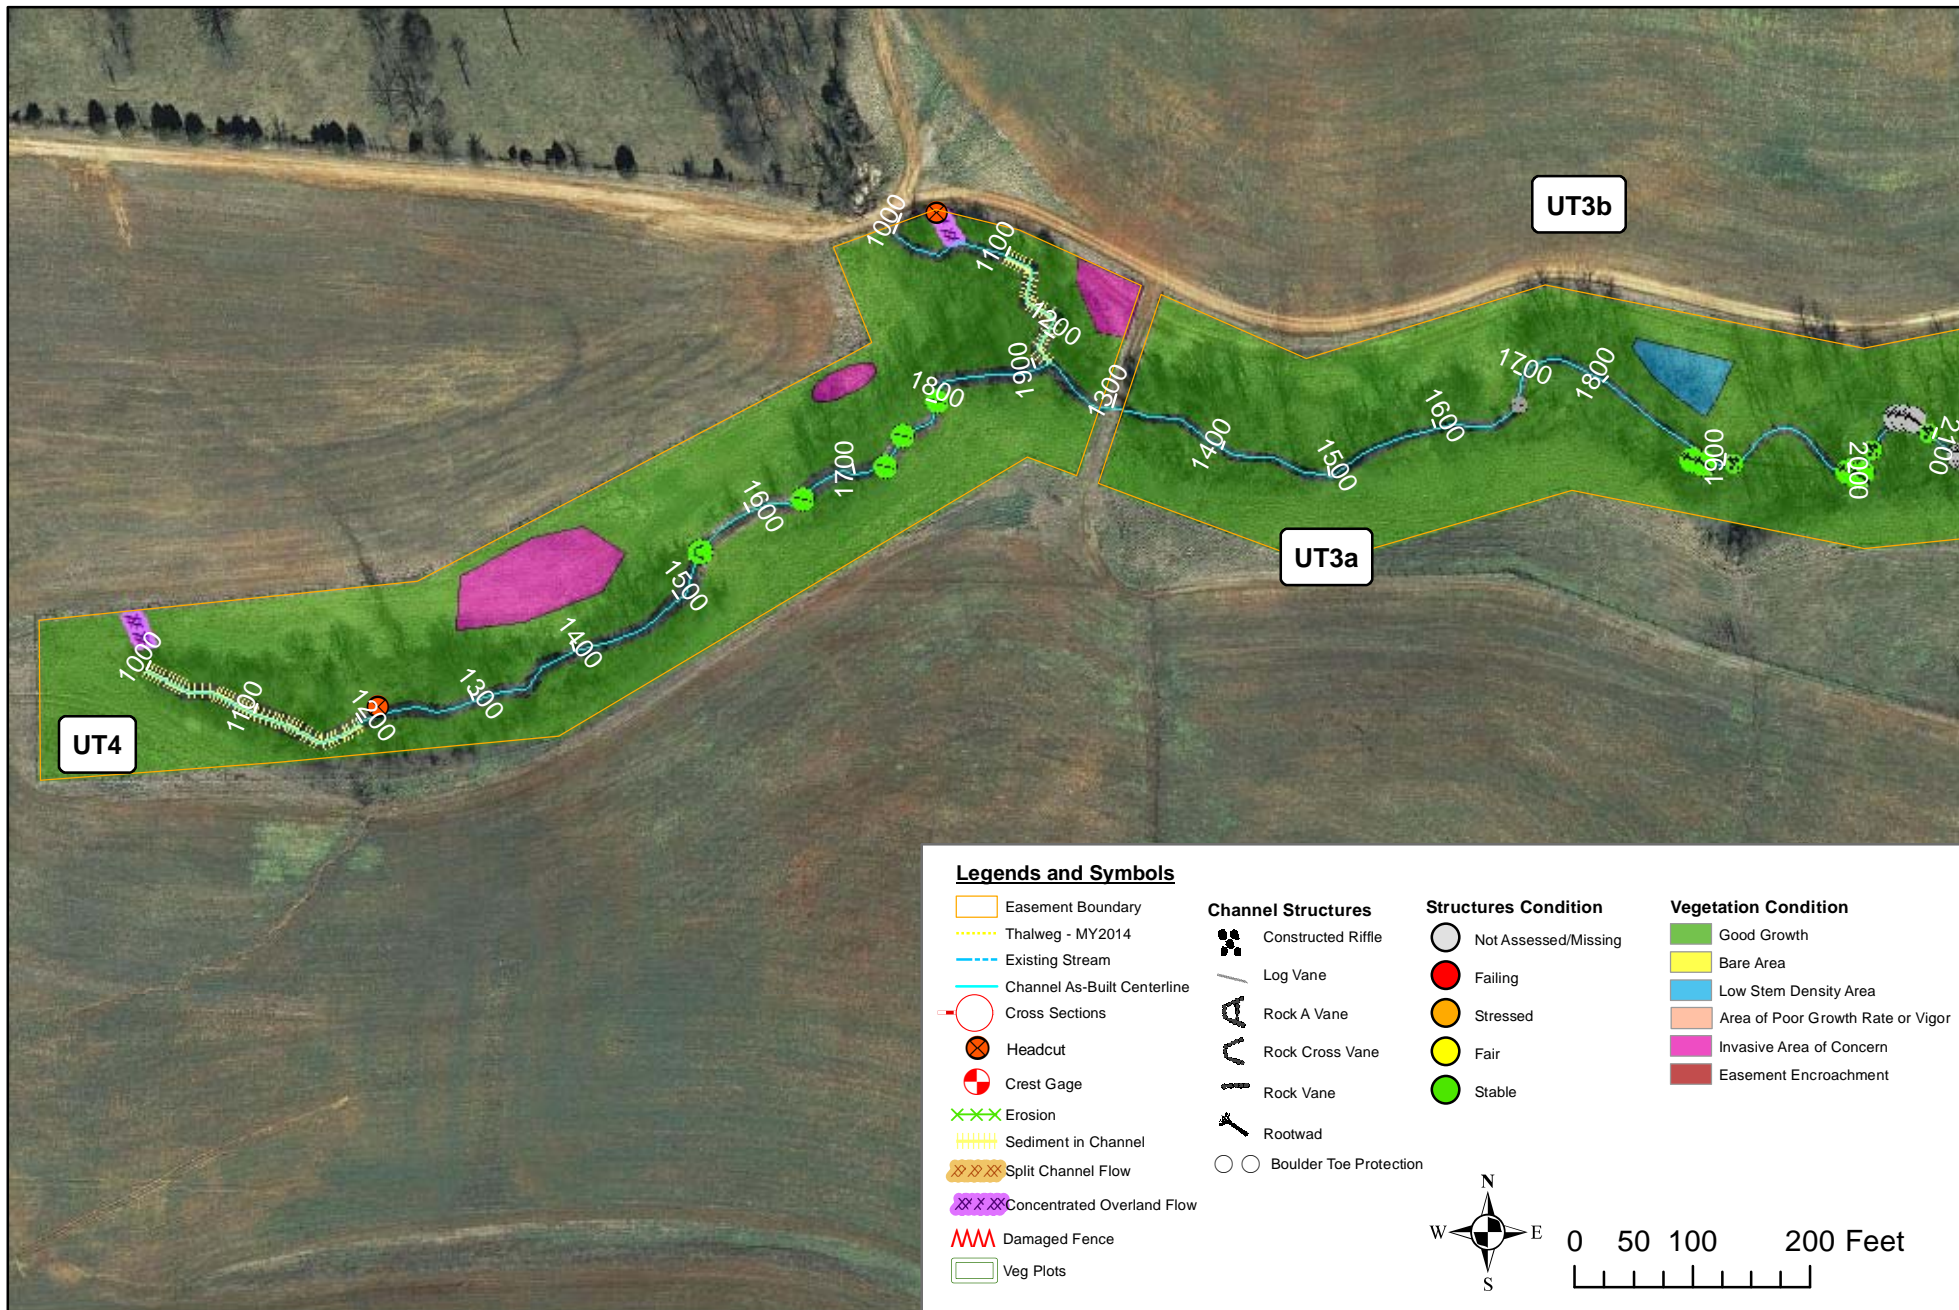
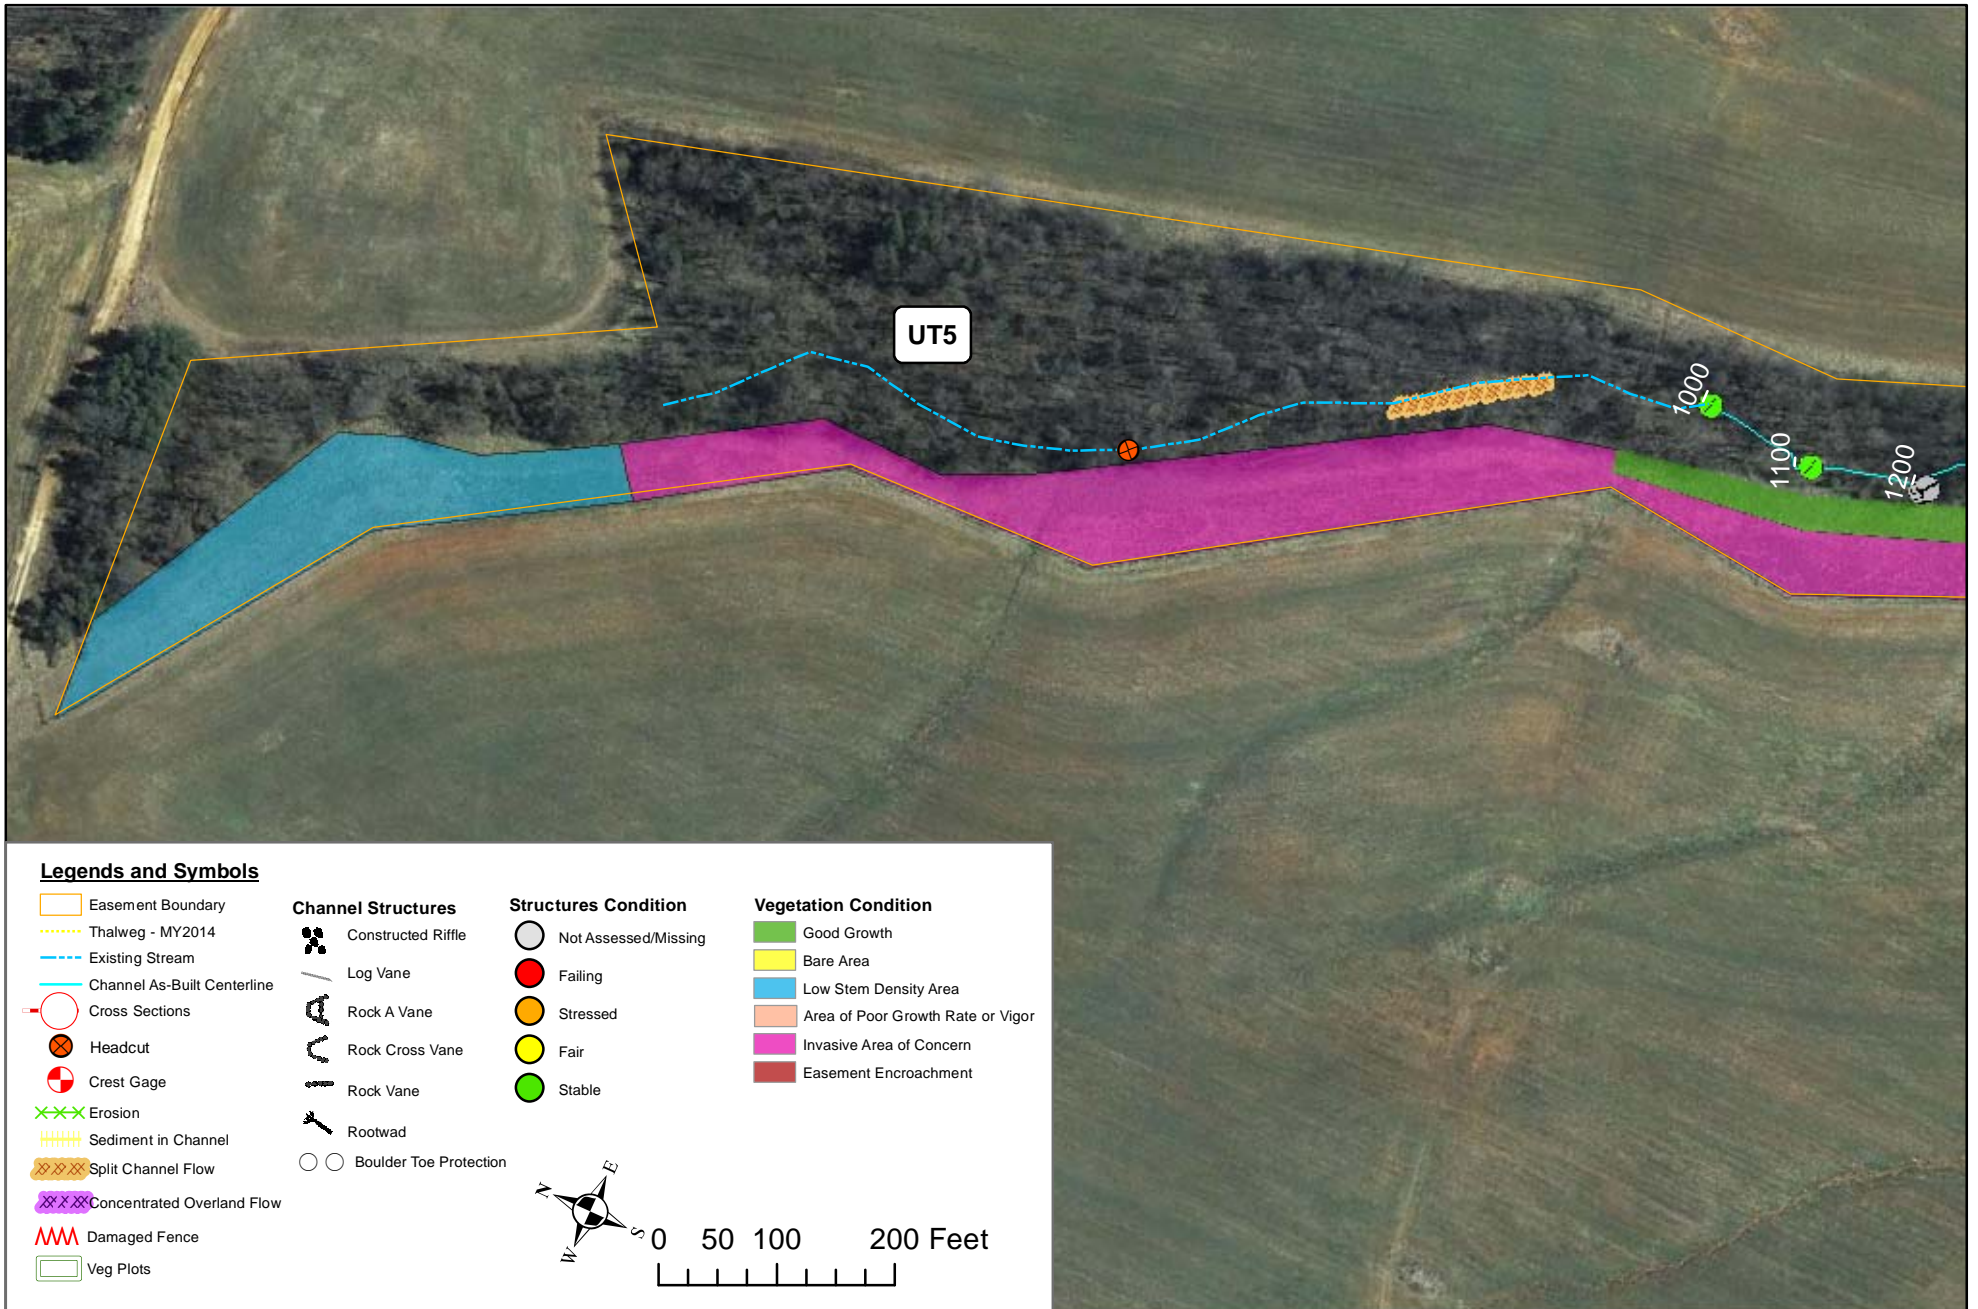
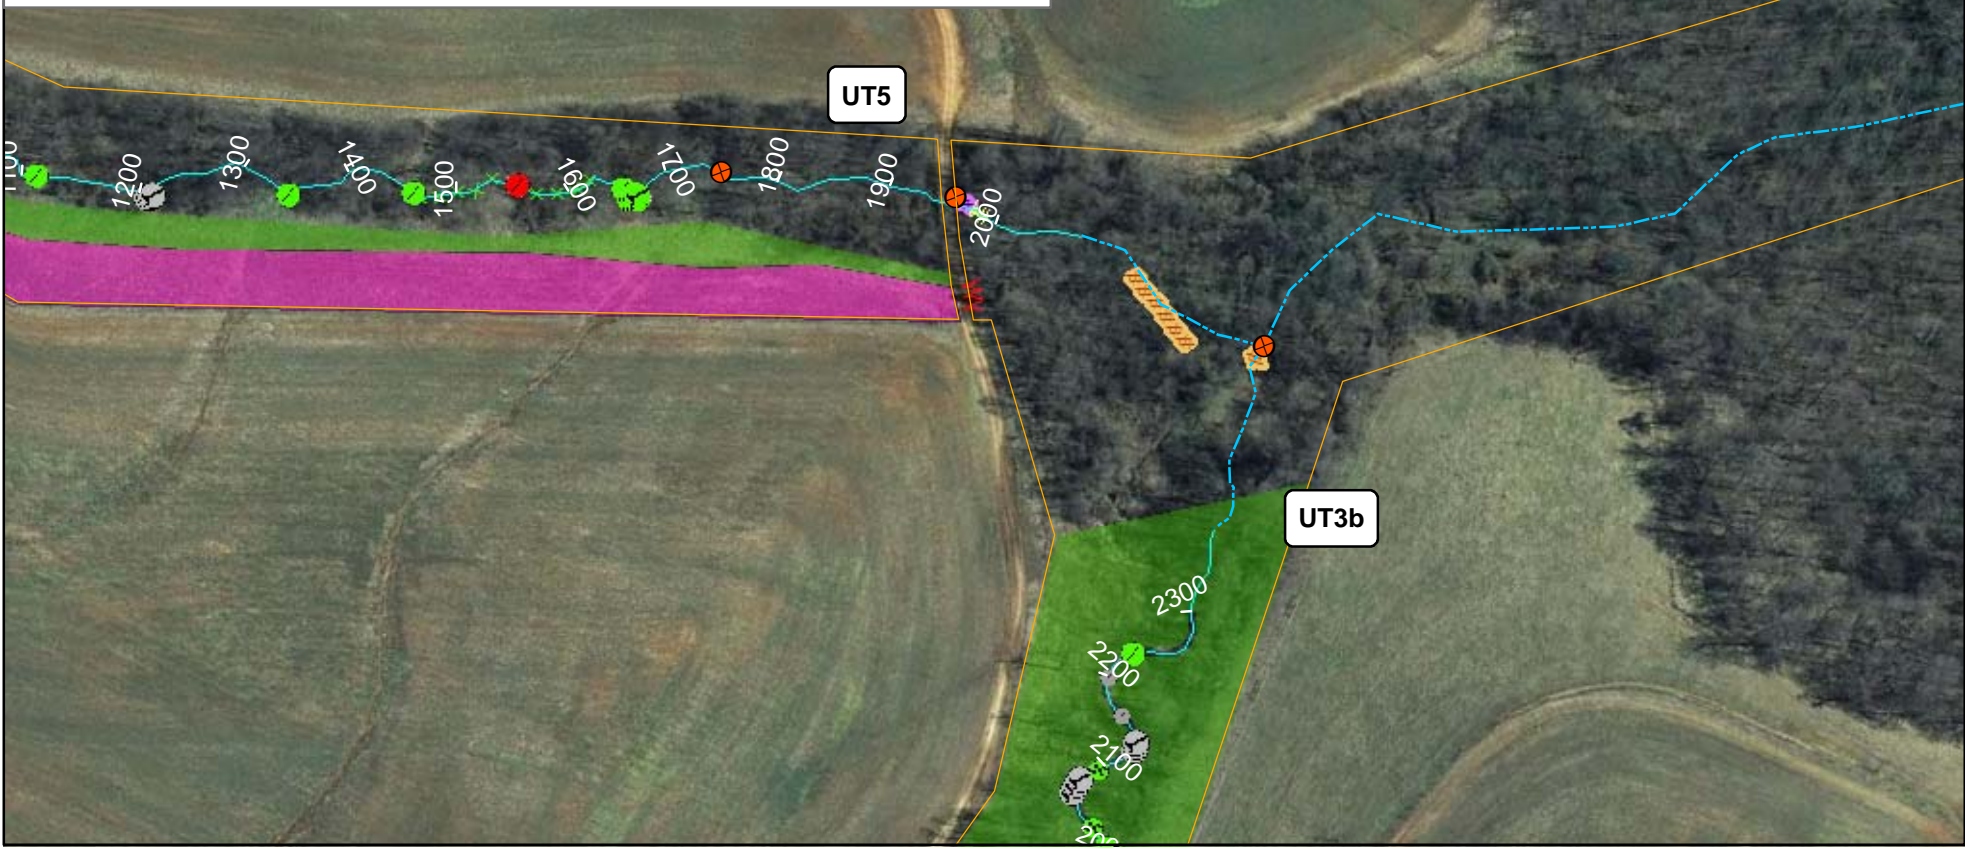
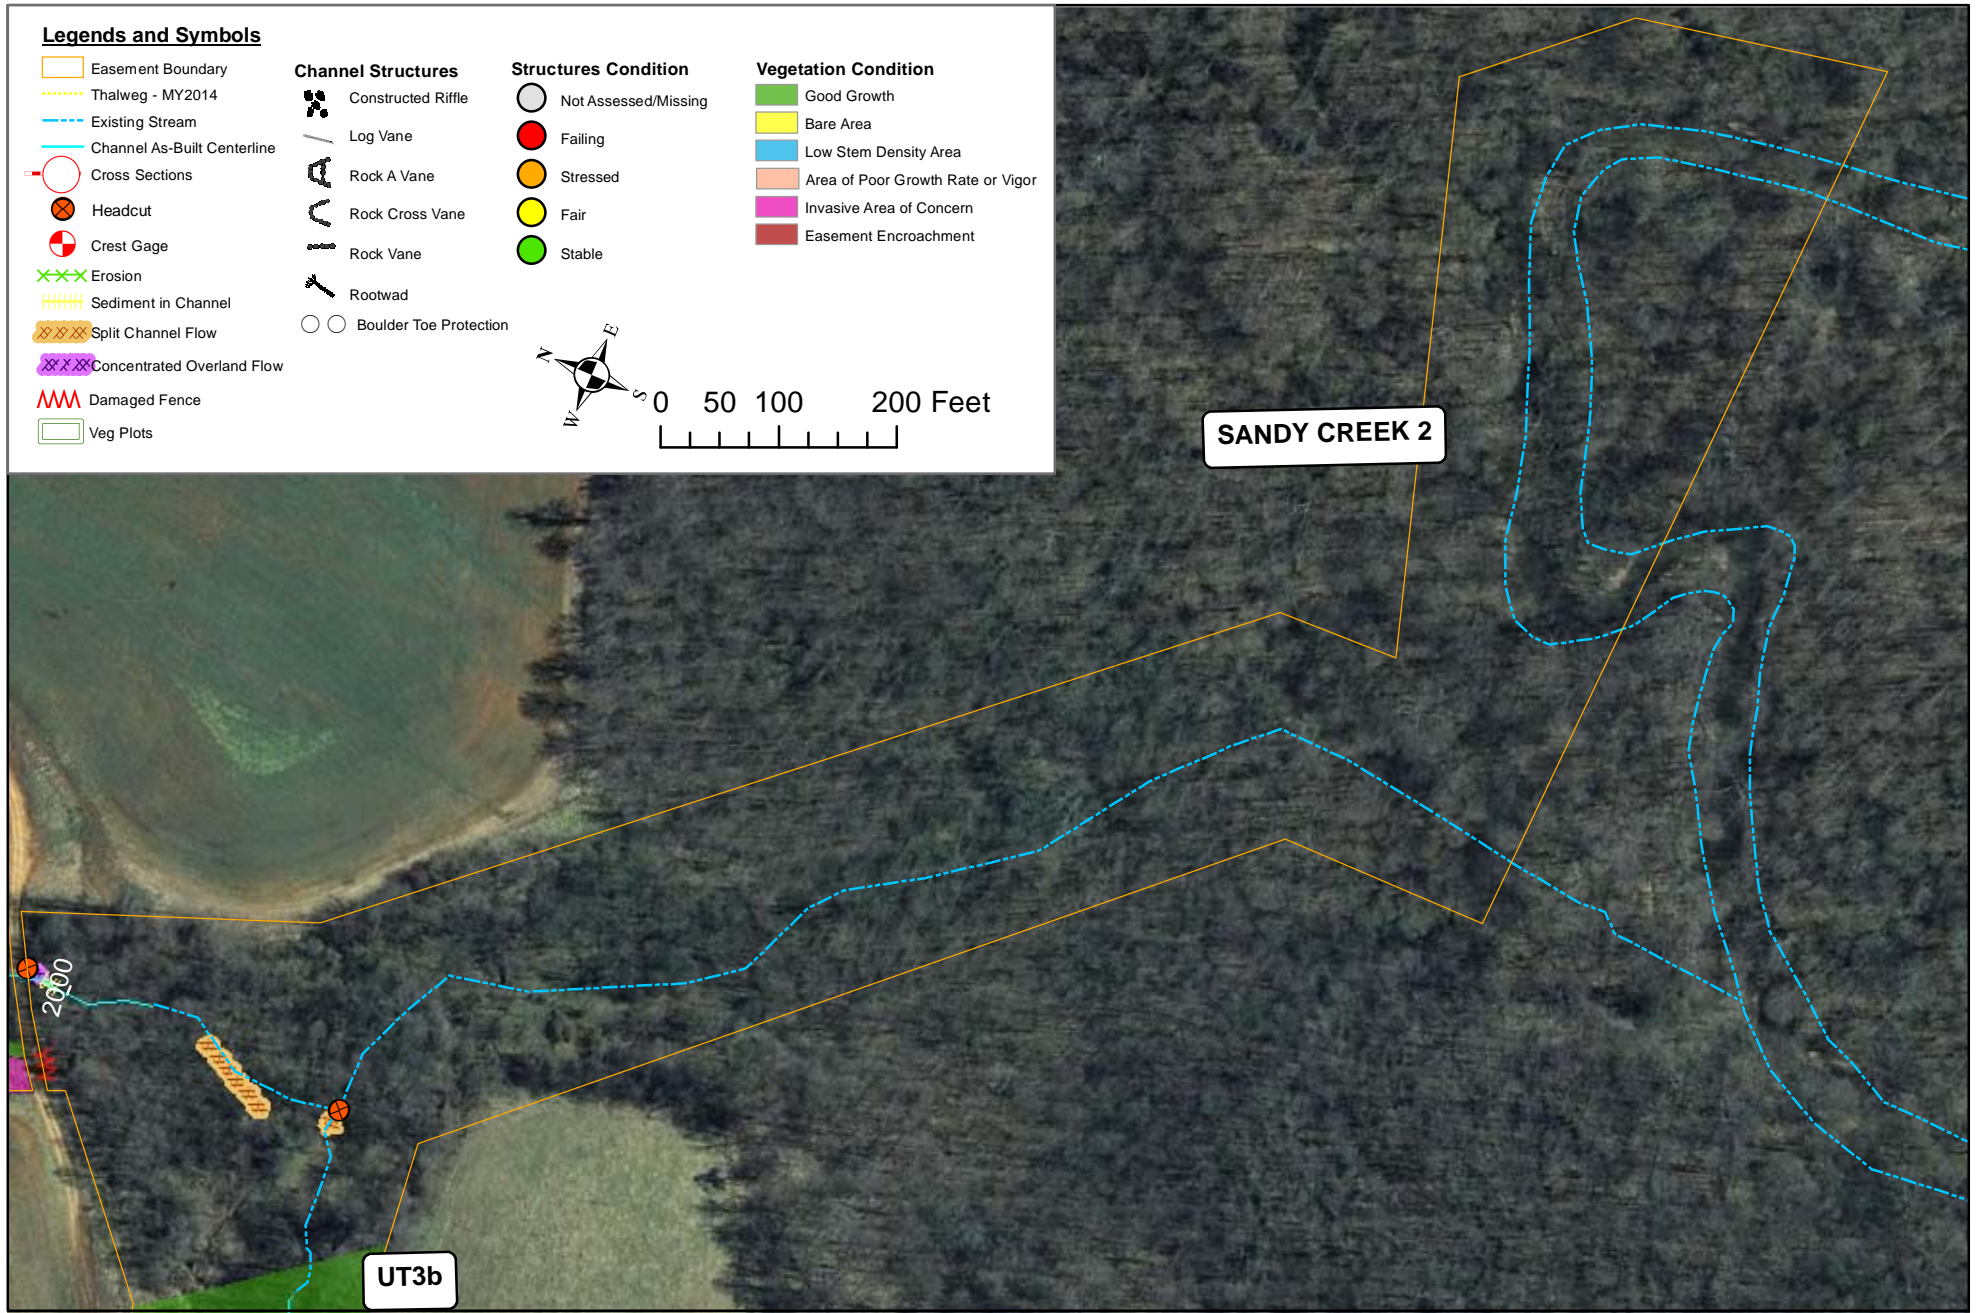
- The conservation easement area surrounding stream reaches UT1, UT2, M1, and UT5 continue to have large areas that lack significant counts of visible planted woody stems. Treatments applied to areas where the easement was replanted seemed to have little effect on herbaceous cover. It was visually observed that the vegetation established within the buffer and outside of the bankfull bench area primarily consists of grasses and herbaceous species. Good vegetation growth was primarily observed within the bankfull bench area for each of these reaches.

- The lower M1 area (downstream of the stream crossing) continues to have a significant invasive species population consisting of Chinese privet and cattails.

- UT3 and UT4 also had instances of tree-of-heaven and Chinese privet throughout the reaches.
- The site continues to be free of encroachments to the easement, although a portion of the fence at the stream crossing of UT5 has been damaged.

The visual assessment and geomorphic data collection completed for the site indicated that approximately 95% of the project reaches were performing within established success criteria ranges. The remaining 5% were exhibiting impacts such as headcuts and stream structure instabilities. The observed stream channel conditions are reflected in the CCPV figures (**Figures 2-9**) within this report and briefly discussed below.

- Two instream structures (Stations M1: 303+25 and 305+00) had flow going between the sill and arm boulders, but no further instability was observed as a result of the conditions
- Two log vanes and one rootwad (Stations M1: 303+75, 314+50, and 321+00) had approximately 15% bank erosion
- Six instances of headcut were observed on UT3, UT4, and UT5
- There continues to be a small area of concentrated overland runoff through the buffer on the UT3a near Station 10+50, and on UT4 at Station 10+00 that is causing erosion to the stream bank
- Two areas of split channel flow were identified along the existing stream at the upstream and downstream section of UT5

Invasive species continue to be treated on reaches UT1, UT2, UT3, UT4, and M1. The target species of concern includes *Ailanthus altissima* and *Ligustrum sinense*. Detailed maps on invasive species control efforts can be found in **Appendix C**.

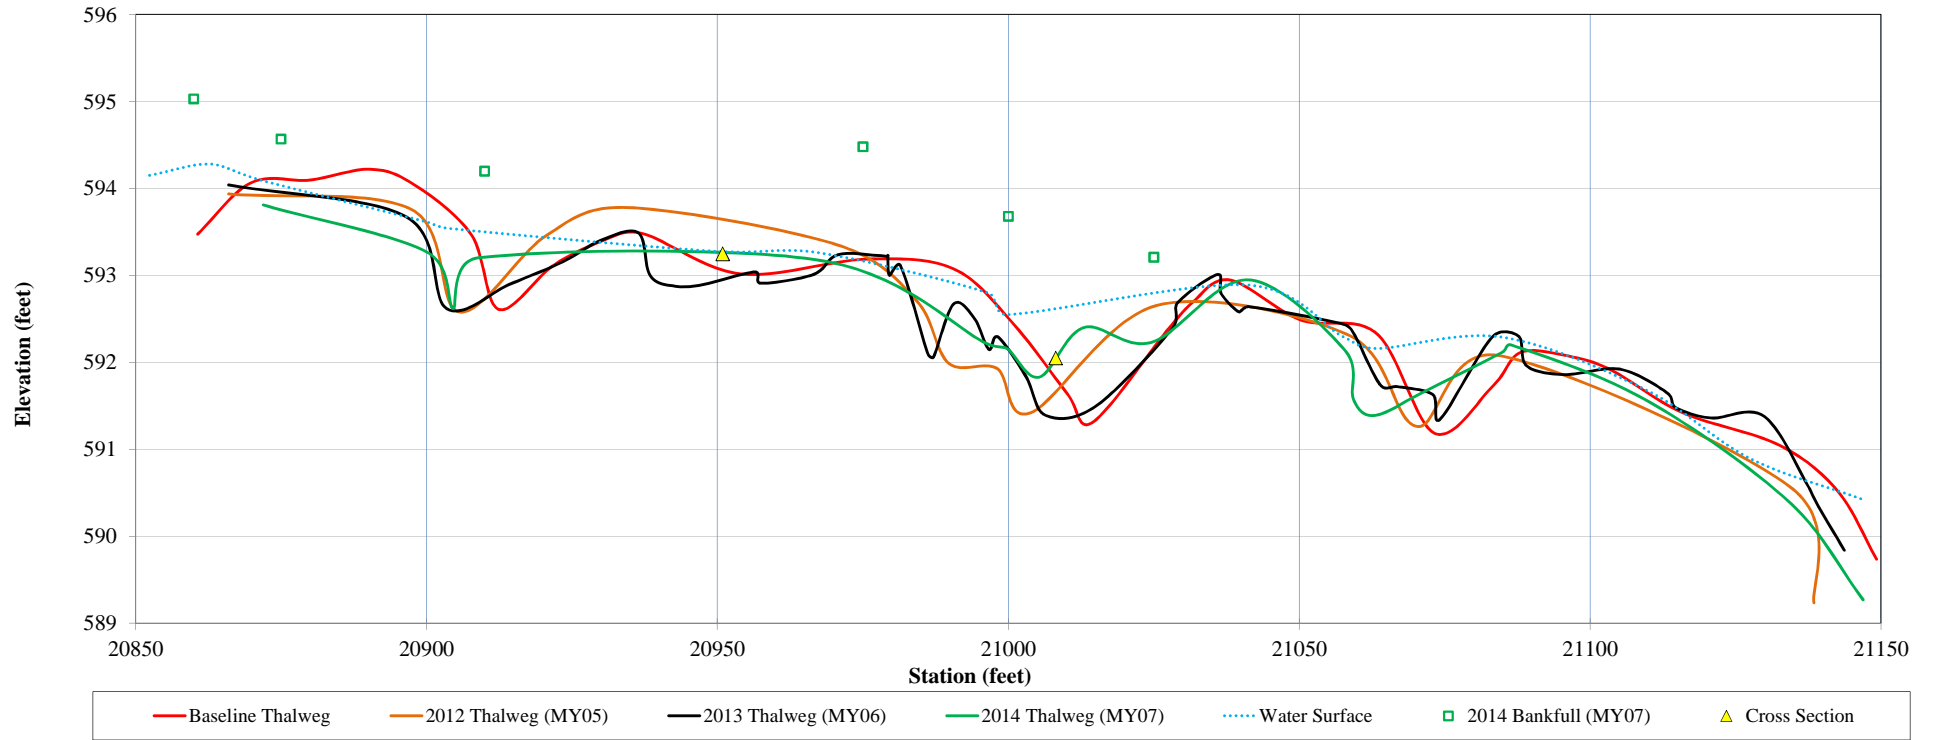
### MEREDELL UT2 STREAM THALWEG PROFILE 2014

NOTE: No areas of significant stream instability were observed during the field survey. Survey monuments were not present in the field. Due to this and differences in surveying methodologies between monitoring year 5 and monitoring years 6 and 7, the longitudinal profile data may differ in some areas.

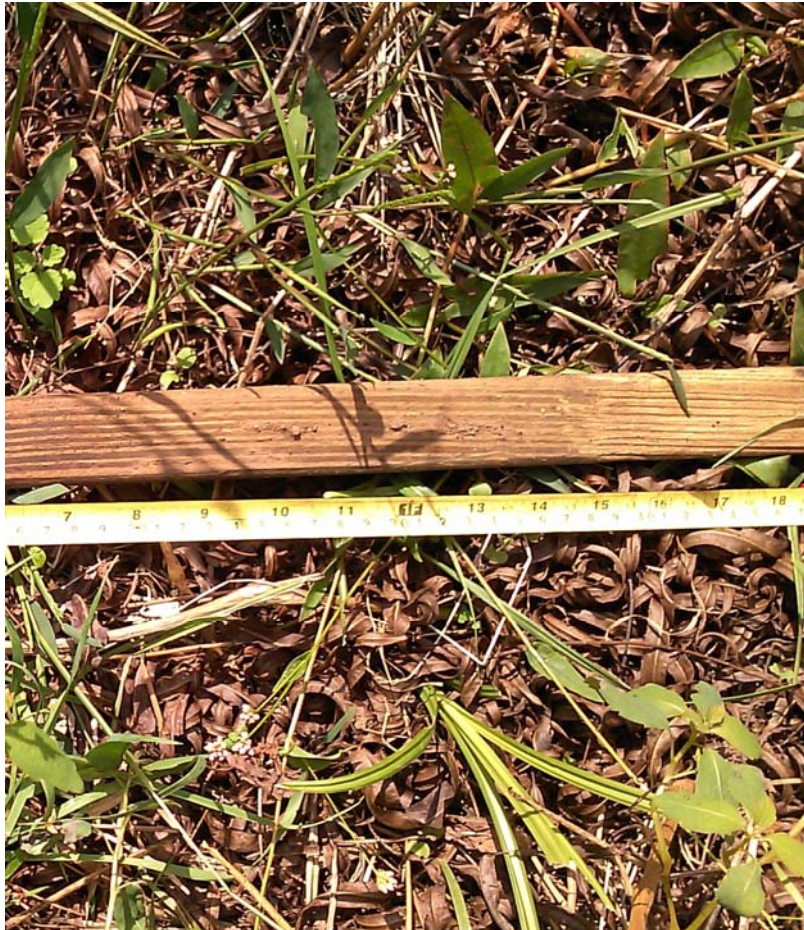
SP1: Crest Gauge Reading

- Wracklines were noted above the bankfull bench and within the floodplain during the site assessment field visit conducted on October 1, 2014.
- A crest gauge reading of 1.08 feet was recorded during the annual monitoring field visit conducted on October 1, 2014. The baseline bankfull design maximum depth range for reach M1 is 1.0 foot (min) to 1.3 feet (max); therefore, the crest gauge reading indicates that a bankfull event had occurred onsite. Refer to photograph SP1 within **Appendix E** of this report.

Date of Data Collection	Date of Occurrence	Method	Photo # (if available)
8/24/2010	N/A	*Crest Gauge Reading: 1.96'	
10/20/2011	N/A	Crest Gauge indicates BKF event	
3/26/2012	N/A	Wracklines indicate BKF event on UT1b	SP2 (MY5 report)
10/18/2012	N/A	*Crest Gauge Reading: 1.17'	SP1 (MY5 report)
10/30/2013	N/A	*Crest Gauge Reading: 3.6'	SP1 (MY6 report)
10/30/2013	N/A	Wracklines indicate BKF event on M1	SP2 (MY6 report)
10/1/2014	N/A	*Crest Gauge Reading: 1.17'	SP1 (below)

\*Design bankfull depth range for reach M1 is 1.0' to 1.3'. Crest gauge readings occurring at, above, or within this range are recorded as bankfull indicators
