**MEREDELL FARM  
ANNUAL MONITORING REPORT  
YEAR 8 OF 8**

DMS Project #247  
Randolph County, North Carolina  
Completed Construction: 2008  
Submitted January 2016

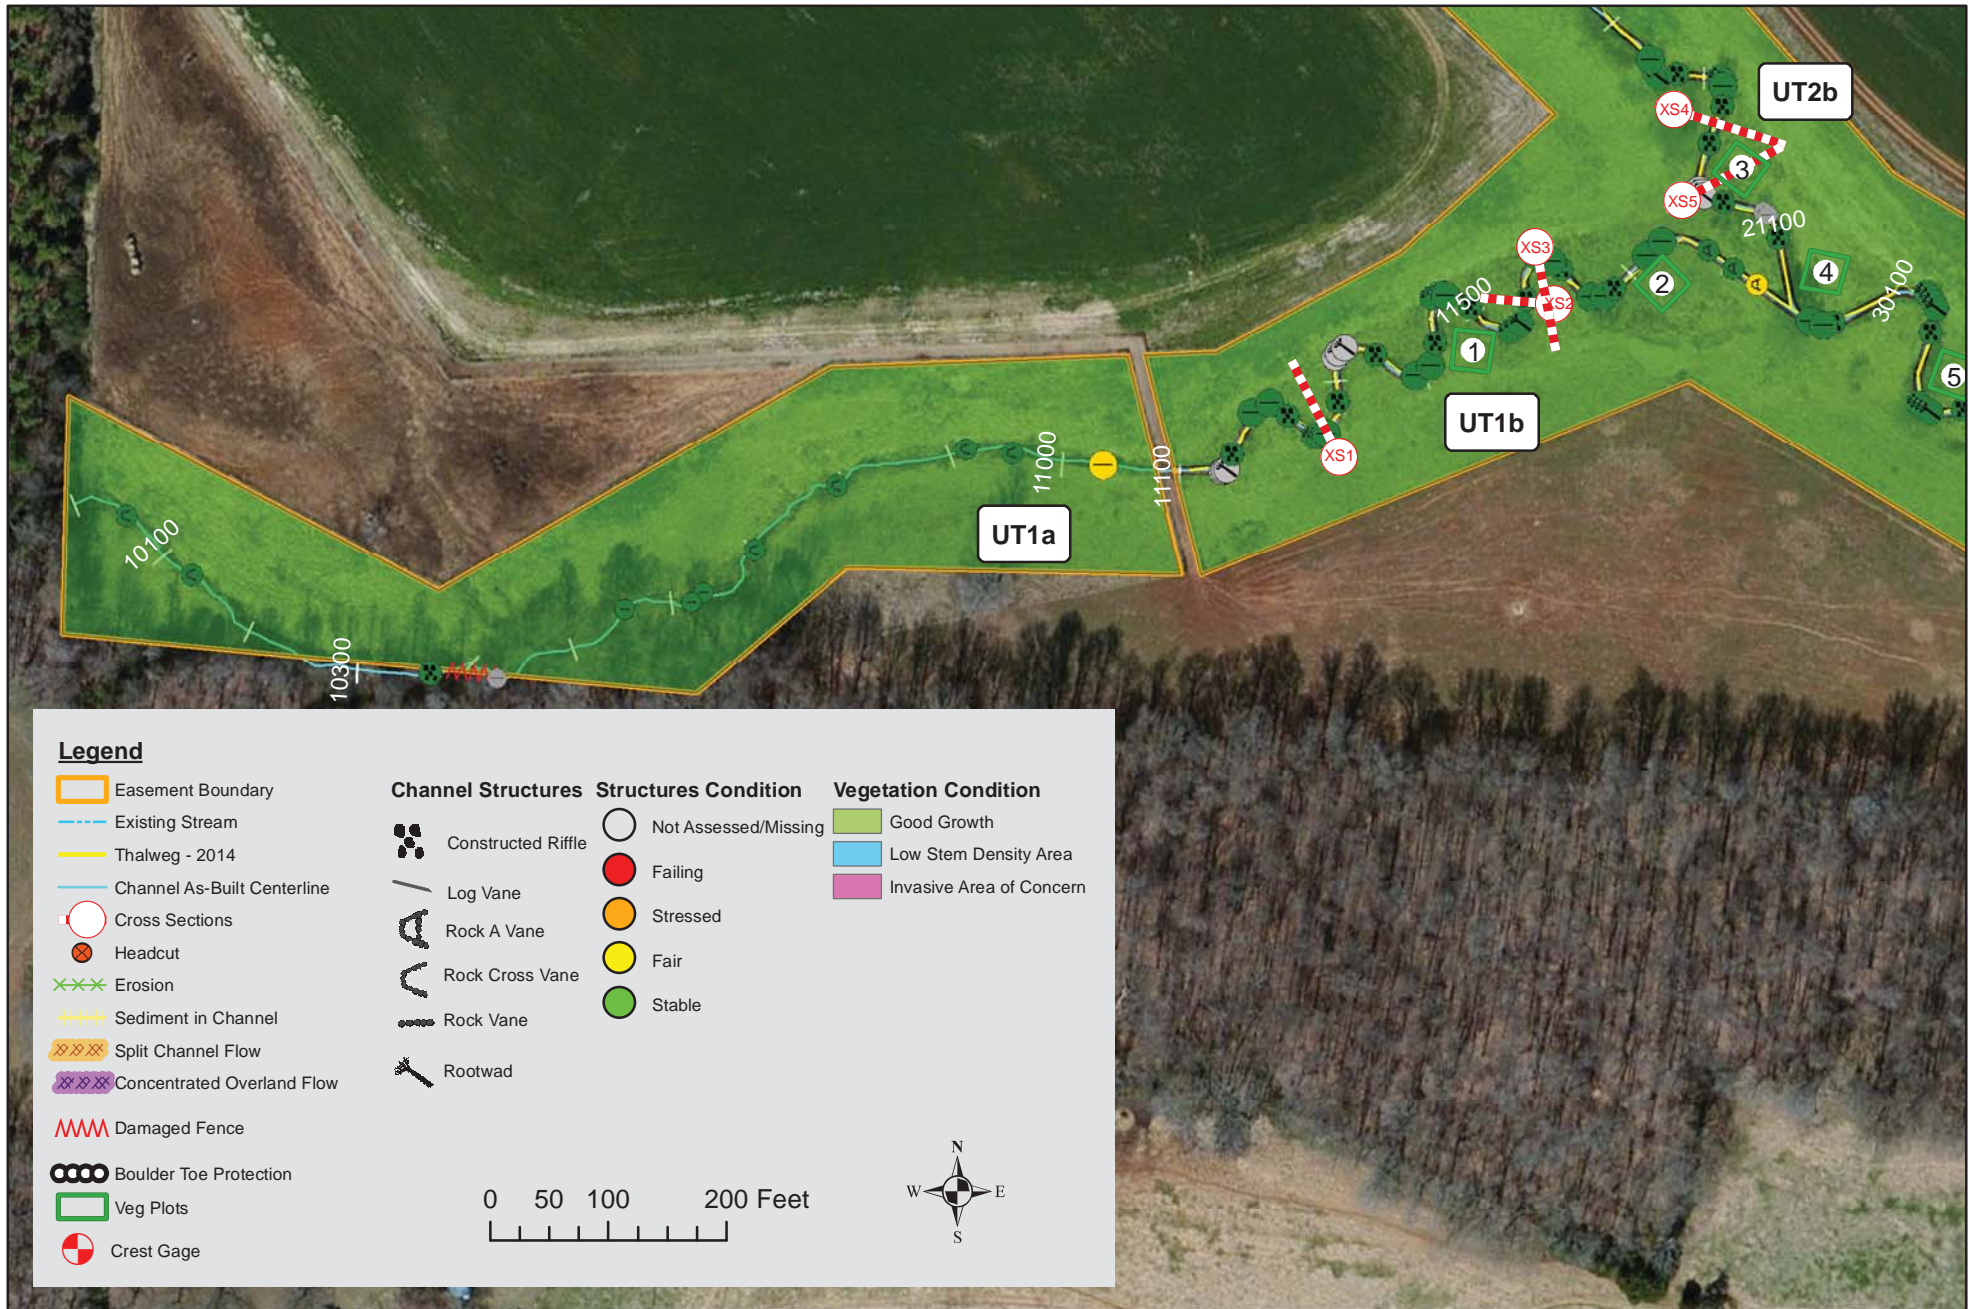
**Figure**

The visual assessment completed for the site indicated the project reaches were performing within established success criteria ranges. Some areas of headcuts and stream structure instabilities that were observed in previous monitoring years were observed this year, but had not increased in severity or number. The observed stream channel conditions are reflected in the CCPV figures (**Figures 2-9**) within this report and briefly discussed below.

- Two instream structures (Stations M1: 303+25 and 305+00) had flow going between the sill and arm boulders, but no further instability was observed as a result of the conditions.
- Two log vanes and one rootwad (Stations M1: 303+75, 314+50, and 321+00) had approximately 15% bank erosion.
- Six instances of headcut were observed on UT3, UT4, and UT5.
- There continues to be two small areas of concentrated overland runoff through the buffer on UT3a at Station 10+00 and UT4 at Station 10+00 that are causing erosion to the stream banks. One area was also observed on UT5 and Station 20+00.
- Two areas of split channel flow were identified along the existing stream at the upstream and downstream section of UT5.
- The sediment noted during the site assessment in May 2015 in UT1b, UT2a, and M1 Upper is no longer present in large amounts.

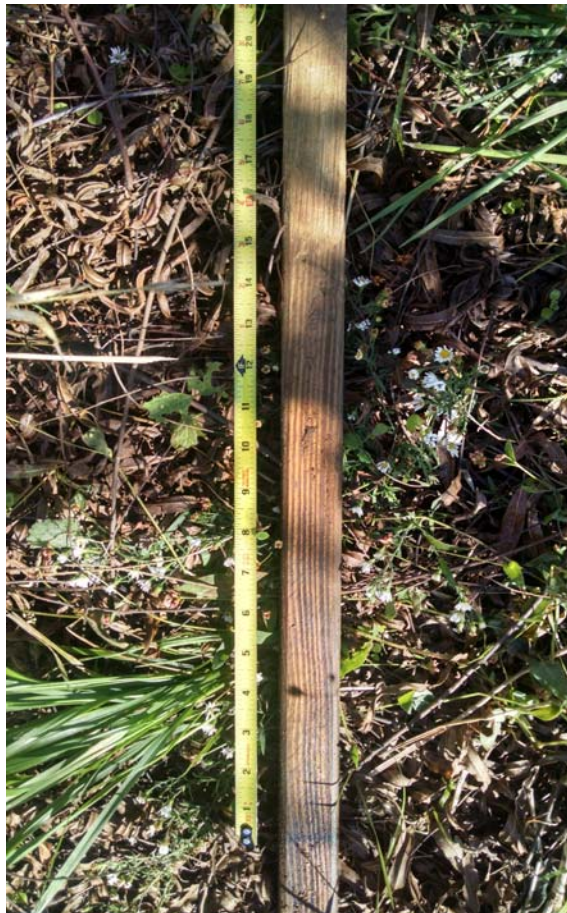
- Wracklines were noted above the bankfull bench and within the floodplain during the site assessment field visit conducted on October 19-20, 2015.
- A crest gauge reading of 1.13' was recorded during the annual monitoring field visit conducted on October 20, 2015. The baseline bankfull design maximum depth range for reach M1 is 1.0 foot (min) to 1.3 feet (max); therefore, the crest gauge reading indicates that a bankfull event had occurred onsite. Refer to photograph SP1 within **Appendix E** of this report.

SP1: Crest Gauge Reading
