Annual Monitoring Report

Monitoring Year 1 of 5

Middle South Muddy Stream Restoration Site

NCDMS Project No.: 93875

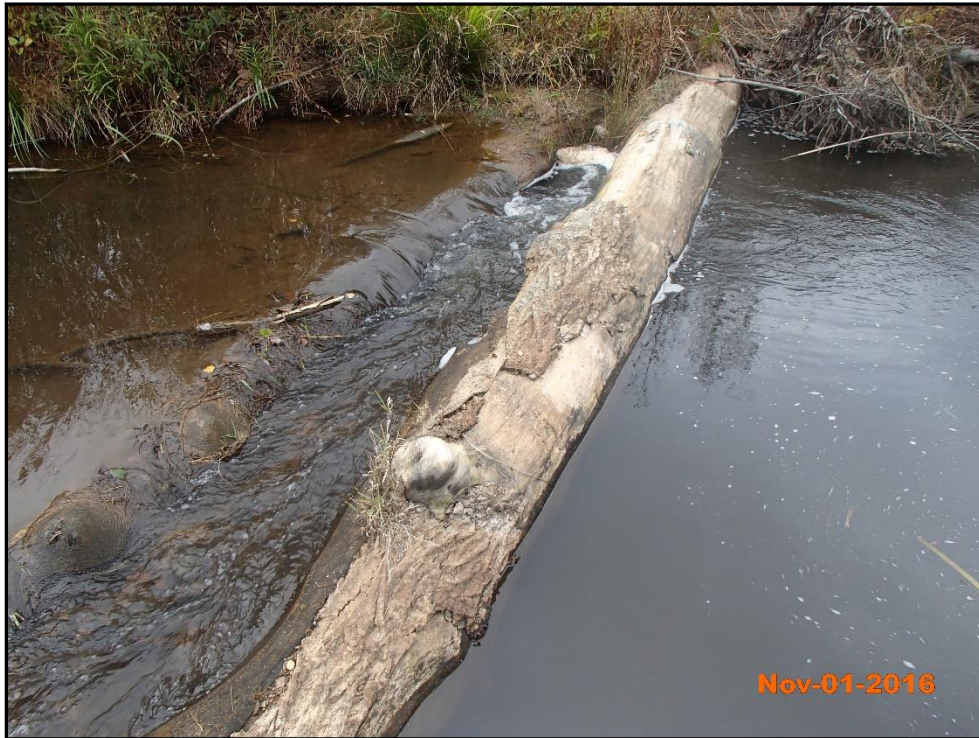
Visual assessment of the stream channel was performed to document signs of instability, such as eroding banks, structural instability, or excessive sedimentation. One structure on South Muddy Creek at STA 108+83 has been classified as being stressed. Displacement of backfill material has exposed the backer log and filter fabric which has resulted in partial piping through the structure. Additionally, the downstream head-of-riffle has lowered approximately 0.3 ft which has increased the drop over this structure (Table 5 and Figure 2). This area will be assessed during future site visits to monitor the integrity of the structure. Deposition of fine sediment is evident throughout the South Muddy Creek reach. This can be attributed to drought conditions and forest clearcutting activities upstream causing an influx of sediment moving into the project site. A pipe that is being used as a water intake was located at

Stressed Structure – South Muddy Creek STA 108+83

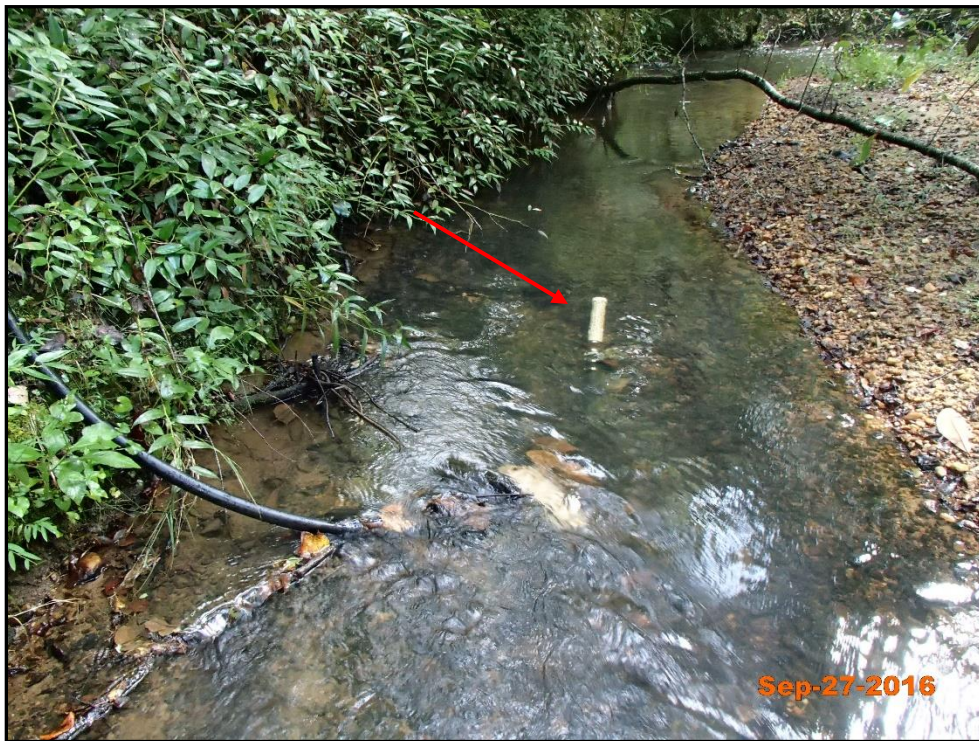
STA 7+75 within the Haney Preservation Tract (Figure 2). It appears a pump is being used to remove water from the stream for mining operations outside of the conservation easement.

Pump Intake – Haney Preservation Tract South Muddy Creek 7+75

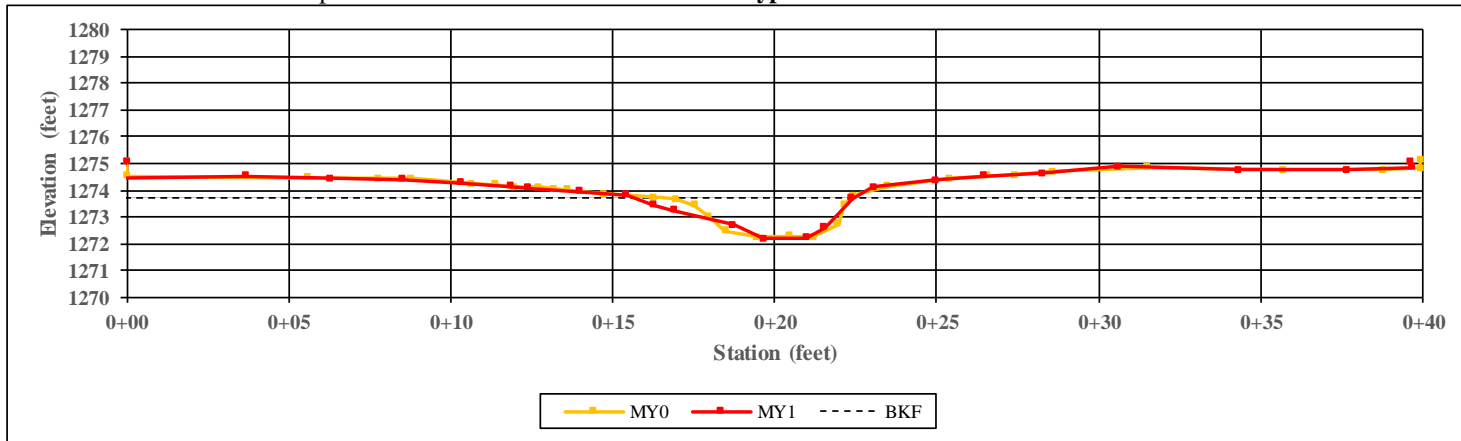
XS Number: 3
XS Type: Pool

Geomorphic data for MY1 was collected from November through December 2016. Summary tables and cross-section data plots related to stream morphology are located in Appendix D. Noticeable change in the cross-section data between MY0 and MY1 occurred only at cross-section 3, where scour along the left descending bankfull bench led to an increase in the bankfull width from 6.1 feet to 6.8 feet (Appendix B, Table 11a).

CHANNEL DIMENSIONS SUMMARY	MY0	MY1	MY2	MY3	MY4	MY5	MY6	MY7
Bankfull Width (ft)	6.1	6.8	-	-	-	-	-	-
Floodprone Width (ft)	32.0	32.0	-	-	-	-	-	-
Bankfull Mean Depth (ft)	1.0	0.9	-	-	-	-	-	-
Bankfull Max Depth (ft)	1.5	1.6	-	-	-	-	-	-
Bankfull Cross-Sectional Area (ft ²)	5.9	6.3	-	-	-	-	-	-
Width/Depth Ratio	6.3	7.5	-	-	-	-	-	-
Entrenchment Ratio	5.3	4.7	-	-	-	-	-	-
Bank Height Ratio	1.0	1.0	-	-	-	-	-	-

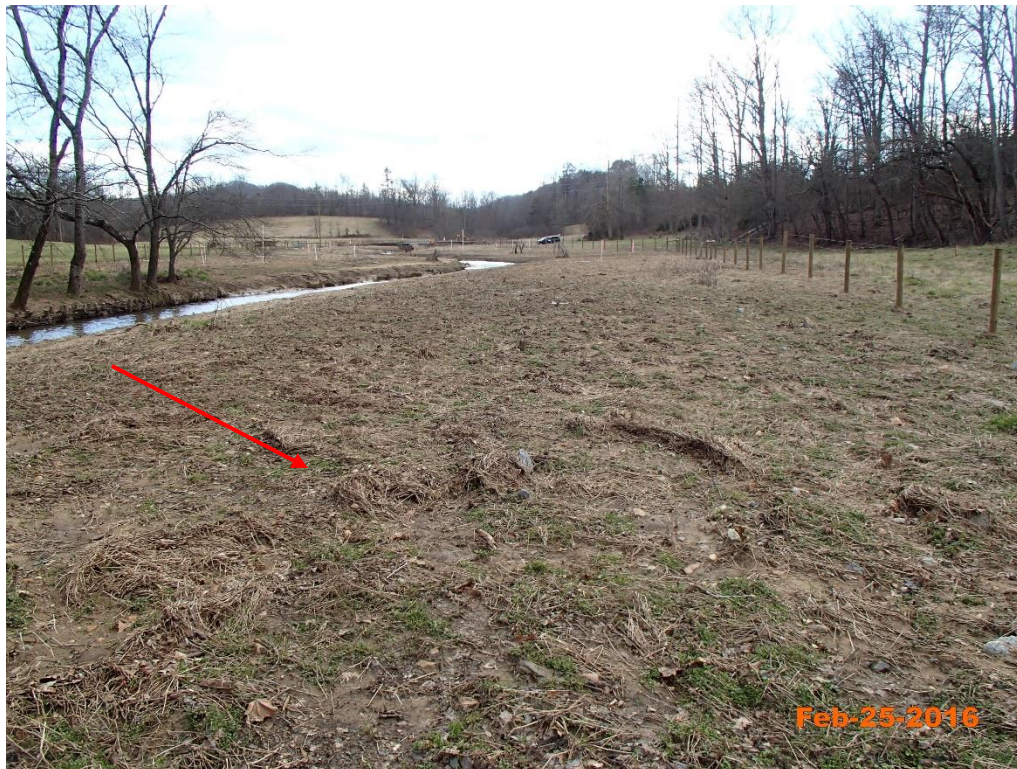
Since project completion in December 2015 one bankfull event was documented on both Iva Branch and South Muddy Creek (Table 13). Based on precipitation data, the suspected date is February 3rd, 2016. This is the first recorded bankfull since project completion.

Photo #1 - South Muddy Creek Wrack Lines

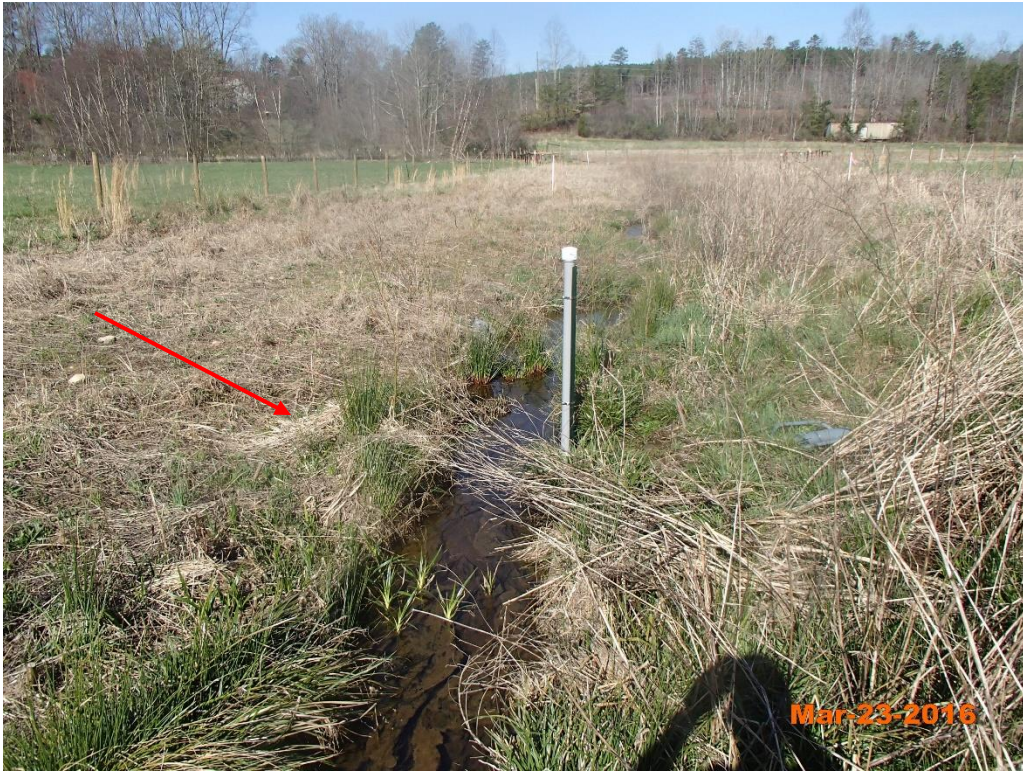
Photo #2 – Sprouse Branch Wrack Lines

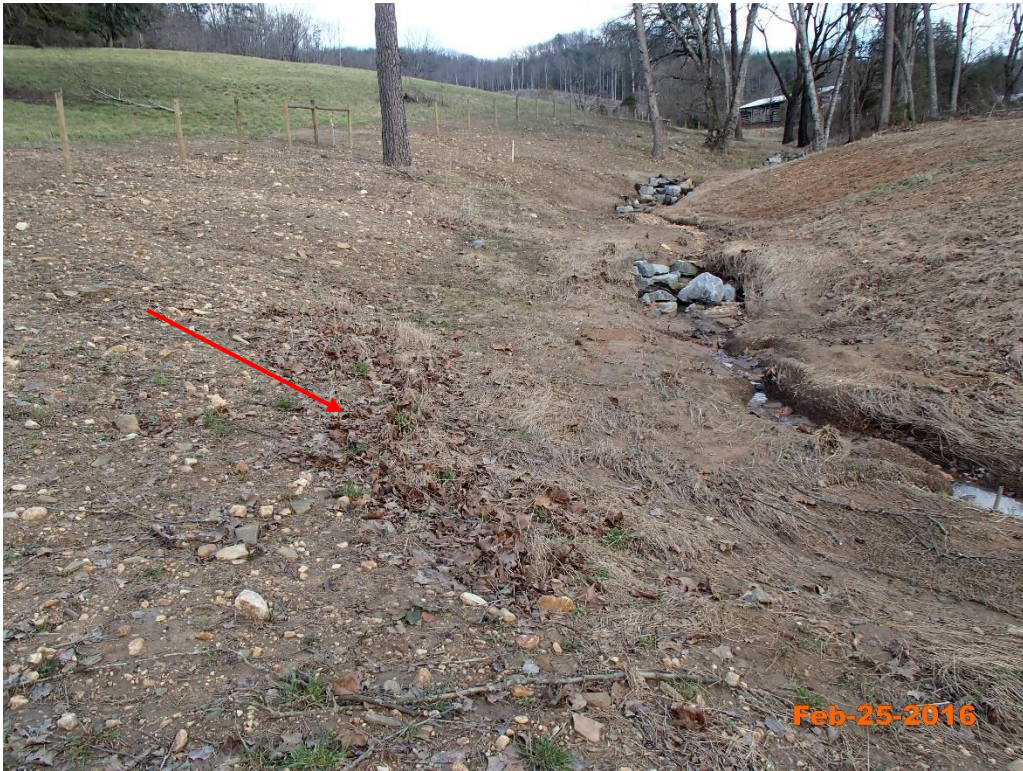
Photo #3 – Iva Branch Wrack Lines
