# **Annual Monitoring Report**

Monitoring Year 2 of 5

Middle South Muddy Stream Restoration Site

NCDMS Project No.: 93875

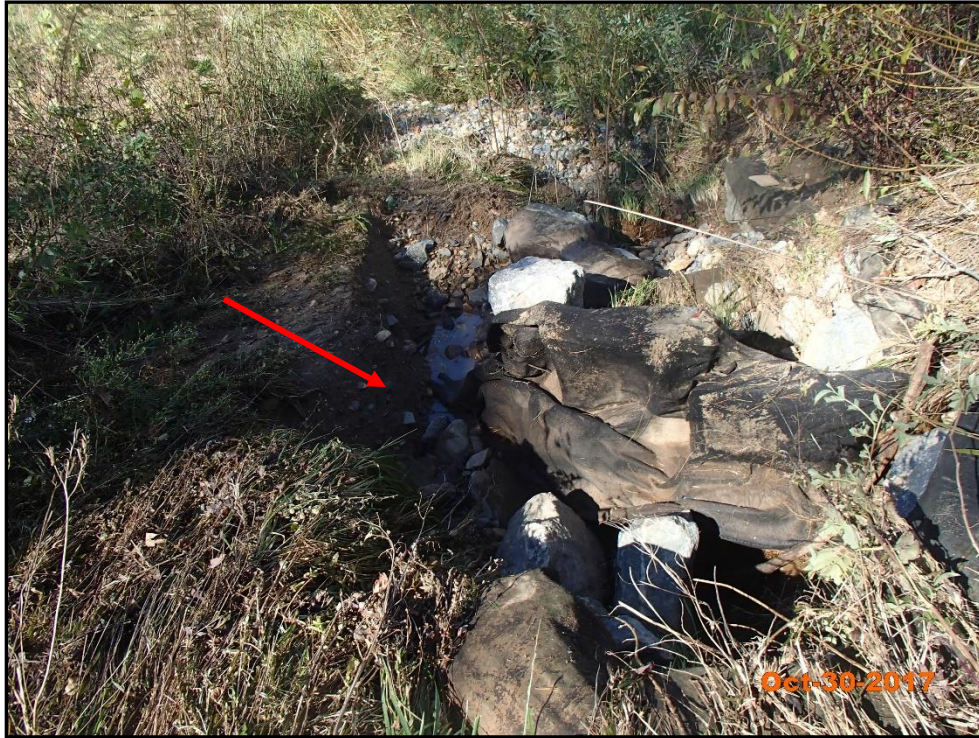
Failed Structure – Iva Branch STA 303+67 (looking downstream)

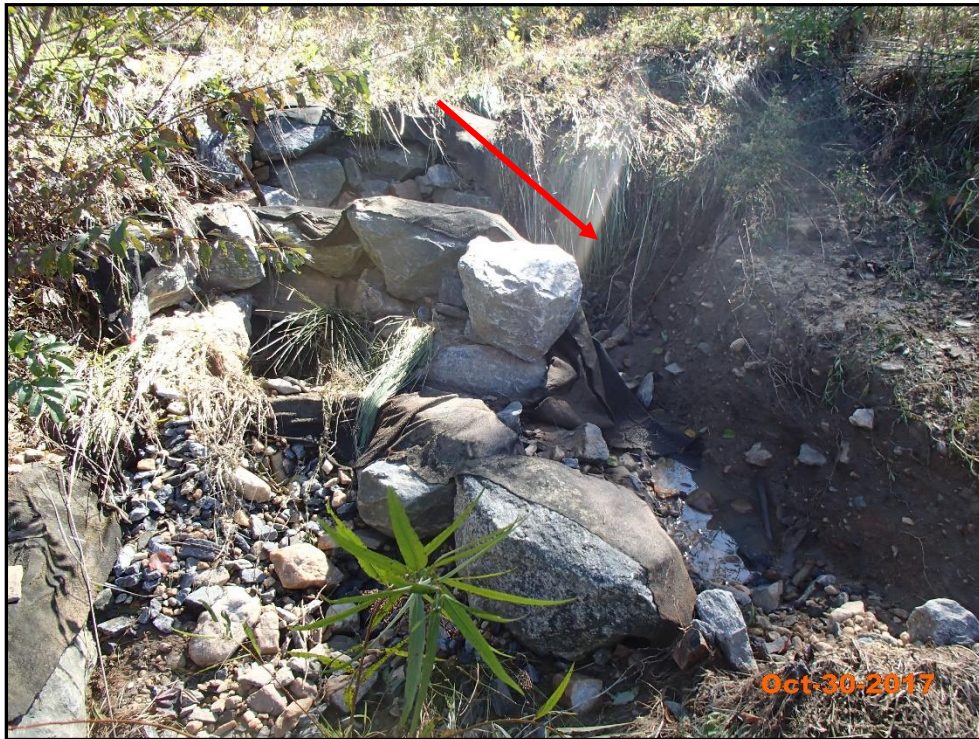
Failed Structure – Iva Branch STA 303+67 (looking upstream)

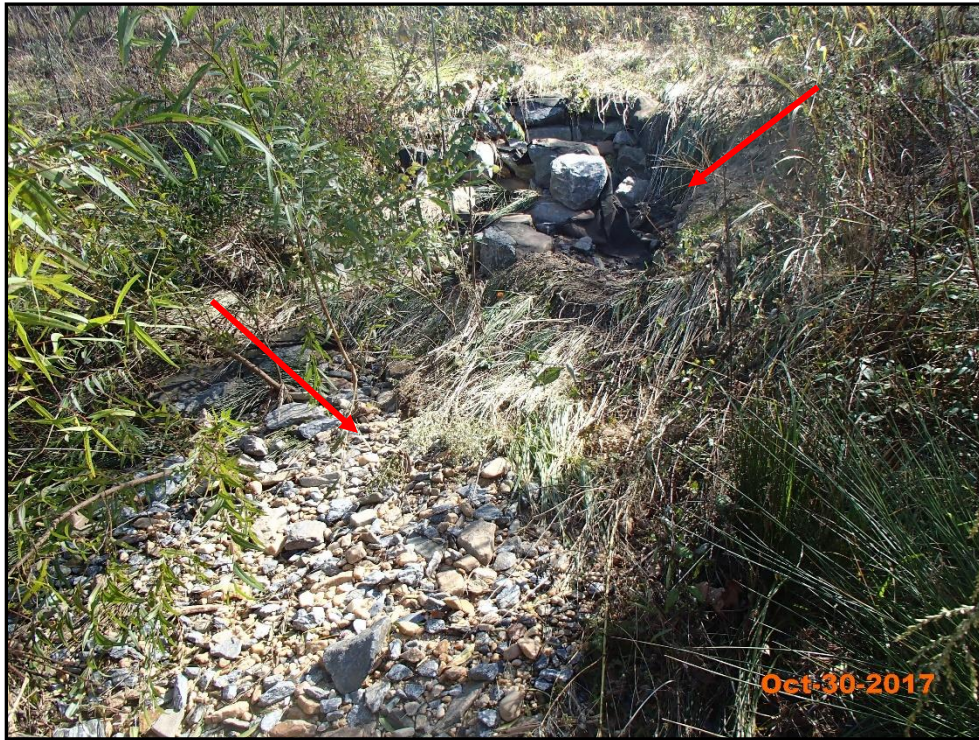
Aggradation/ Failed Structure – Iva Branch STA 303+75

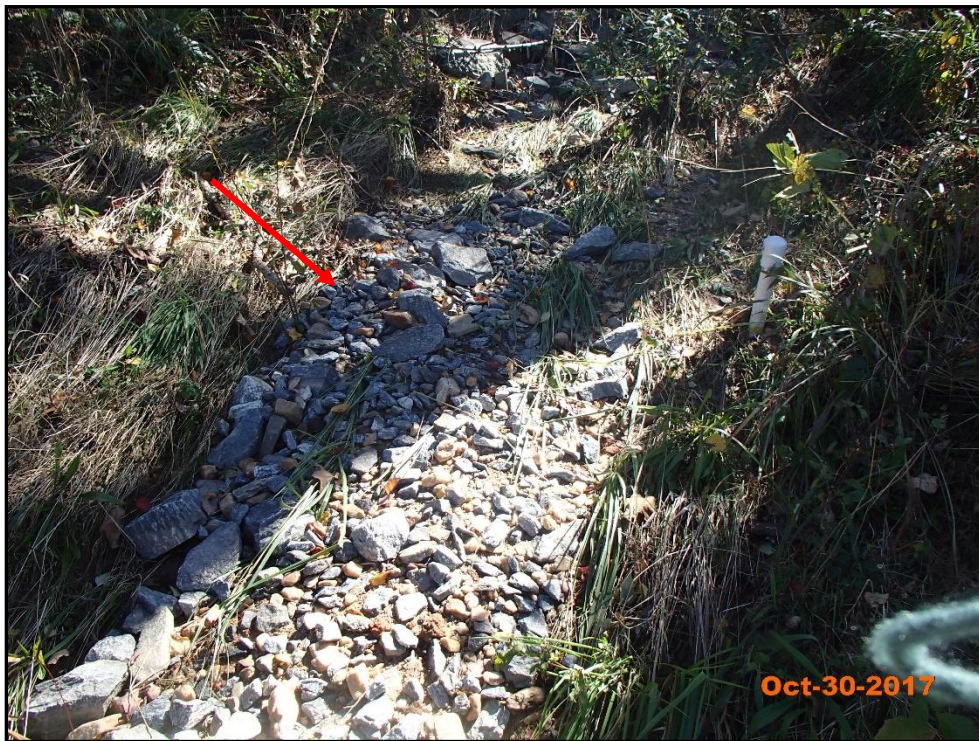
Aggradation – Iva Branch 303+25

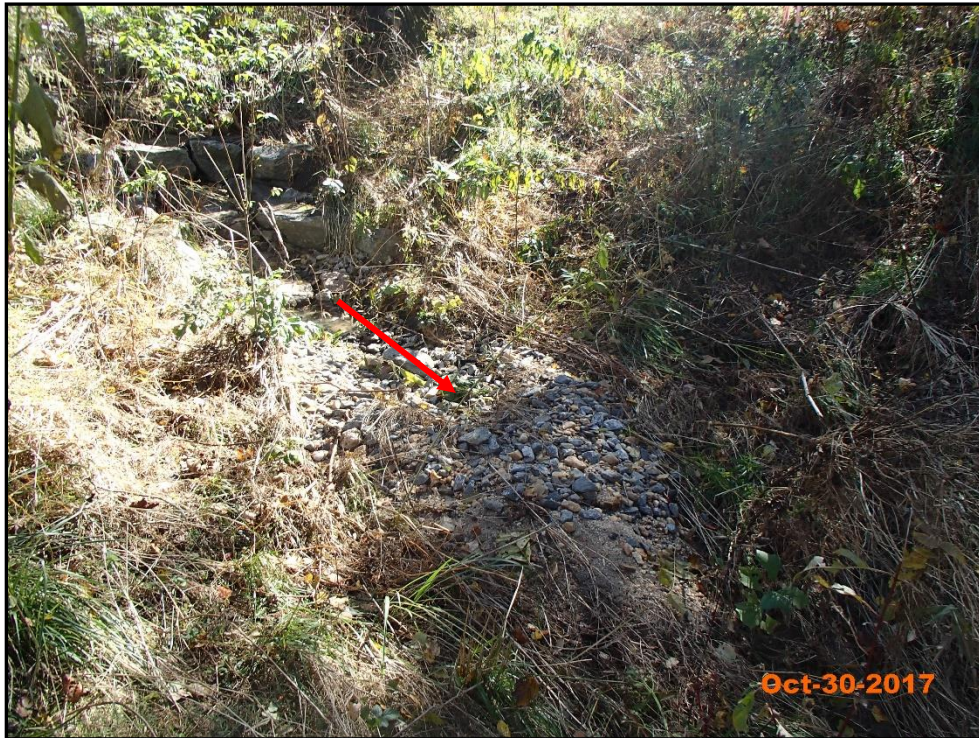
Aggradation – Iva Branch STA 302+25

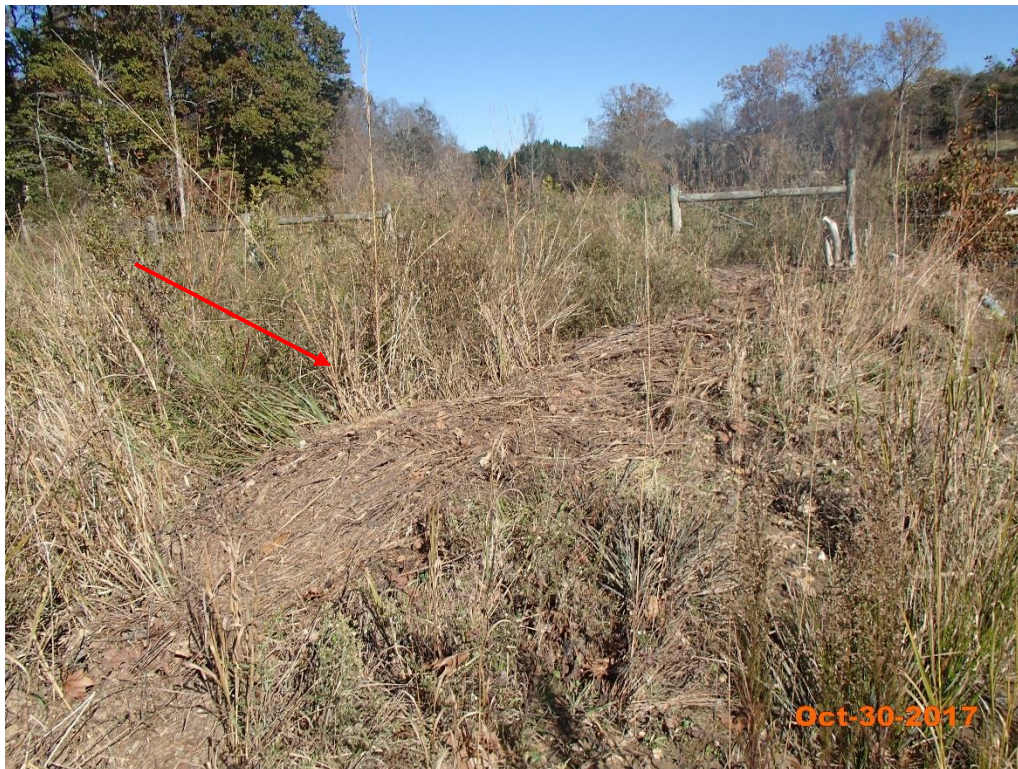
Photo #1 - South Muddy Creek Wrack Lines STA 104+00

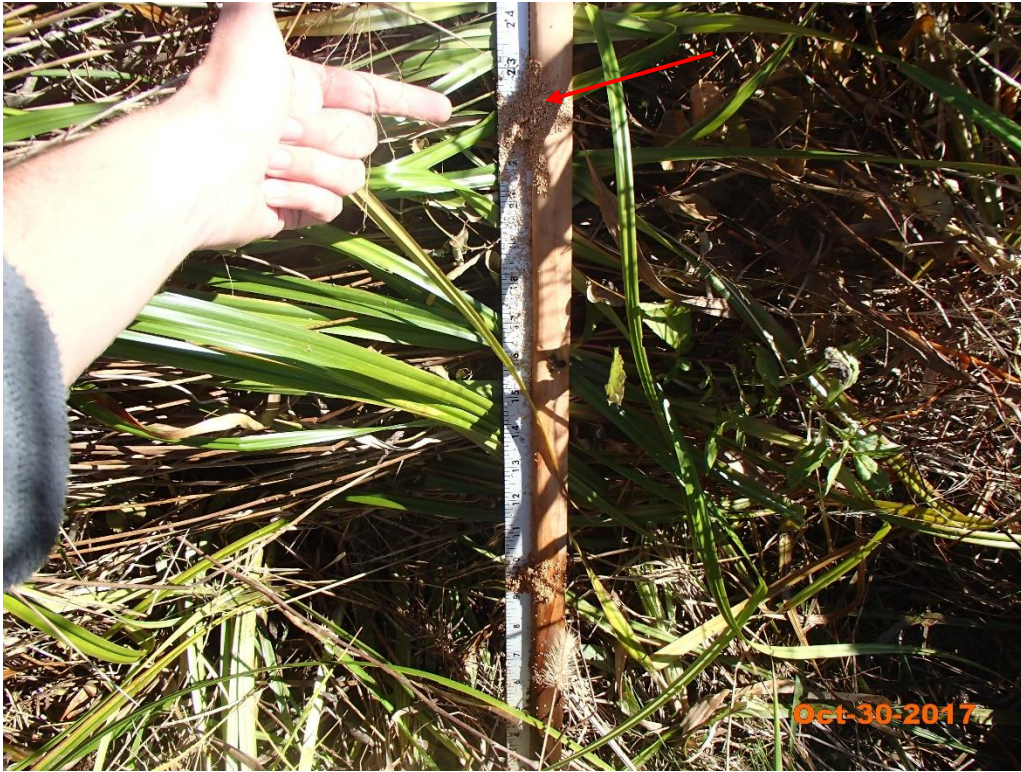
Photo #2 – Sprouse Branch Crest Gauge at 22 inches

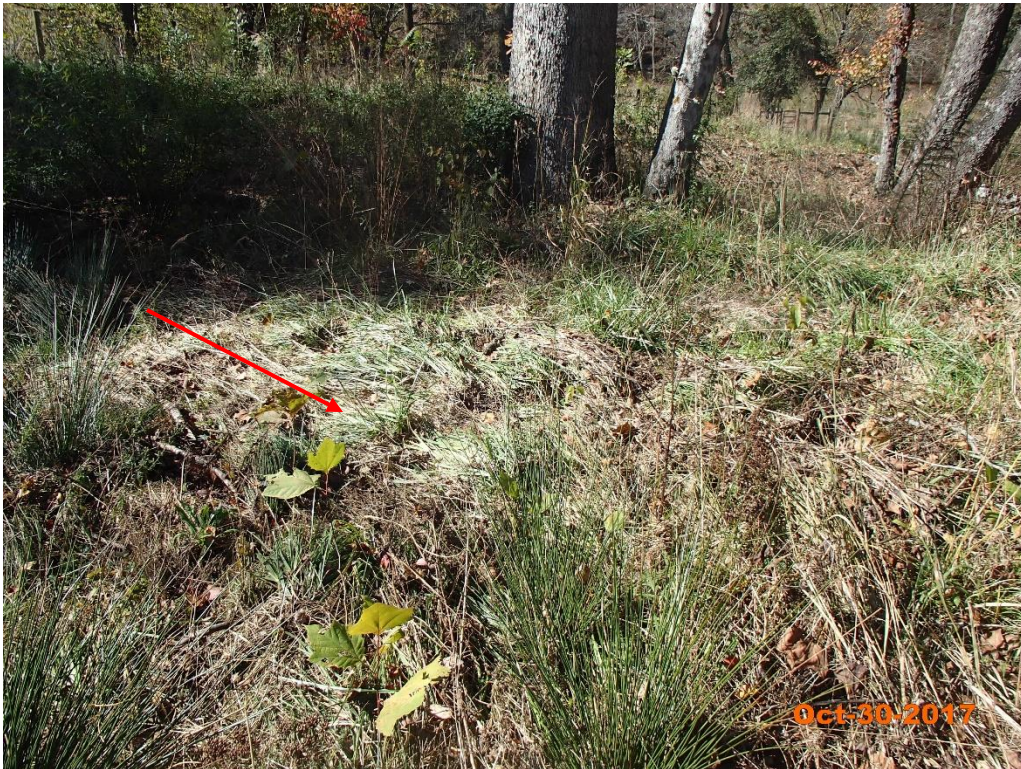
Photo #3 – Iva Branch Wrack Lines at STA 305+00
