Annual Monitoring Report

Monitoring Year 4 of 5

Middle South Muddy Stream Restoration Site

McDowell County, North Carolina

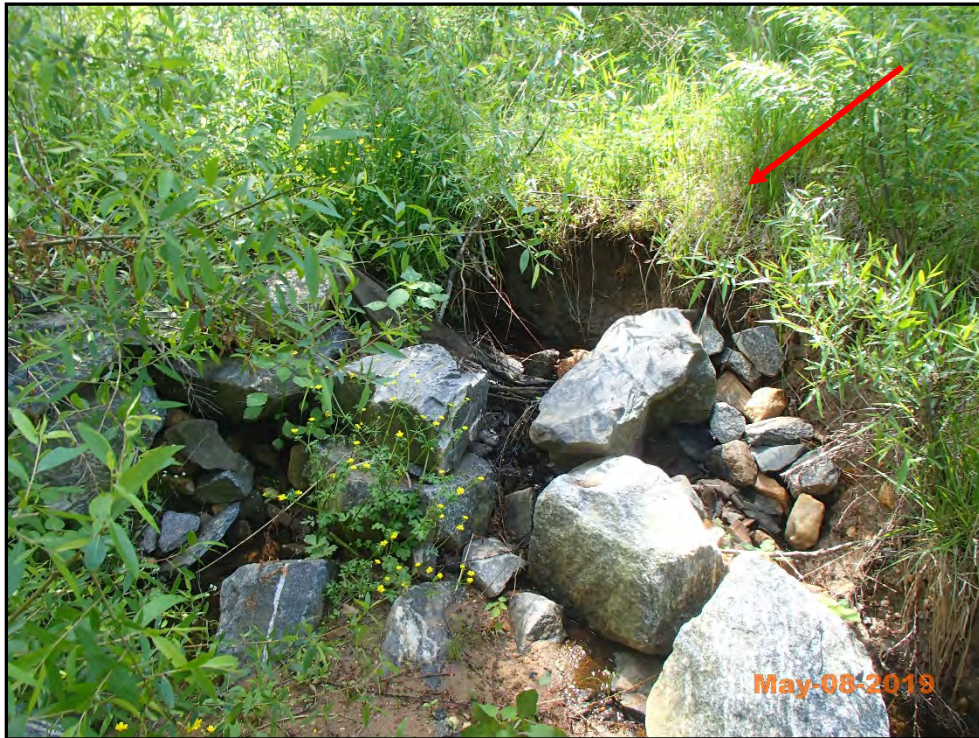
Failed Structure – Iva Branch STA 303+67 (looking upstream)

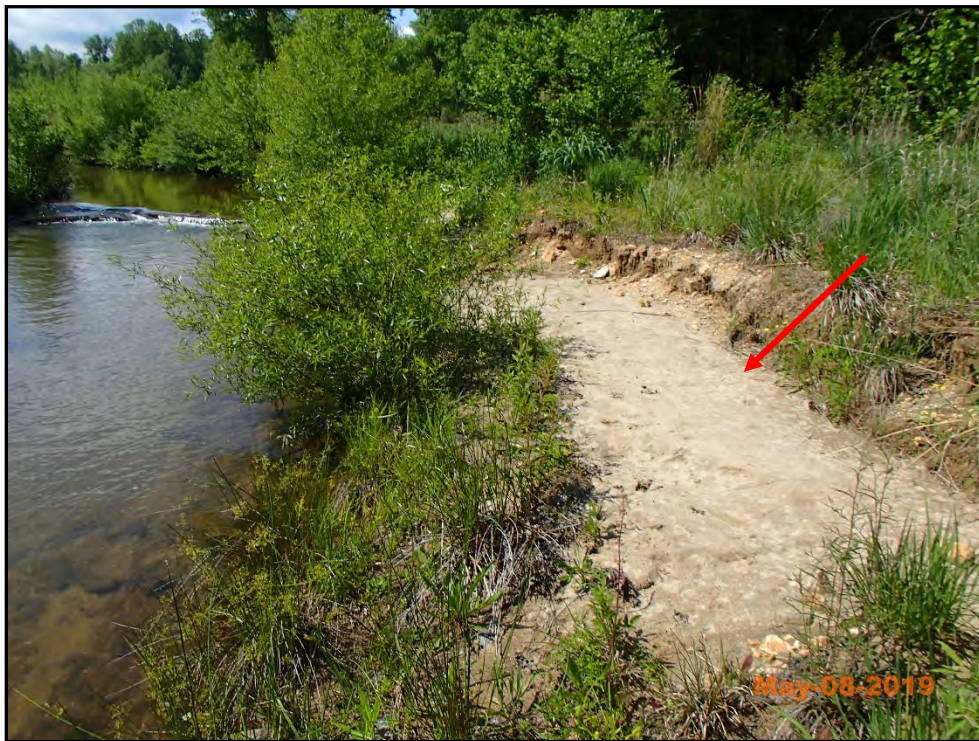
Bank Scour LDB– South Muddy Creek 109+00 (looking upstream)

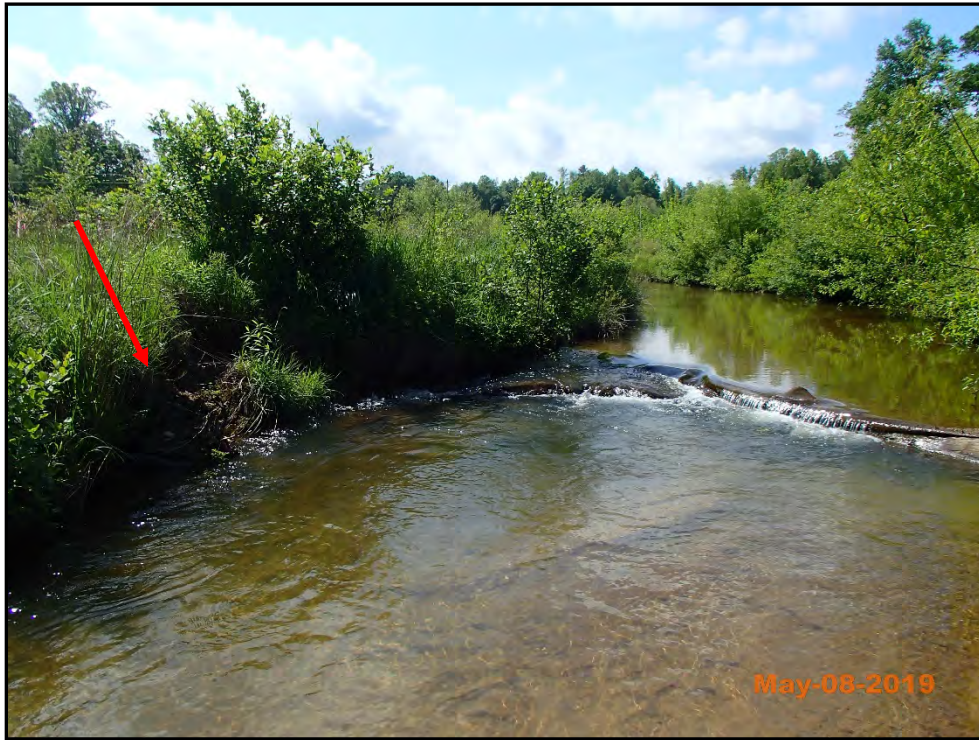
Bank Scour RDB– South Muddy Creek 109+00 (looking upstream)

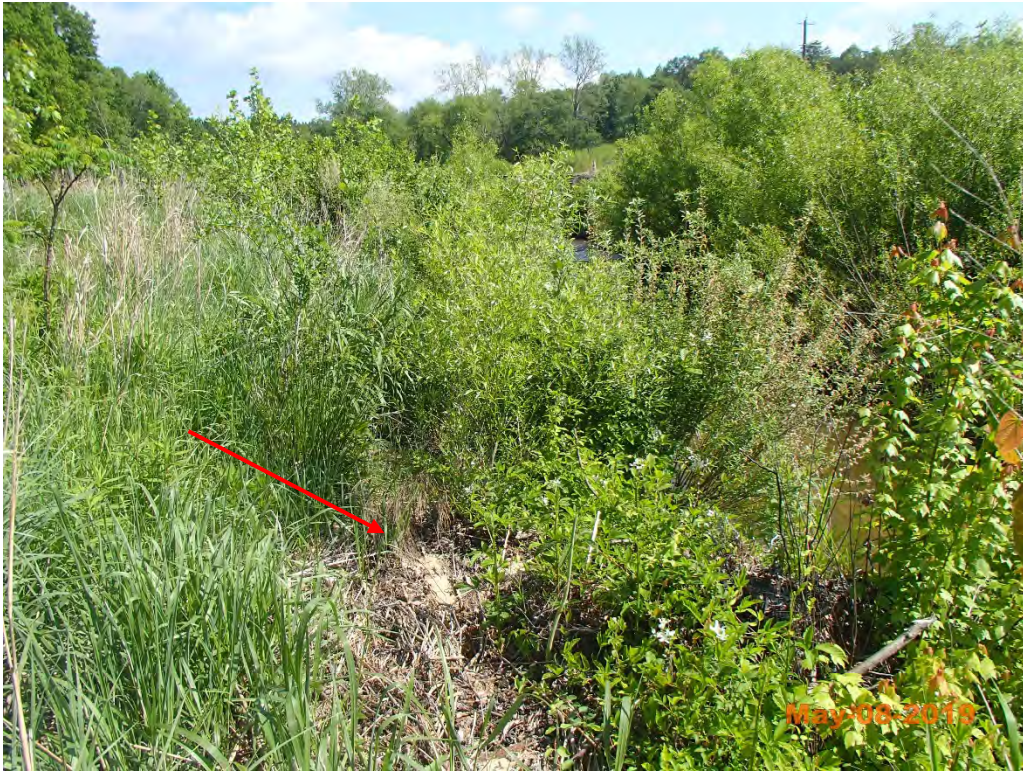
Photo #1 - South Muddy Creek Wrack Lines

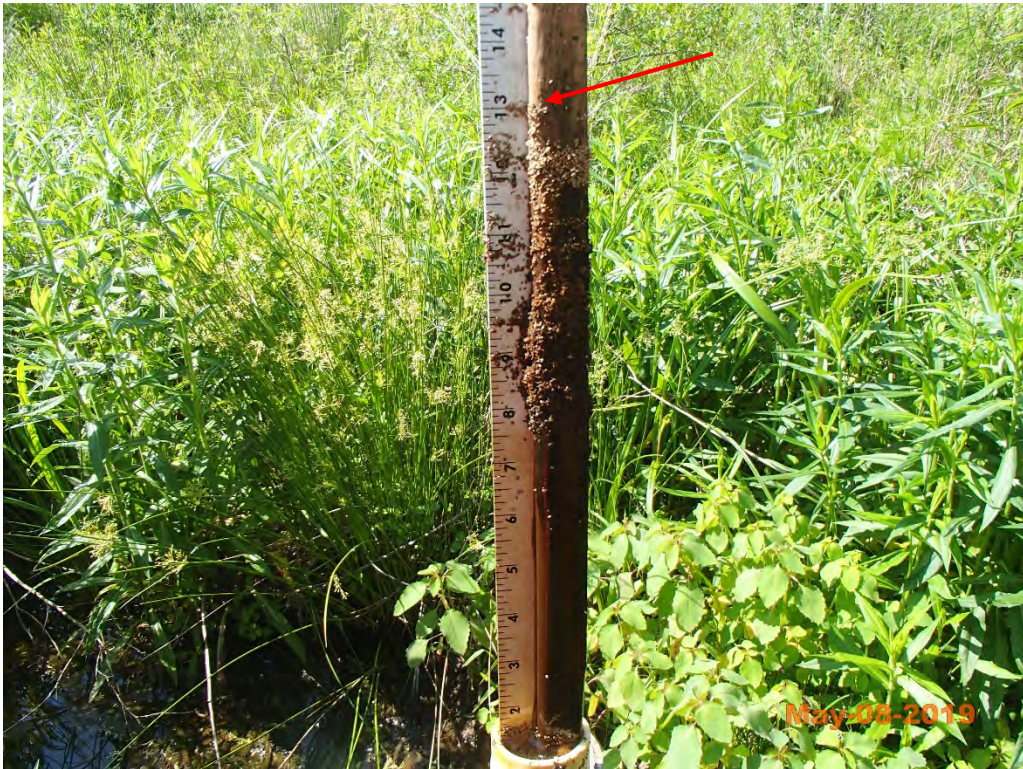
Photo #2 – Sprouse Branch Crest Gauge at 13 inches (recorded bankfull is 9”)

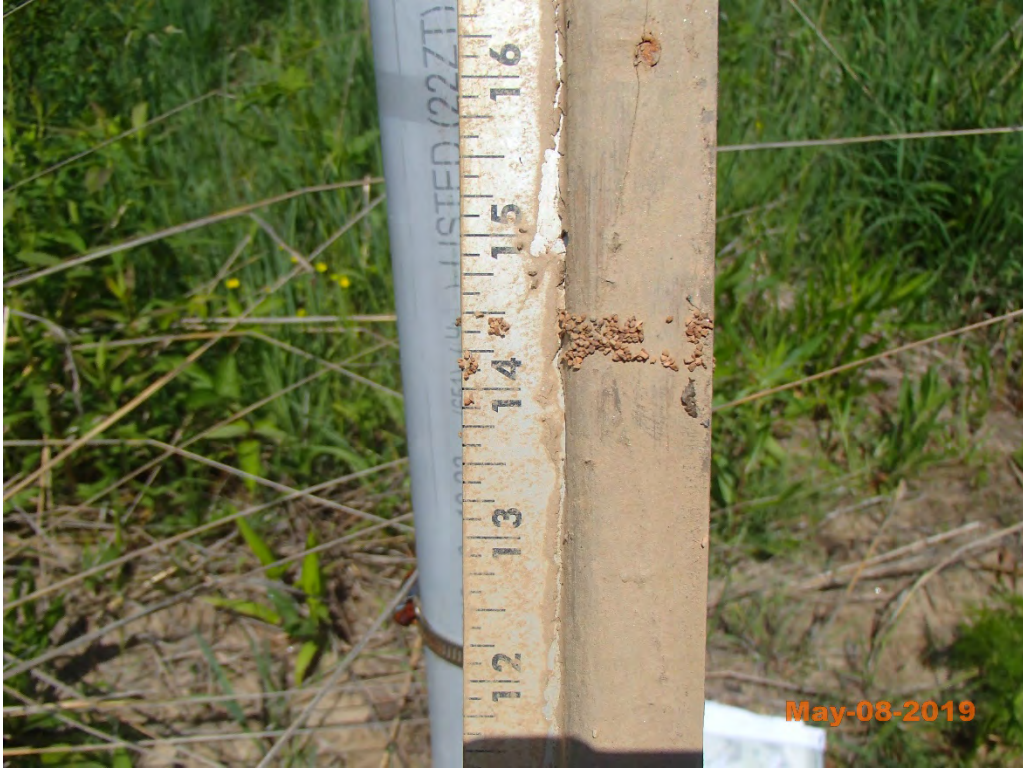
Photo #3 – South Muddy Creek Crest Gauge at 14 inches
