Annual Monitoring Report

Monitoring Year 5 of 5

Middle South Muddy Stream Restoration Site

NCDMS Project No.: 93875

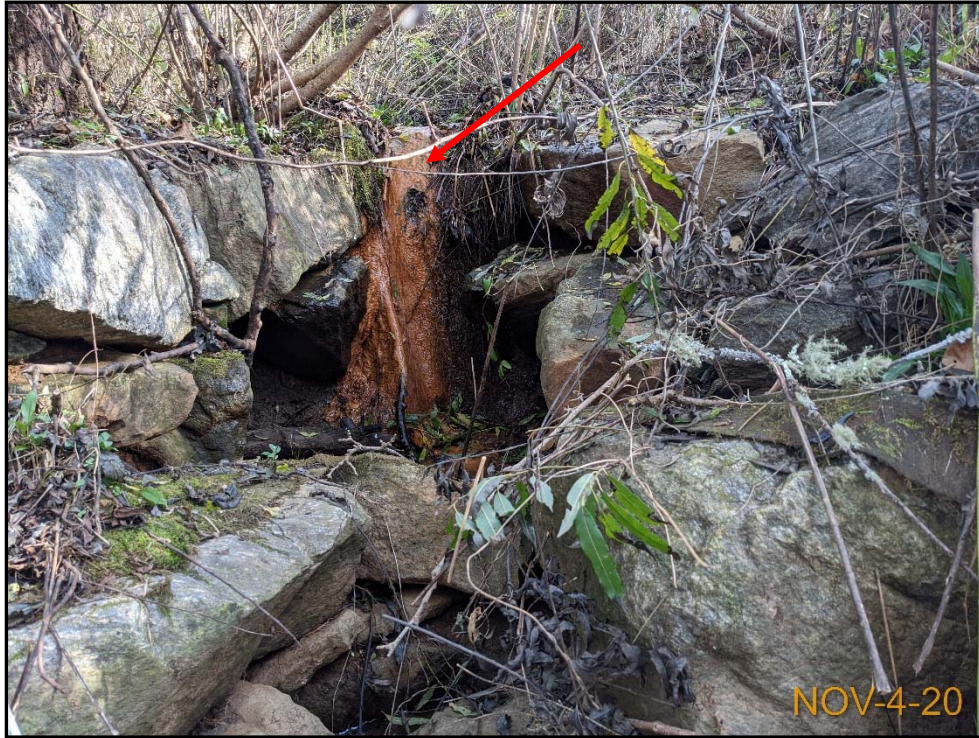
Failed Structure – Iva Branch STA 303+67 (looking upstream)

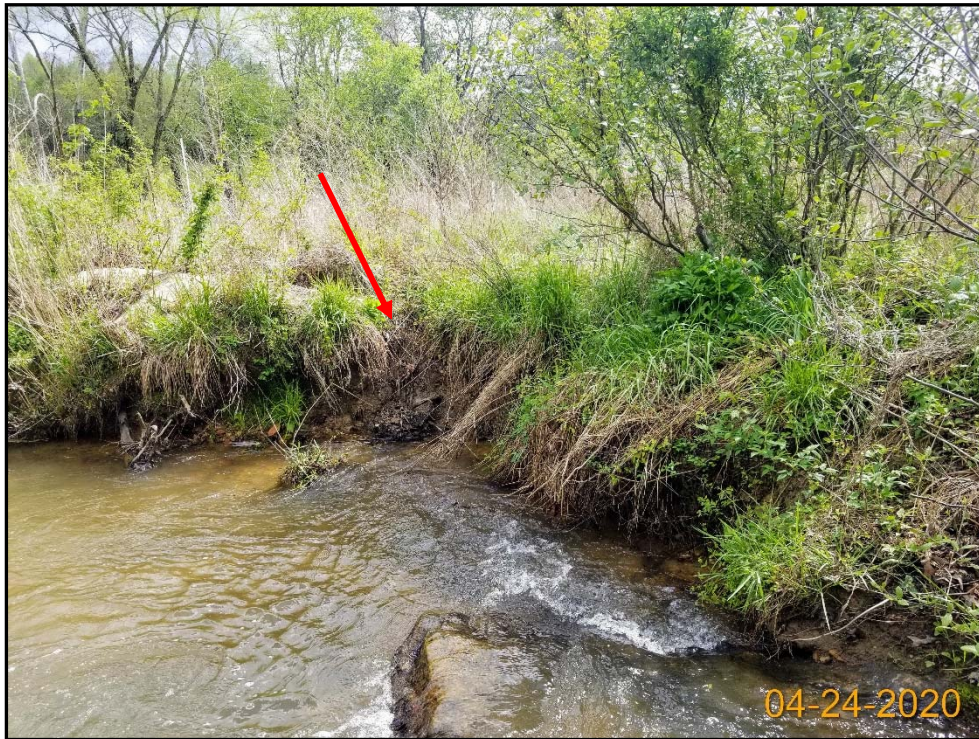
Bank Scour RDB– South Muddy Creek 109+00 (looking downstream)

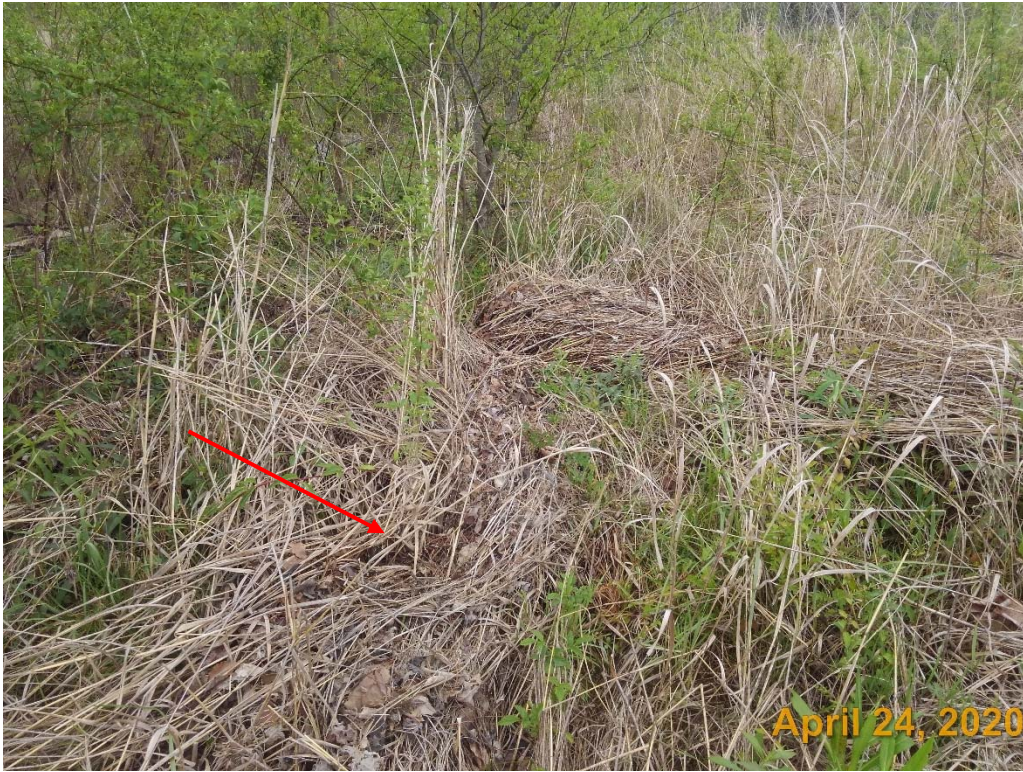
Photo #1 - South Muddy Creek Wrack Lines

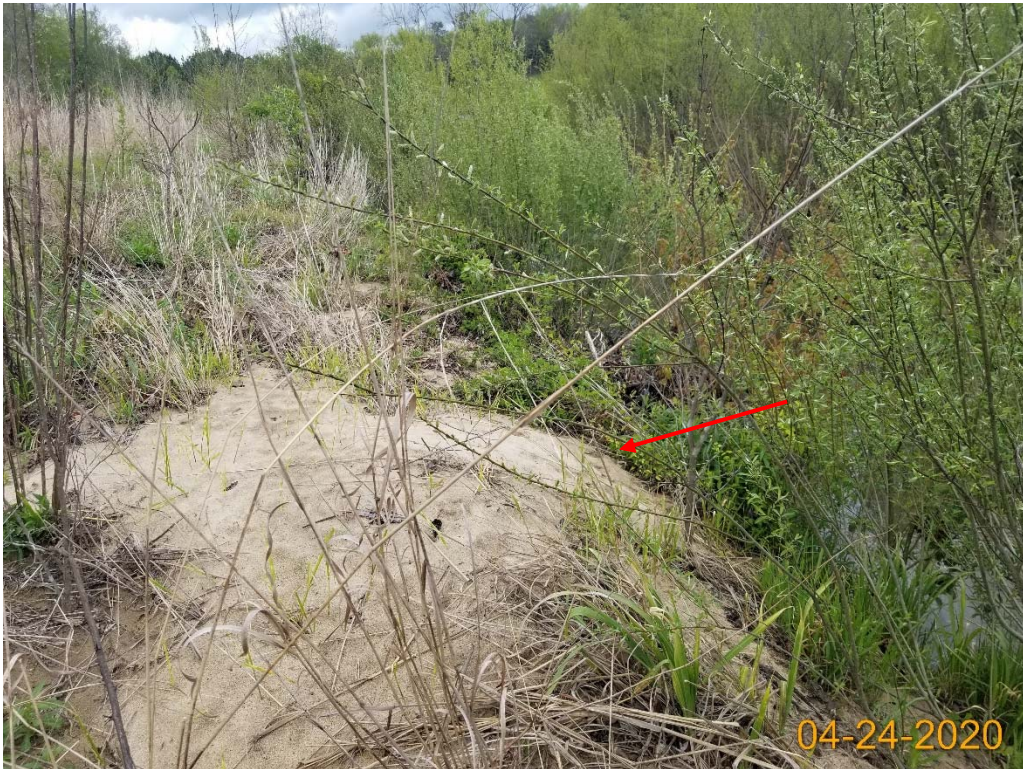
Photo #2 – South Muddy Creek, sediment deposits.
