# Annual Monitoring Report

Mill Dam Creek Restoration Site  
Yadkin River Basin - 03040101  
Monitoring Year 03  
DEQ Contract 6898  
DMS Project Number 97136  
DMS RFP No. 16-006706 (Date of Issue: October 21, 2015)

DWR #: 18-1349  
USACE Action ID: 2016-01335  
Yadkin County, North Carolina

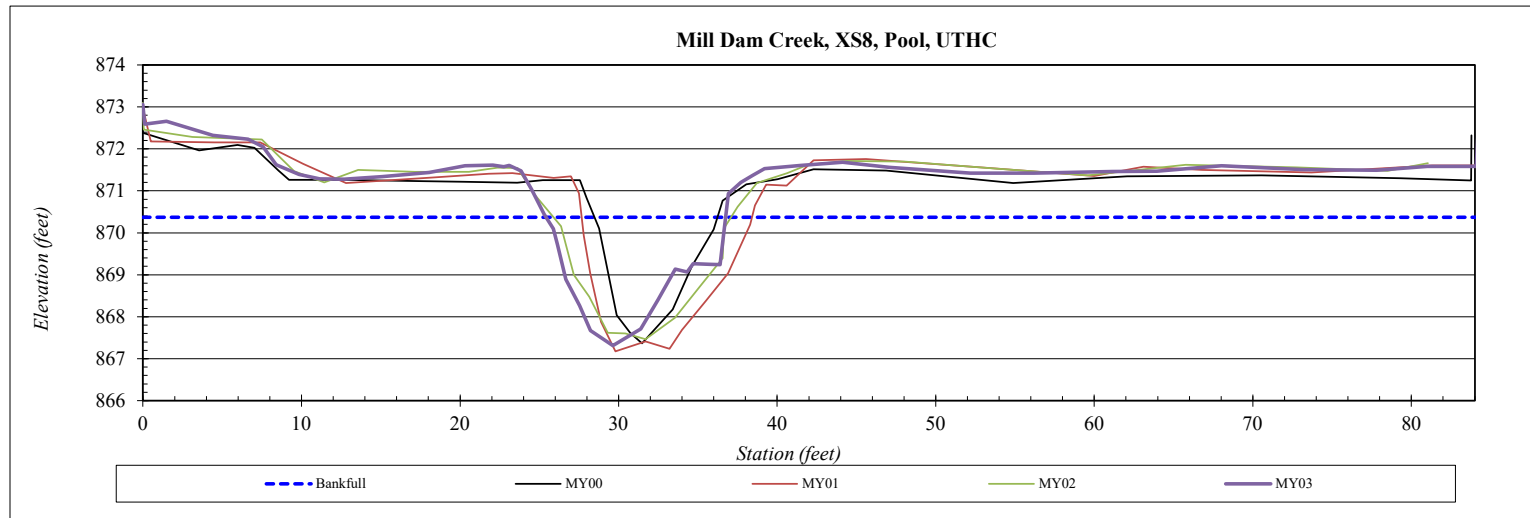
- Cross-section plots 8 and 13: Recommend adding a note that the cross-section is located in an area that was repaired in MY1 (July 2021).  
*KCI Response: This change has been made.*

\*Cross-section located in an area that was repaired in MY1 (July 2021).

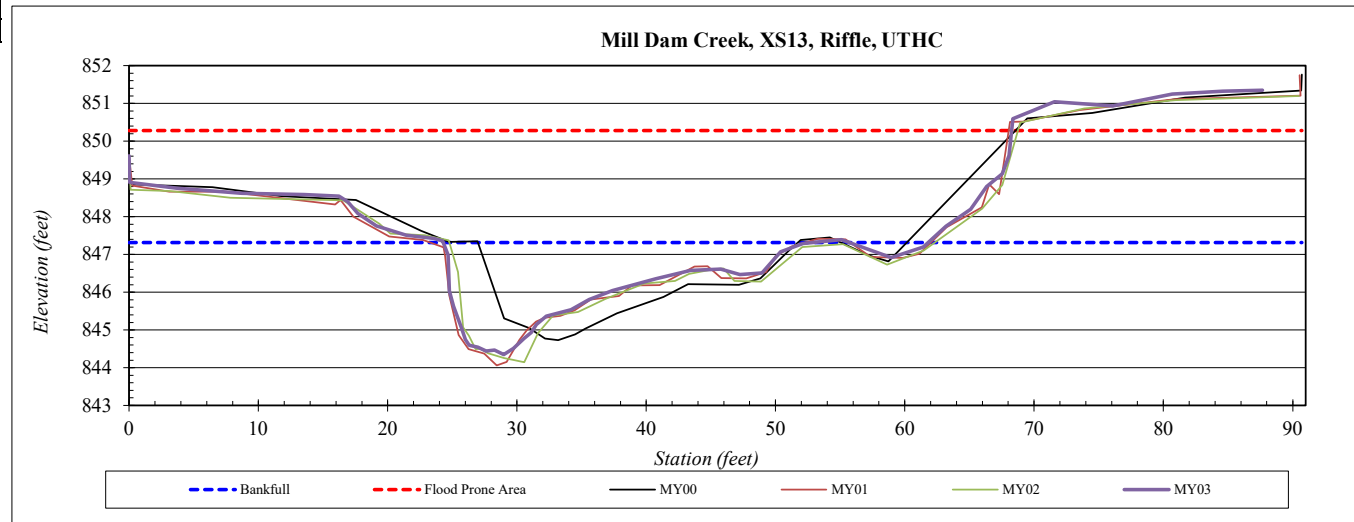
\*Cross-section located in an area that was repaired in MY1 (July 2021).
