# **Annual Monitoring Report**

**Mill Dam Creek Restoration Site**

**Monitoring Year 01**

**DMS Project Number 97136**

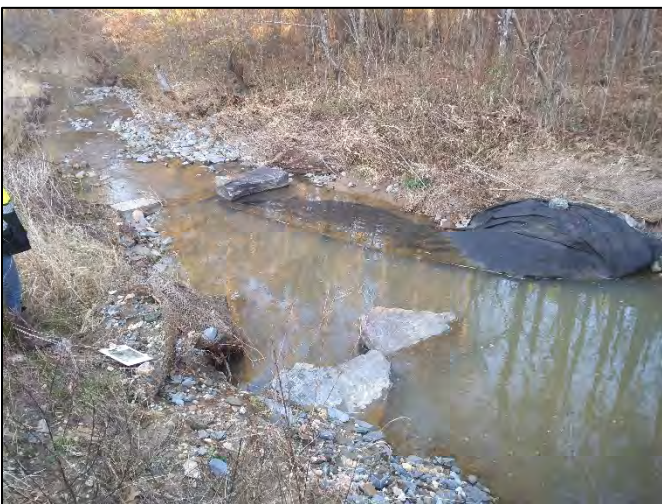
- Monitoring Results: Please add short discussion in second paragraph concerning erosion areas noted on CCPV and the damaged boulder sill on UTHC4-1 in regards to heavy rainfall events in 2020.  
*KCI Response: This discussion has been added to the report.*

Damaged boulder sill, Sta 55+60, 12/18/20

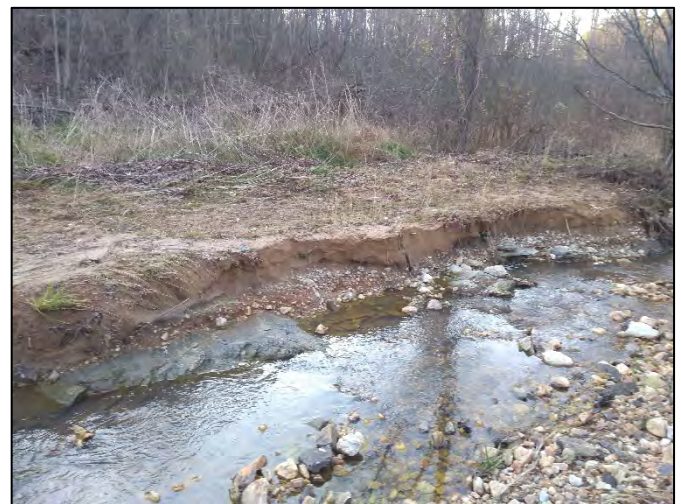
Outer bend erosion, Sta 61+00, 12/18/20
