# MILL BRANCH STREAM RESTORATION PROJECT

## MONITORING REPORT (YEAR 1 OF 5)

Columbus County, North Carolina  
SCO Project Number 020611301A  
EEP Project Number 0251

Status of Plan: Final  
Submission Date: August 2008

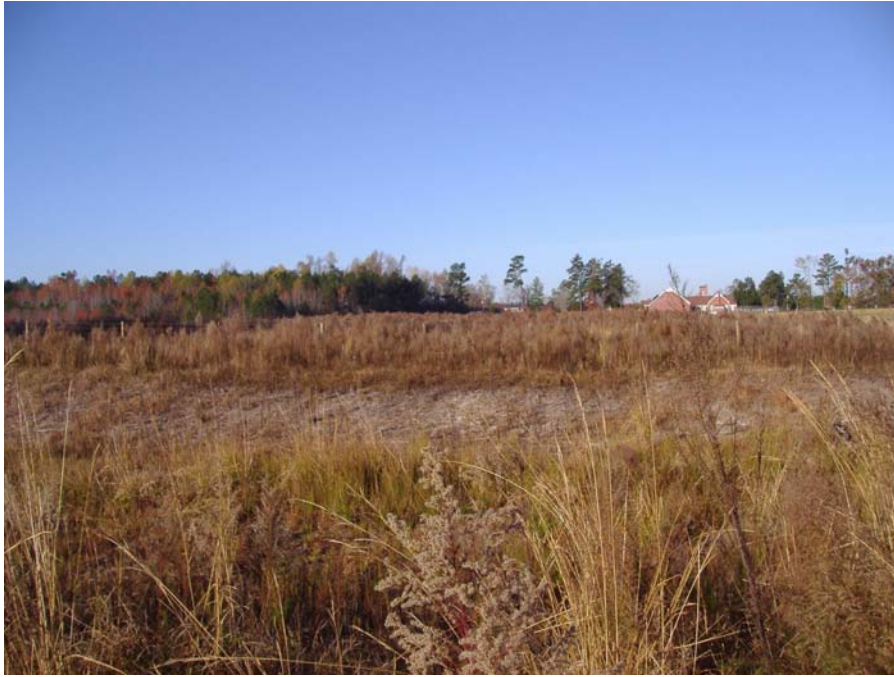
<b>Feature Issue</b>	<b>Reach</b>	<b>Station Number</b>	<b>Suspected Cause</b>	<b>Photo Number</b>
<b>Bare Area</b>	Upper	10+20	Poor planting/drought	VPA1, VPA2
	Upper	11+55	Poor planting/drought	
	Middle	12+20	Poor planting/drought	
	Middle	20+50	Poor planting/drought	
	Middle	20+60	Poor planting/drought	
	Middle	22+50	Poor planting/drought	
	Lower	15+40	Poor planting/drought	
	Lower	16+50	Poor planting/drought

Photo VPA1: Bare area on left bank near Vegetation Plot 2

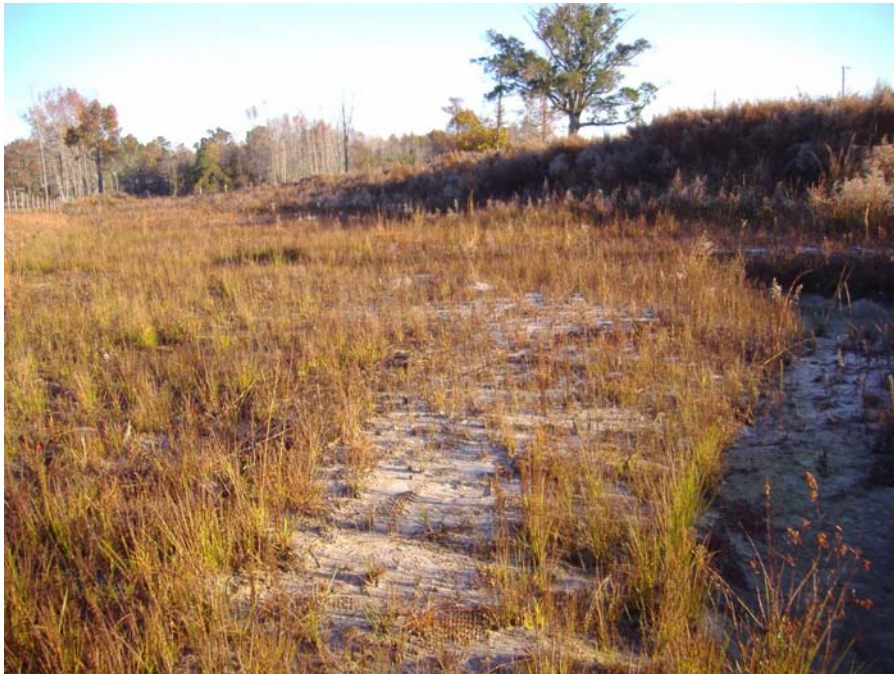
Photo VPA2: Bare area on floodplain near Middle Reach STA 20+30

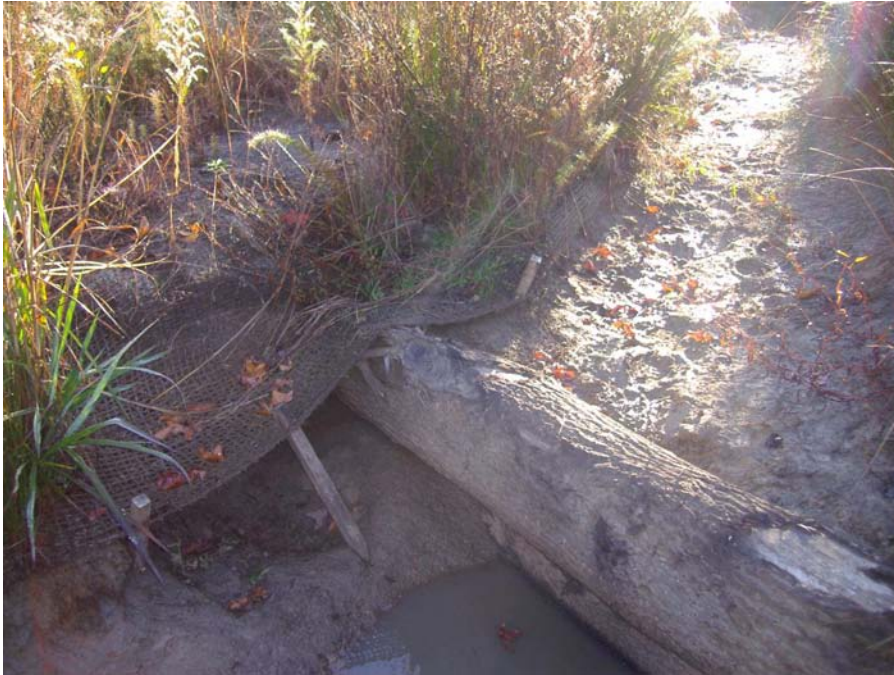
<b>Exhibit Table B.1. Stream Problem Areas</b> <b>Mill Branch Stream Restoration Site/EEP Project No. 0251</b> Mill Branch Stream Restoration (3,507.5 l.f.)				
<b>Feature Issue</b>	<b>Reach</b>	<b>Station Number</b>	<b>Suspected Cause</b>	<b>Photo Number</b>
<b>Aggradation</b>	Middle	15+04	Too many structures in Pool	NA
<b>Scour</b>	Middle	24+61	Poor Structure Placement	SP1
	Lower	10+76	Too big of a drop across sill	
	Lower	11+16	Vane arm does not tie into bankfull	
	Lower	12+64	Too big of a drop across sill/placement	
	Lower	13+54	Too big of a drop across sill/placement	
<b>Floodplain rill erosion</b>	Lower	12+85	Floodplain Grading	SP2
<b>Piping</b>	Middle	17+49	Too big of a drop across sill	SP3
	Middle	24+88	Poor Structure Installation

SP 1. Example of scour (STA 12+63)

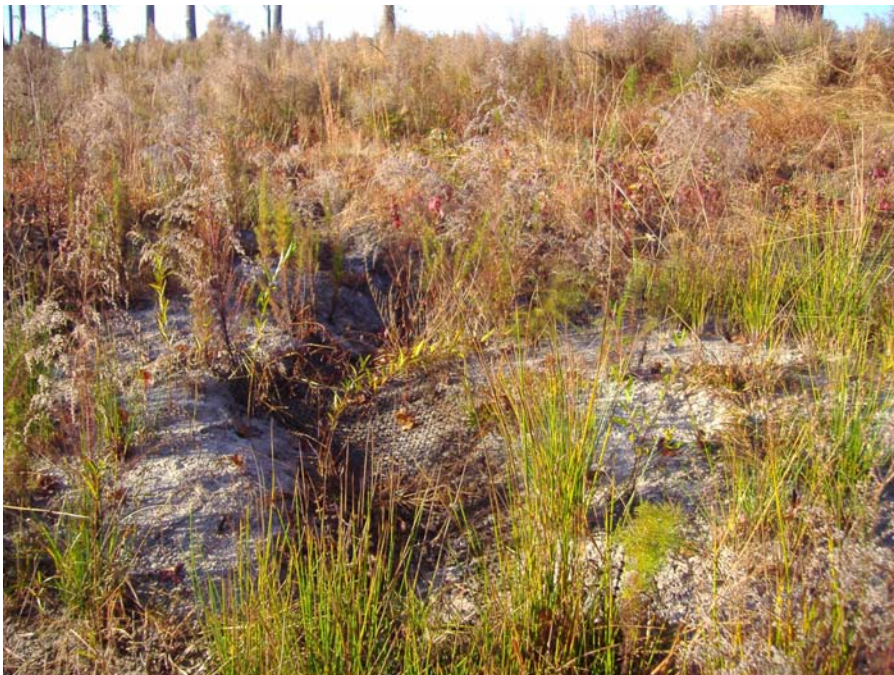
SP 2. Rill erosion (left bank STA 12+88)

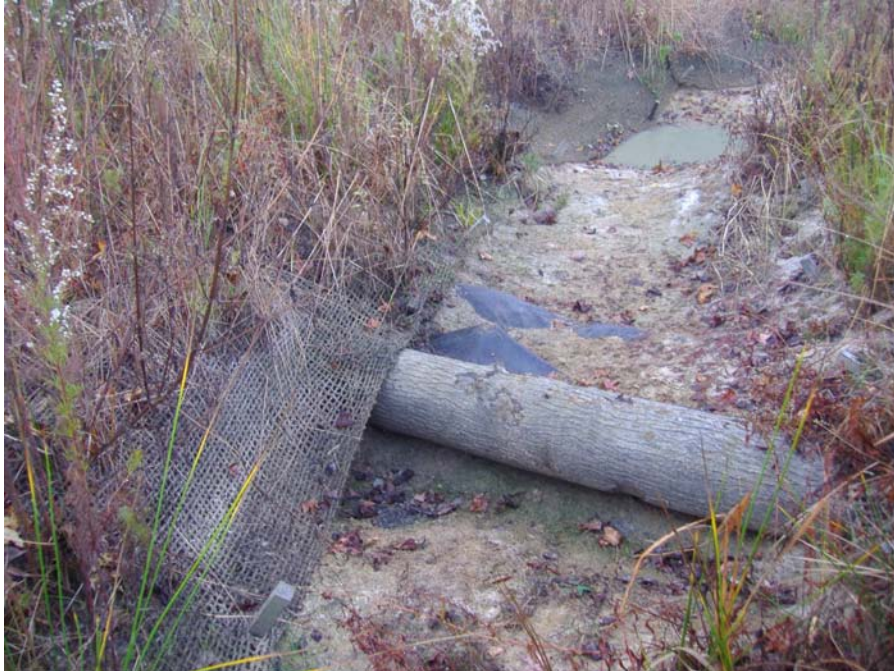
SP 3. Example of piping around a structure (STA 17+48)
