Mill Branch Stream Restoration Project Columbus County North Carolina

**CU: 03040103
SCO# 020611301A
EEP Project No. 251**

2nd Year Monitoring Report January 22, 2009

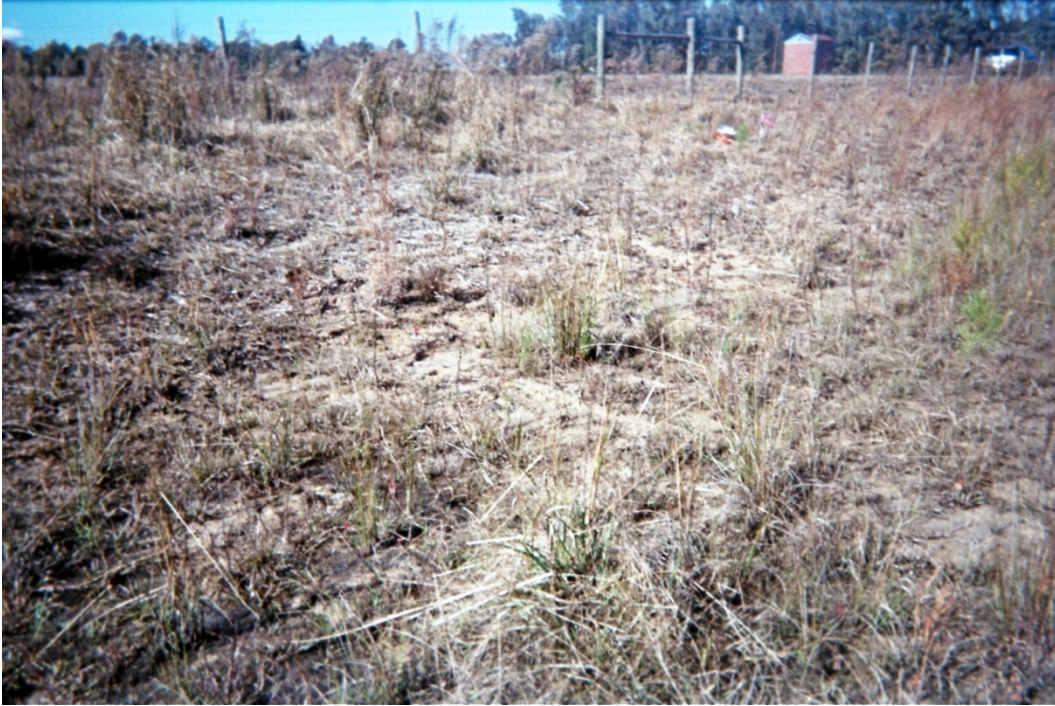
VPA 1 – Middle Reach – 20+50

Feature Issue	Reach	Station Number	Suspected Cause	Photo Number
Bare Area	Upper	10+20	Poor planting/Drought	VPA 1
	Upper	11+55	Poor planting/Drought	
	Middle	12+20	Poor planting/Drought	
	Middle	20+50	Poor planting/Drought	
	Middle	20+60	Poor planting/Drought	
	Middle	22+50	Poor planting/Drought	
	Lower	15+40	Poor planting/Drought	
	Lower	16+50	Poor planting/Drought	
Cattails	All Reaches	Located throughout the project	Dry conditions that have allowed seeds to germinate	VPA 2

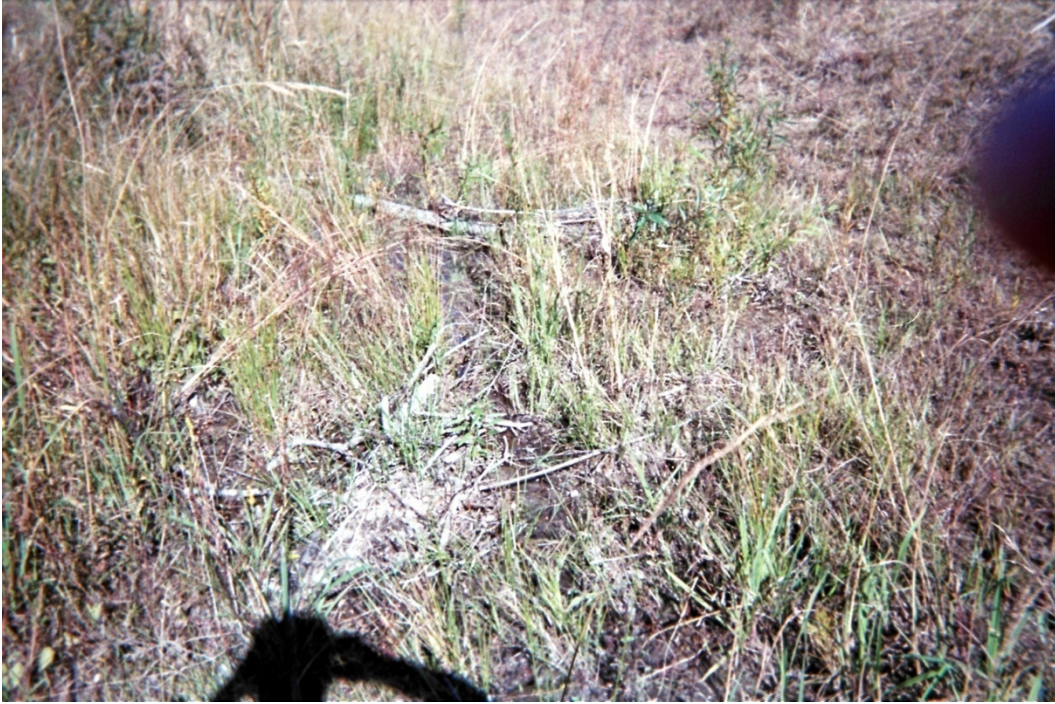
Photo 35 - Bankfull Event – Rack line in the flood plain

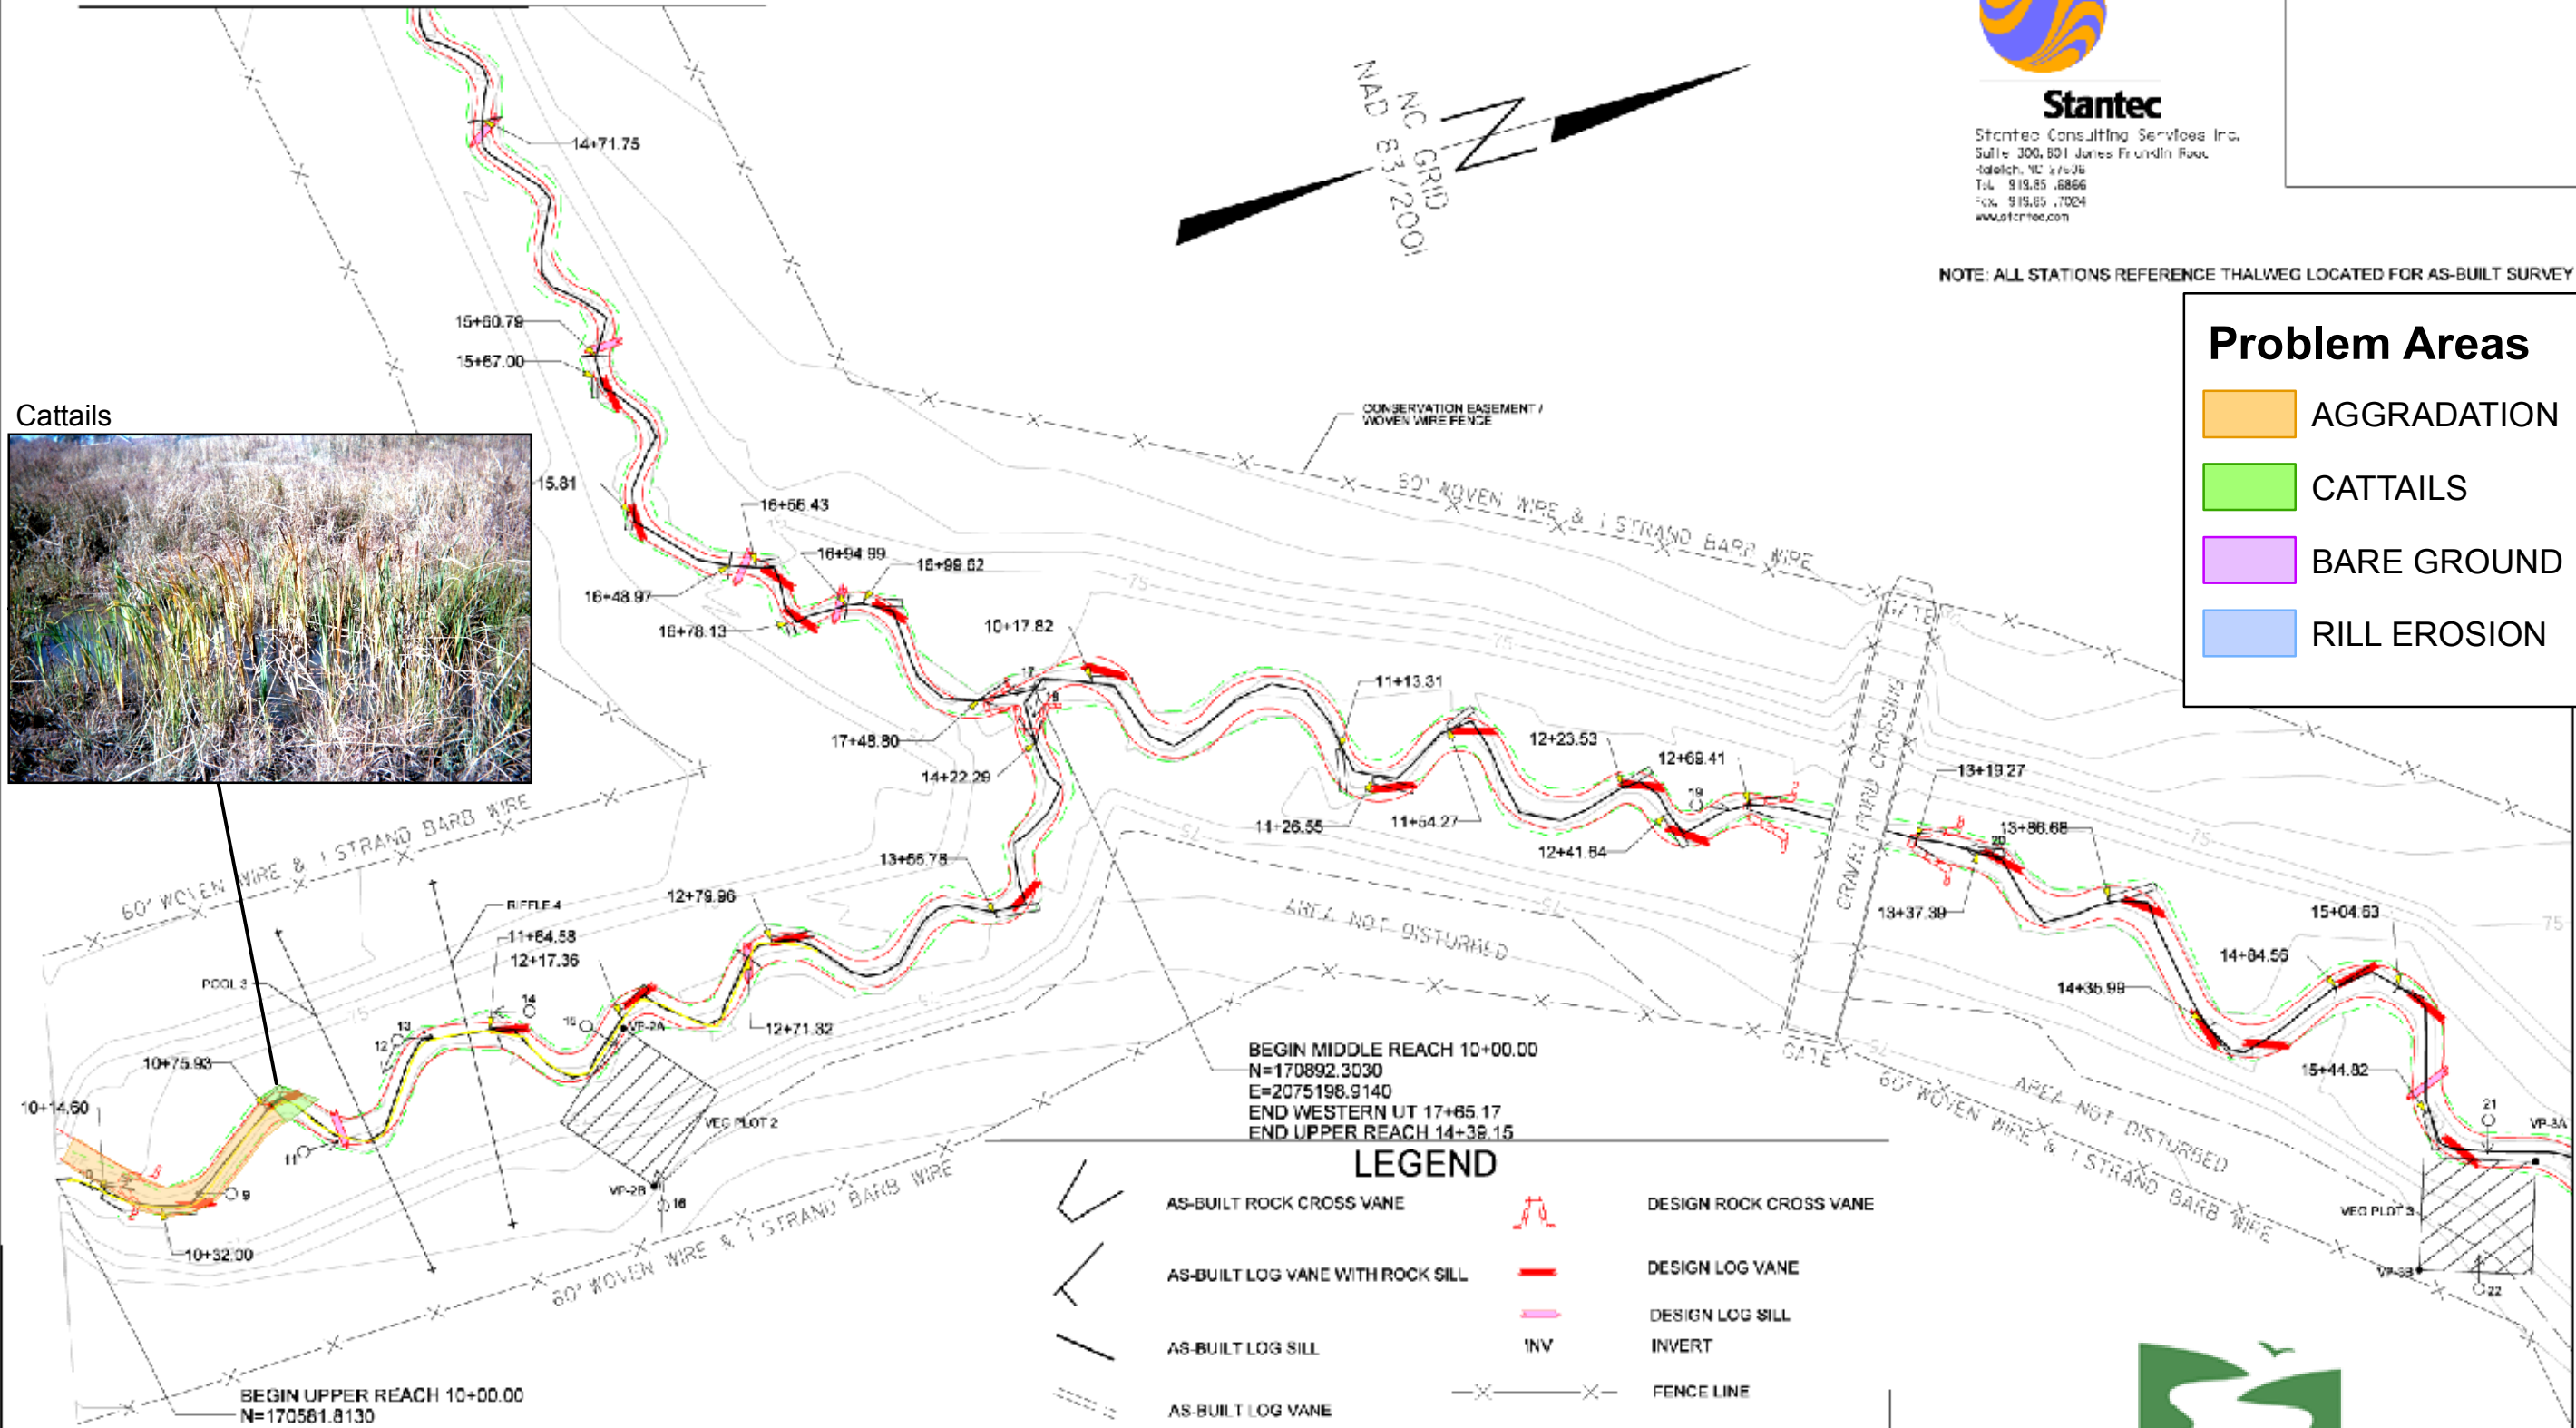
Cattails

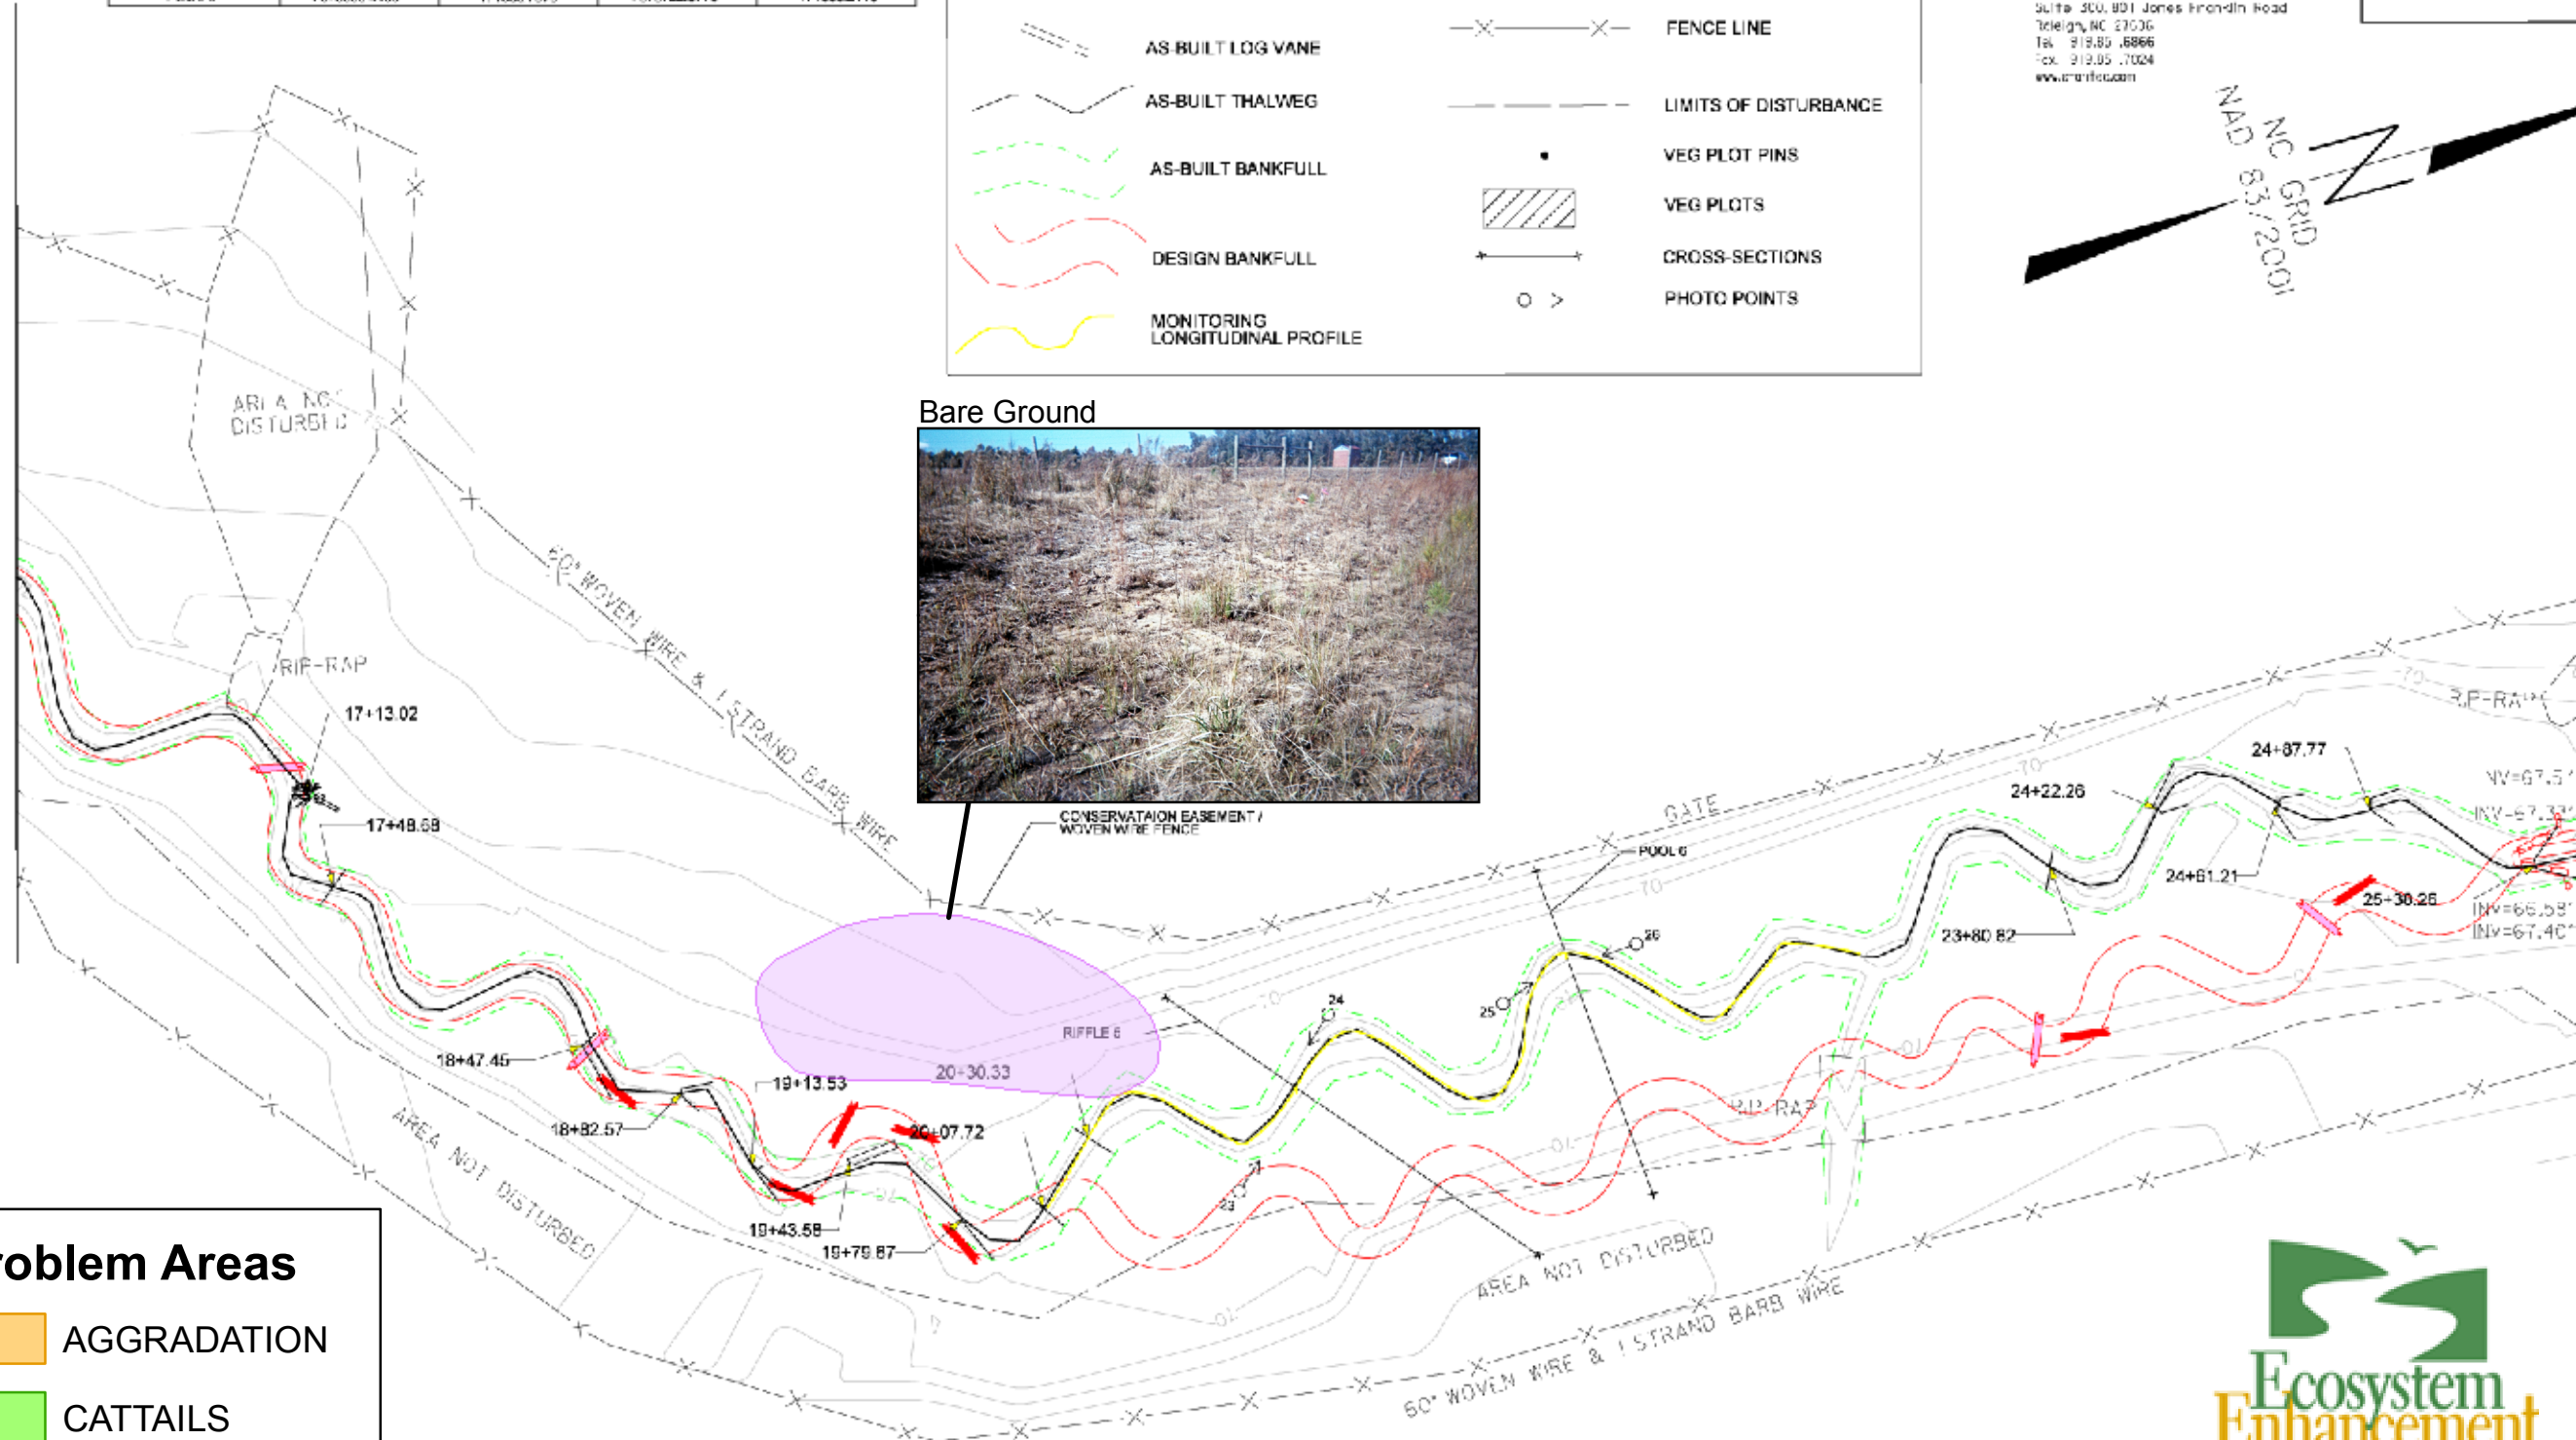
Bare Ground
