Mill Branch Stream Restoration Project Columbus County North Carolina

**CU: 03040206
SCO# 020611301A
EEP Project No. 251**

**3rd Year Monitoring Report
November 15, 2009**

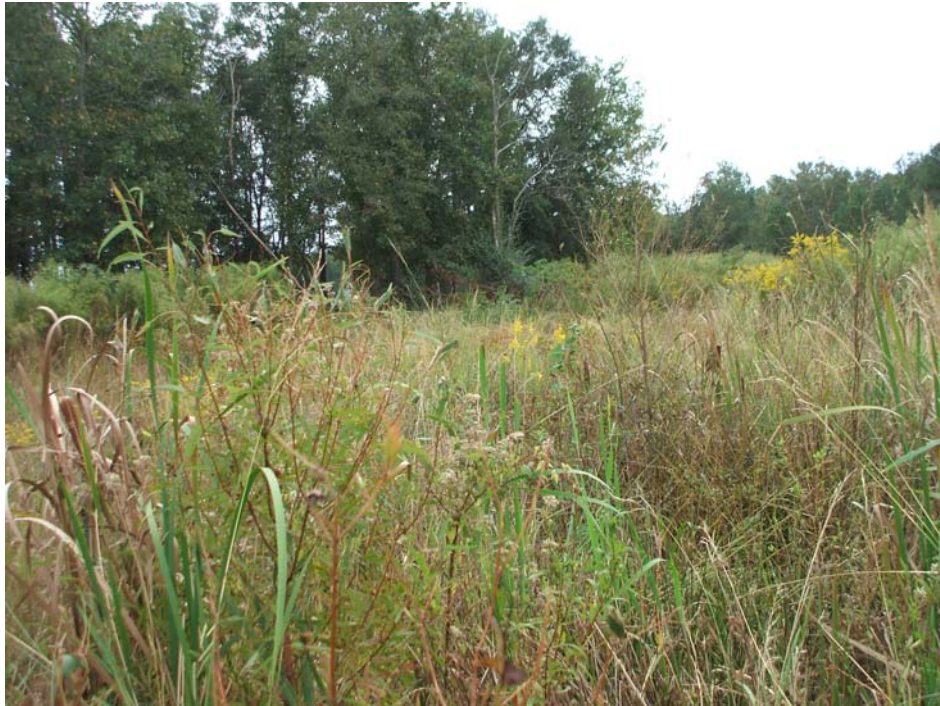
VPA 1 – Cattail – Throughout the project site

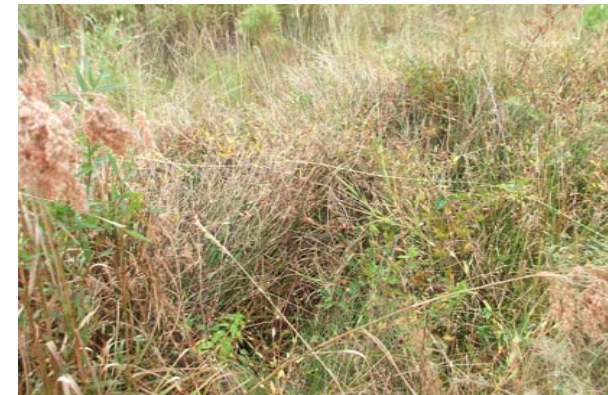
Mill Branch 2009 - Riffle Cross Section 1- Western Reach STA: 2+15

Photo of Cross-Section 1 - Looking Downstream @ STA 2+15

Year 5 - 2012	Year 4 - 2011	Year 3 - 2009	Year 2 - 2008	Year 1	AS-BUILT 2007
Area			4.1	4.0	2.3	1.8
Width			23.4	19.5	8.7	6.0
Mean Depth			0.2	0.2	0.3	0.3
Max Depth			0.6	1.1	0.6	0.6
W/D			133.0	96.0	33.5	19.8

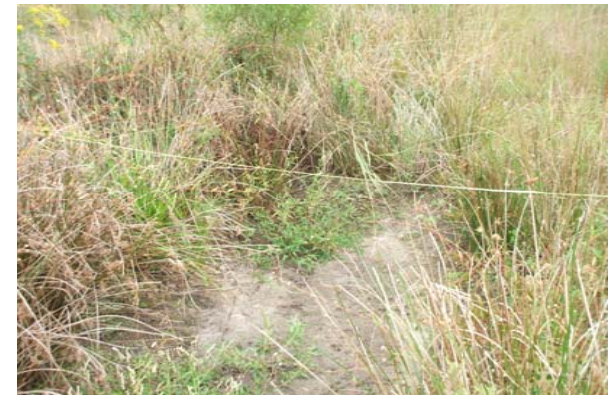
Mill Branch 2009 - Pool Cross Section 2 - Western Reach STA: 2+50

Photo of Cross-Section 2 - Looking Upstream @ STA 2+50

Year 5 - 2011	Year 4 - 2010	Year 3 - 2009	Year 2 - 2008	Year 1	AS-BUILT 2007
Area			6.7	8.2	7.5	8.7
Width			23.7	17.4	11.2	11.7
Mean Depth			0.3	0.5	0.7	0.7
Max Depth			1.4	1.3	1.3	1.7
W/D			83.2	37.1	16.7	15.7

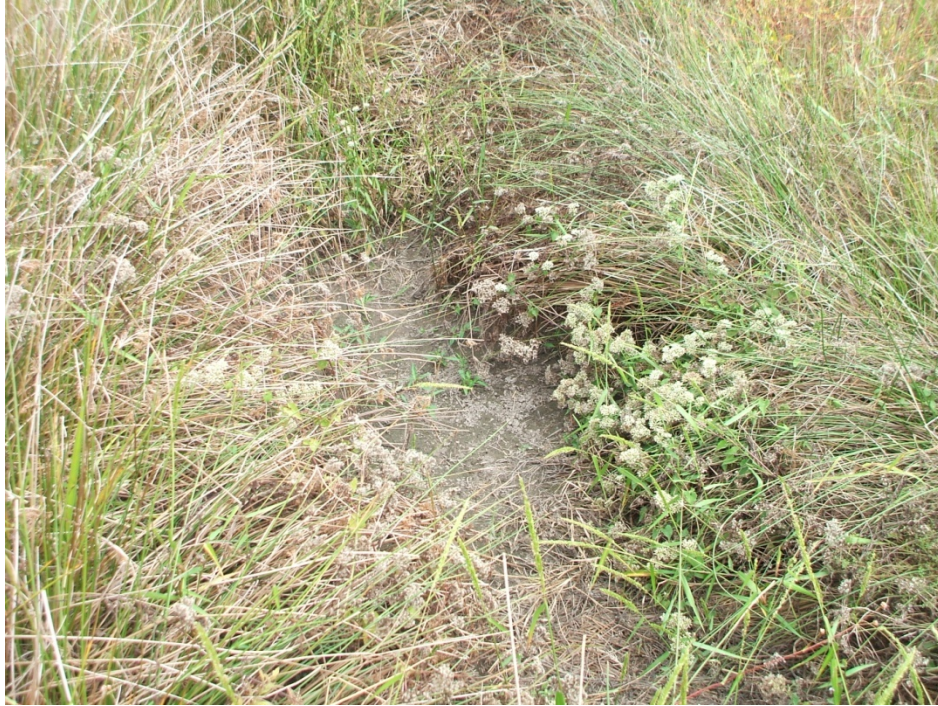
SPA 1 - Dry stream bed. Western Reach and Lower Reach

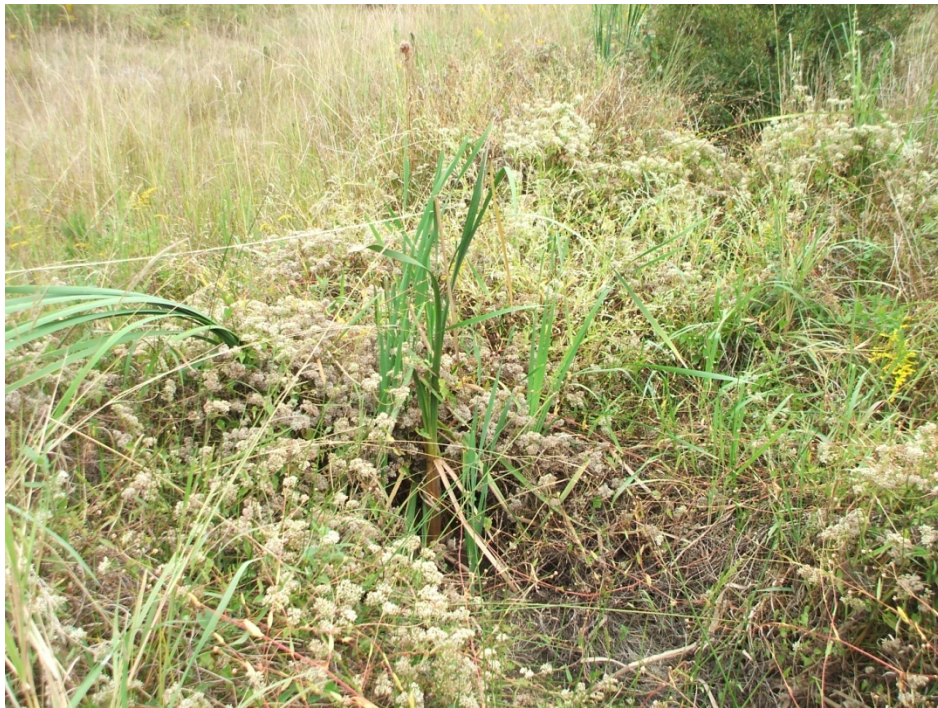
SPA 2 - Cattail – Throughout project site

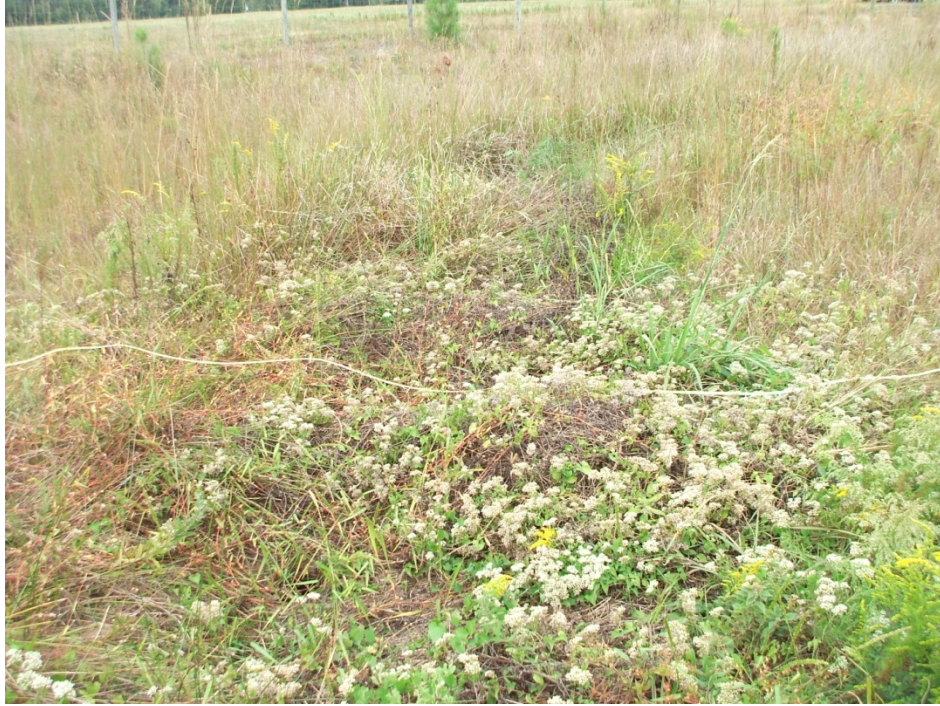
SPA 3 - Vegetation growing in the channel bed. Throughout the project site

Exhibit Table B.1 Stream Problem Areas Mill Branch Stream Restoration Site EEP Project No. 251				
Feature Issue	Reach	Station Number	Suspected Cause	Photo Number
Aggradation	Western	10+00 to 13+50	N/A	*
	Upper	10+00 to 12+50	N/A	*
Cattails	All	Throughout	Dry Conditions	SPA 2
Vegetation Growth in channel bed	All	Throughout	Dry Conditions	SPA 3
