# **Mill Branch Stream Restoration Project Columbus County North Carolina**

**EEP Project No. 251  
CU: 03040206  
SCO# 020611301A**

**Year 4 of 5 Monitoring Report  
Data Collection: June through October 2010  
Submission Date: March 31, 2011**

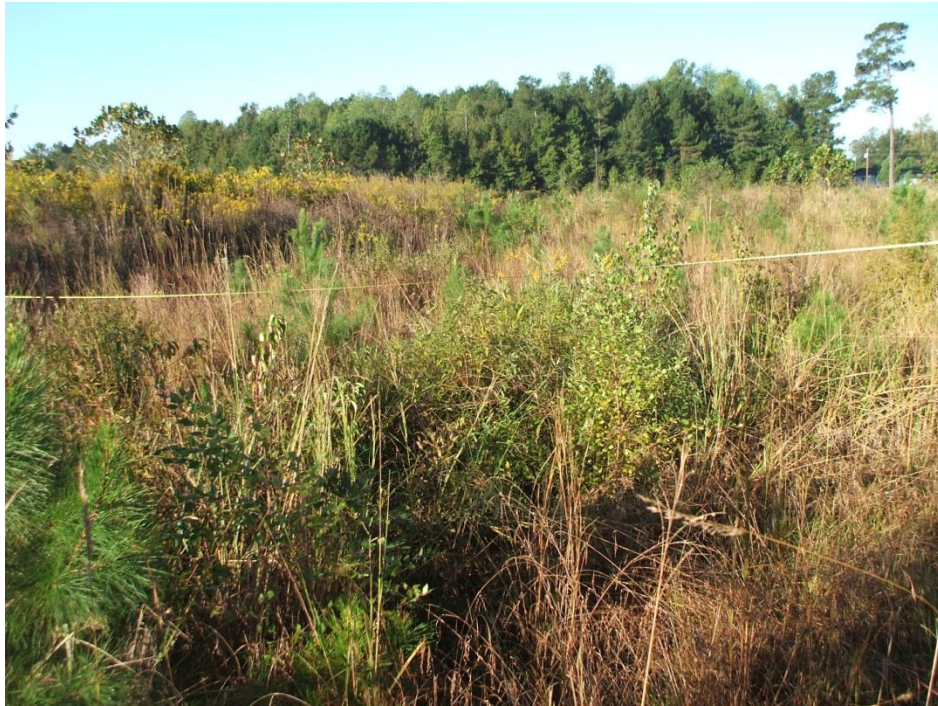
SPA 1 – Rooted woody vegetation growing in the stream bed. Western Reach and Lower Reach

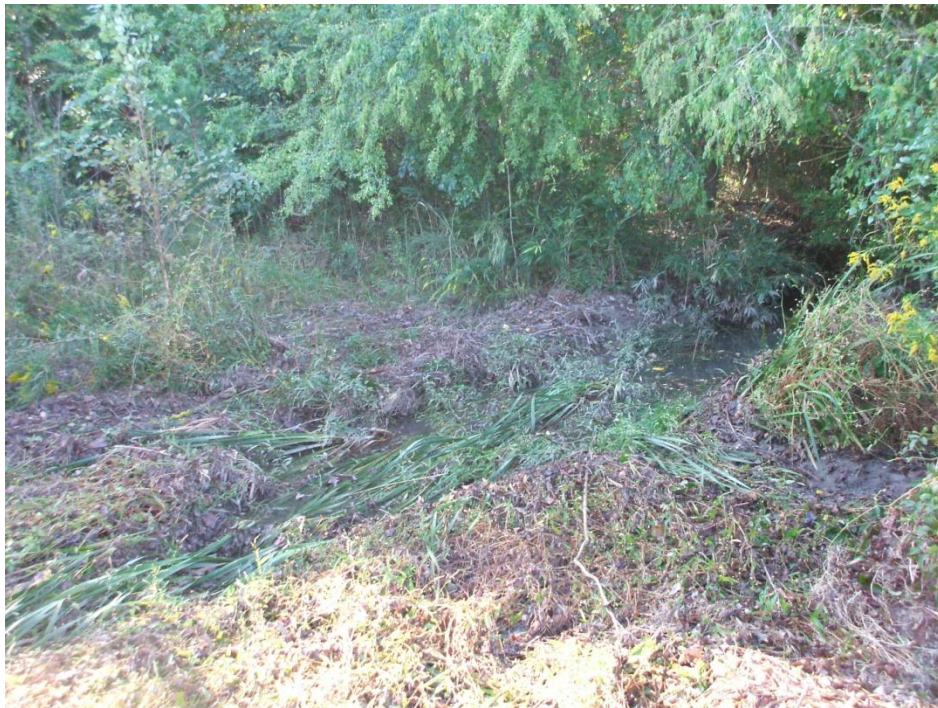
SPA 2 – Cattail growing in stream channel – Throughout project site

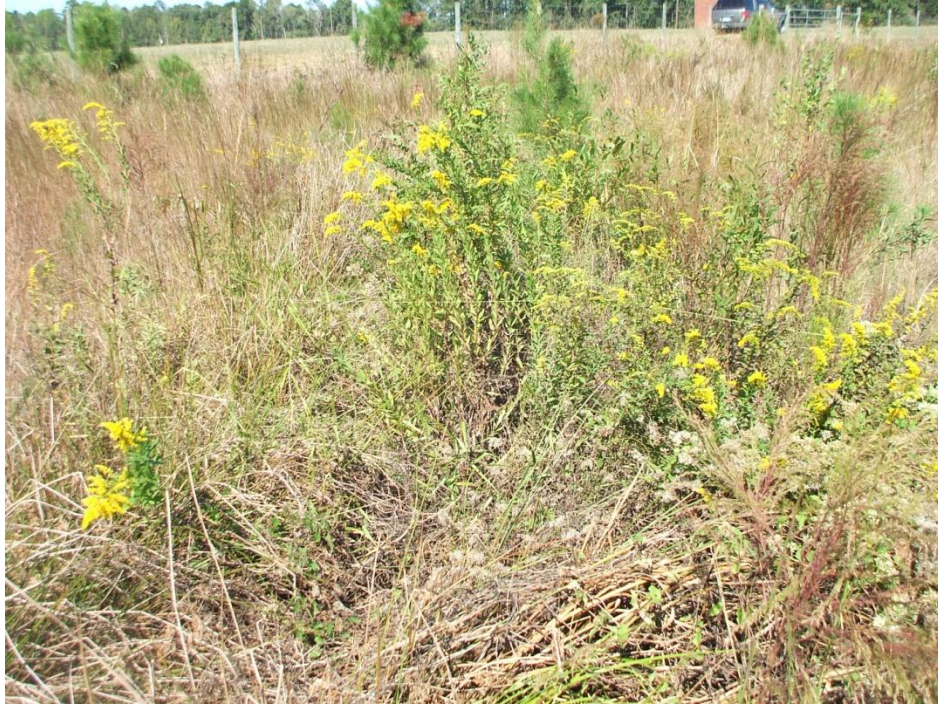
SPA 3 - Vegetation growing in the channel bed. Middle Reach
