Mill Branch Stream Restoration Project Columbus County North Carolina

EEP Project No. 251

**Year 5 of 5 Monitoring Report
Data Collection: June through October 2011
Submission Date: February 17, 2012**

Rummel, Klepper & Kahl, LLP
900 Ridgefield Drive
Suite 350
Raleigh, NC 27609

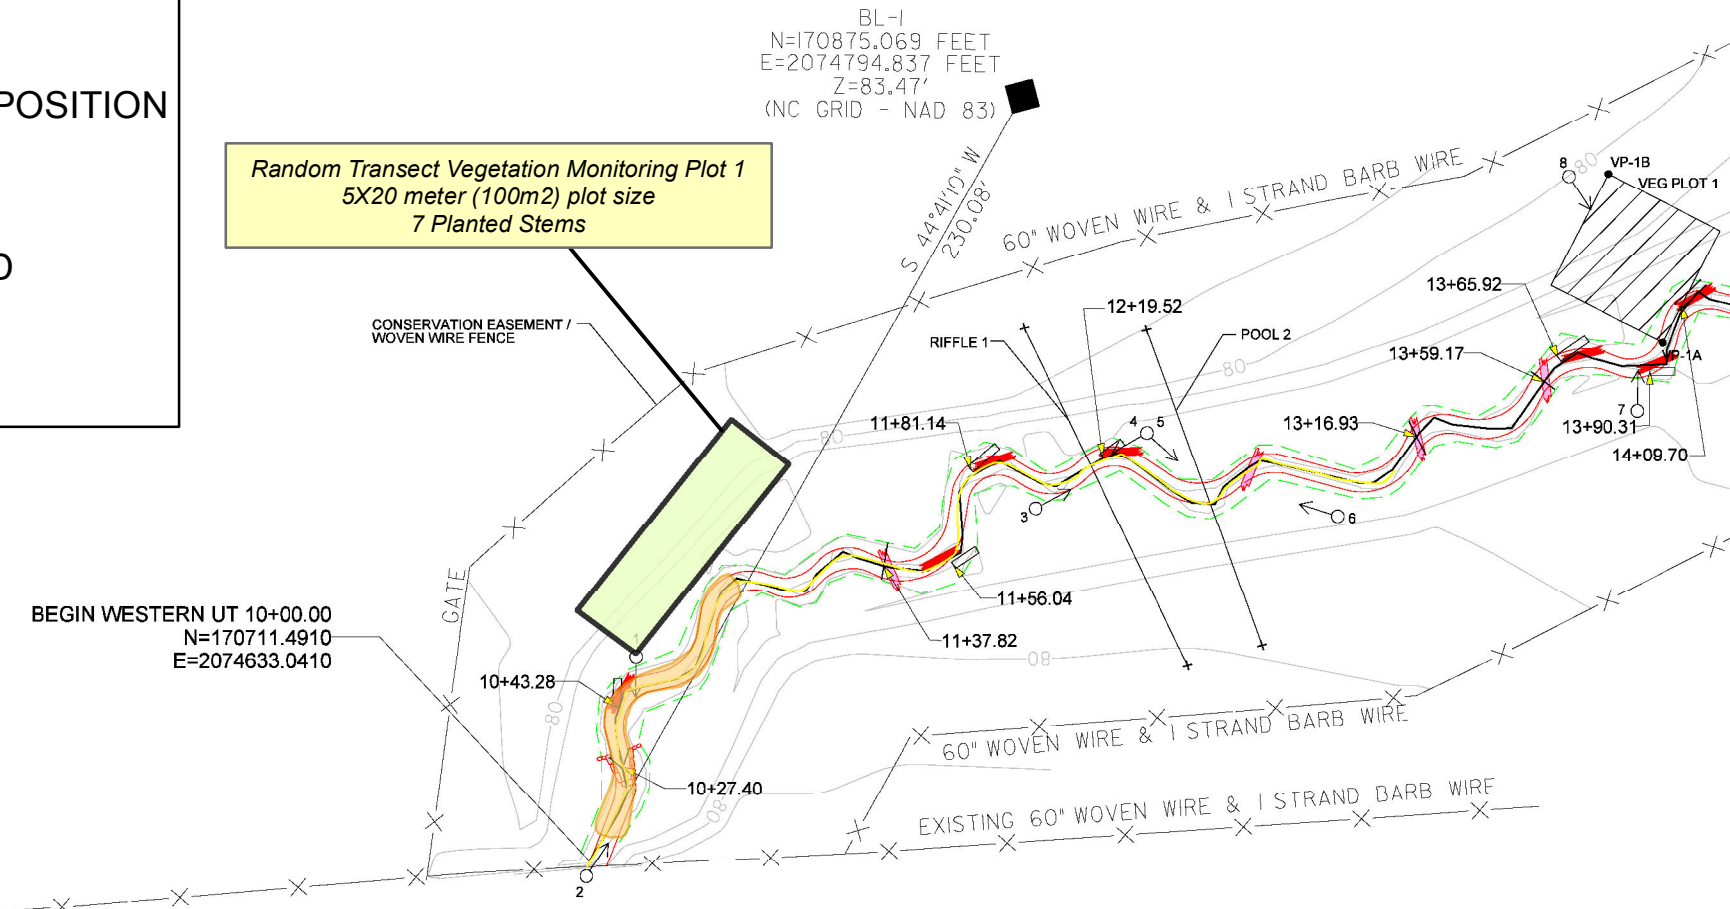
FIGURE 2b
Mill Branch
Stream Restoration Site
 October 20, 2011

- SEDIMENT DEPOSITION
- CATTAILS
- BARE GROUND
- RILL EROSION

Random Transect Vegetation Monitoring Plot 1
 5X20 meter (100m²) plot size
 7 Planted Stems

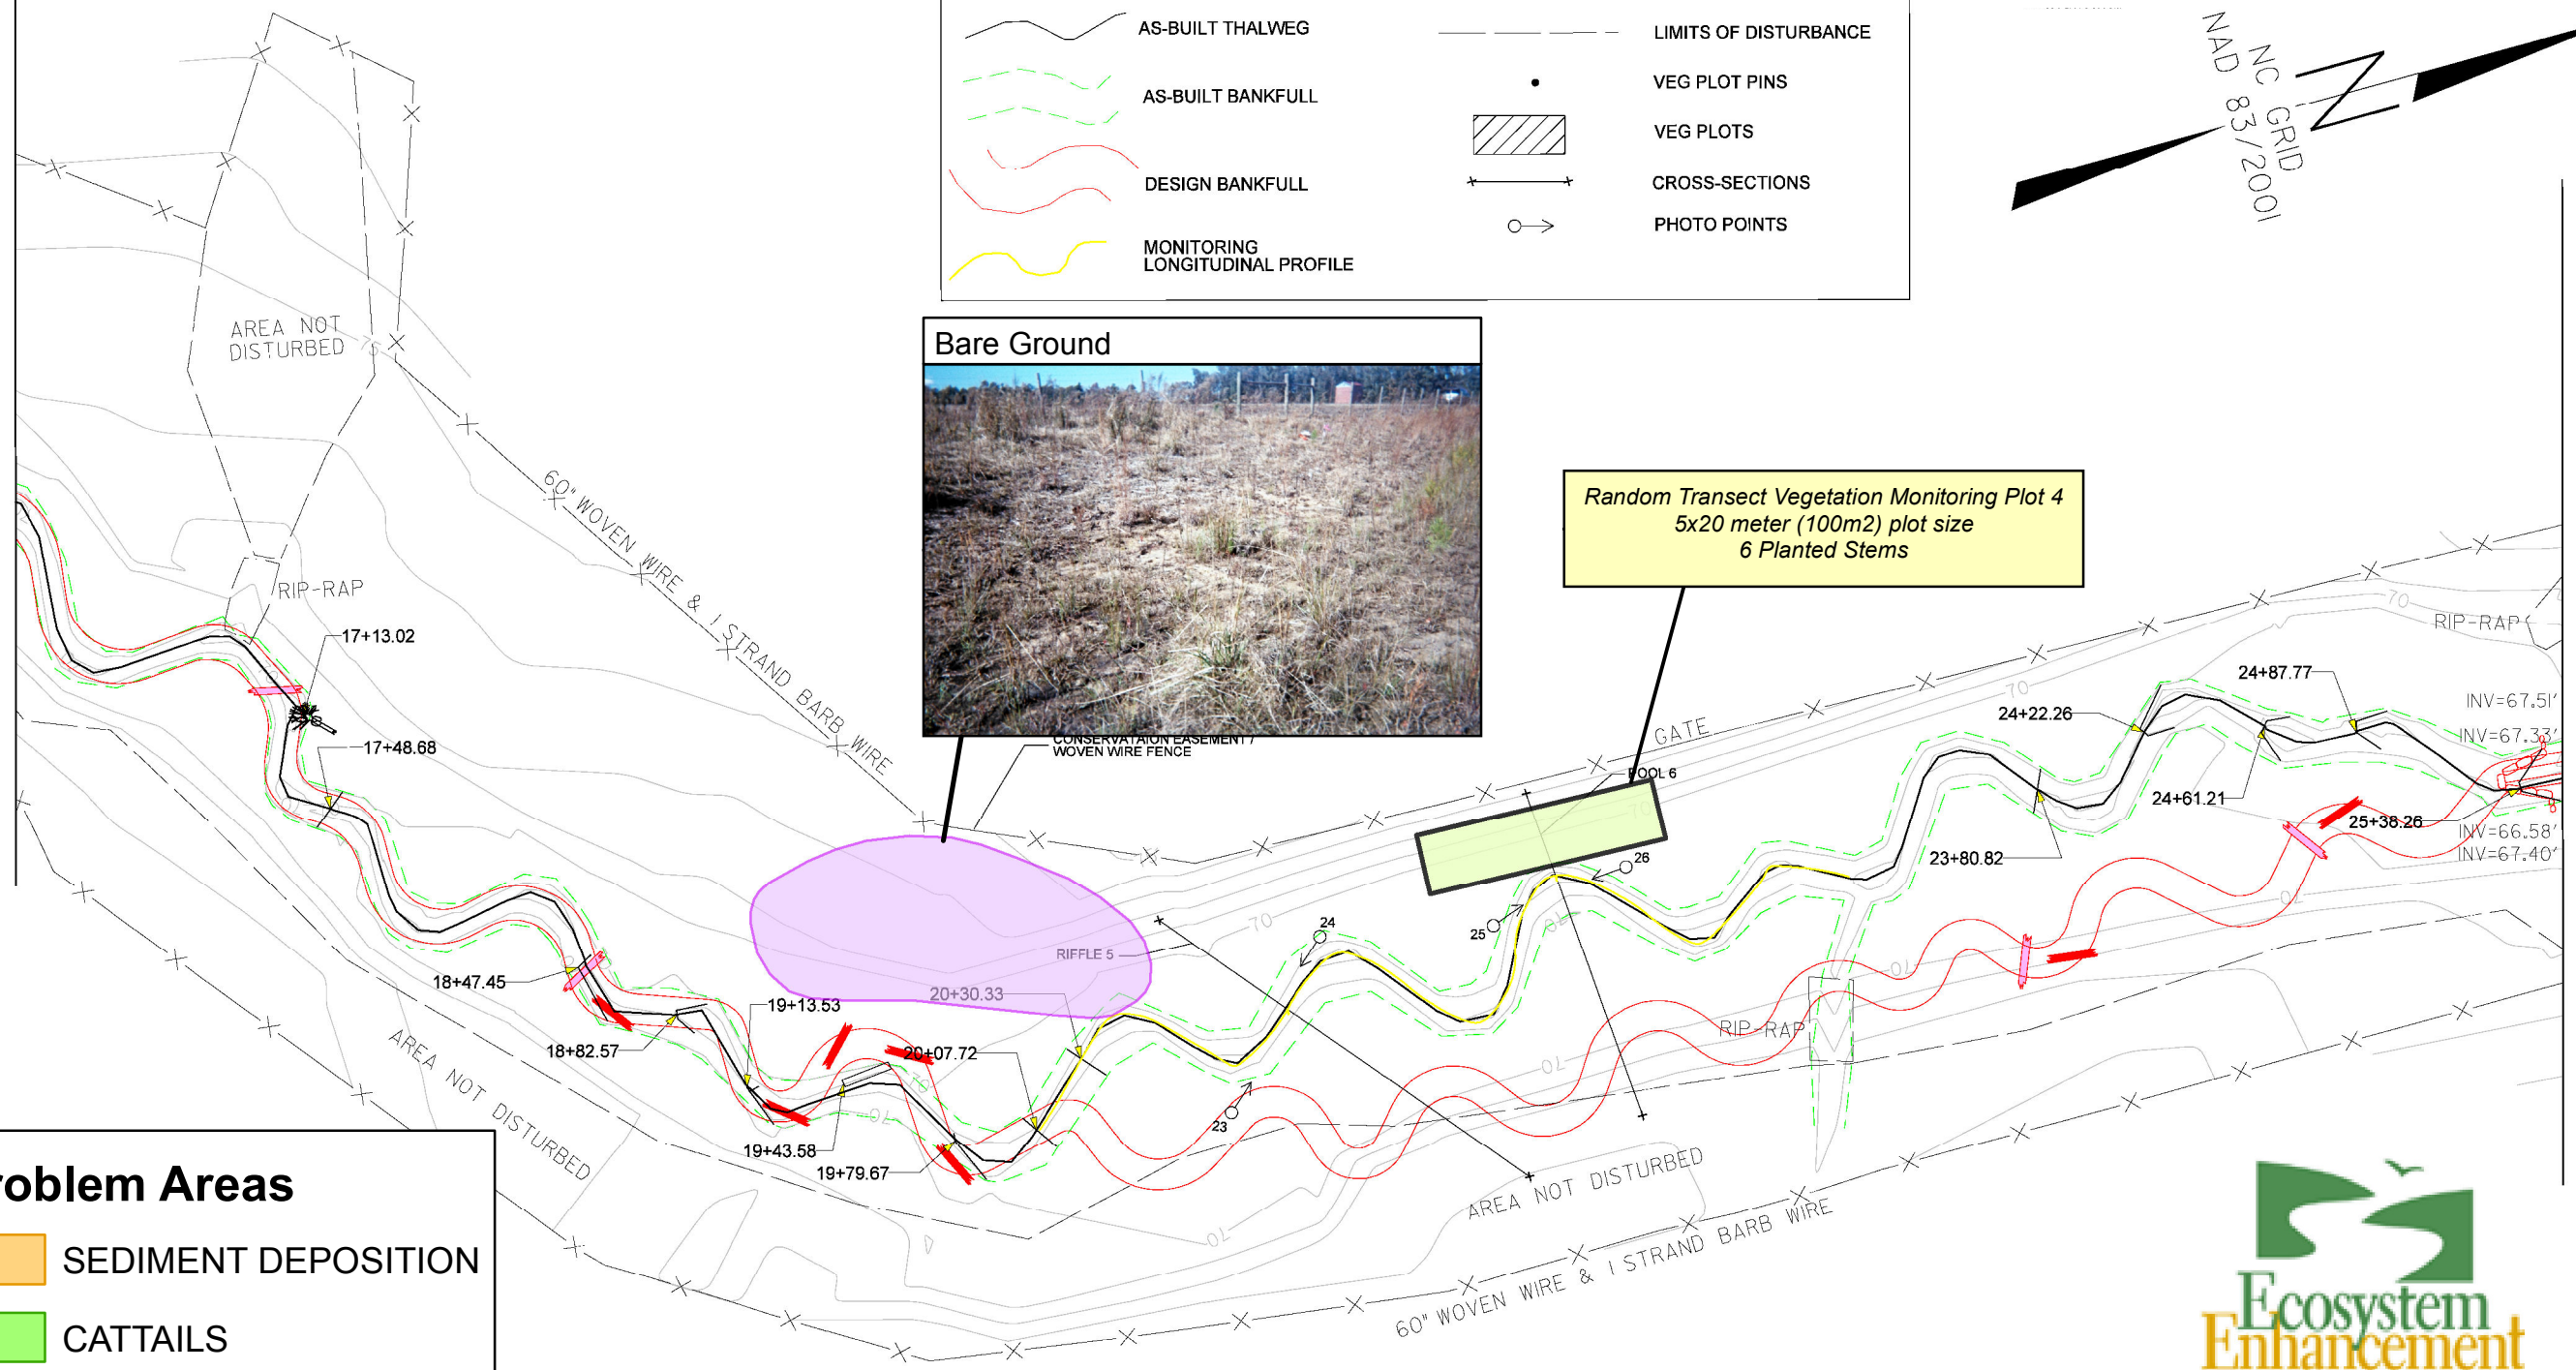
FIGURE 2d
Mill Branch
Stream Restoration Site
 October 20, 2011

Random Transect Vegetation Monitoring Plot 4
 5x20 meter (100m²) plot size
 6 Planted Stems

Problem Areas

- SEDIMENT DEPOSITION
- CATTAILS
- BARE GROUND
- RILL EROSION

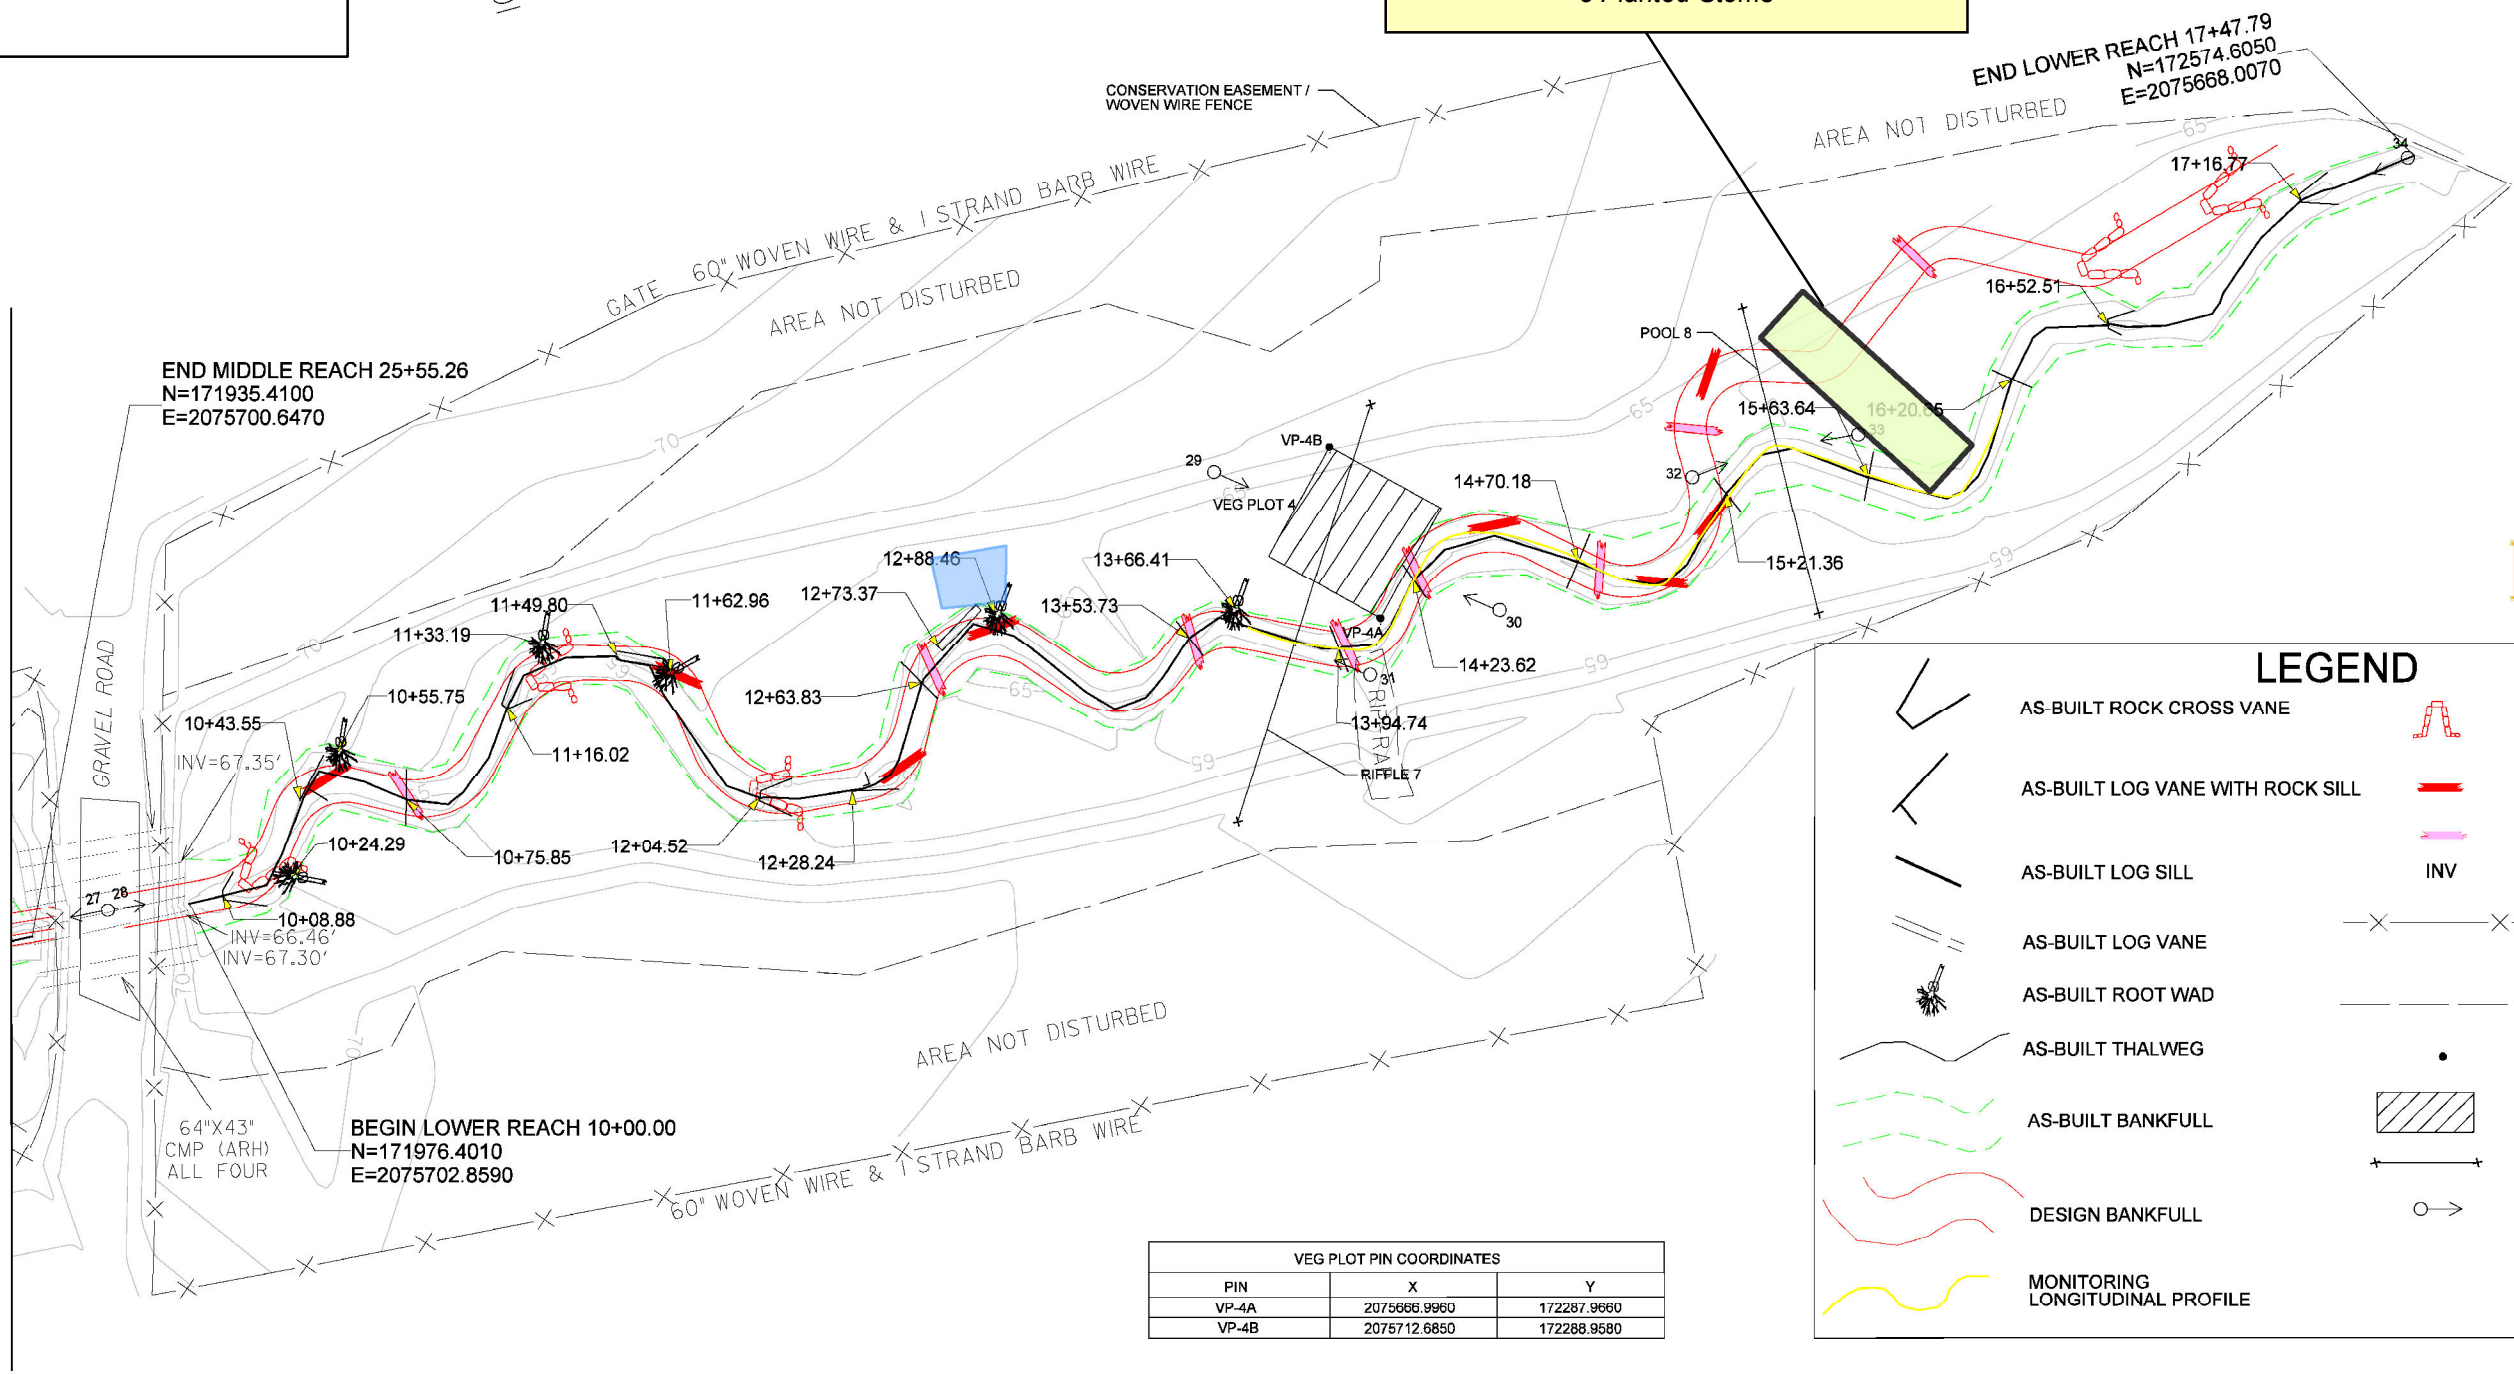
Problem Areas

- SEDIMENT DEPOSITION
- CATTAILS
- BARE GROUND
- RILL EROSION

Random Transect Vegetation Monitoring Plot 5
5x20 meter (100m²) plot size
8 Planted Stems

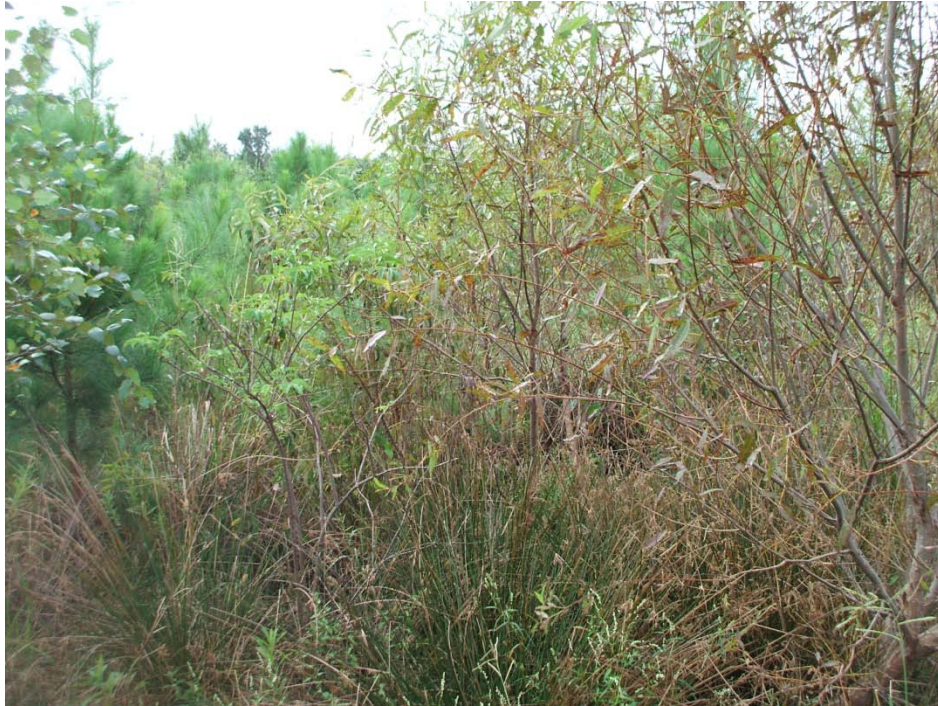
Stream Problem Areas			
Mill Branch Stream Restoration Site EEP Project No. 251			
Feature Issue	Station Number	Suspected Cause	Photo Number
Sediment Deposition	Western 10+00 to 13+50	Trapped Sediment/Low Flow	SPA 1
Sediment Deposition	Upper 10+00 to 14+00	Trapped Sediment/Low Flow	
Bare Ground	Figure 2c, Figure 2b	Dry Conditions/Possible Rill Erosion outside of Easement Boundary	VPA 1

SPA 1 – Rooted woody vegetation growing in the stream bed. Western Reach and Lower Reach

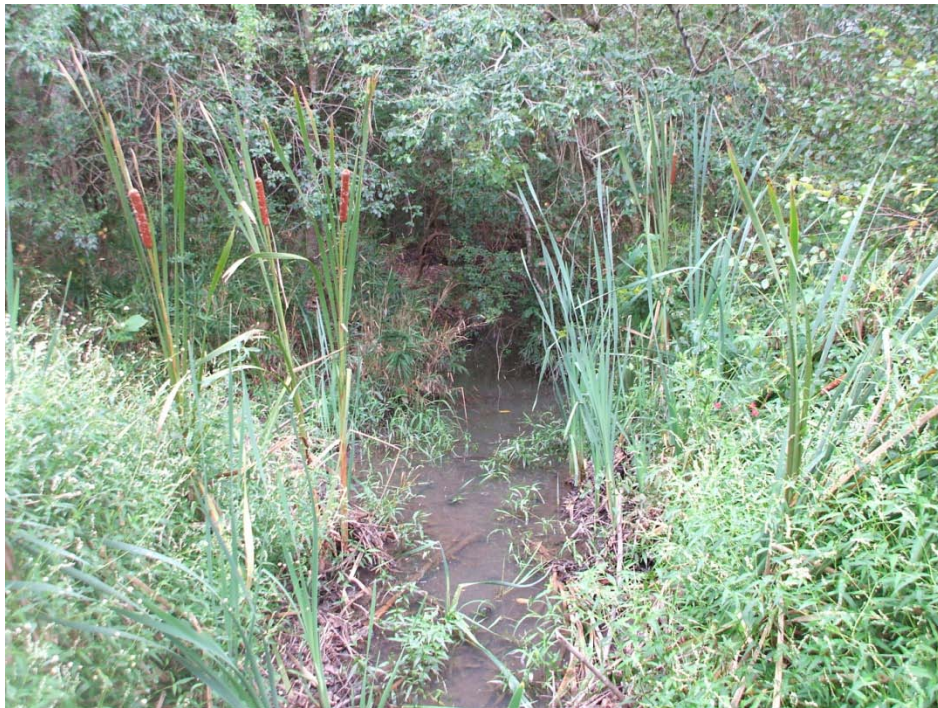
Vegetation Problem Areas			
Mill Branch Stream Restoration Site EEP Project No. 251			
Feature Category	Station Number	Suspected Cause	Photo Number
Cattail	Throughout	Low Flow Conditions	VPA 2

SPA 2 – Cattail growing in stream channel – Throughout project site

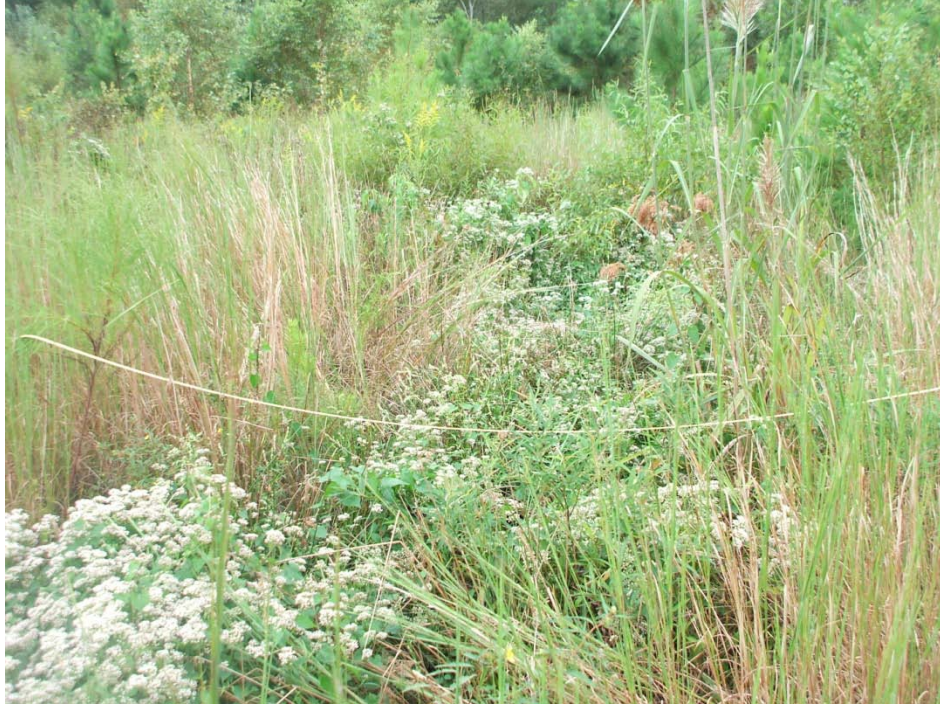
SPA 3 - Vegetation growing in the channel bed. Middle Reach
