FINAL
ANNUAL MONITORING REPORT
YEAR 3 (2014)
MILL CREEK STREAM/WETLAND RESTORATION SITE
RANDOLPH COUNTY, NORTH CAROLINA
(EEP Project No. 253, Contract No. 004803)
Construction Completed March 2011

Prepared by:
Axiom Environmental, Inc.
218 Snow Avenue
Raleigh, North Carolina 27603

October 2014

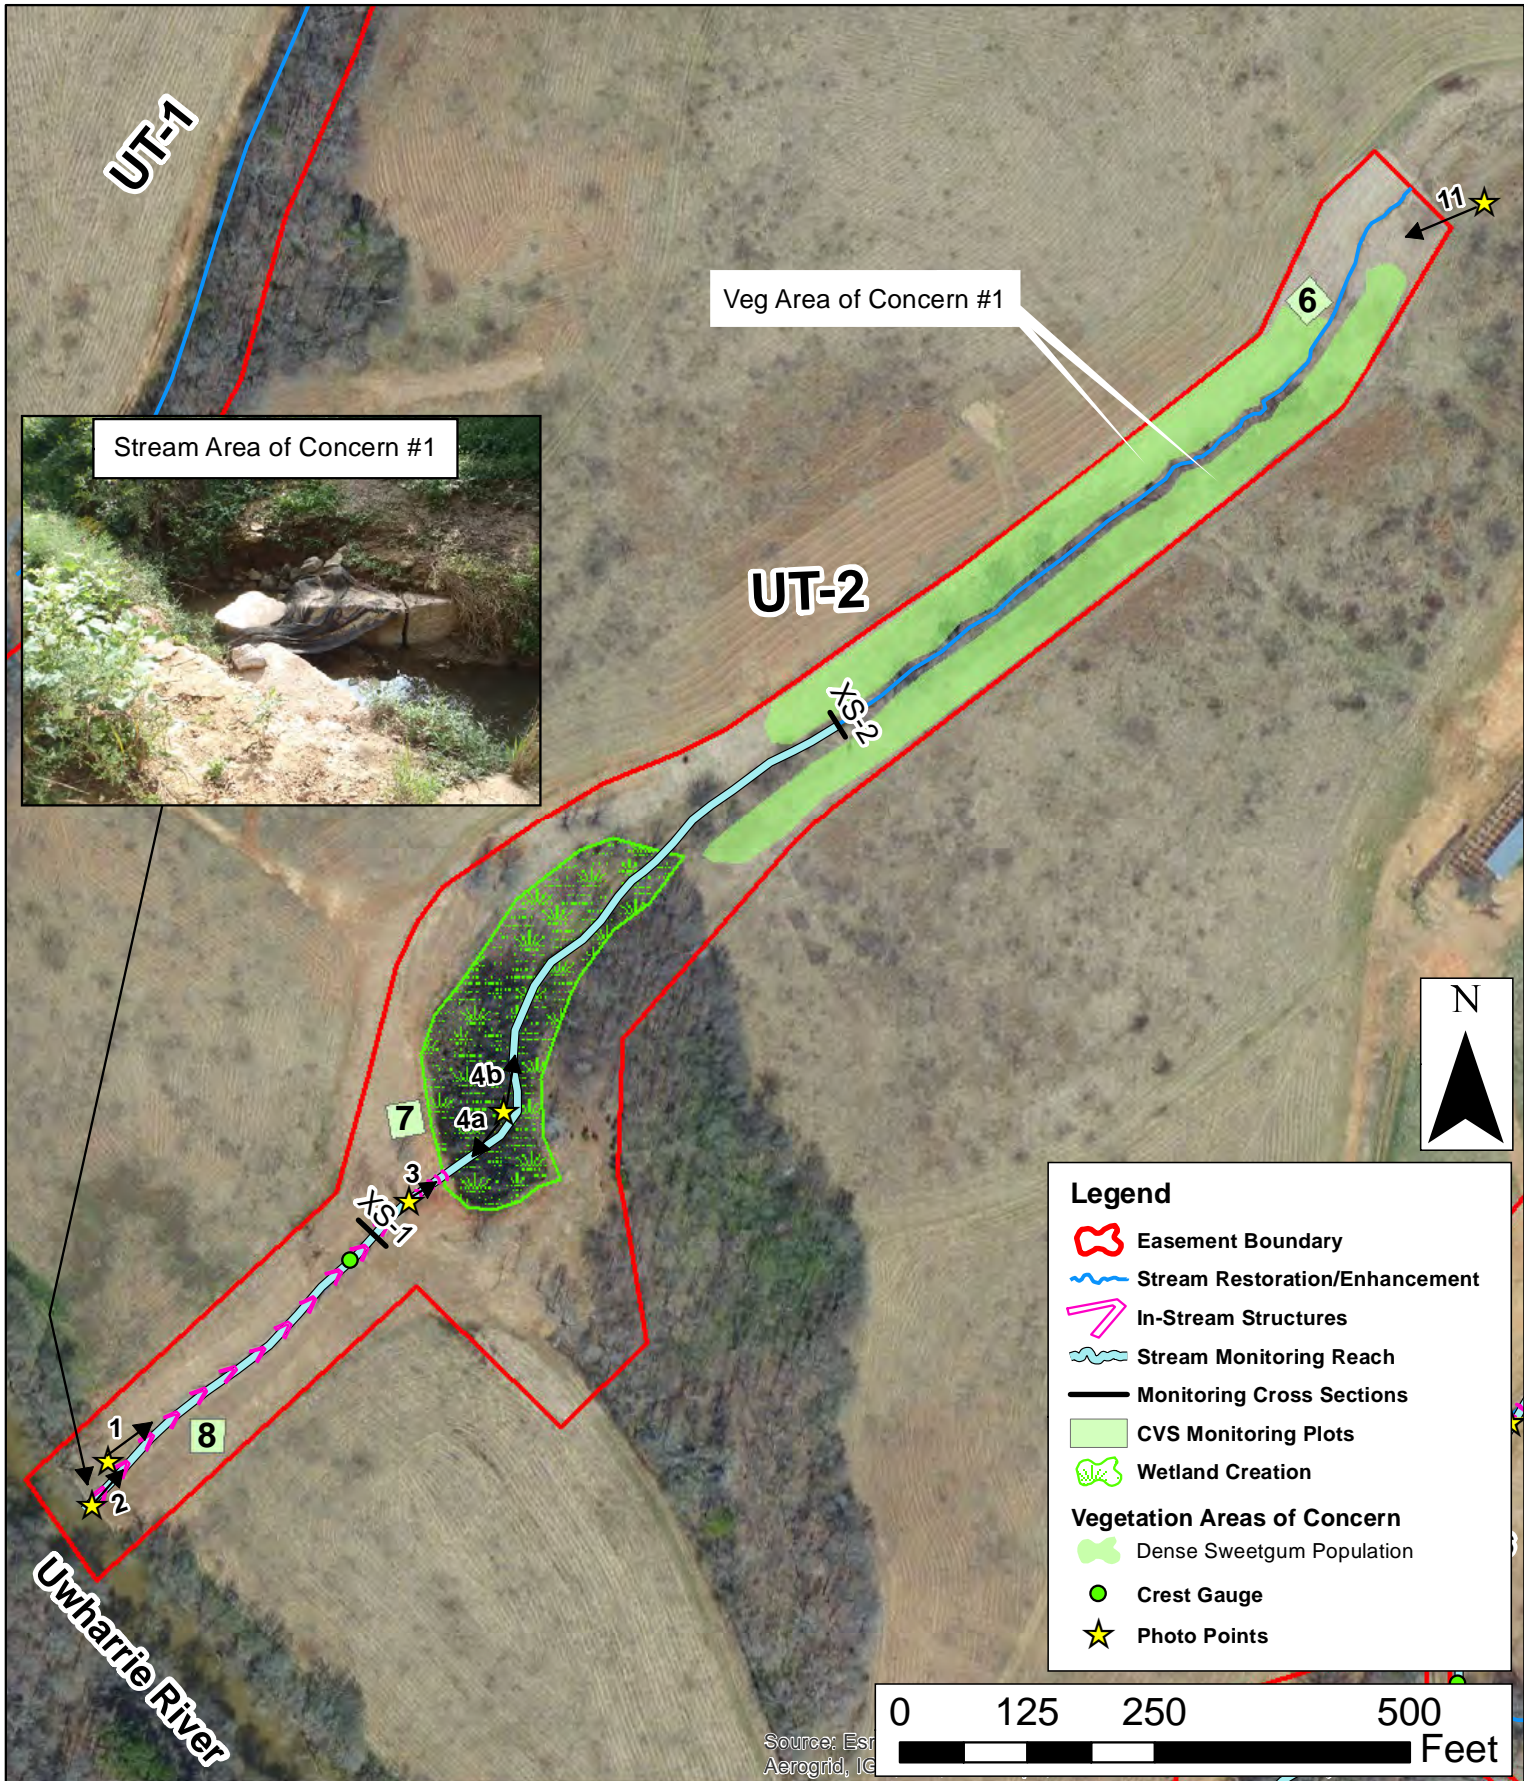
FIGURE
2A

Map Identifier	Feature/Issue
Veg Area of Concern #1	Dense sweet gum (<i>Liquidambar styraciflua</i>) and blackberry (<i>Rubus</i> sp.) community outcompeting planted stems on the upstream portion of UT2
Veg Area of Concern #2	Dense sweet gum (<i>Liquidambar styraciflua</i>) population mostly between UT4 and Mill Creek

Map Identifier	Feature/Issue
Stream Area of Concern #1	Cross vane at bottom of Mill Creek has been compromised due to high flows of the Uwharrie River. Structure is intact but adjacent banks have been eroded causing water to flow around arms and pipe underneath headers
Stream Area of Concern #2	Sixth upstream cross vane in series of drop structures has failed completely, upstream and downstream structures are intact and functioning. Failure likely due to localized heavy rain event between June and September 2014.

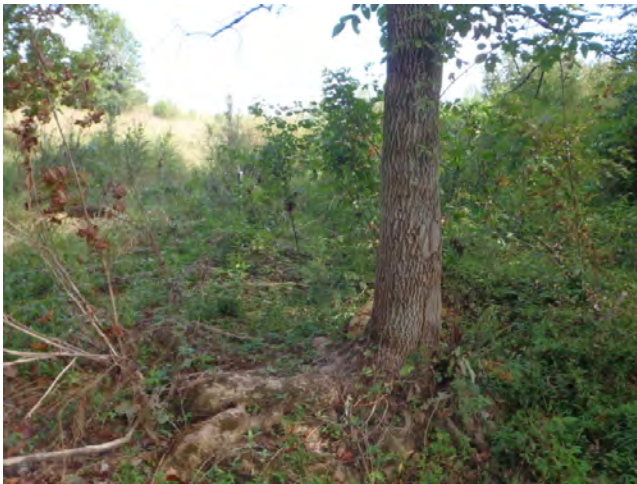
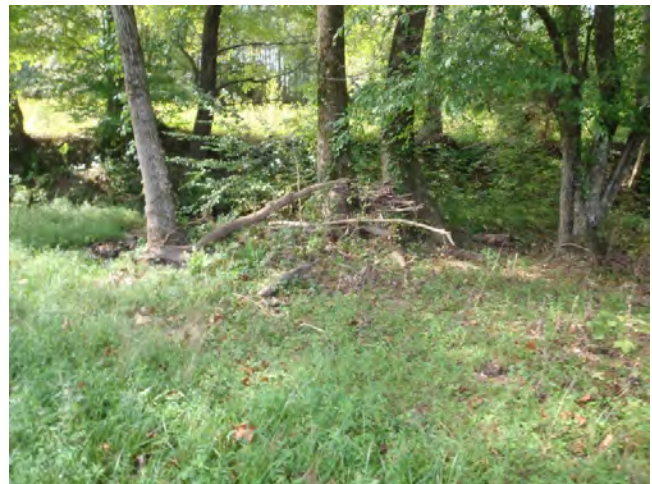
Date of Data Collection	Date of Occurrence	Method	Photo (if available)
June 10, 2013	June 7, 2013	Crest gauge observations indicated bankfull event on UT2 and UT5 after 3.64 inches* of rain between June 2 and 7, 2013.	-
November 25, 2013	July 11, 2013	Crest gauge observations indicated a bankfull event 2.06 inches* of rain fall documented between July 10-11, 2013 following a total of 4.31 inches* of rain fall documented to fall during 14 out of the proceeding 15 days (June 25-July 8, 2013).	-
August 18, 2014	March 7, 2014	2.02 inches* of rain fall documented between March 6-7, 2014.	-
August 18, 2014	May 15, 2014	2.08 inches* of rain fall documented on May 15, 2014.	
September 16, 2014	August 1, 2014	Large wrack and debris piles observed on Mill Creek, UT2, and UT5, as well as structure failures on UT2 and UT5 indicating a bankfull event from a localized, heavy rain event.	1-2
