FINAL
ANNUAL MONITORING REPORT
YEAR 4 (2015)
MILL CREEK STREAM/WETLAND RESTORATION SITE
RANDOLPH COUNTY, NORTH CAROLINA
(DMS Project No. 253, Contract No. 004803)
Construction Completed March 2011

December 2015

Prepared by:
Axiom Environmental, Inc.
218 Snow Avenue
Raleigh, North Carolina 27603

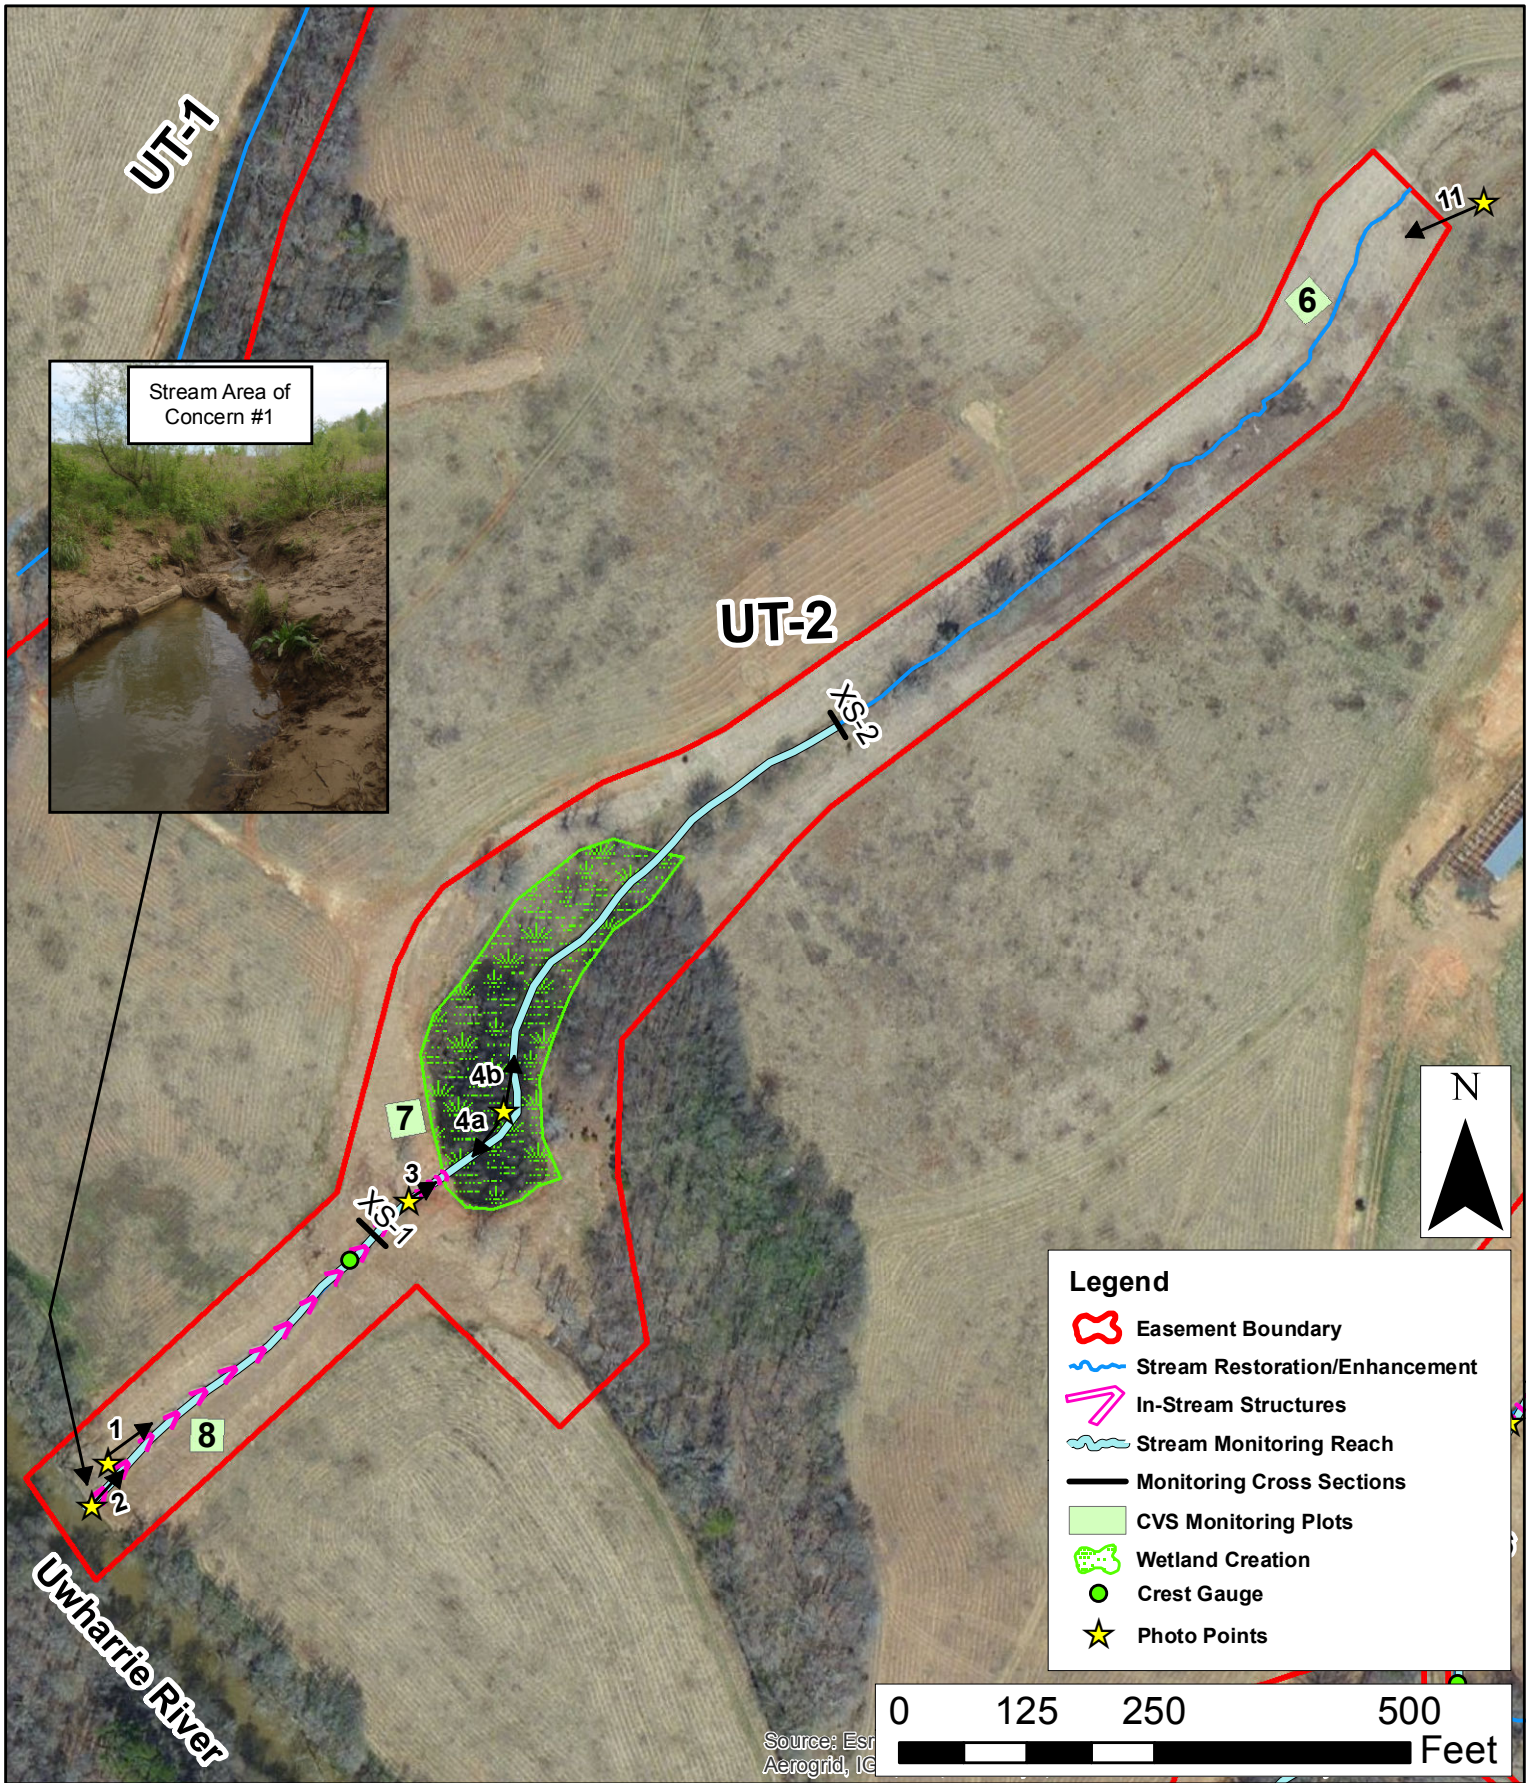
FIGURE
2A

Map Identifier	Feature/Issue
Stream Area of Concern #1	Cross vane at bottom of UT-2 has been compromised due to high flows of the Uwharrie River. Structure is intact but adjacent banks have been eroded causing water to flow around arms and pipe underneath headers
Stream Area of Concern #2	Sixth upstream cross vane in series of drop structures has failed completely, upstream and downstream structures are intact and functioning. Failure likely due to localized heavy rain event between June and September 2014.

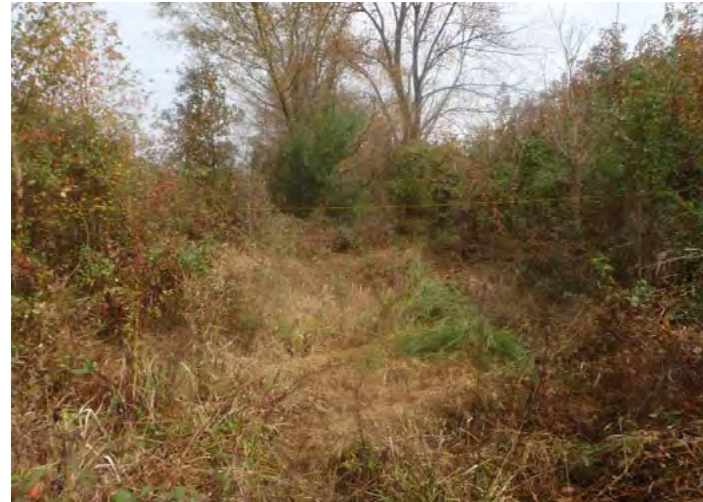
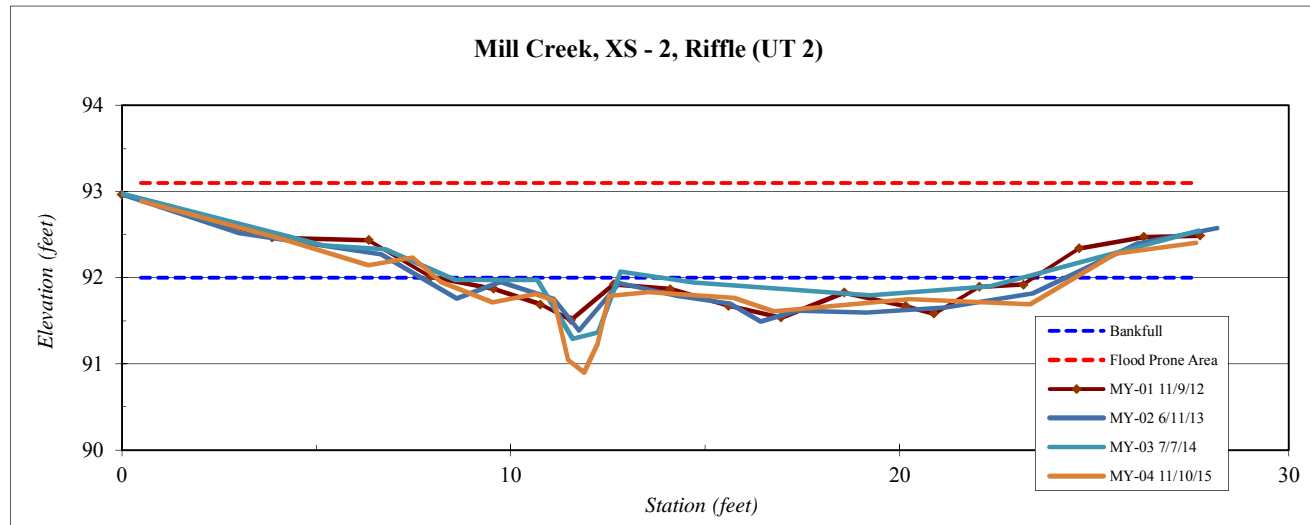
River Basin:	Yadkin
Site	Mill Creek
XS ID	XS - 2, Riffle (UT 2)
Drainage Area (sq mi):	0.08
Date:	11/10/2015
Field Crew:	Perkinson, Keith

SUMMARY DATA	
Bankfull Elevation:	92.0
Bankfull Cross-Sectional Area:	4.8
Bankfull Width:	16.4
Flood Prone Area Elevation:	93.1
Flood Prone Width:	35.0
Max Depth at Bankfull:	1.1
Mean Depth at Bankfull:	0.3
W / D Ratio:	56.0
Entrenchment Ratio:	2.1
Bank Height Ratio:	1.0

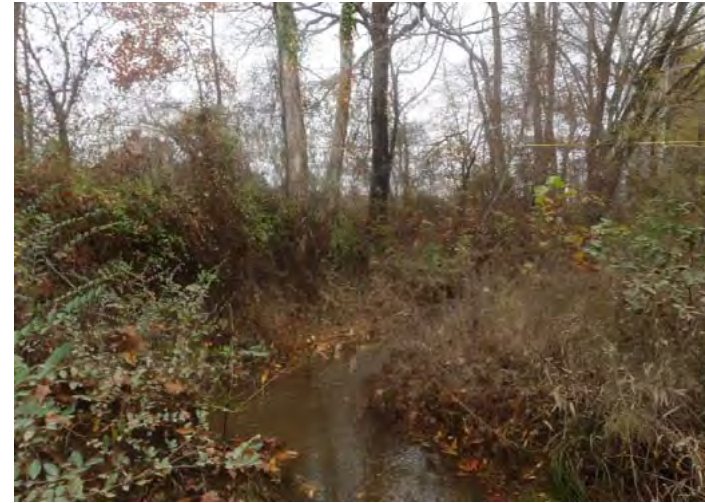
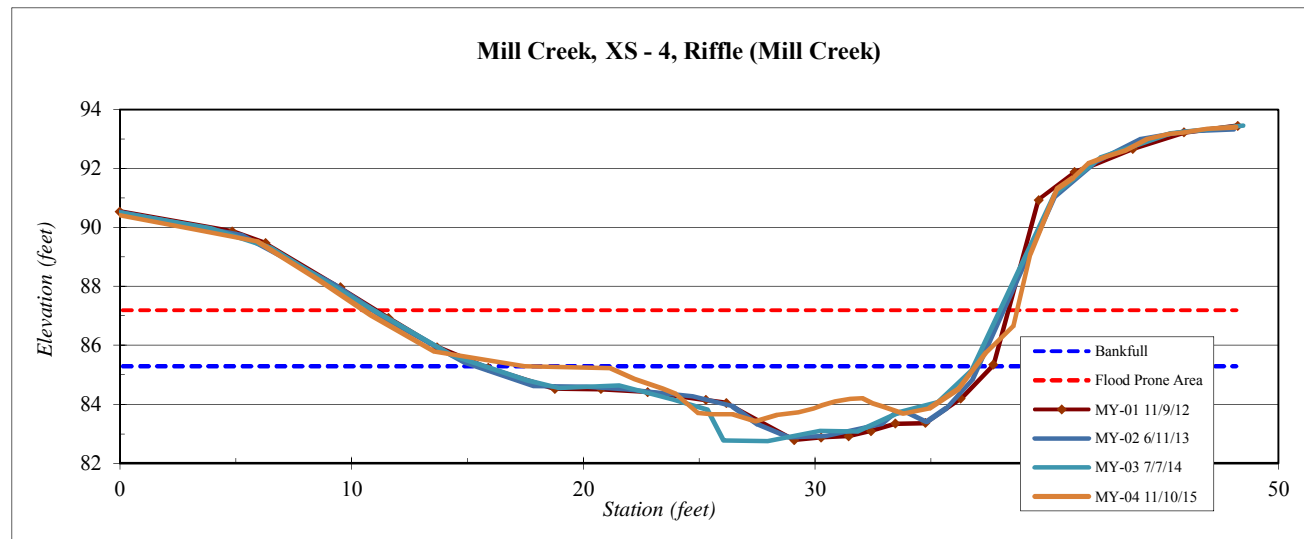
River Basin:	Yadkin
Site	Mill Creek
XS ID	XS - 4, Riffle (Mill Creek)
Drainage Area (sq mi):	1.33
Date:	11/10/2015
Field Crew:	Perkinson, Keith

SUMMARY DATA	
Bankfull Elevation:	85.3
Bankfull Cross-Sectional Area:	19.3
Bankfull Width:	19.5
Flood Prone Area Elevation:	87.2
Flood Prone Width:	28.0
Max Depth at Bankfull:	1.9
Mean Depth at Bankfull:	1.0
W / D Ratio:	19.7
Entrenchment Ratio:	1.4
Bank Height Ratio:	1.0

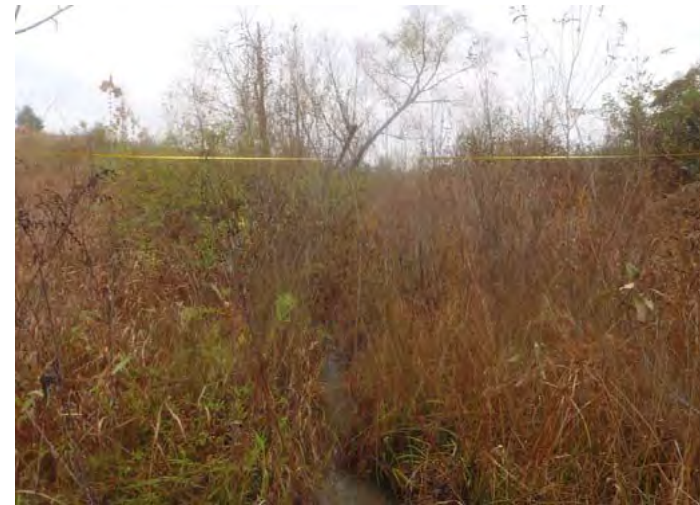
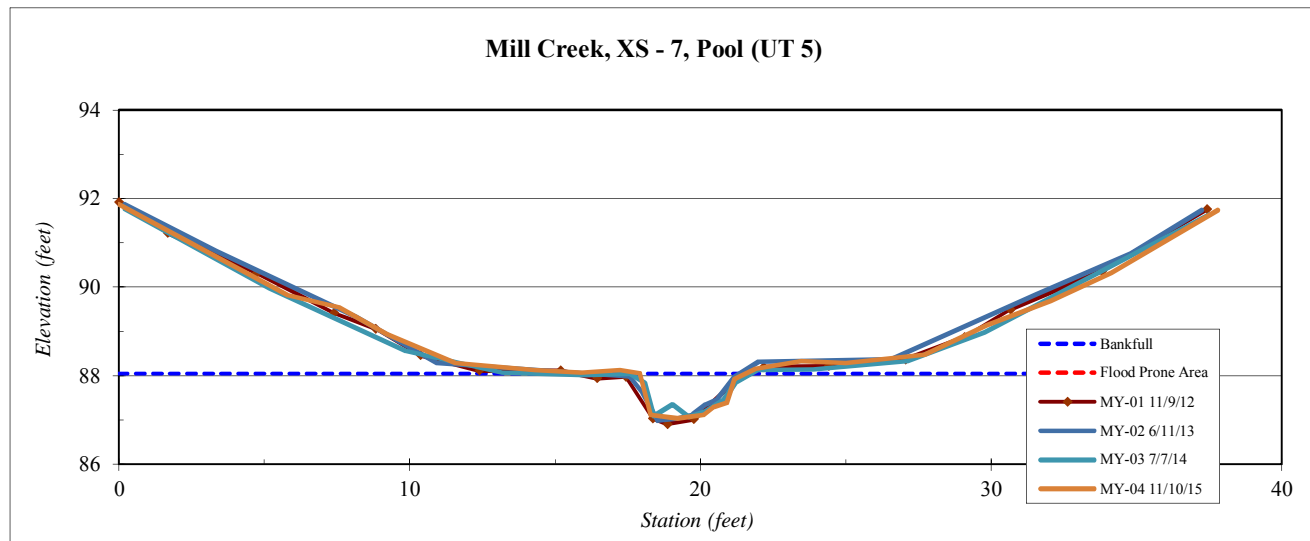
River Basin:	Yadkin
Site	Mill Creek
XS ID	XS - 7, Pool (UT 5)
Drainage Area (sq mi):	0.06
Date:	11/10/2015
Field Crew:	Perkinson, Keith

SUMMARY DATA	
Bankfull Elevation:	88.1
Bankfull Cross-Sectional Area:	2.7
Bankfull Width:	3.6
Flood Prone Area Elevation:	-
Flood Prone Width:	-
Max Depth at Bankfull:	1.0
Mean Depth at Bankfull:	0.8
W / D Ratio:	-
Entrenchment Ratio:	-
Bank Height Ratio:	1.0

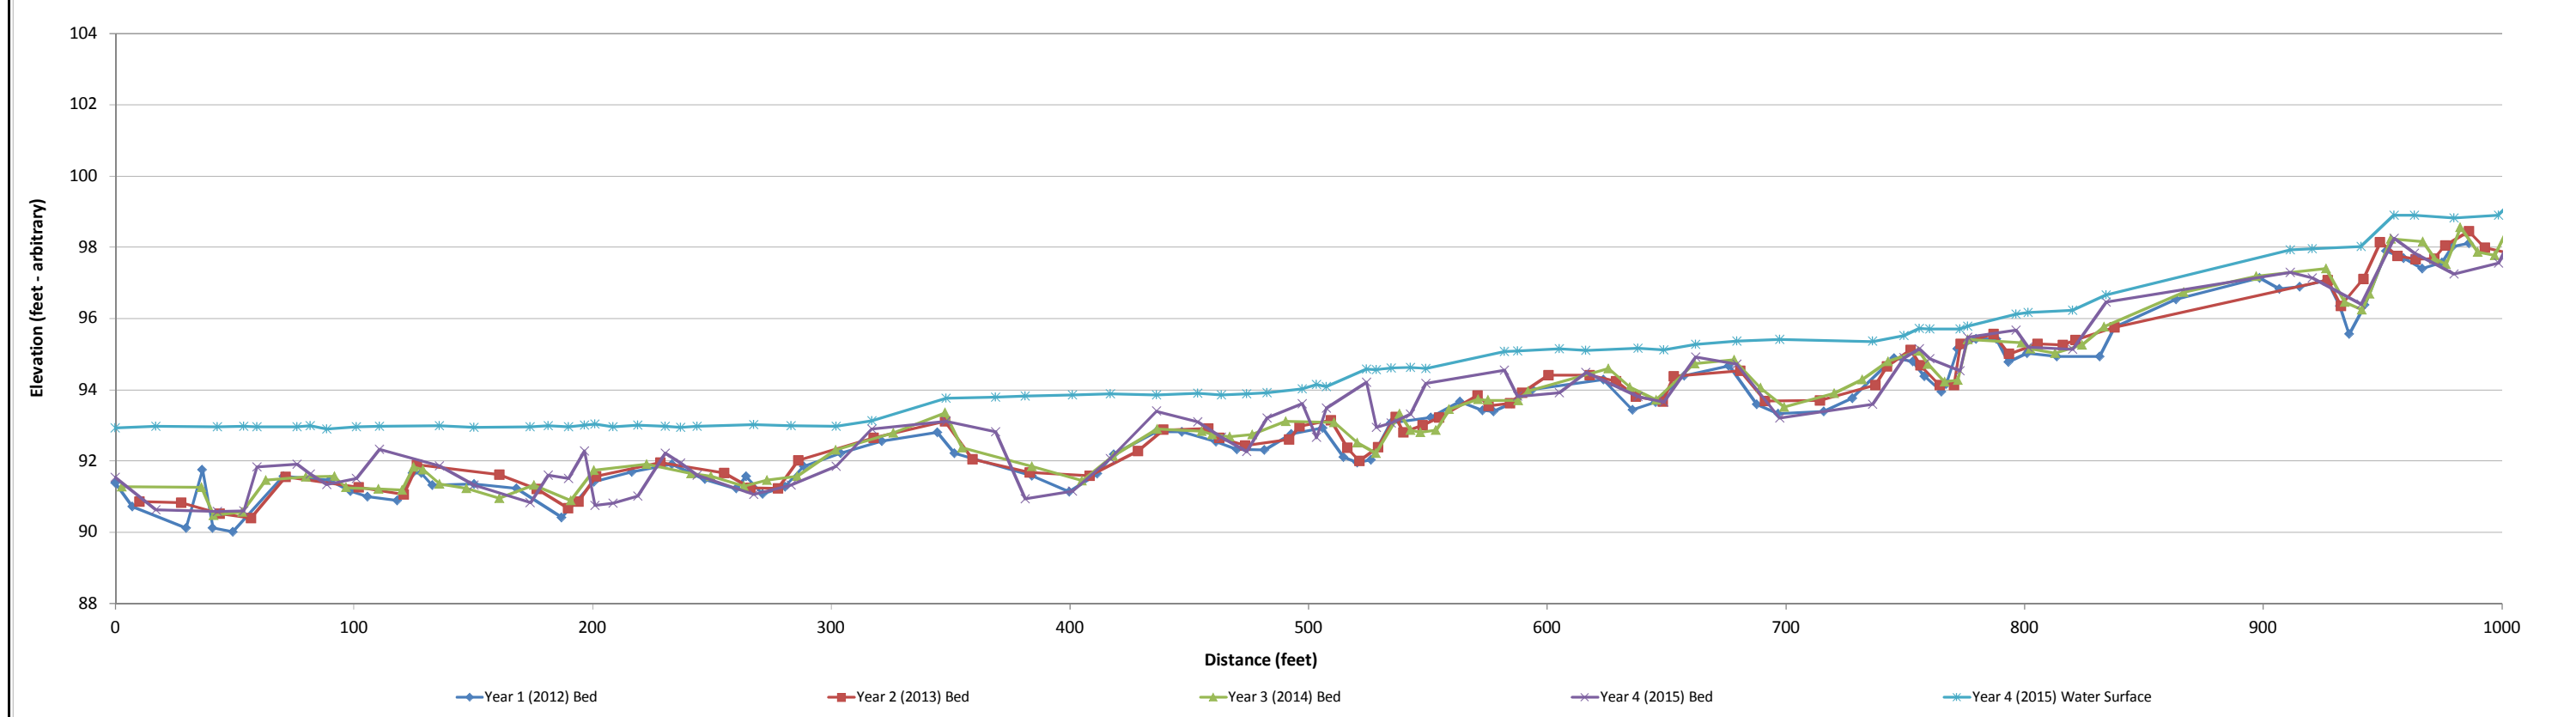
Mill Creek Year 4 (2015) Profile - Mill Creek 00+00 to 10+00

2012	2013	2014	2015	2016
Avg. Water Surface Slope	0.0074	0.0062	0.0072	0.0071	
Riffle Length	23	42	28	25	
Avg. Riffle Slope	0.0118	0.0108	0.0107	0.0124	
Pool Length	34	33	38	42	
Pool to Pool Spacing	57	62	63	62

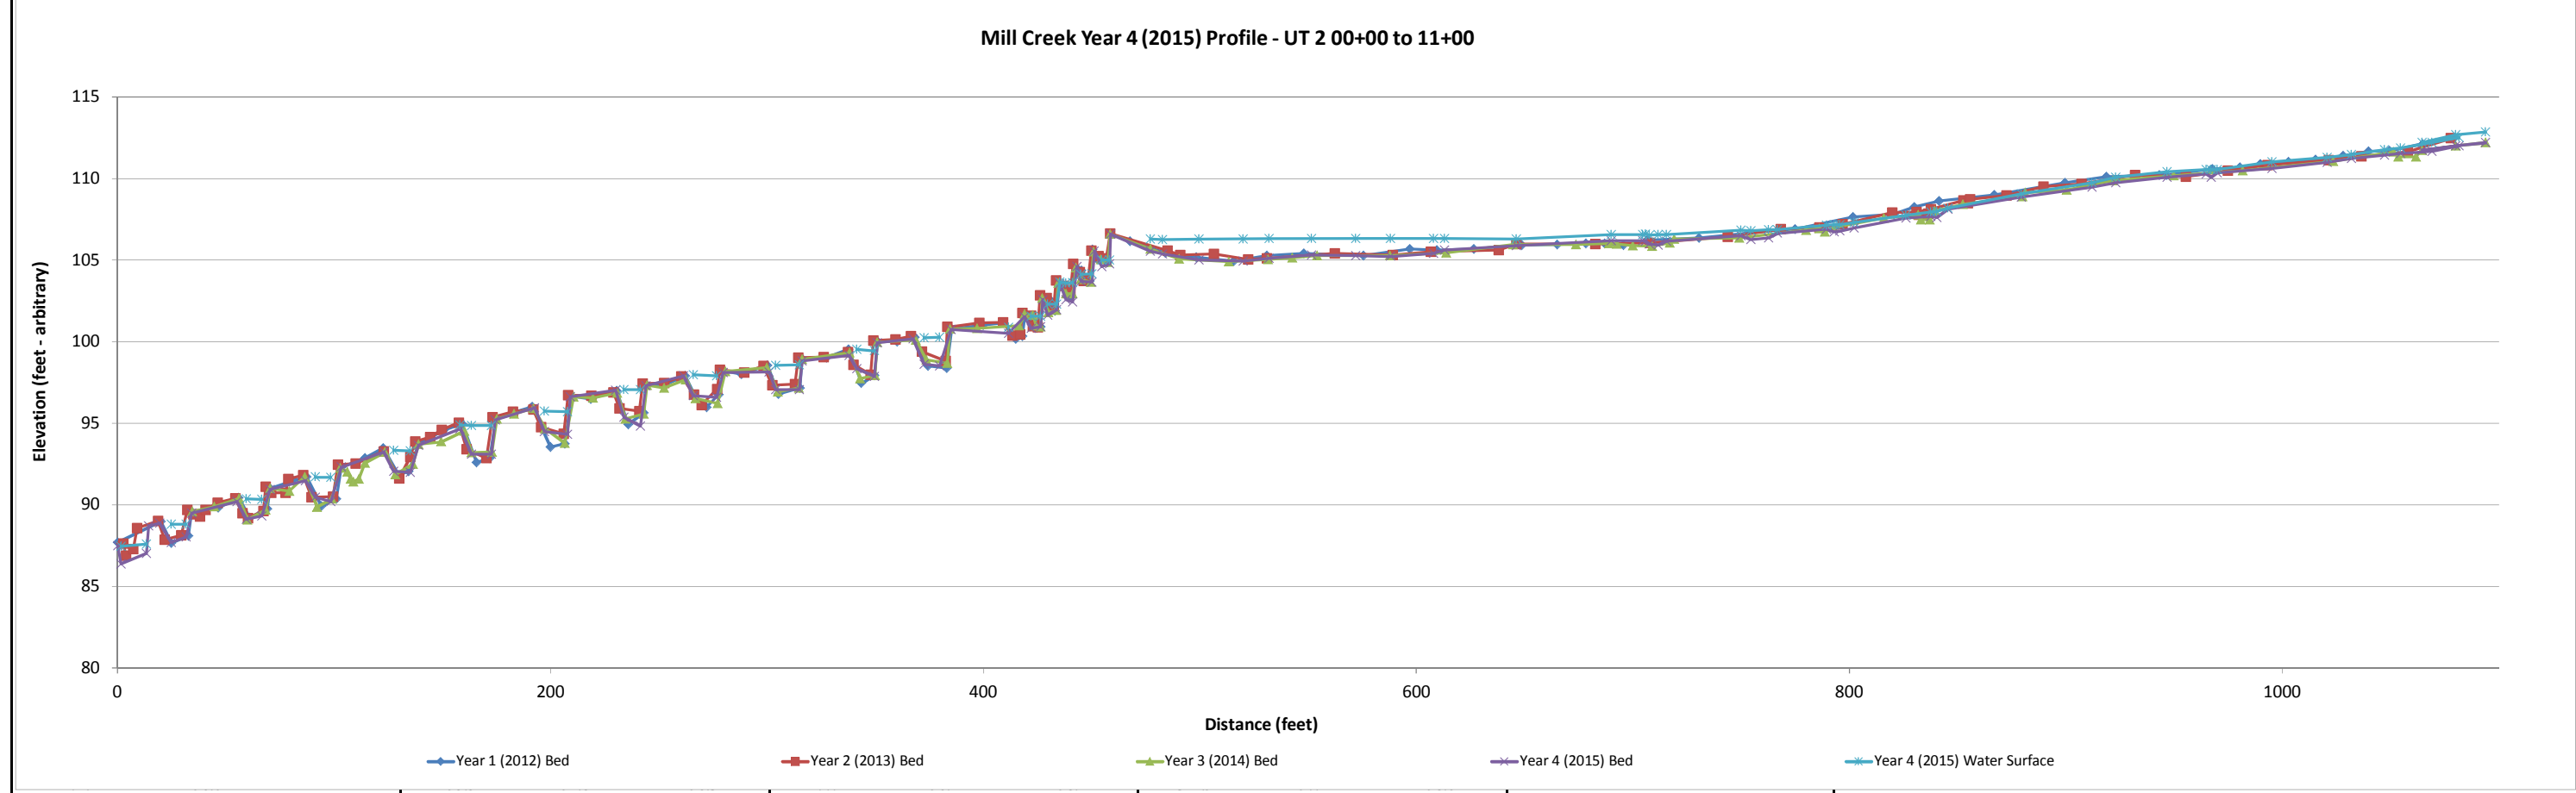
Project Name	Mill Creek - Profile
Reach	UT 2 Station 00+00 - 11+00
Feature	Profile
Date	11/10/15
Crew	Perkinson, Jernigan

2012	2013	2014	2015	2016
Avg. Water Surface Slope	**	0.0249	0.0204	0.0226	
Riffle Length	20	15	20	33	
Avg. Riffle Slope	**	0.0325	0.0239	0.0138	
Pool Length	15	11	14	18	
Pool to Pool Spacing	34	23	36	44

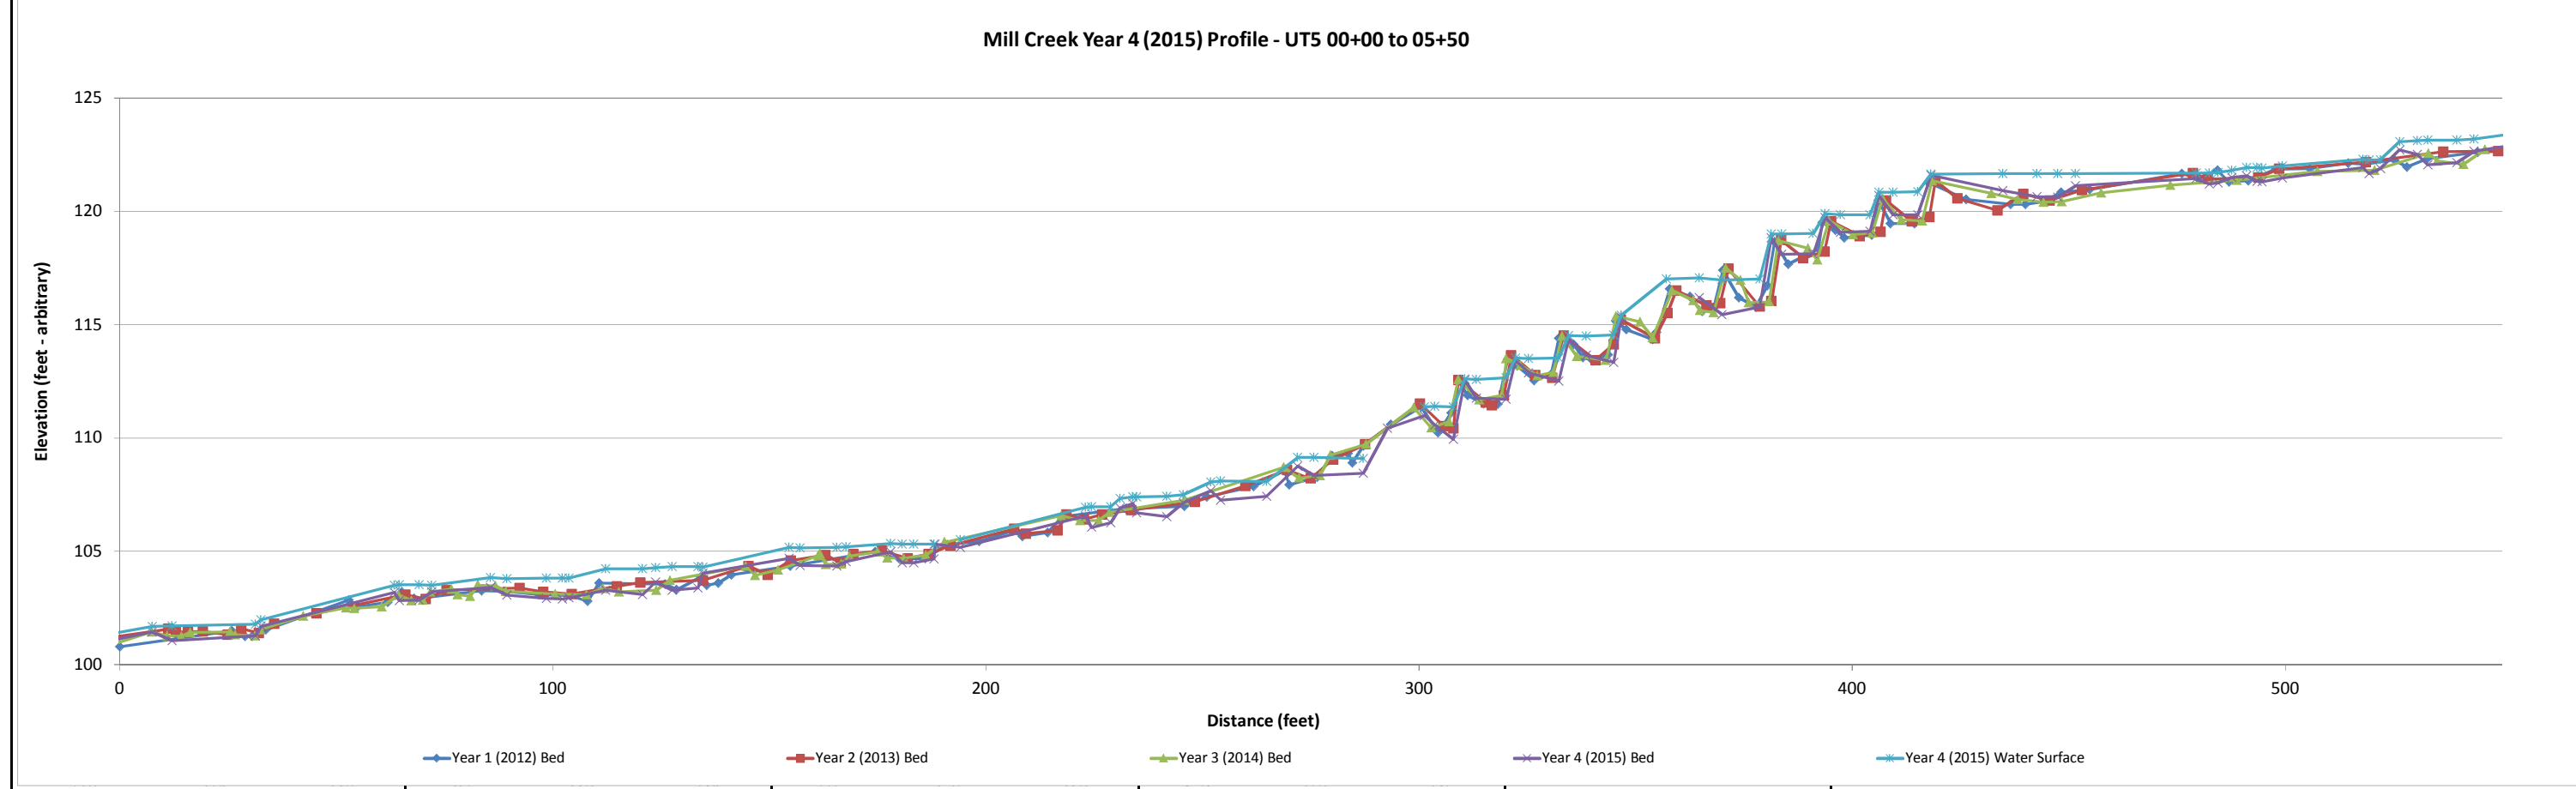
Project Name	Mill Creek - Profile
Reach	UT 5 Station 00+00 - 05+50
Feature	Profile
Date	11/10/15
Crew	Perkinson, Jernigan

2012	2013	2014	2015	2016
Avg. Water Surface Slope	0.0201	0.0419	0.0397	0.0400	
Riffle Length	30	23	15	9	
Avg. Riffle Slope	0.0235	0.0401	0.0273	0.0315	
Pool Length	21	13	12	17	
Pool to Pool Spacing	44	21	23	22
