FINAL
ANNUAL MONITORING REPORT
YEAR 5 (2016)
MILL CREEK STREAM/WETLAND RESTORATION SITE
RANDOLPH COUNTY, NORTH CAROLINA
(DMS Project No. 253, Contract No. 004803)
Construction Completed March 2011

Submitted to:
North Carolina Department of Environmental Quality
Division of Mitigation Services
Raleigh, North Carolina

December 2016

Prepared by:
Axiom Environmental, Inc.
218 Snow Avenue
Raleigh, North Carolina 27603

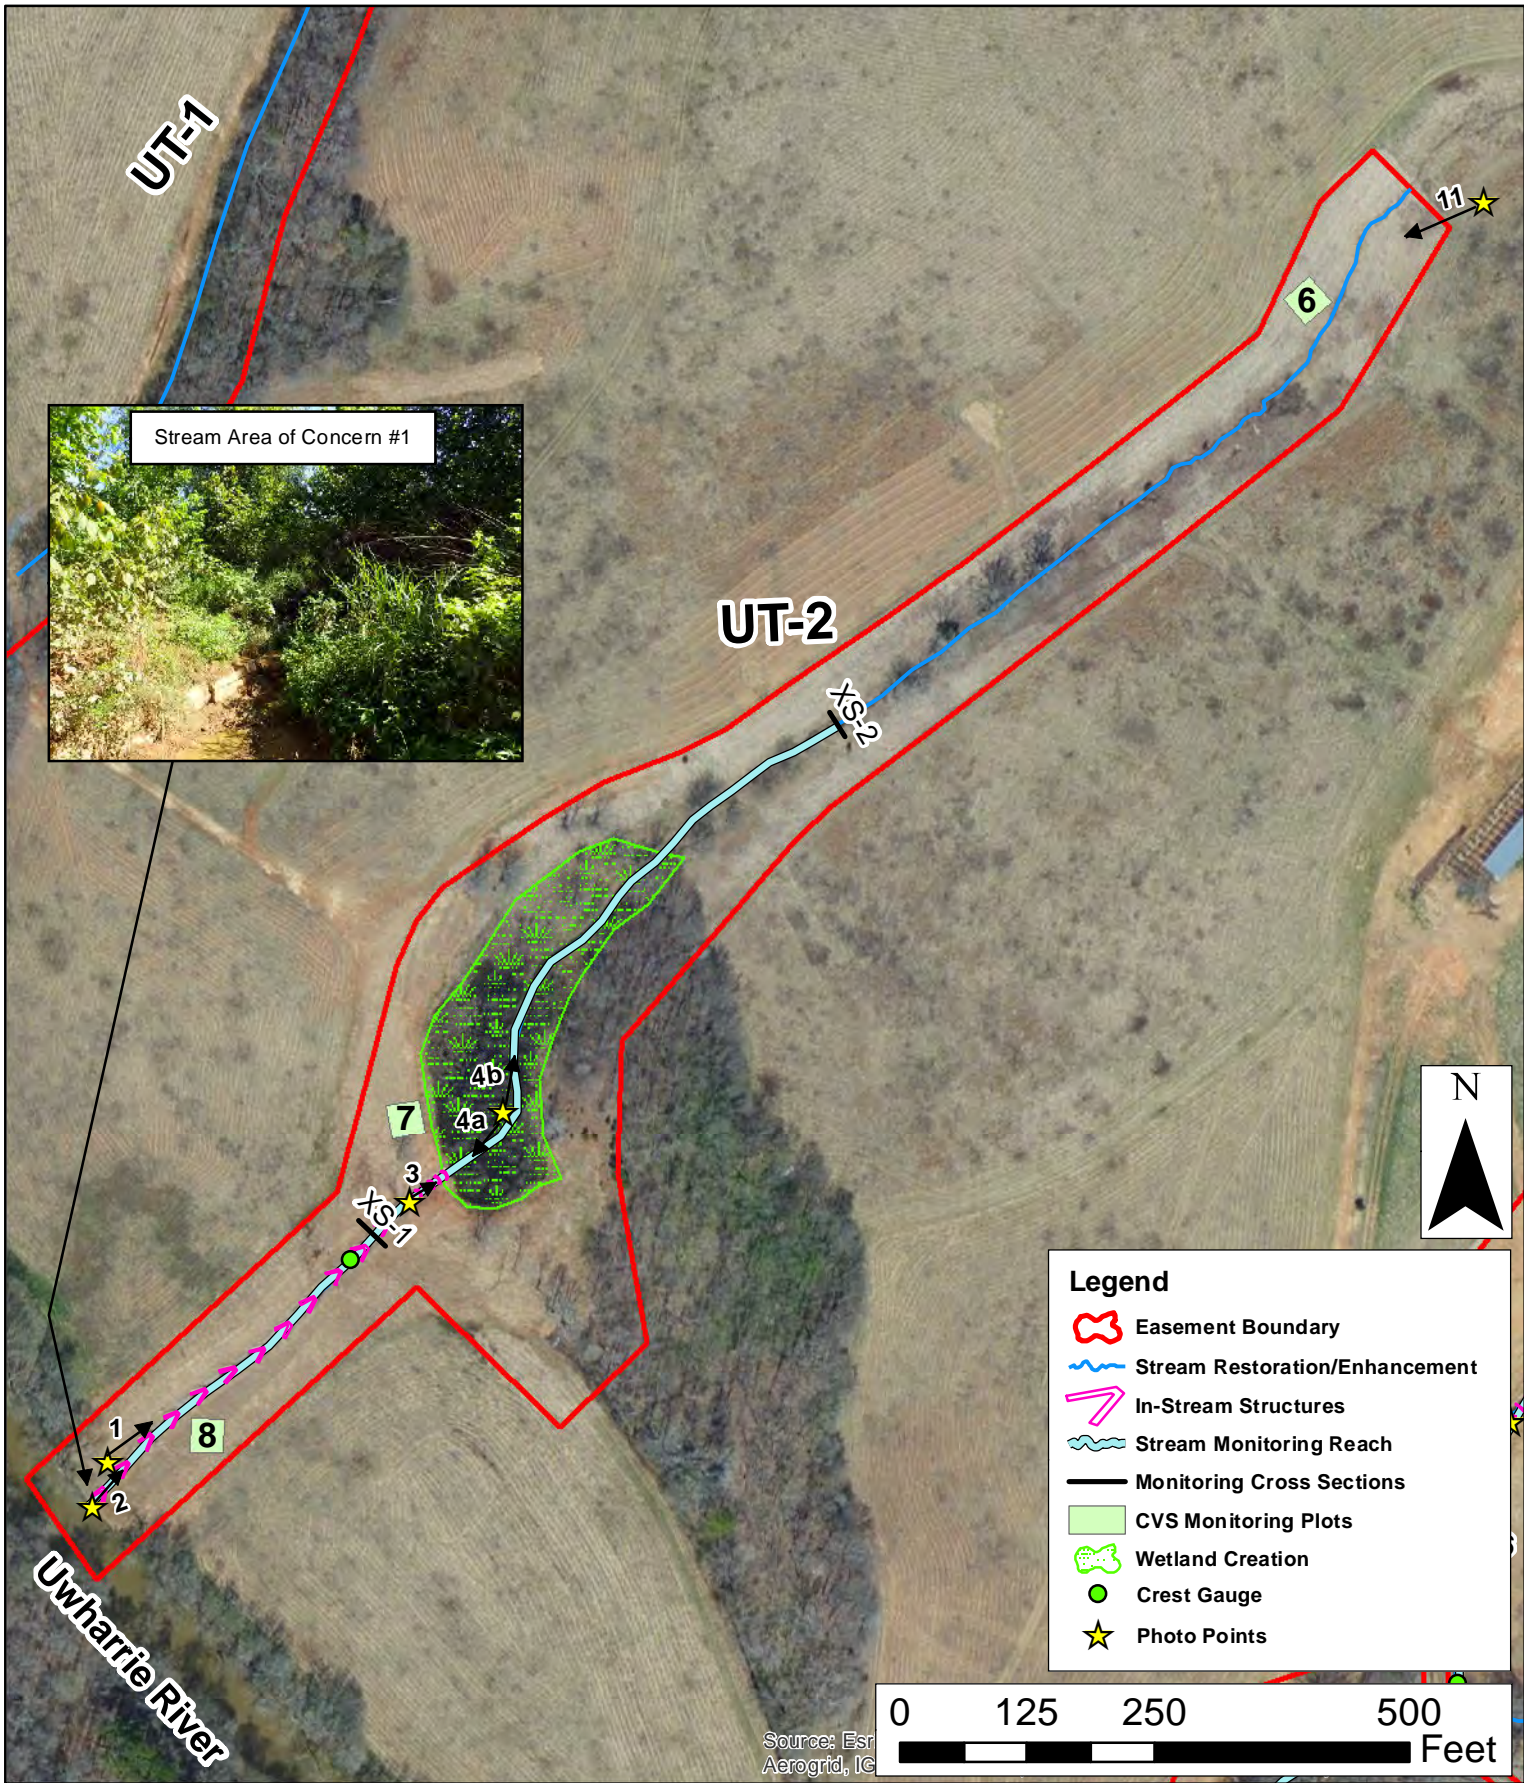
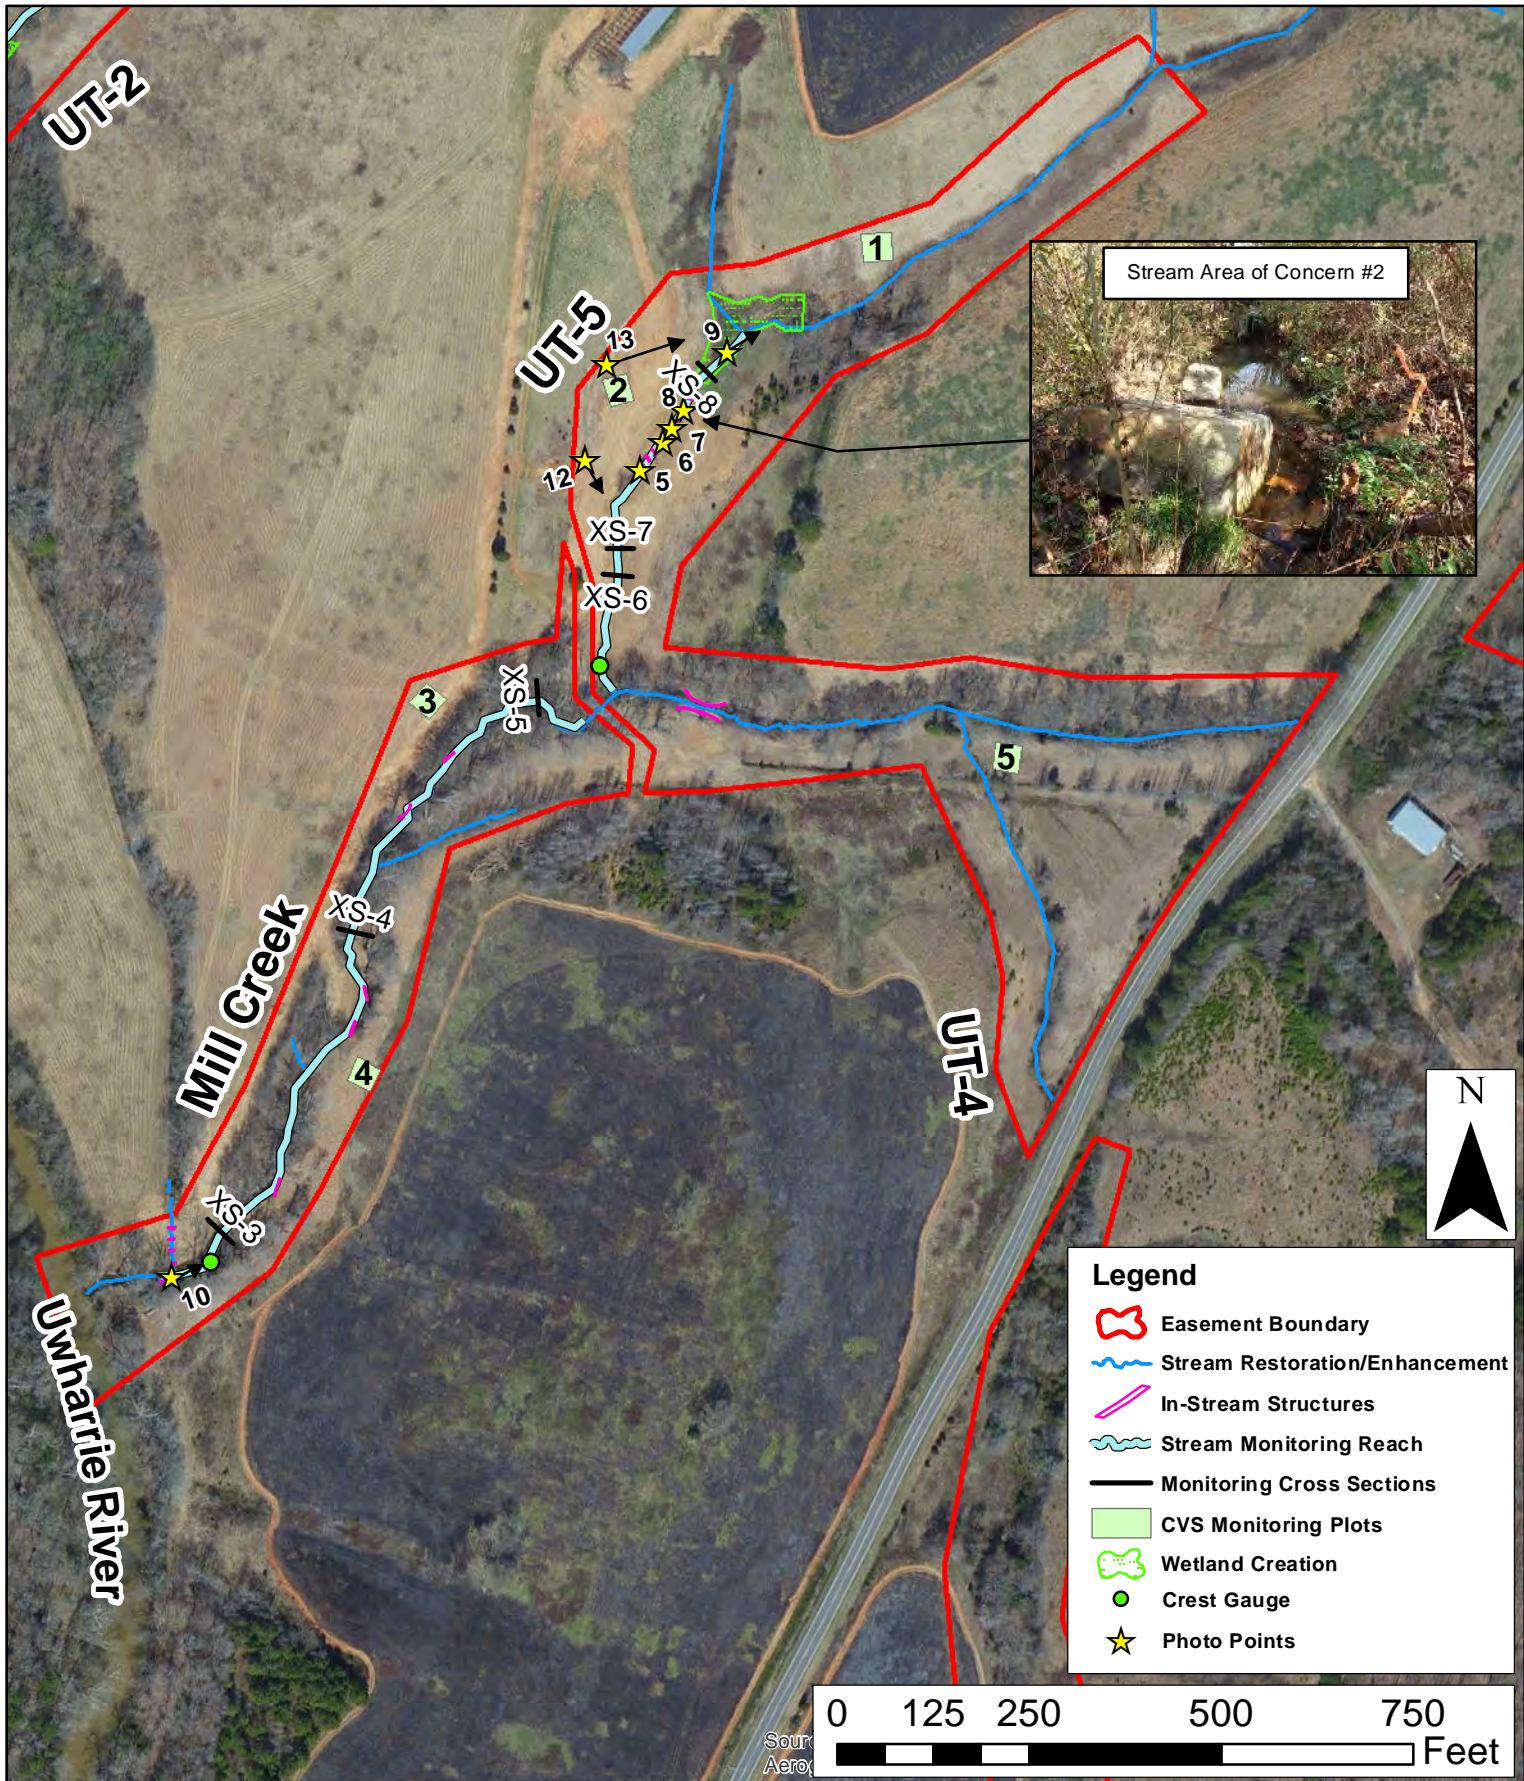
Visual assessment and geomorphic surveys completed for the Site indicate that project reaches were performing within established success criteria ranges as shown below. No significant bank erosion was recorded, and geomorphic measurements are within the range of the design parameters. Slight temporal down-cutting was observed in the cross-section data at cross-sections 2 and 8 over the course of the monitoring period. This down-cutting is considered natural channel variation and is not viewed as a threat to stream stability or Site success. Two areas of concern were observed along stream monitoring reaches within the sites during year 5 (2016) monitoring. The following table describes the issues and each area is identified on Figures 2A and 2B (Appendix B).

Map Identifier	Feature/Issue
Stream Area of Concern #1	Cross vane at bottom of UT-2 has been compromised due to high flows of the Uwharrie River. Structure is intact but adjacent banks have been eroded causing water to flow around arms and pipe underneath headers.
Stream Area of Concern #2	Sixth upstream cross vane in series of drop structures has failed completely, upstream and downstream structures are intact and functioning. Failure likely due to localized heavy rain event between June and September 2014.
