**2005 Monitoring Report for the Miller et al.
Mitigation Site on Meat Camp Creek, Watauga
County**

North Carolina Department of Transportation Stream Mitigation
Program

Transportation Improvement Project R-529

2005

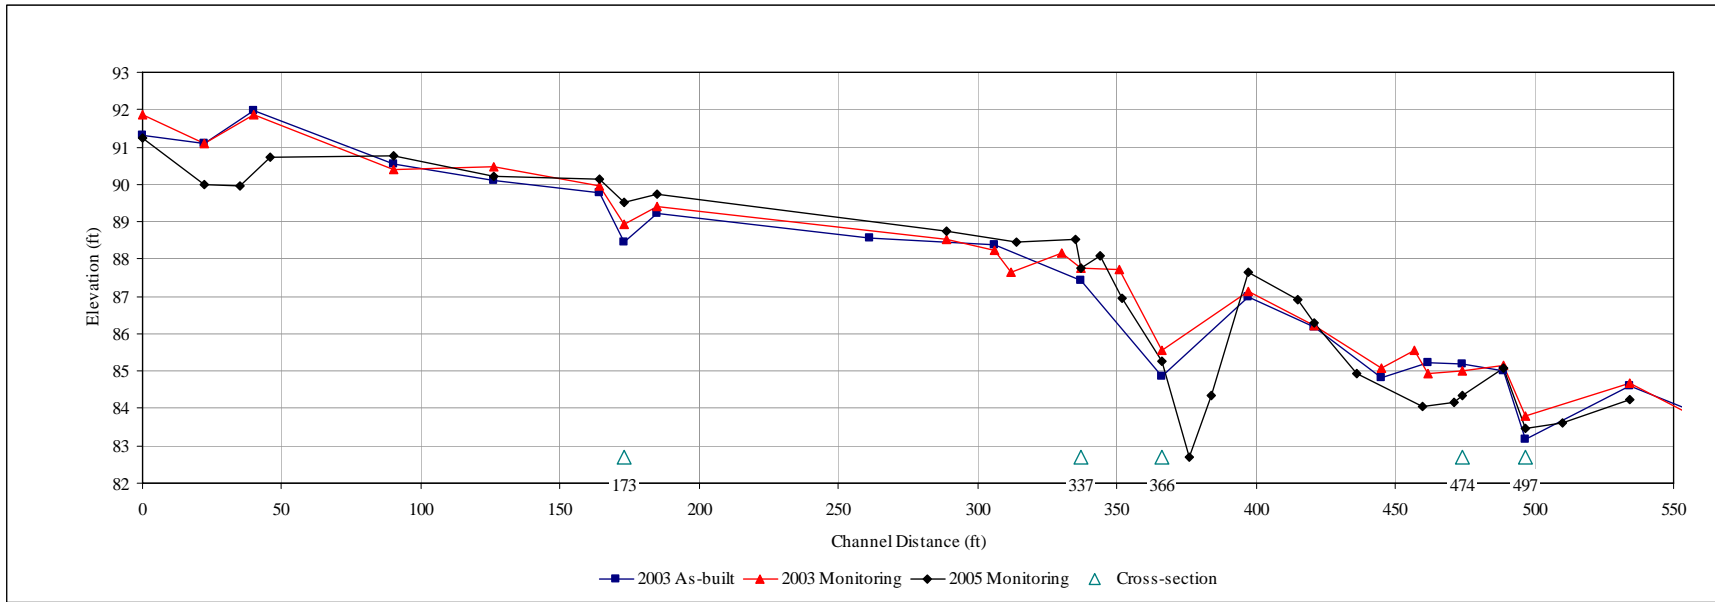
FIGURE 2. Comparison of the 2003 as-built, 2003, and 2005 monitoring survey longitudinal profiles, Miller et al mitigation site, Meat Camp Creek, New River basin, Watauga County.

The 2005 longitudinal profile revealed some changes in the channel thalweg (Figure 2). The pool at station 0+22 deepened 1.12 ft and the pool at station 1+73 aggraded 1.24 ft and is now a run. There has also been some channel aggradation (0.2 ft – 0.5 ft) from stations 1+85 to 2+89. The pool at station 3+76 increased in depth by 2.78 ft and the pool at station 4+97 increased in depth by 0.32 ft from the 2003 monitoring survey. These thalweg changes are due to the three hurricane storms that occurred on September 8, 13, and 27, 2004. From stations 4+45 to 4+89, the thalweg increased in maximum depth by 0.83 ft. The increase in depth at this location is a direct result of the repair work to rock vanes that occurred in this area on November 19, 2004.

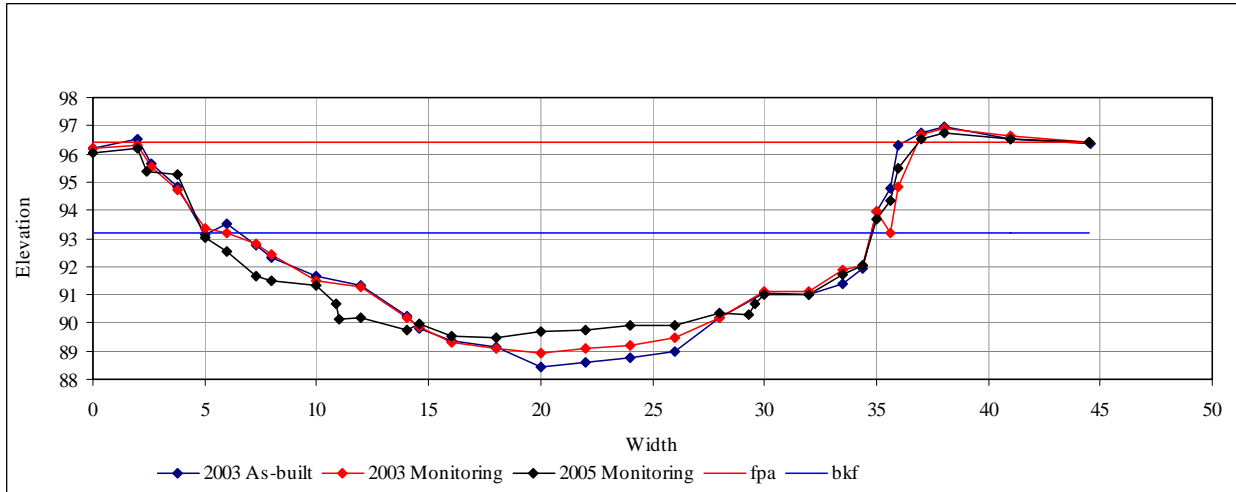
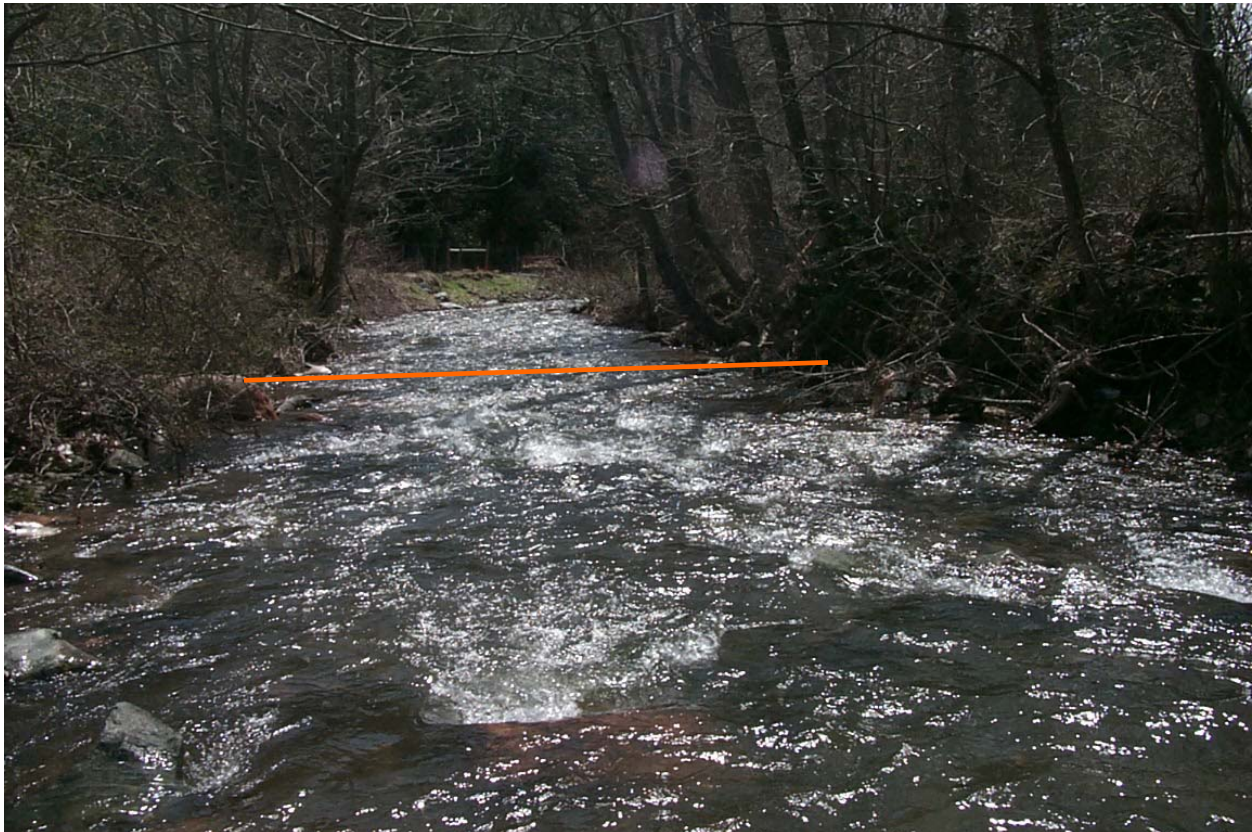
FIGURE 3.1. Cross-section 1+73, run.

Five cross-sections are monitored at the site. Cross-sections showed some adjustments following the September, 8, 13, and 27, 2004 hurricanes and November 19, 2004 repairs when compared with the 2003 monitoring survey (Figure 3). As a result of the hurricanes, cross-section 1+73 has aggraded 1.24 ft and the stream feature has changed from a pool to a run. The streambank at cross-section 3+37 received the most damage from the September 2004 hurricanes and required major repairs (Figure 3.2, Appendix 1). The thalweg at pool cross-section 3+66 increased 0.39 ft in depth. (Figure 3.3). The thalweg depth at cross-section 4+74 increased 0.83 ft (Figure 3.4). This is a direct result of repair work that occurred at this site on November 19, 2004. During repairs, the left bank point bar at cross-section 4+74 from stations 0+30 to 0+46 was lowered approximately 1.2 ft. Materials from the point bar were used to rebuild the right bank after the September 2004 hurricanes. This point bar should increase in height over a period of time following future bankfull events. Cross-section 4+97 showed slight increase in depth of, 0.32 ft compared to the depth found during the 2003 monitoring survey (Figure 3.5).

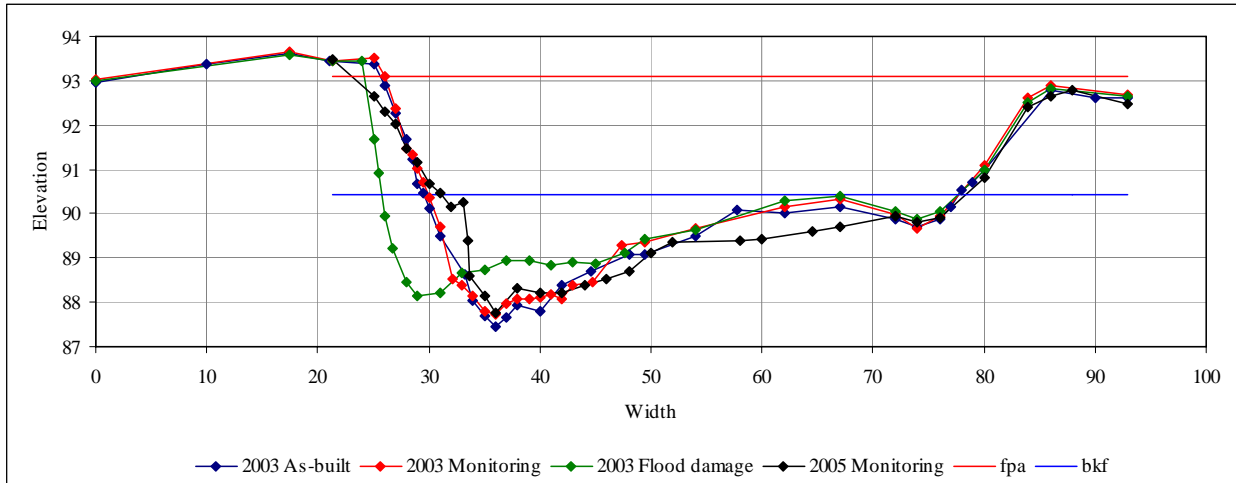
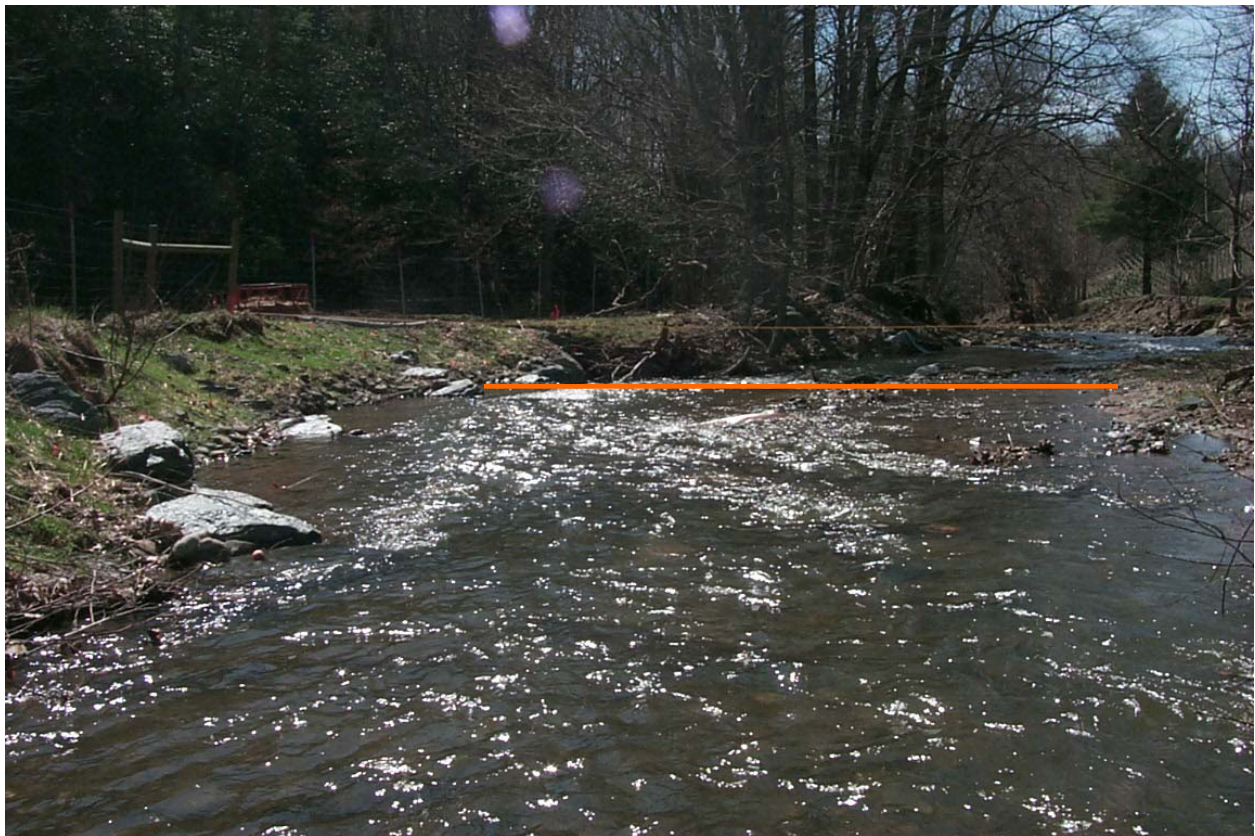
FIGURE 3.2. Cross-section 3+37, riffle. Note: graph green line represents flood damage that occurred on November 19, 2003 after the 2003 monitoring report was completed. Photograph was taken during high flows on March 30, 2005.

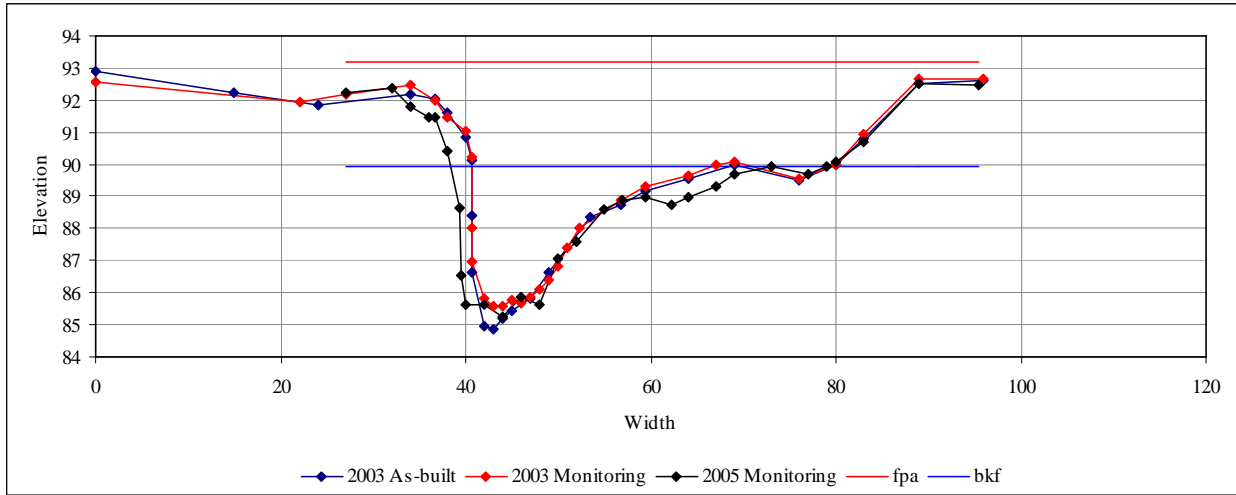
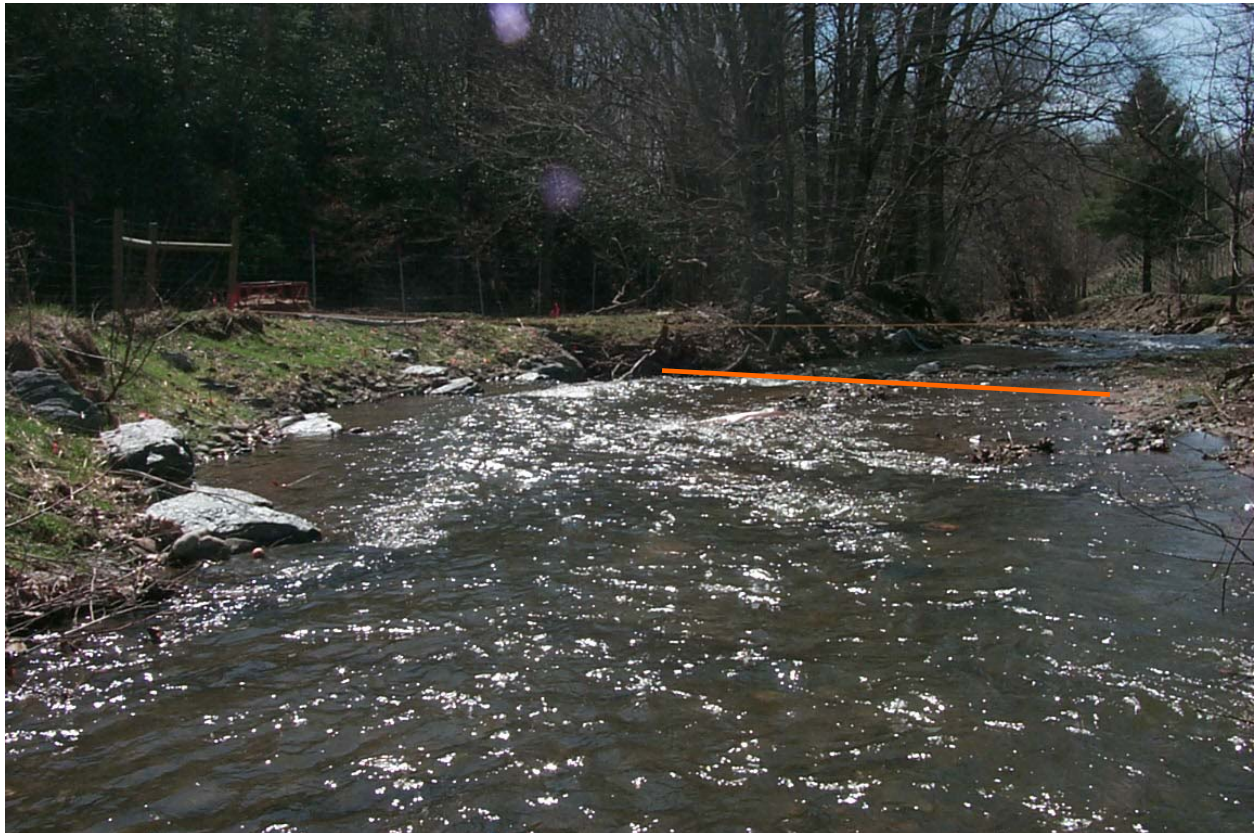
FIGURE 3.3. Cross-section 3+66, pool. Photograph was taken during high flows on March 30, 2005.

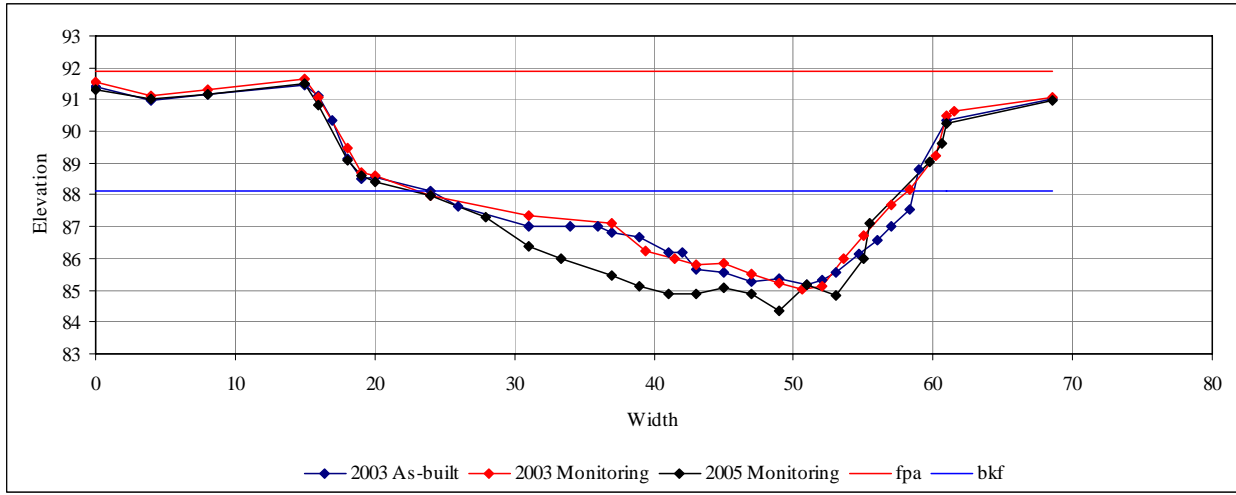
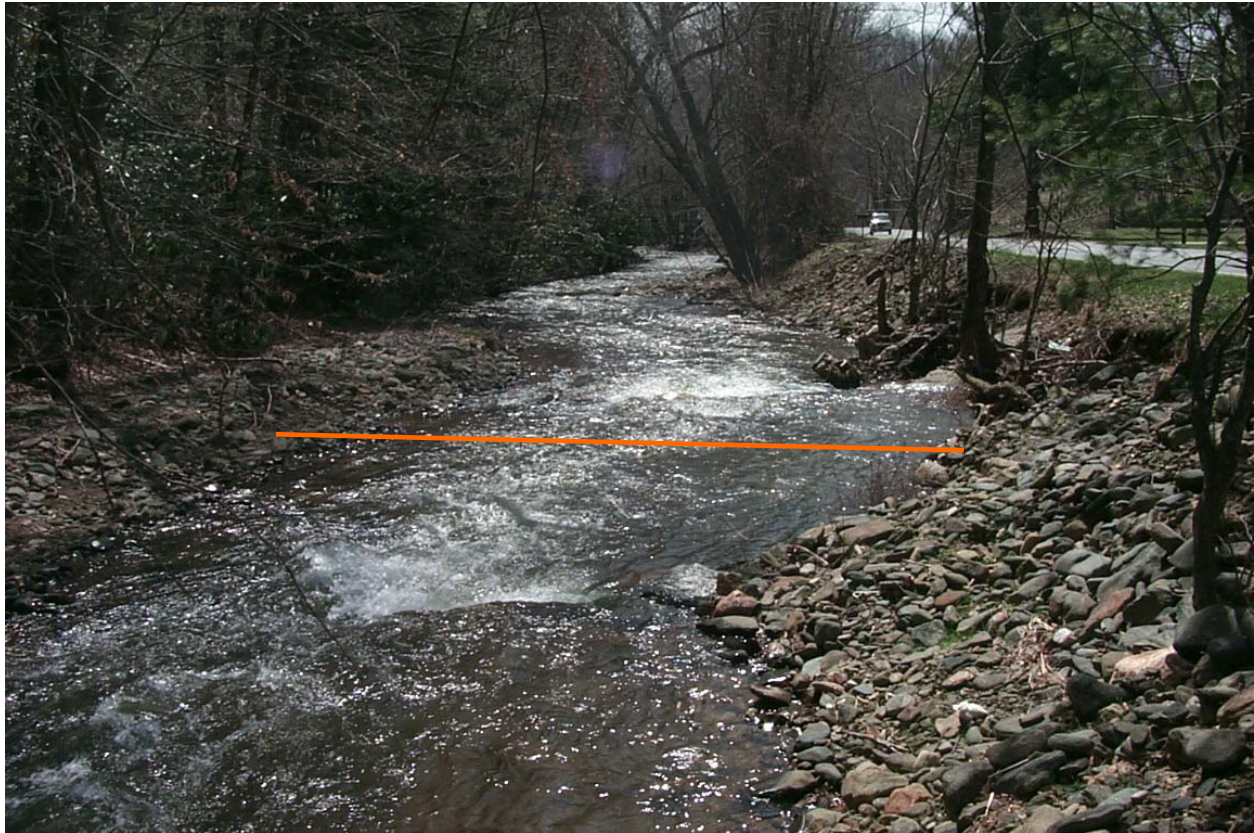
FIGURE 3.4. Cross-section 4+74, riffle. Photograph was taken during high flows on March 30, 2005.

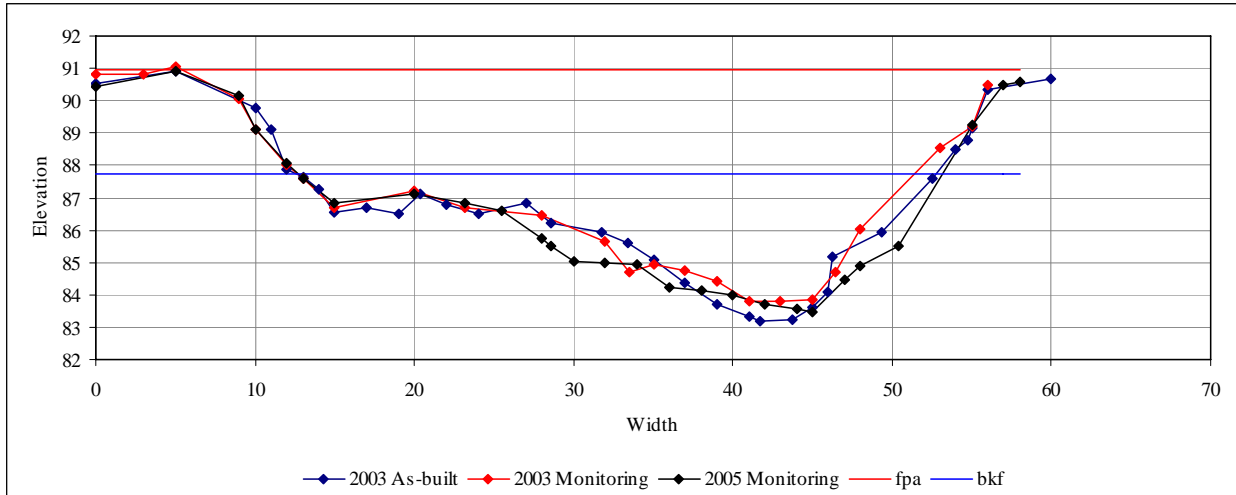
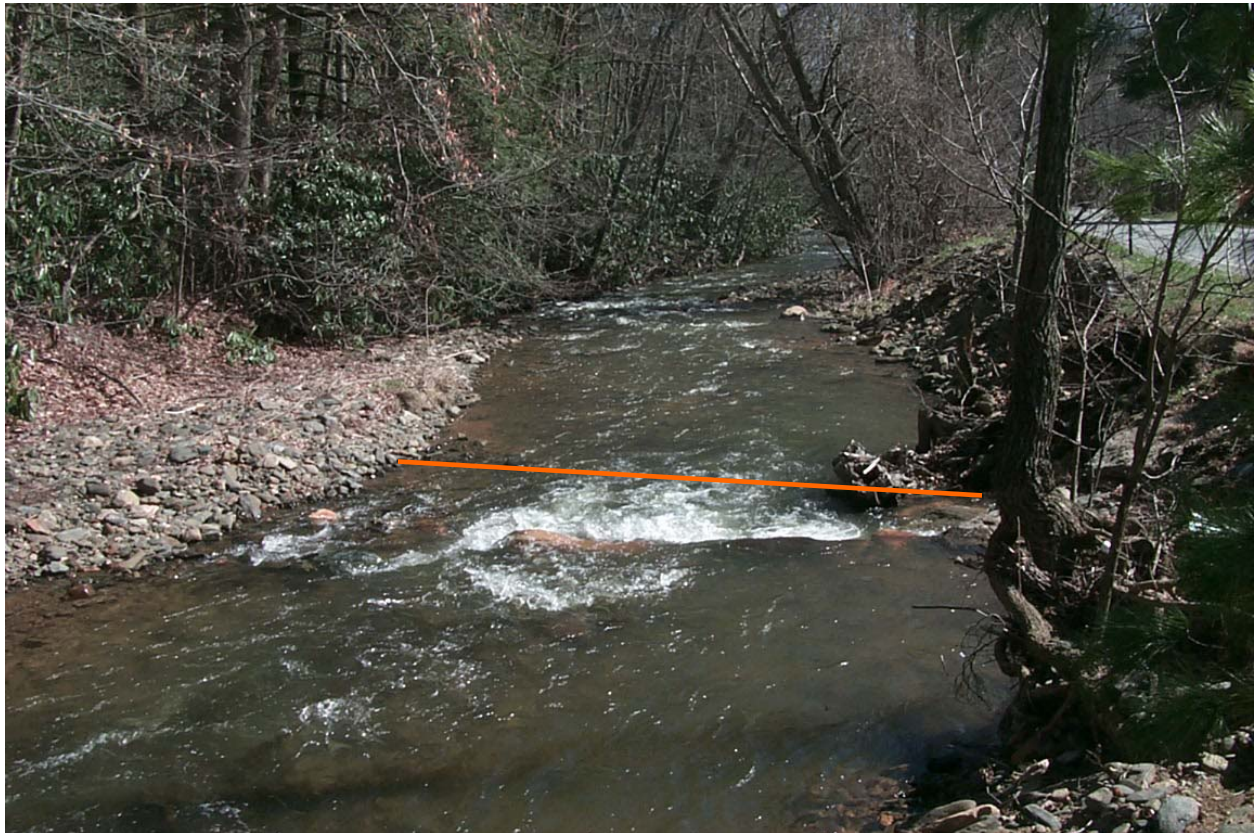
FIGURE 3.5. Cross-section 4+97, pool. Photograph was taken during high flows on March 30, 2005.

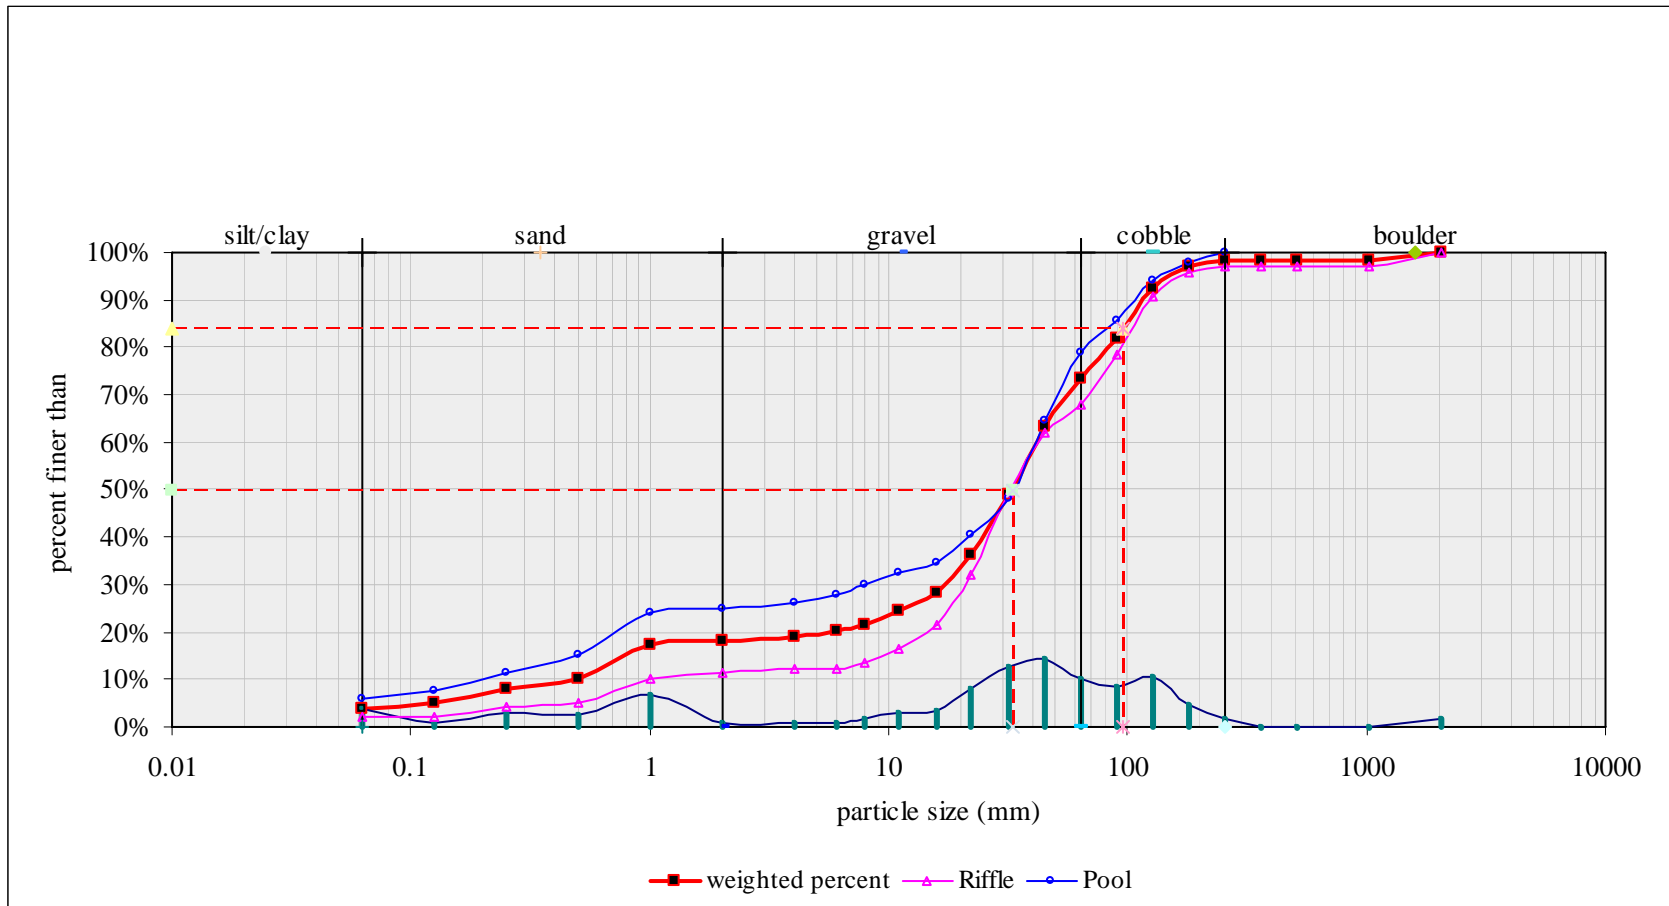
FIGURE 4. Pebble count summary for the Miller et al. mitigation site on Meat Camp Creek, New River basin, Watauga County, March 30, 2005.

The pre-construction and as-built riffle pebble counts revealed D_{50} s of 45.0 mm and 46.6 mm (coarse gravel) (Mickey and Hining 2003a, 2003b). The 2003 monitoring pebble count D_{50} was 37.2 mm (Mickey and Hining 2003b) whereas the 2005 weighted and riffle D_{50} s were 33.0 mm and 32.0 mm. While the 2005 monitoring D_{50} pebble size was slightly smaller than the post and as-built D_{50} s, it is still in the coarse gravel range.

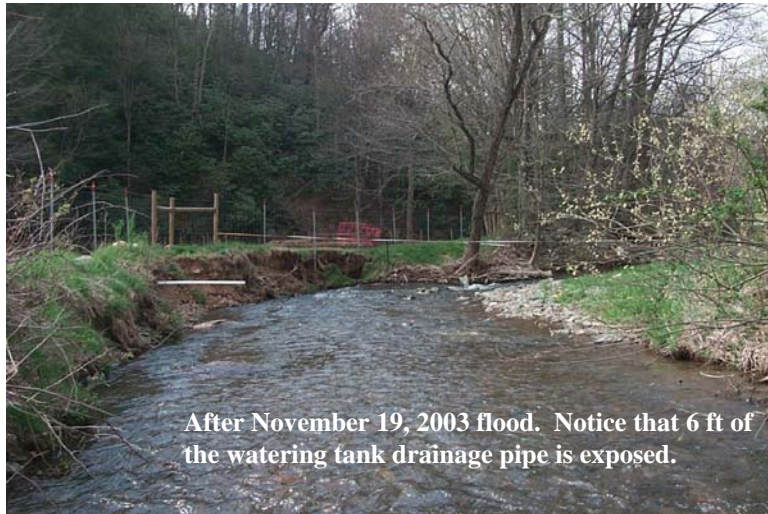
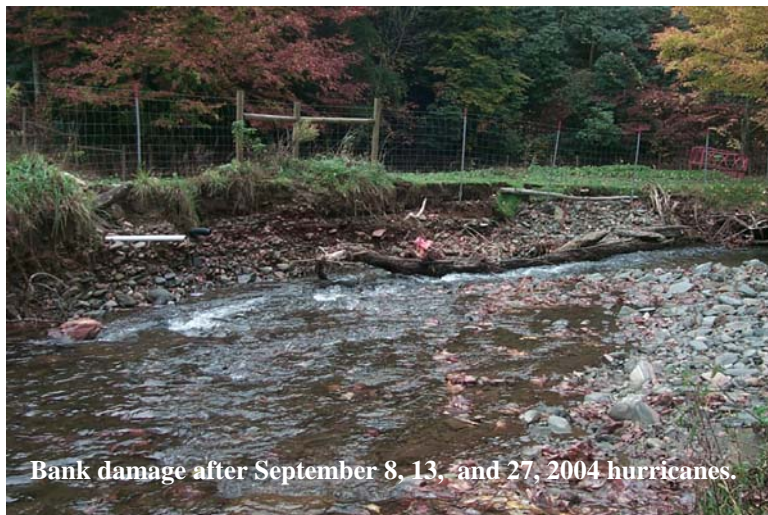
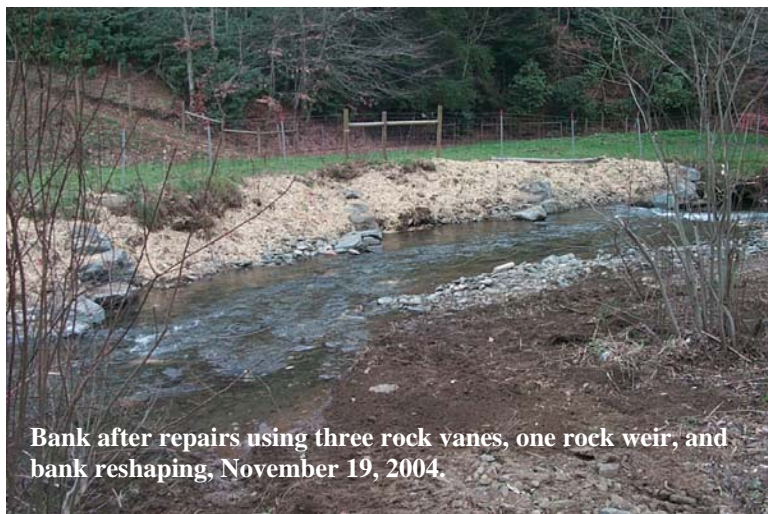
Since completion of the project on September 23, 2002, the Miller et al. mitigation site on Meat Camp Creek had remained stable until the November 19, 2003 flood and September 8, 13, 27, 2004 hurricanes. As a result of these floods, some damage occurred to streambanks, most notably at stations 3+10 to 3+55 and 4+45 to 4+89. Repairs were completed on November 19, 2004 and the 2005 monitoring survey documents the impacts of the hurricanes and repairs to this site. Streambanks have been returned to stable condition and in-stream structures are functioning as designed. The 2006 monitoring survey will determine if the repairs made to this site are stable.

Appendix 1: Photographs of damage and repairs to stations 3+10 to 3+55 at the Miller et al. mitigation site on Meat Camp Creek, New River drainage, Watauga County. November 19, 2003 – November 19, 2004.

Streambank stabilization work at the Miller et al. mitigation site on Meat Camp Creek was completed on September 23, 2002. Since completion of the project, an as-built survey report (Mickey and Hining 2003a) and one monitoring report (Mickey and Hining 2003b) have been submitted to the DWQ and USACE. At the time of the 2003 monitoring report, all work was reported to be stable and functioning as designed. However, following the submittal of the 2003 monitoring report, a storm event on November 19, 2003 caused major bank failure between stations 3+10 to 3+55 (45 linear feet) and containing reference cross-section 3+37. Local landowners noted that the re-constructed streambank at this location was functioning as planned as floodwaters neared the top of the bank. However, during the storm an upstream culvert became blocked. When this temporary dam broke, a “wall of water” could be heard and then seen coming down Meat Camp Creek, covering both the state maintained road and adjacent floodplain at the site. This “wall of water” caused the failure of the left streambank (Appendix 1). The flood also damaged 34 feet of the right streambank at stations 5+00 to 5+34. Repairs were made to these sites on July 13, 2004. However, they were not completed as planned due to circumstances beyond our control to have large boulders delivered to the site. We planned to return at a later date to complete the repairs. Unfortunately, before the final repairs could be made utilizing large boulders, the site experienced hurricane floods on September 8, 13, and 27, 2004. These floods caused additional damage to the site (Appendices 1 and 2). Final repairs were made to the site on November 19, 2004. These repairs included reshaping the damaged bank and adding three rock vanes and one rock cross-vane from station 3+10 to 3+55. Additional repairs requiring the repositioning or addition of large boulders also required at stations 4+15 to 4+90 (Appendices 1 and 2).

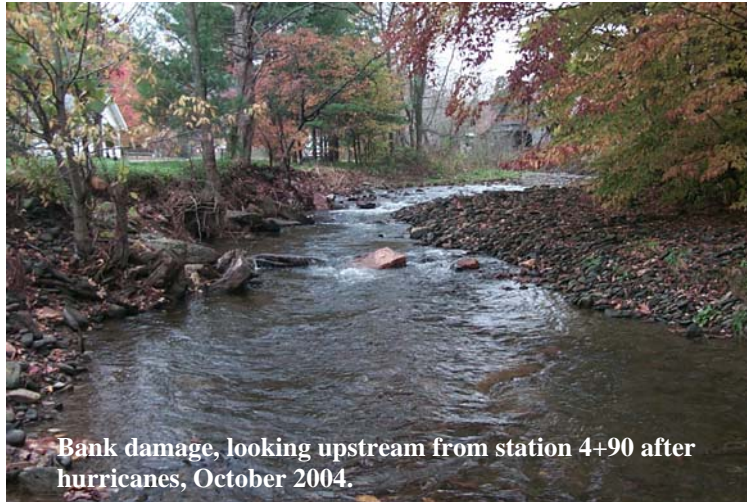
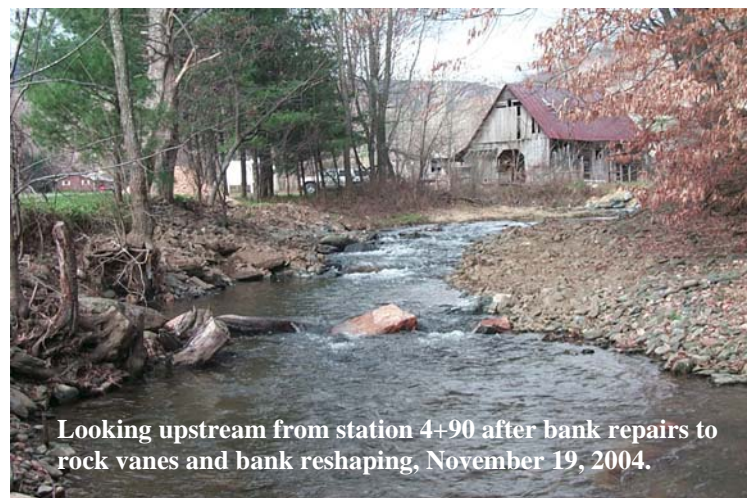
Appendix 2: Photographs of September 8, 13, 27, 2004 hurricane damage from stations 4+15 to 4+90 at the Miller et al. mitigation site on Meat Camp Creek, New River drainage, Watauga County. This site was repaired on November 19, 2004.
