**MILLER ET AL. MITIGATION SITE ON MEAT CAMP CREEK,
WATAUGA COUNTY**

Year 4 Monitoring Report
Period Covered: March 30, 2005 – December 22, 2006

Prepared for the
North Carolina Ecosystem Enhancement Program

North Carolina Wildlife Resources Commission
Division of Inland Fisheries
Watershed Enhancement Group
Raleigh

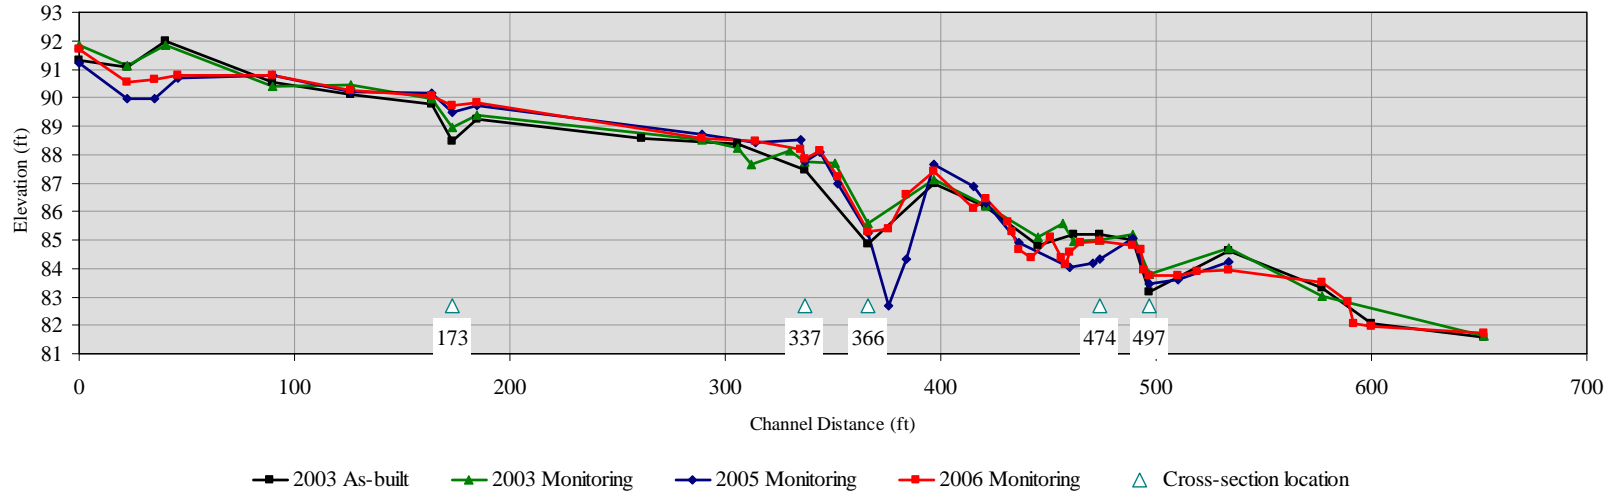
FIGURE 2.—Comparison of the 2003 as-built, 2003, 2005, and 2006 longitudinal profile data taken at the Miller et al. mitigation site, Meat Camp Creek, New River basin, Watauga County.

The 2006 longitudinal profile data revealed minor changes in the channel thalweg (Figure 2). The pool at station 0+22 aggraded 0.55 feet from 2005; however this pool is deeper than found during the 2003 as-built and 2003 monitoring surveys. The channel profile from stations 0+46 to 1+64 remained virtually unchanged. The pool at station 1+73 continues to evolve into a run. There was little change in the channel profile from stations 1+85 to 2+89 based on the data and observations. The pool at station 3+76 decreased in depth by 2.6 feet since 2005 and is now at a depth found in the as-built and 2003 monitoring surveys. The pool between stations 4+60 and 4+74 has aggraded between 0.54 and 0.62 feet since 2005. At station 4+65 the channel aggraded up to the 2003 monitoring survey elevation. From stations 4+97 to 5+34, the thalweg increased in maximum depth by 0.74 feet since 2005. These minor changes in the longitudinal profile appear to be natural occurrences and not because of instabilities caused by the stream enhancement activities.

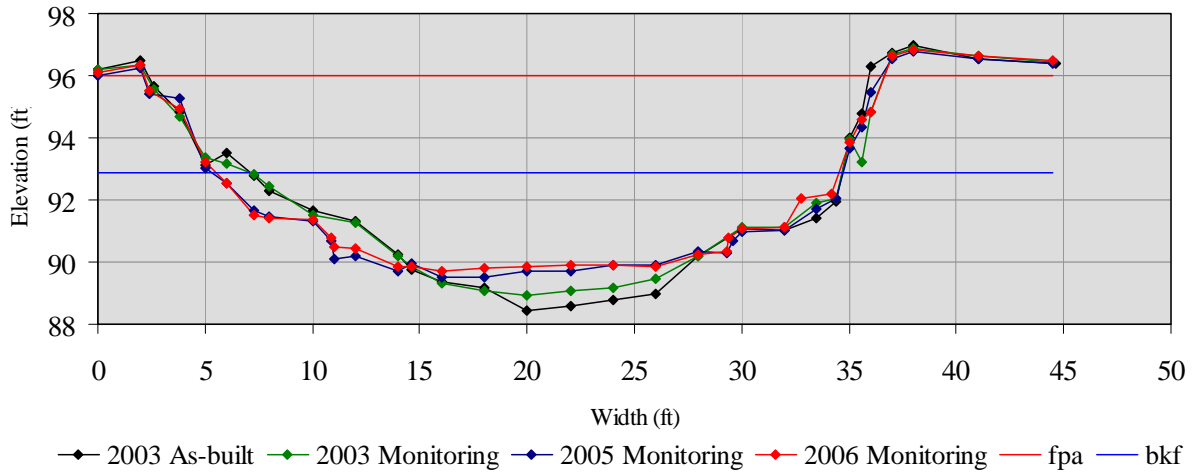
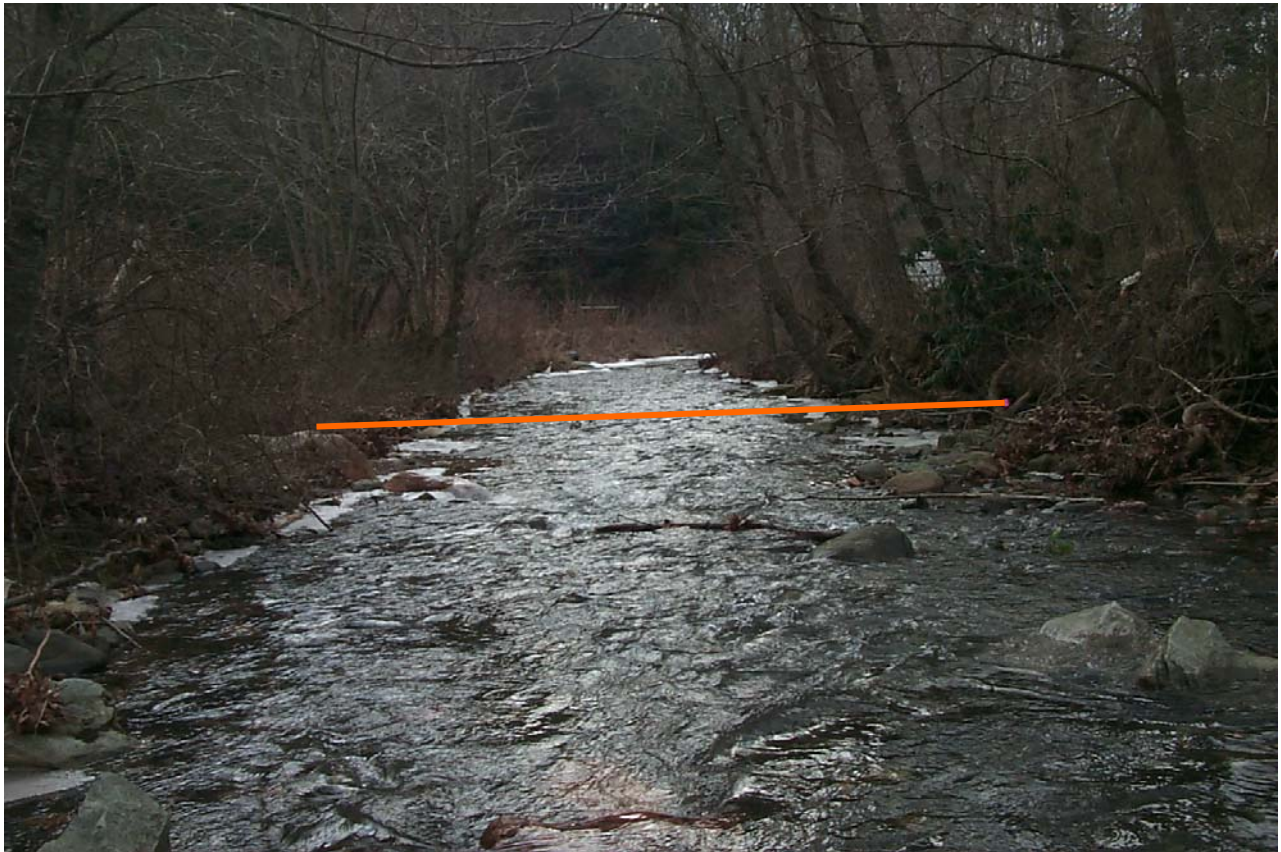
FIGURE 3.1.—Cross-section at station 1+73, run.

CROSS-SECTION 1+73 – run (Figure 3.1): This cross-section is located below a rock weir. Following construction this cross-section was a pool. Over the years and with the movement of substrate materials it has evolved to a run. The channel widened slightly following the three September 2004 hurricanes. The cross-section data indicate the stream channel is stable with no bank erosion or lateral movement occurring since the 2005 survey.

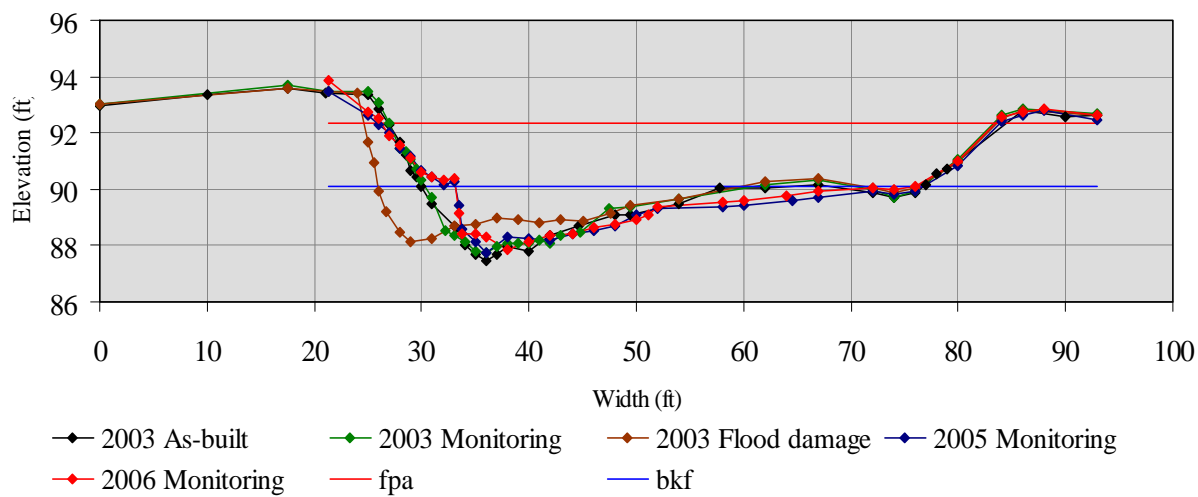
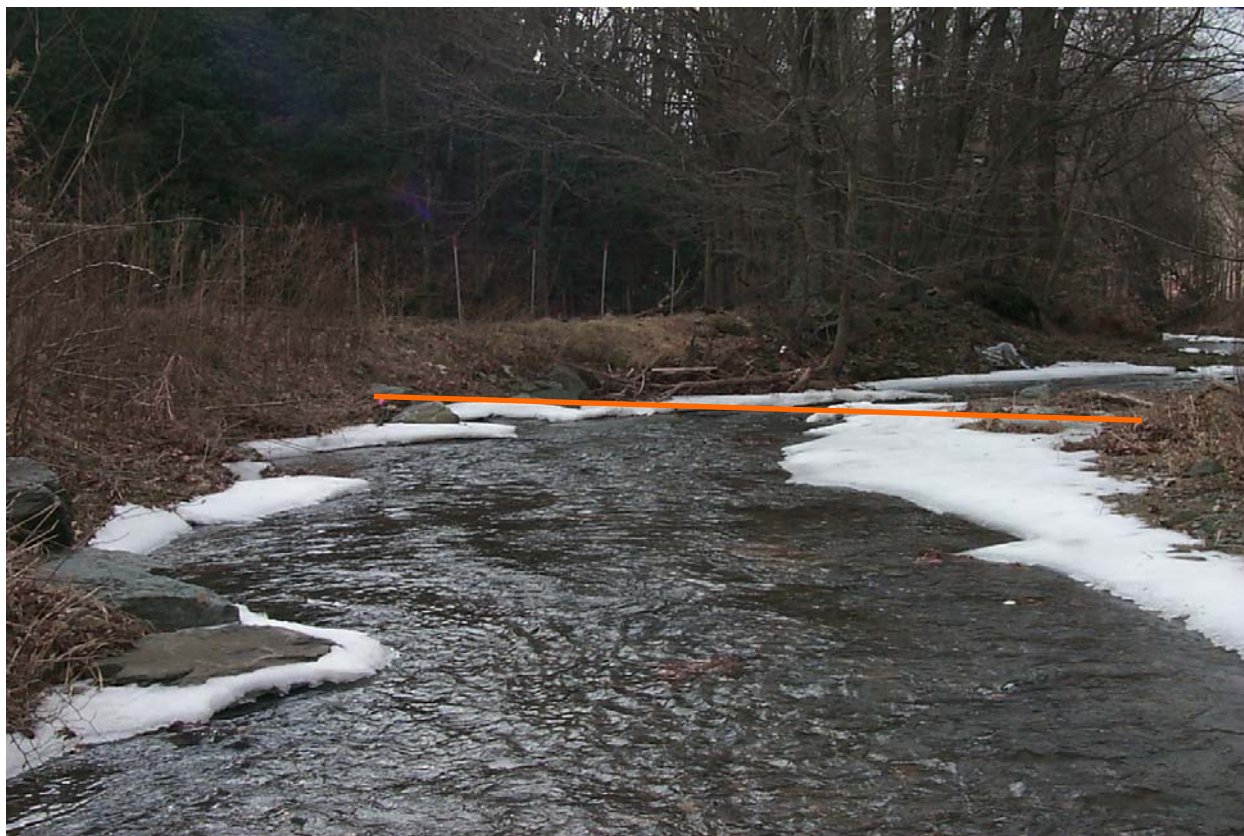
FIGURE 3.2.—Cross-section at station 3+37, riffle.

CROSS-SECTION 3+37 – riffle (Figure 3.2): This cross-section is situated at the back end of a rock vane and traverses a riffle. The channel has remained stable since repairs were completed in 2004. There is no bank erosion or lateral movement taking place. Note the pin at location 0+00 was positioned in the middle of an overgrazed pasture and could not be located in 2006. Subsequently, the cross-section was measured from a pin at the fence line (location 0+22) to location 0+93.

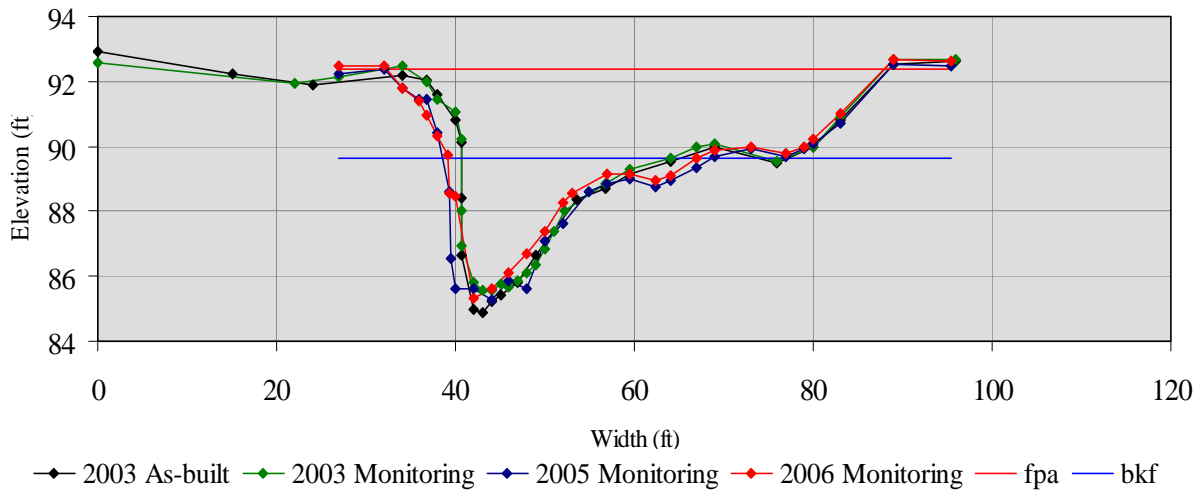
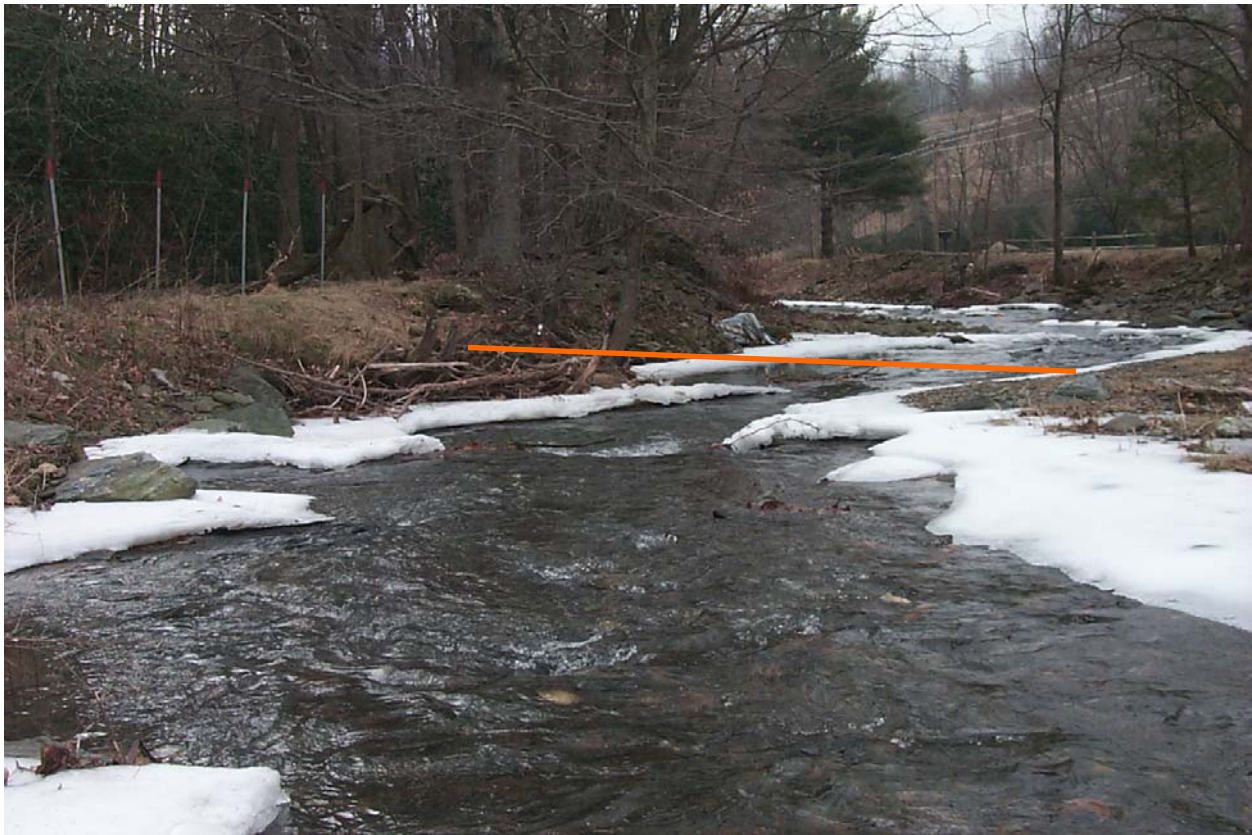
FIGURE 3.3.—Cross-section at station 3+66, pool.

CROSS-SECTION 3+66 – pool (Figure 3.3): This cross-section traverses the middle of a pool just below a rock vane. The right side of this cross-section has aggraded 1.08 ft since the 2005 monitoring survey. However the stream channel is stable with no bank erosion or lateral movement occurring. Note that the pin at location 0+00 was positioned in the middle of an overgrazed pasture and could not be located in 2006. Subsequently, the cross-section was measured from a pin at the fence line (location 0+24) to location 0+95.

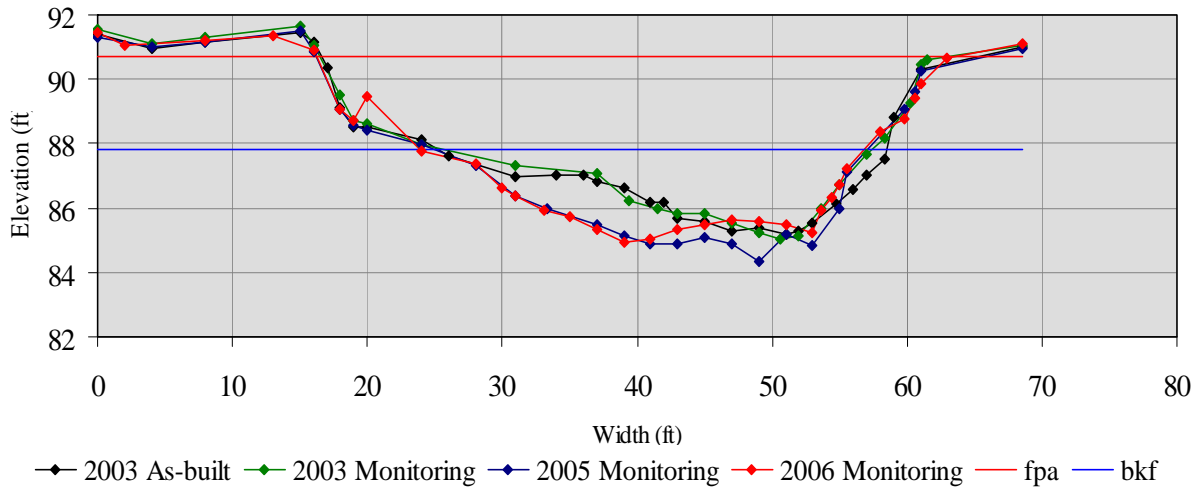
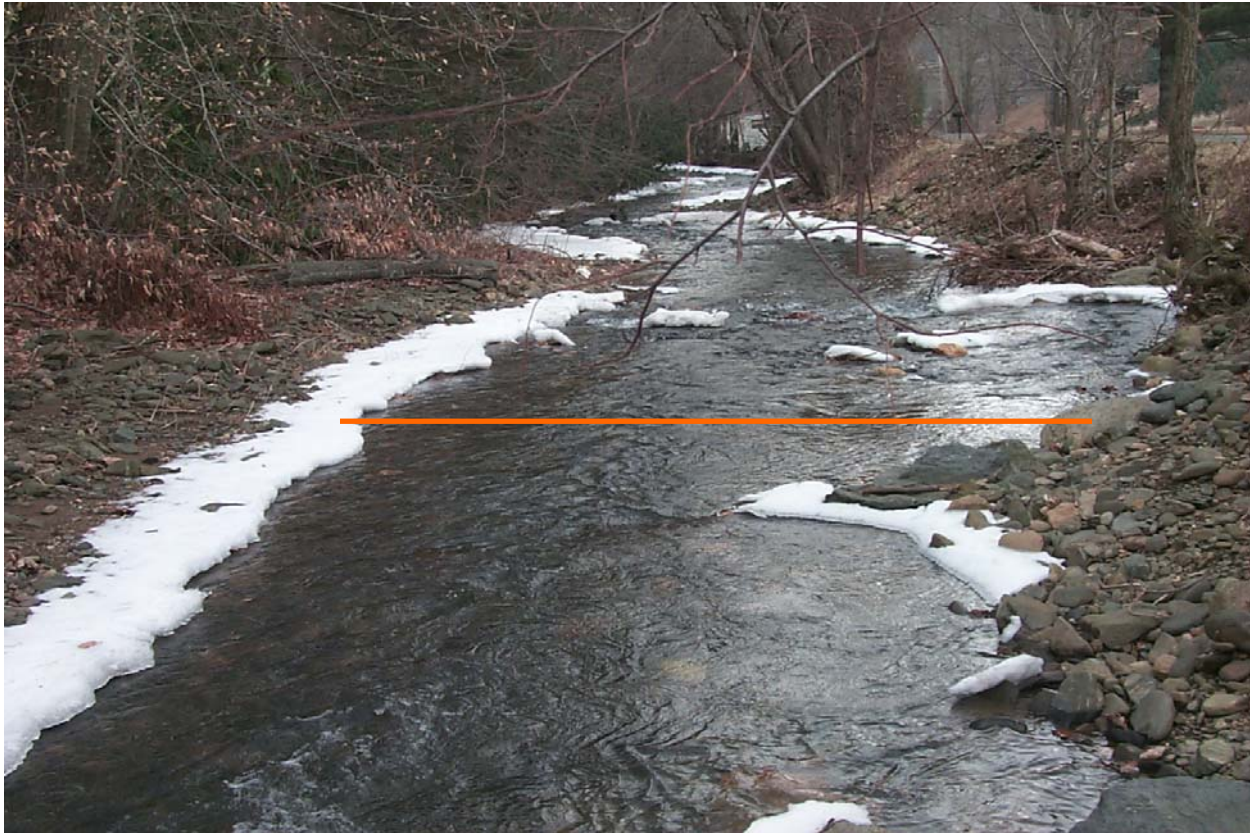
FIGURE 3.4.—Cross-section at station 4+74, riffle.

CROSS-SECTION 4+74 – riffle (Figure 3.4): This cross-section is situated above a rock weir and traverses a riffle. There has been some minor substrate material build-up between

locations 0+41 and 0+53, when compared to previous years. The thalweg has moved towards the center of the channel away from the right bank. The transect point at location 0+20 is the top of a point bar. The banks are stable and there has been no lateral shift in the stream channel.

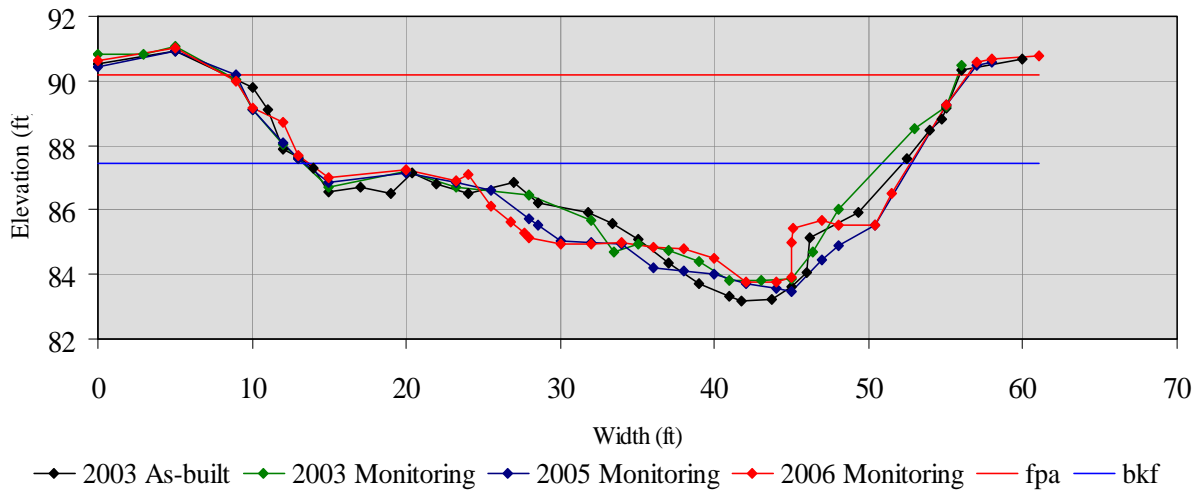
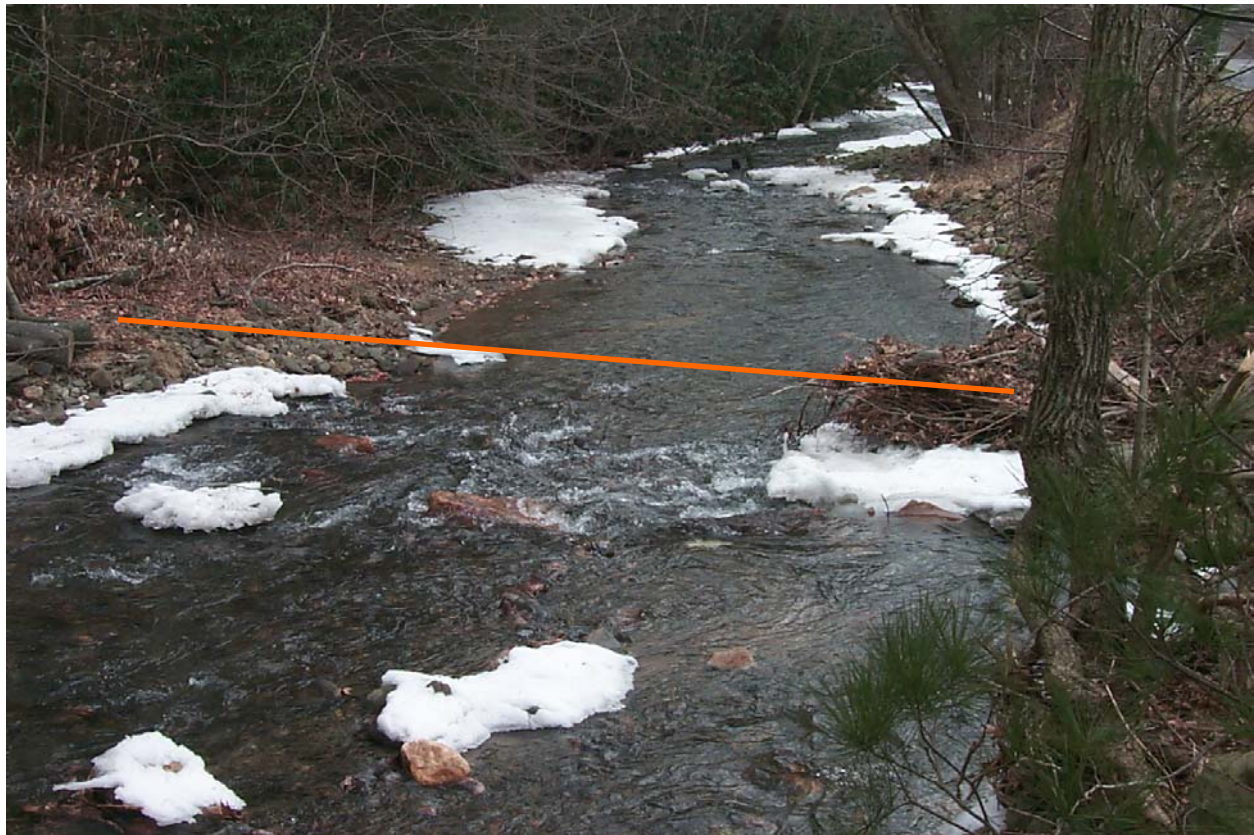
FIGURE 3.5.—Cross-section at station 4+97, pool.

CROSS-SECTION 4+97 – pool (Figure 3.5): The channel at this cross-section displays signs of aggradation. Buildup of substrate materials from location 0+45 to 0+50 is due to woody debris being caught by stumps along the bank. Material buildup also occurred between location 0+34 and 0+42, however the banks are stable with no bank erosion or lateral movement occurring.

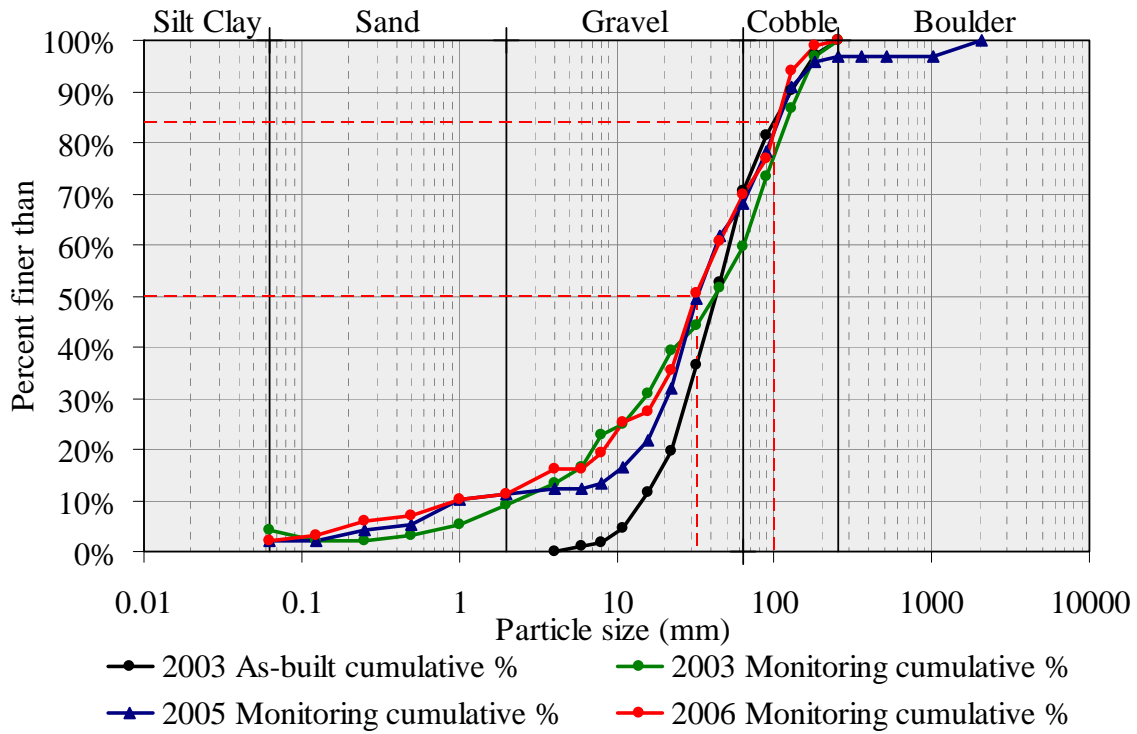
FIGURE 4.—Pebble count data comparisons, Miller et al. mitigation site, Meat Camp Creek, New River basin, Watauga County, 2003-2006.

Pebble count data were collected from a riffle at cross-section 3+37 (Figure 4). Substrate analyses indicate most particle size classes have remained stable when compared to the as-built data. In 2006, there was a slight downward trend for all particle sizes except for D_{50} , which was the same as the 2005 count. Since 2003 the D_{50} particle size has ranged from 32 mm to 47 mm and remained in the very coarse gravel category (Figure 4). The D_{84} cumulative distribution has ranged from of 100 mm (small cobble) to 120 mm (small cobble) (Figure 4). The D_{16} cumulative distribution has decreased from 18 mm (medium gravel) to 4 mm (fine gravel). This is a result of an increase in the percentage of sand and fine gravels since the 2003 as-built survey. The as-built survey did not record any sand or gravel below 3 mm in size. Since the as-built survey the D_{16} cumulative distribution has fluctuated between 4 mm (fine gravel) and 10 mm (medium gravel). These fluctuations in particle size are normal and can be attributed to sampling variability and flood events whereby sediment was transported from disturbed land higher in the watershed. These changes are not significant enough to show any trends or negative impacts.

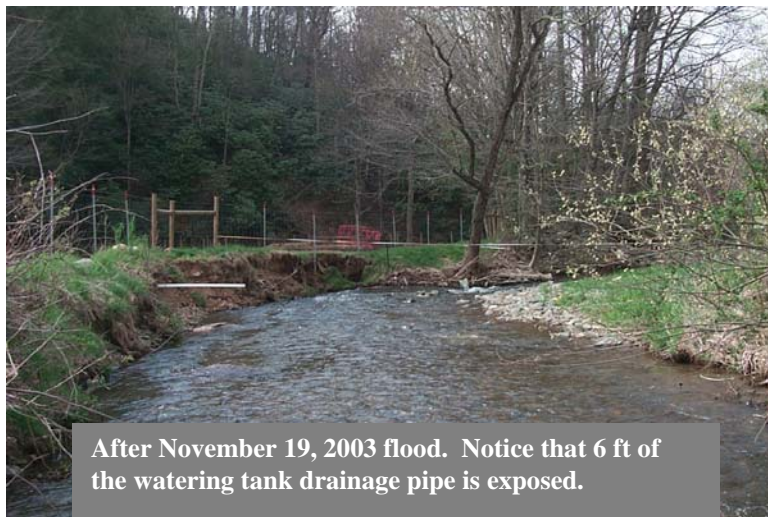
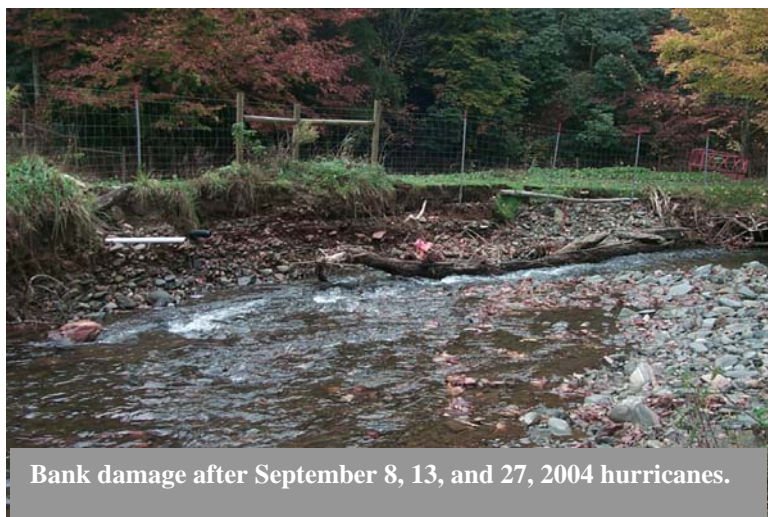
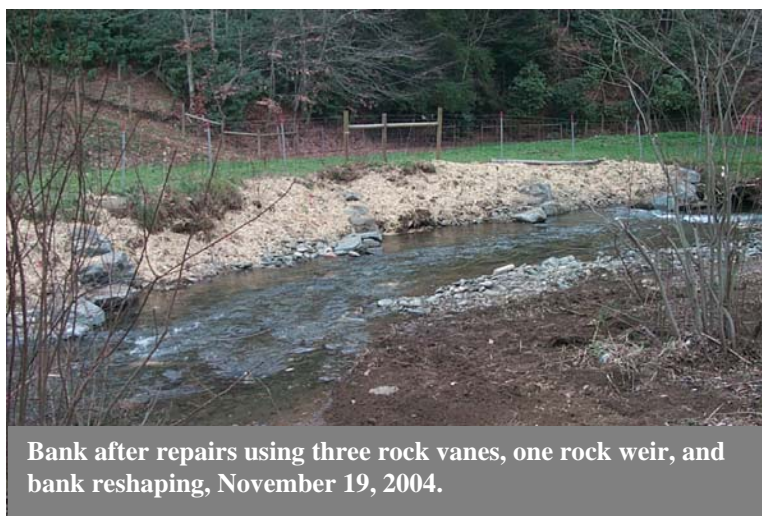
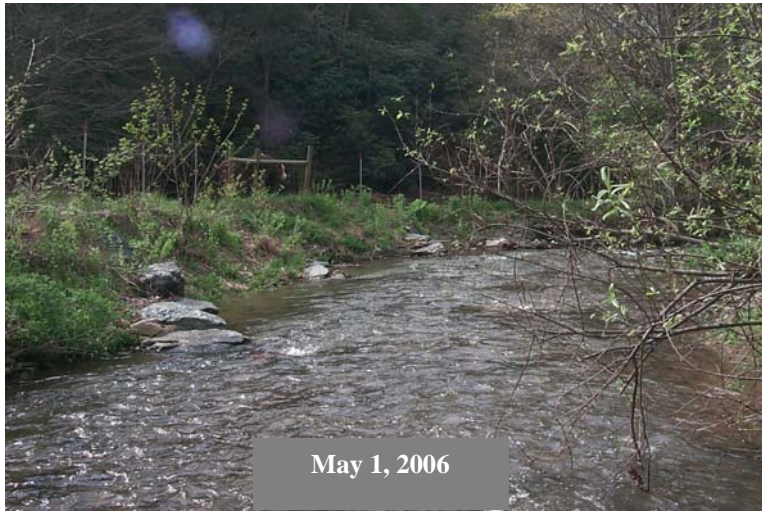
Appendix 1: Photographs of damage and repairs between station 3+10 and station 3+55 at the Miller et al. mitigation site on Meat Camp Creek, New River drainage, Watauga County, November 19, 2003 – November 19, 2004.

Streambank stabilization work at the Miller et al. mitigation site on Meat Camp Creek was completed on September 23, 2002. A storm event on November 19, 2003 caused major bank failures between stations 3+10 and 3+55 (45 linear feet) and 5+00 and 5+34 (34 linear feet). Before repairs could be made, flooding caused by three hurricanes in September 2004 caused additional damage to the site (Appendices 1 and 2). This damage was repaired on November 19, 2004 (Mickey and Wasseen 2005).

A photographic log of the damages, 2004 repairs, and 2006 monitoring from station 3+10 to station 3+55 and station 4+15 to station 4+90 is also provided (Appendices 1 and 2). The repairs stabilized the stream banks and sediment is accumulating on the upstream side of rock vanes. Vegetation has become established on the stream banks from station 3+10 to station 3+55. Vegetation has had a harder time becoming reestablished between station 4+15 and station 4+90 due to the rocky substrate.
