**MILLER ET AL. MITIGATION SITE ON MEAT CAMP CREEK,
WATAUGA COUNTY**

Year 5 Monitoring Report
Period Covered: December 22, 2006 – December 1, 2007

Prepared for the
North Carolina Ecosystem Enhancement Program

North Carolina Wildlife Resources Commission
Watershed Enhancement Group
Raleigh

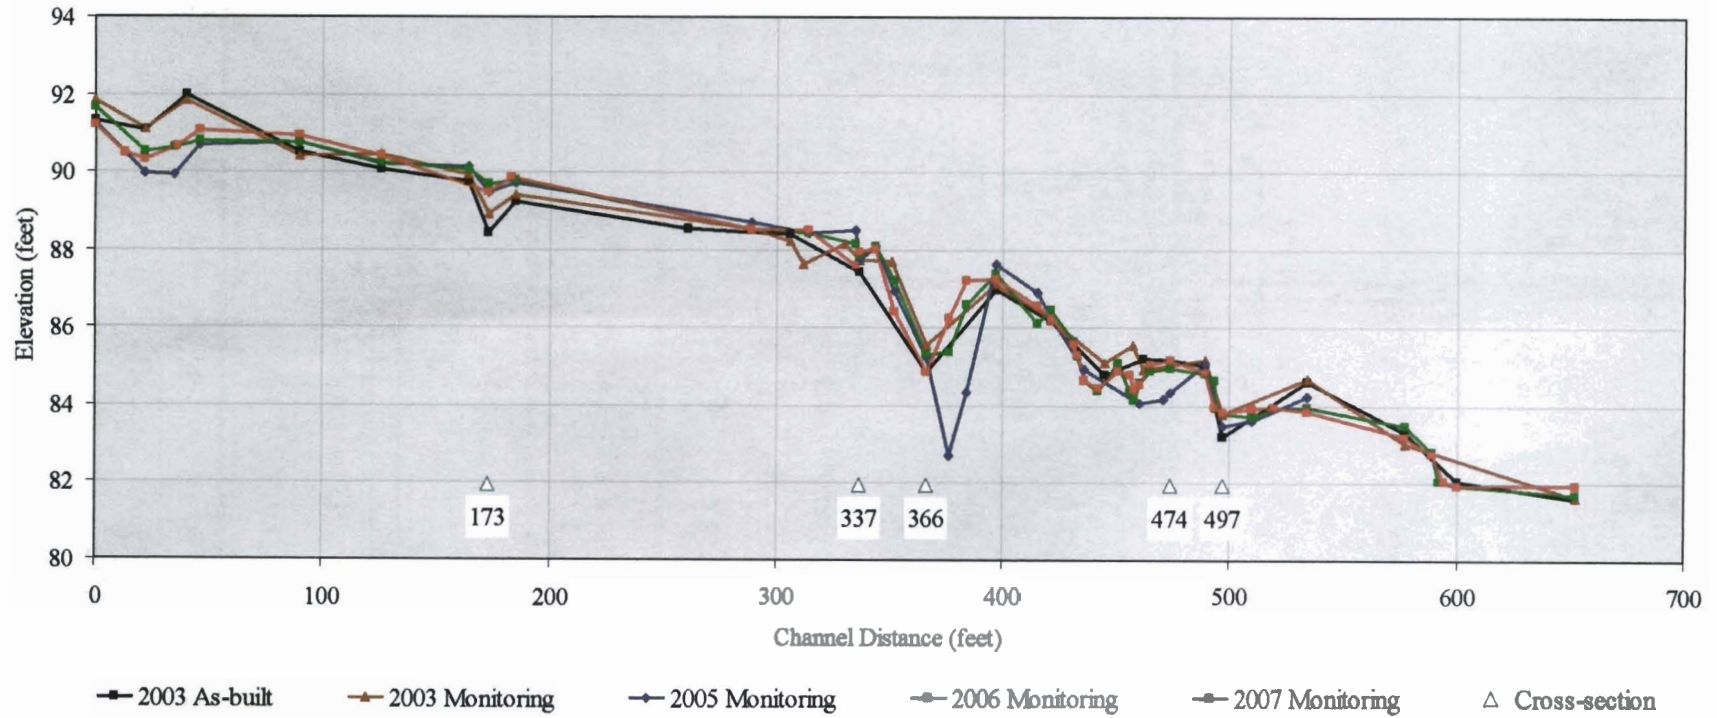
FIGURE 2.—Comparison of the 2003 as-built, 2003, 2005, 2006, and 2007 longitudinal profile data taken at the Miller et al. mitigation site, Meat Camp Creek, New River basin, Watauga County.

The 2007 longitudinal profile data revealed minor changes in the channel thalweg (Figure 2). The pool at station 0+22 aggraded 0.55 feet from 2005; however this pool is deeper than found during the 2003 as-built and 2003 monitoring surveys. The channel profile from stations 0+46 to 1+64 remained virtually unchanged; due to the dense vegetation a thalweg elevation reading was not taken at 1+64. However, based on observations at this location there did not appear to be any changes in the slope of the riffle. The pool at station 1+73 is 0.23 feet deeper than it was in 2005 and 2006; however it is still shallower than found in the 2003 as-built and monitoring surveys, by 1.02 feet and 0.53 feet. There was little change in the channel profile from stations 1+83 to 2+89 based on the data and observations. From stations 3+14 to 3+35 the channel has degraded 0.55 feet. The pool at station 3+66 increased in depth by 0.43 feet since 2006 and is now at a depth found in the as-built survey. It also appears that the pool has shortened by 0.86 feet. From station 3+97 to the end of the project the longitudinal profile closely resembles that found in 2006. The pool between stations 4+60 and 4+74 has aggraded between 0.49 and 0.82 feet since 2005. At station 4+65 the channel aggraded up to the 2003 monitoring survey elevation. From stations 4+97 to 5+34, the thalweg increased in maximum depth by 0.85 feet since 2003. These minor changes in the longitudinal profile appear to be natural occurrences and not because of instabilities caused by the stream enhancement activities. The comparisons of the longitudinal profiles suggests that the channel has been relatively stable since the 2004 repairs, and that most of the changes in the thalweg from 2003 to 2005 were due to the damage of the hurricanes, and the single storm event in November 2003. Repairs included reshaping the damaged left bank and adding three rock vanes and one rock cross-vane between station 3+10 and station 3+55; large boulders were repositioned or installed between station 4+15 and station 4+90. The right stream bank was reshaped between stations 5+00 and 5+34.

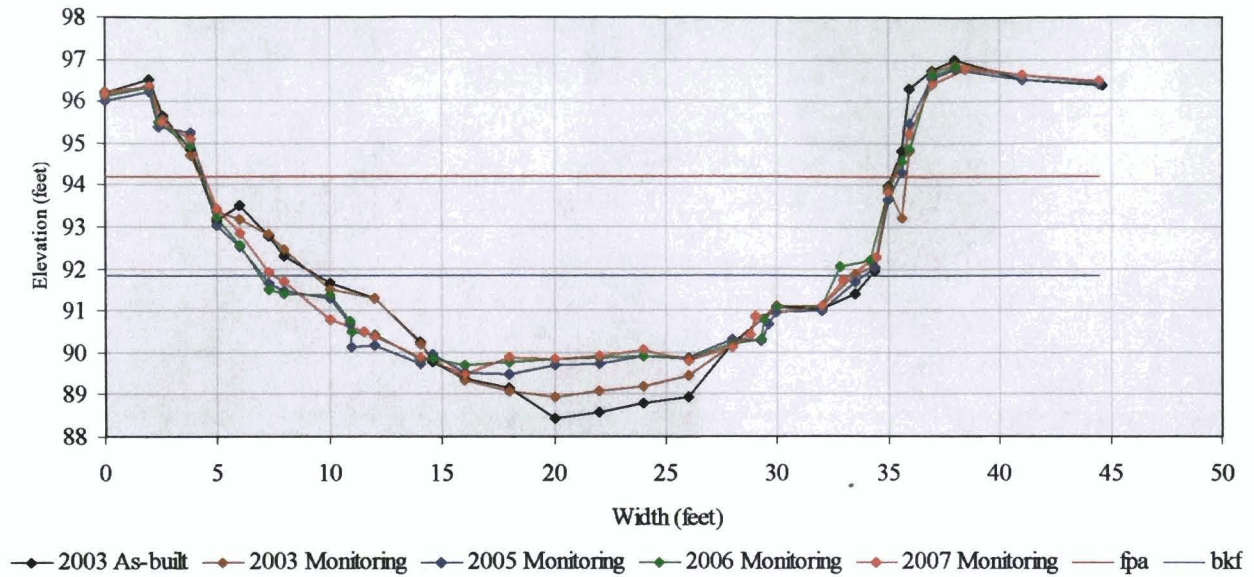
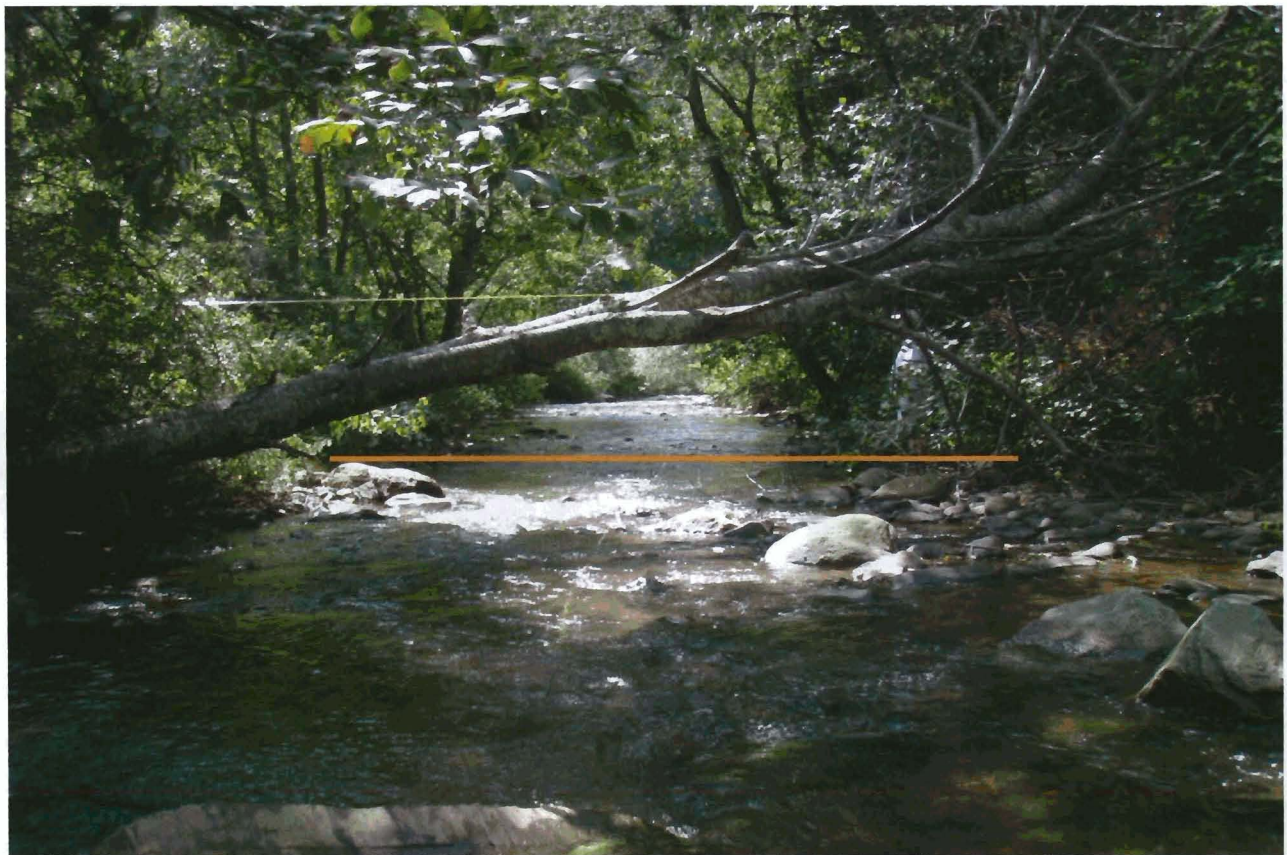
3.1.—Cross-section at station 1+73, run.

CROSS-SECTION 1+73 – run (Figure 3.1): This cross-section is located below a rock weir and originally transected a pool. Over the years and with the movement of substrate materials it has evolved to a run. The channel widened slightly following the three September 2004 hurricanes. The cross-section data indicate the stream channel is stable with no bank erosion or lateral movement occurring since the 2005 survey.

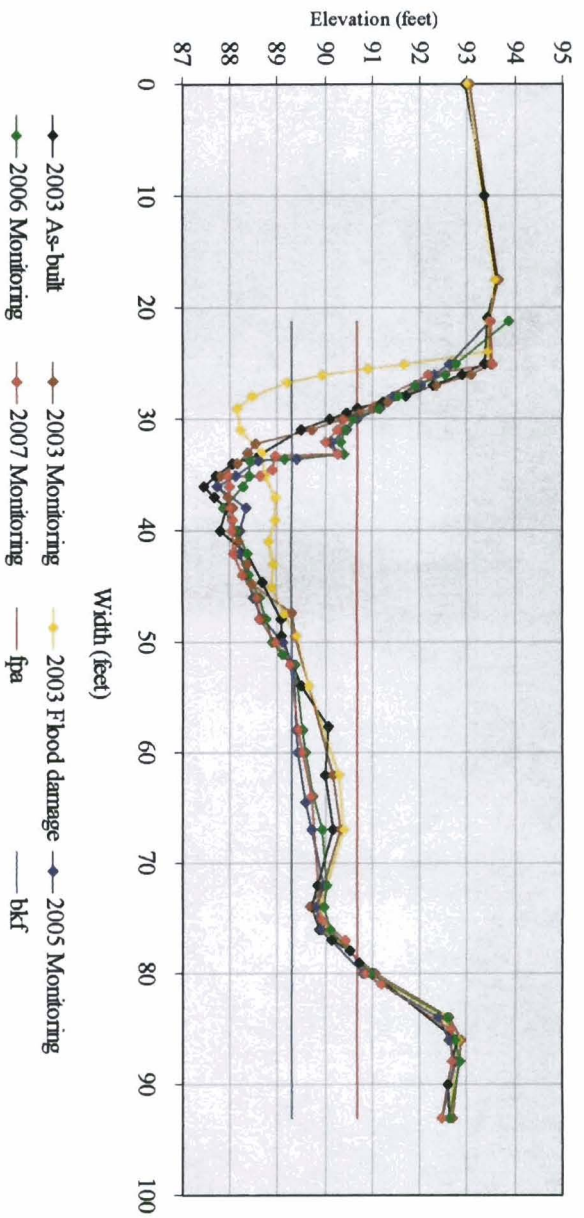
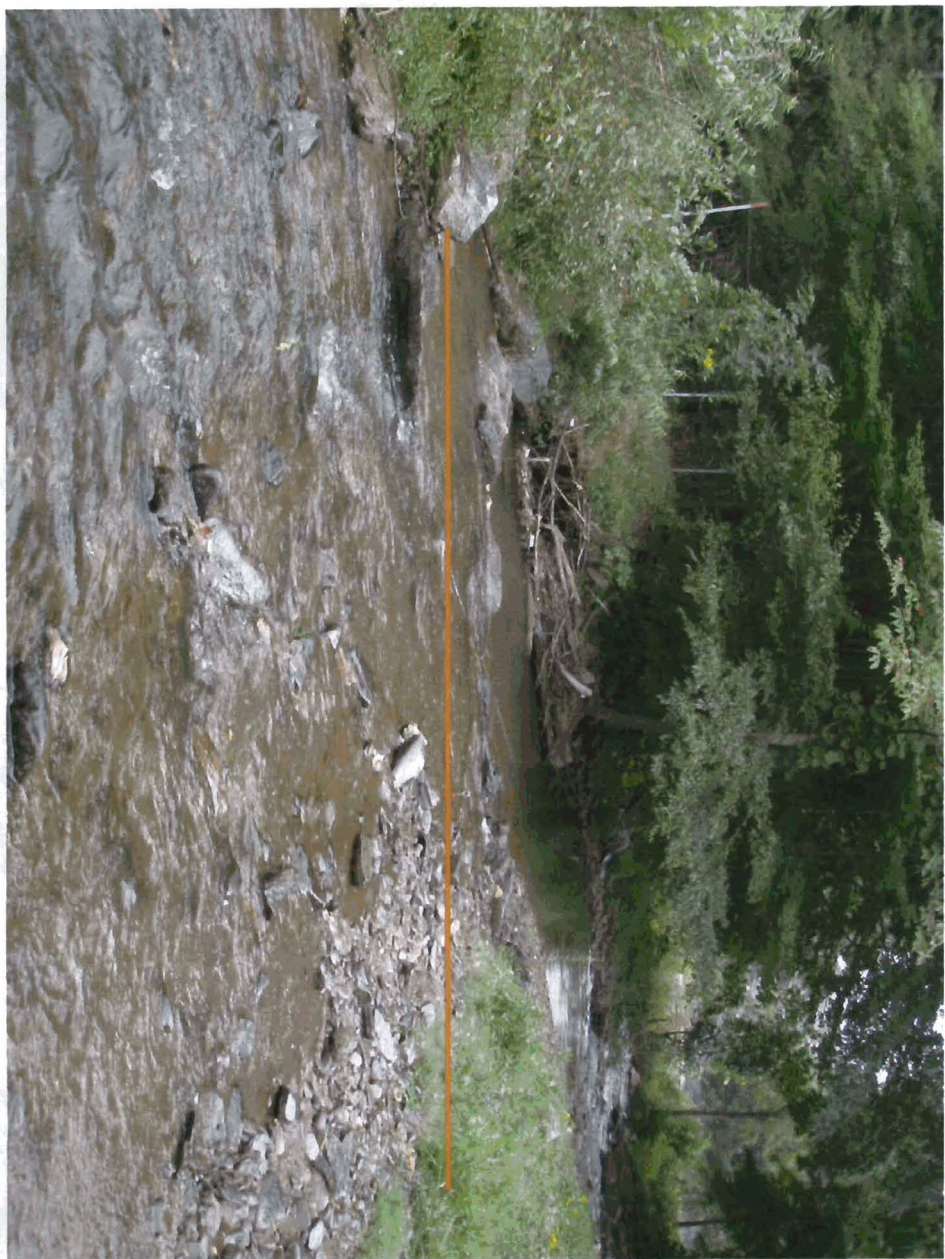
FIGURE 3.2.—Cross-section at station 3+37, riffle.

CROSS-SECTION 3+37 – riffle (Figure 3.2): This cross-section is situated downstream of a rock vane and traverses a riffle. The channel has remained stable at this location since repairs were completed in 2004 (Appendix 1). There has been no bank erosion or lateral movement. Note the pin at location 0+00 was originally positioned in the middle of an overgrazed pasture

and could not be located in 2006. Subsequently, cross-section measurements were taken from a point starting at original location 0+22, the location of a fence line.

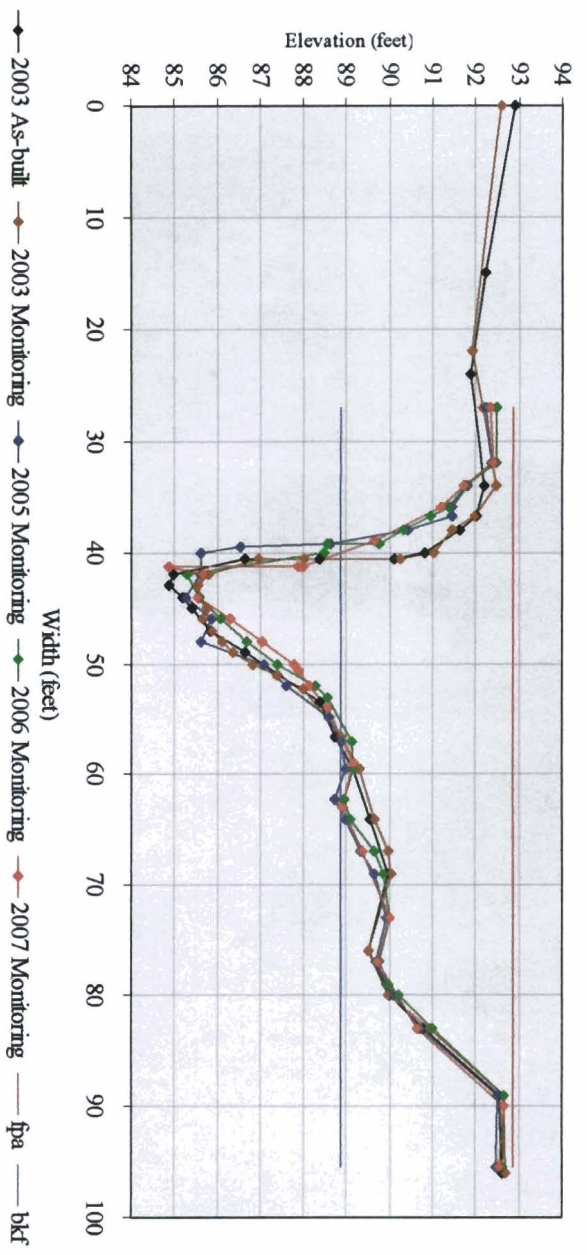
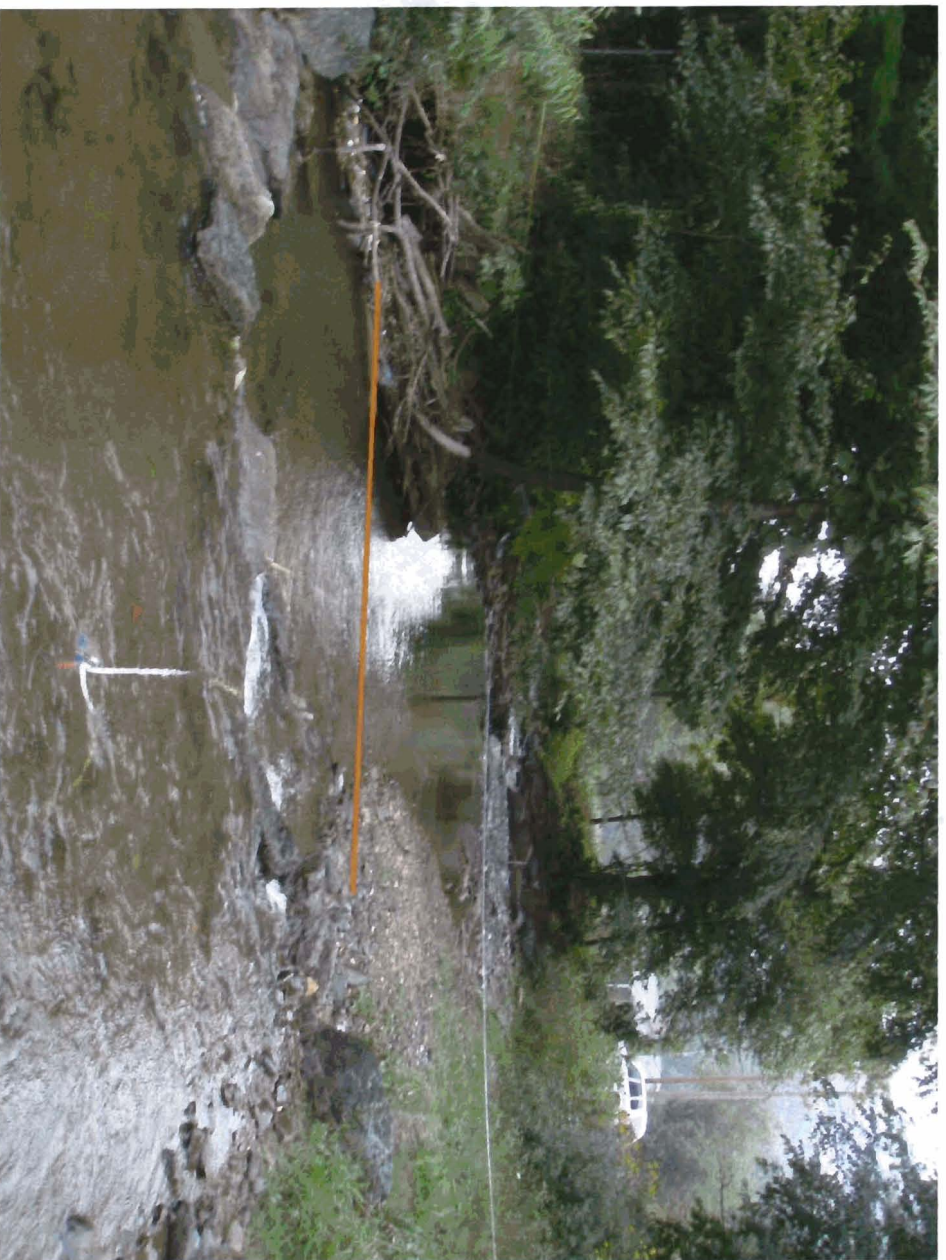
FIGURE 3.3.—Cross-section at station 3+66, pool.

CROSS-SECTION 3+66 – pool (Figure 3.3): This cross-section traverses the middle of a pool just below a rock vane. The pool has deepened at transect location 0+41 since 2006 and rises sharply (0.37 feet) to transect location 0+42. Cross-section location 0+46 has continued to aggrade since the 2005 survey (1.42 feet). However, the stream channel is stable with no bank erosion or lateral movement occurring. Note that the pin at location 0+00 was positioned in the middle of an overgrazed pasture and could not be located in 2006. Subsequently, the cross-section measurements were taken from a point starting at original location 0+24, the location of a fence line.

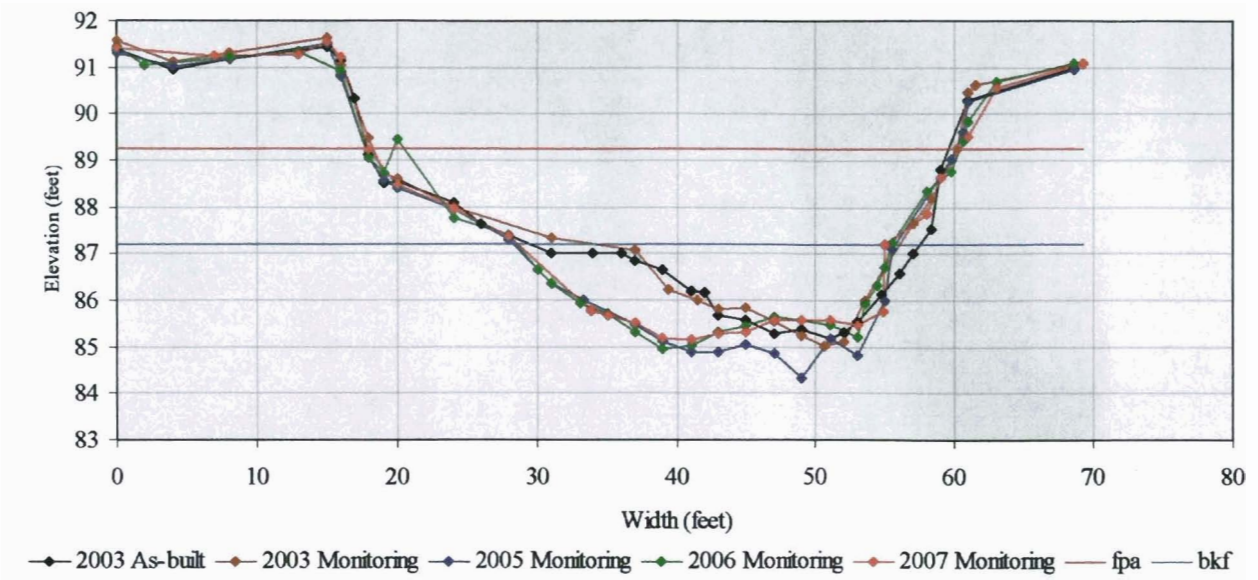
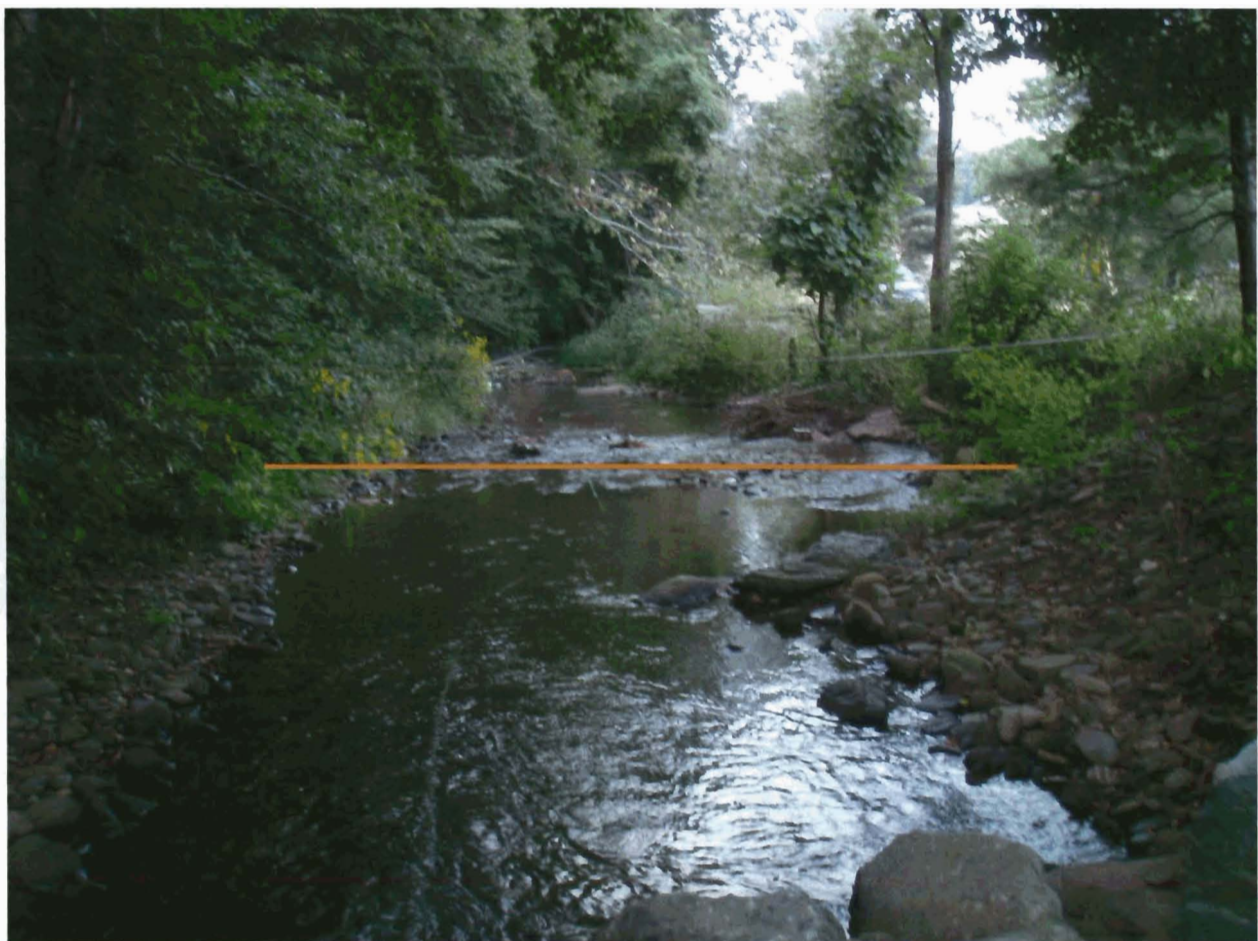
FIGURE 3.4.—Cross-section at station 4+74, riffle.

CROSS-SECTION 4+74 – riffle (Figure 3.4): This cross-section is situated above a rock weir and traverses a riffle. The point bar on the left bank was lowered during the 2004 repairs under the assumption that it would increase in height over time (Mickey and Wasseen 2005). To date, the point bar has not increased in height, but remains stable (Appendix 2). Channel bed material has not accumulated at this location because boulders were added to upstream rock vanes (stations 4+14 to 4+53) as part of the 2004 repairs. Those boulders appear to be deflecting the stream flow toward the left bank (looking downstream) and keeping the point bar at station 4+74 from reforming. The 2006 transect point at location 0+20 was the top of a point bar; however this year's monitoring shows that this high point has been removed. There has been some minor substrate material build-up between locations 0+41 and 0+53, when compared to previous years. The thalweg has moved towards the center of the channel away from the right bank. The banks are stable and there has been no lateral shift in the stream channel since the 2004 repairs.

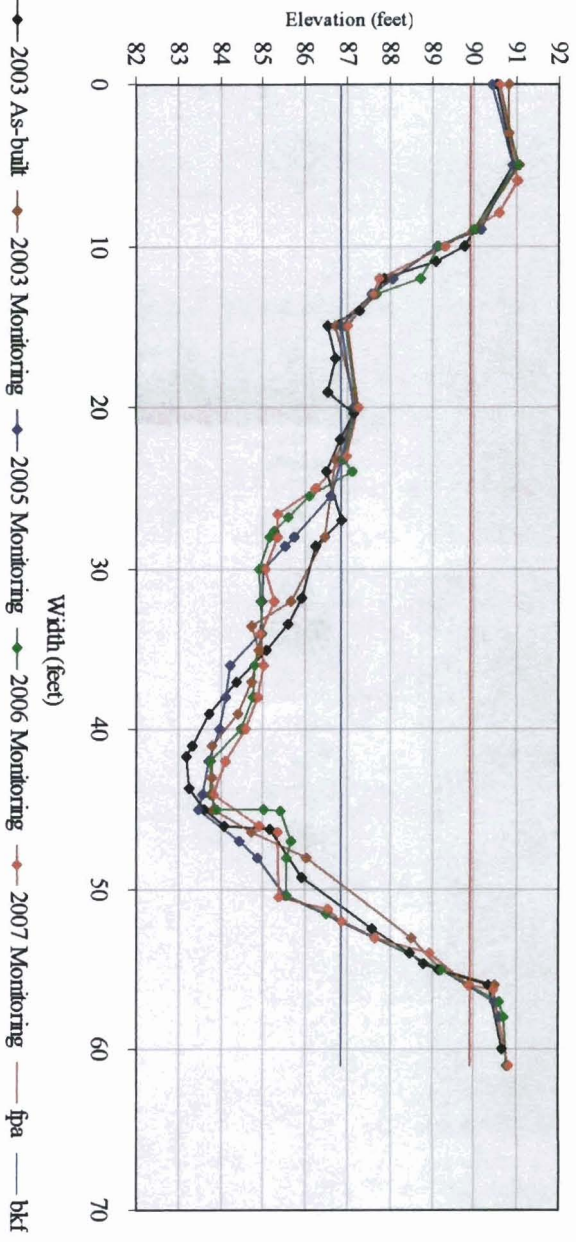
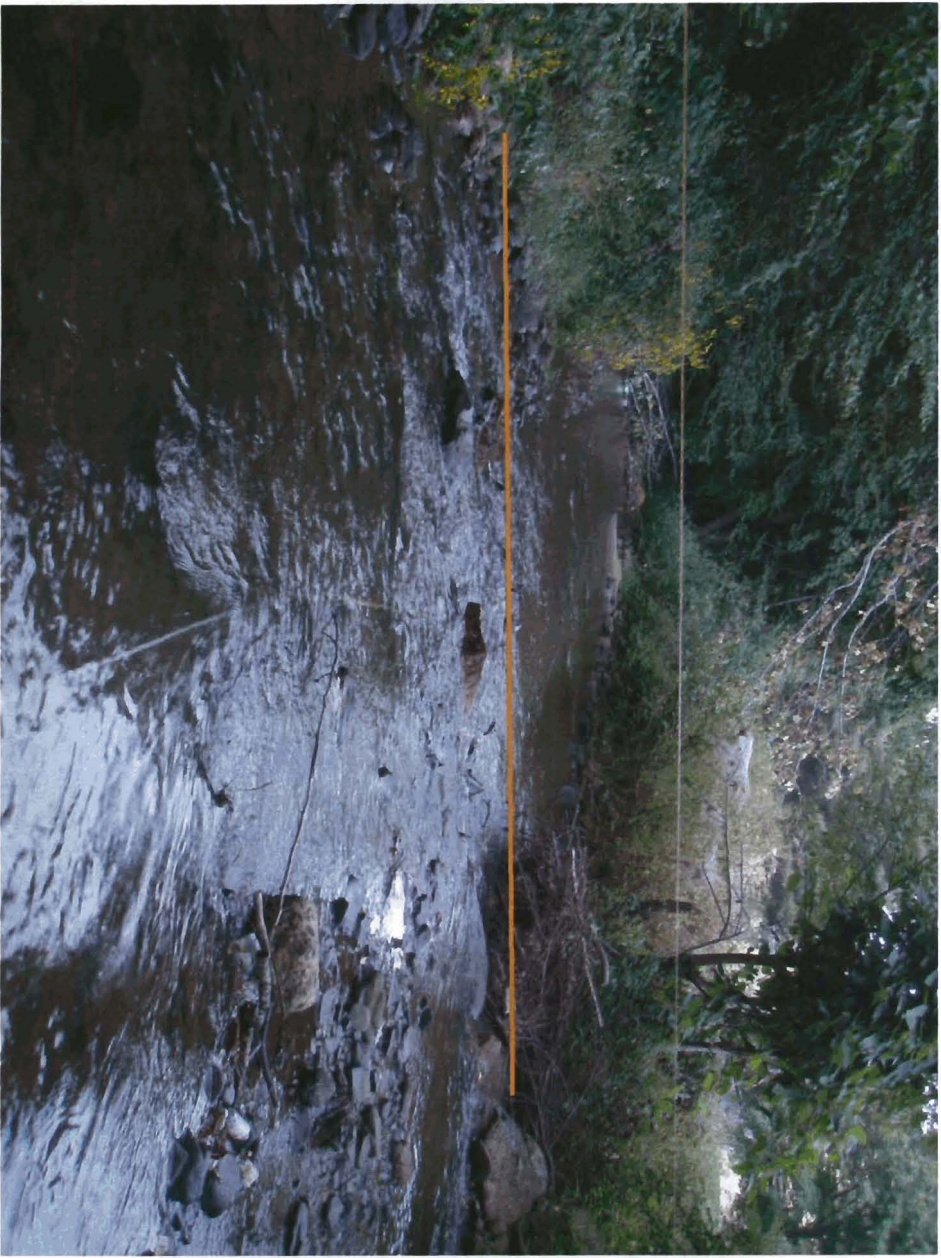
FIGURE 3.5.—Cross-section at station 4+97, pool.

CROSS-SECTION 4+97 – pool (Figure 3.5): The point bar between transect locations 0+25 and 0+35 has degraded and not reformed for the same reasons as the point bar at cross-section 4+74. The channel at transect locations 0+36 to 0+44 displays some signs of aggradation. Some of the woody debris that was caught by the stumps between transect locations 0+45 and 0+50 has been washed away since the 2006 monitoring survey was completed. The banks are stable with no bank erosion or lateral movement occurring.

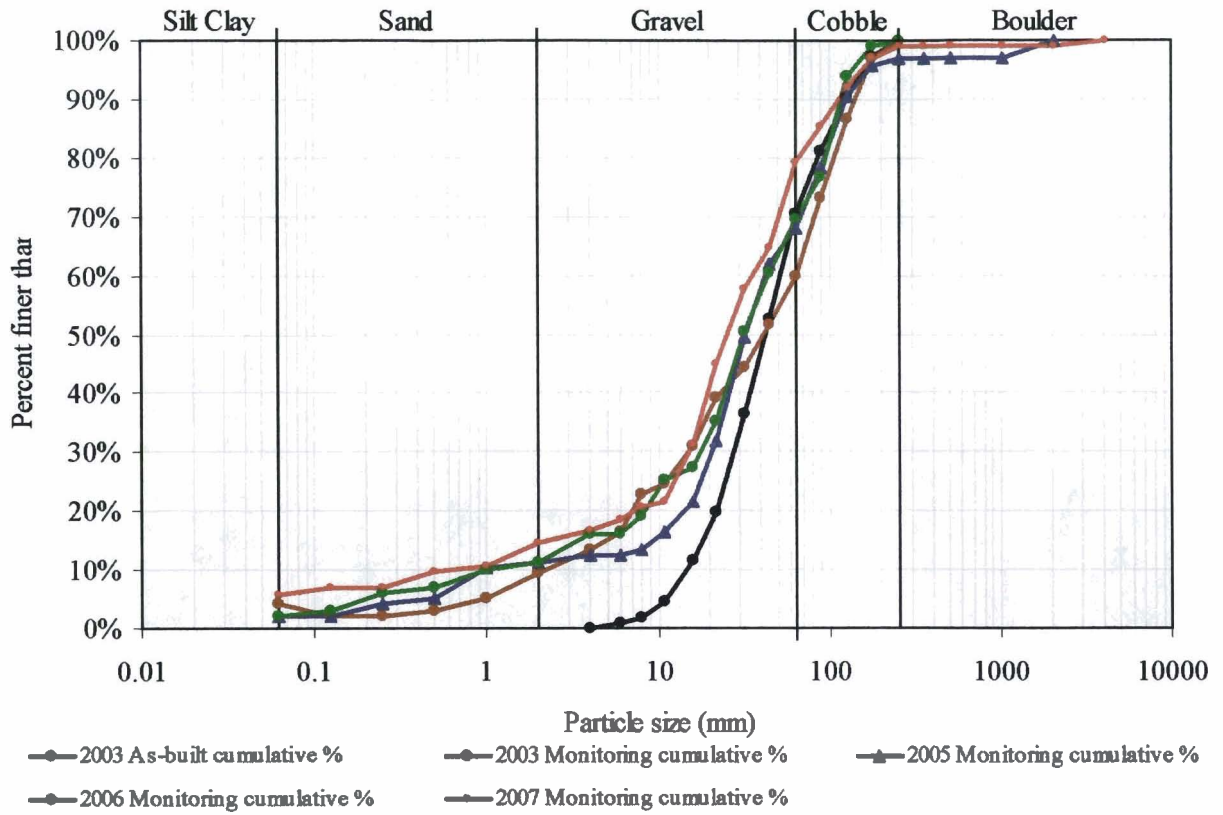
FIGURE 4.—Pebble count data comparisons, Miller et al. mitigation site, Meat Camp Creek, New River basin, Watauga County, 2003-2007.

Pebble count data were collected from a riffle at cross-section 3+37 (Figure 4). Substrate analyses indicate fluctuations in most particle size classes when compared to the previous years' monitoring data. In 2007, there was a slight downward shift of all particle sizes except for D_{95} , which showed an increase over the 2006 count. Since 2003 the D_{50} has decreased from very coarse (47 mm), to coarse (25 mm) gravel (Figure 4). The D_{84} cumulative distribution has ranged from 83 mm to 120 mm (small cobble) (Figure 4). The D_{16} cumulative distribution has decreased from 18 mm (medium gravel) to 3 mm (very fine gravel). This is a result of an increase in the percentage of sand and fine gravels since the 2003 as-built survey. There are four reasons that could explain the decrease in particle sizes:

1. Finer particle sizes are settling out of suspension due to the drought affecting this portion of North Carolina at the time of sampling.

2. Sampling variability.
3. Sediment was transported from disturbed land higher in the watershed.
4. Or a combination of the three.

No signs of active bank erosion were observed during the survey. These changes in particle sizes are not significant enough to be of concern.

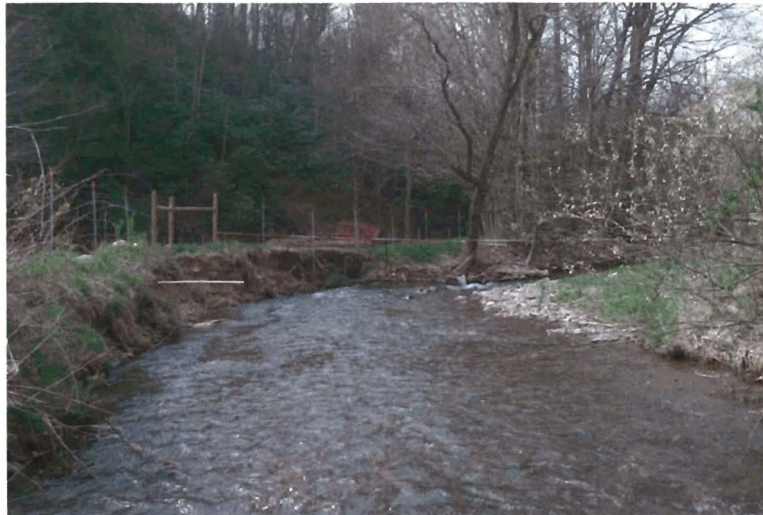
Streambank stabilization work at the Miller et al. mitigation site on Meat Camp Creek was completed on September 23, 2002. A storm event on November 19, 2003 caused major bank failures between stations 3+10 and 3+55 (45 linear feet) and 5+00 and 5+34 (34 linear feet). Before repairs could be made, flooding caused by three hurricanes in September 2004 caused

After November 19, 2003 flood. Notice that 6 ft of the watering tank drainage pipe is exposed.

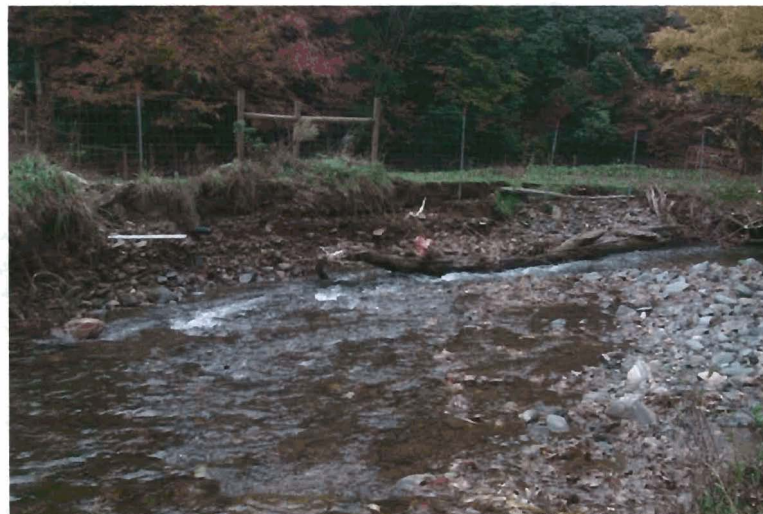
Bank damage after the series of hurricanes in September 2004.

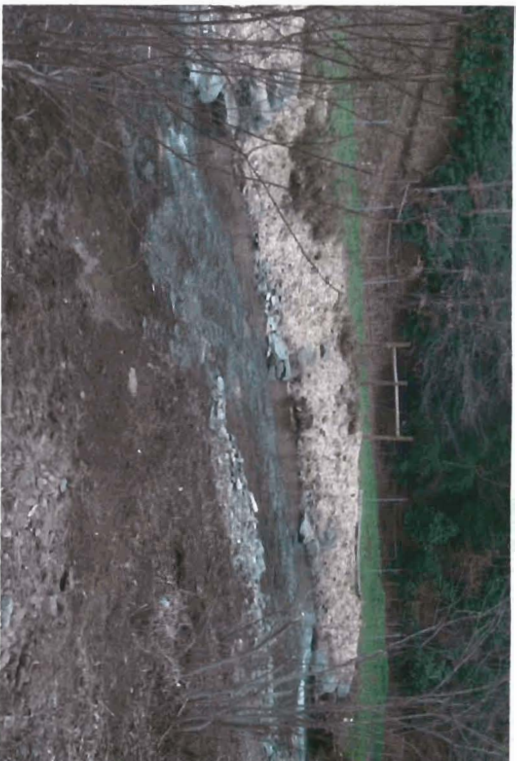
Bank after repairs using three rock vanes, one rock weir, and bank reshaping, November 2004.

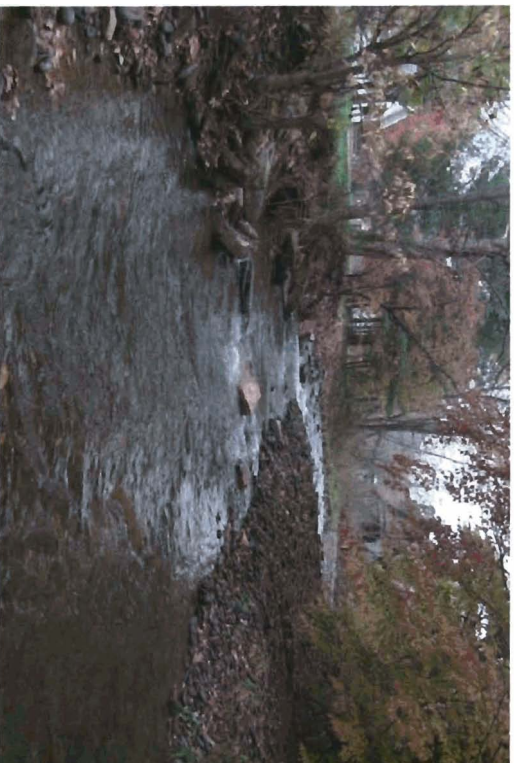
additional damage to the site, from stations 4+15 to 4+90, (Appendices 1 and 2). This damage was repaired on November 19, 2004 (Mickey and Wasseen 2005).

Left and right bank damage after the series of hurricanes, October 2004.

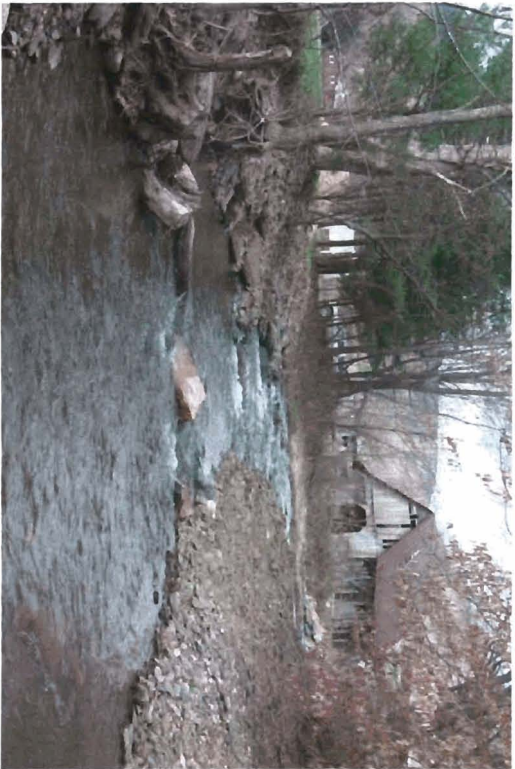
Bank repairs completed, November 2004.
